# National Transportation Safety Board

CEN24LA342

## **MATERIALS LABORATORY**

Factual Report 25-004

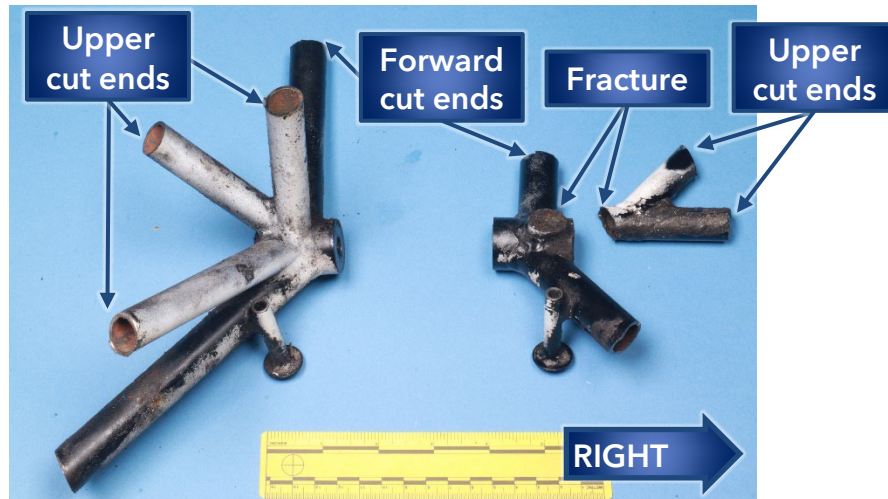
An overall view of the submitted engine mount pieces is shown in figure 1. The pieces consisted of segments of the tubular structure and attachment feet from the attachment location at the upper aft end of the nose landing gear downlock link and brace assembly and had been cut from the remainder of the engine mount. A tubular frame member was fractured at the upper side of the right attachment foot as indicated in figure 1. The frame members connected to the left attachment foot were intact.

**Figure 1.** Overall view of the submitted engine mount pieces.

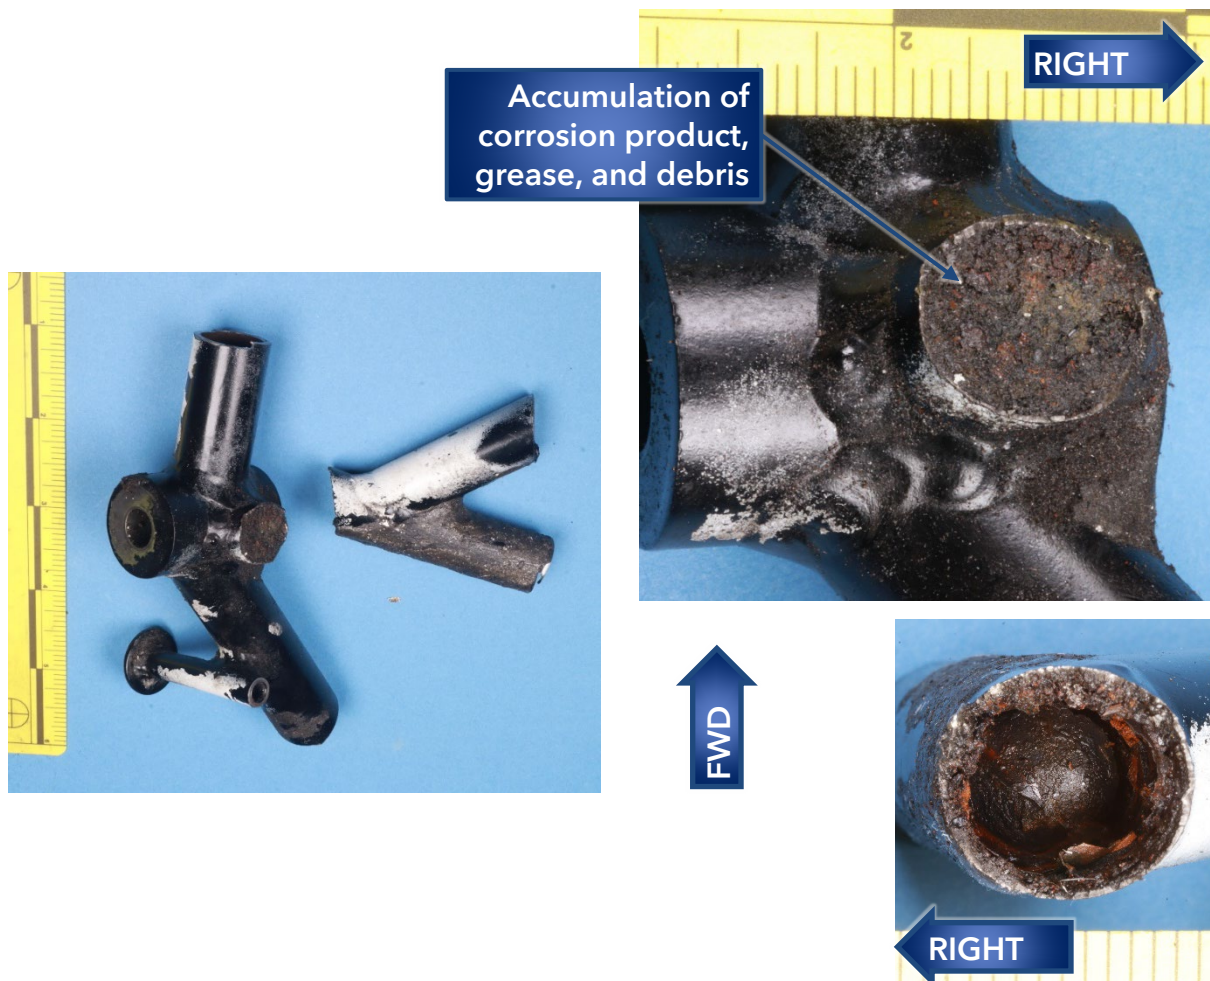
Closer views of the fracture at the upper side of the right attachment foot are shown in figure 2. An angled tube was welded to the left side of the fractured tube just above the fracture location, and both the angled and fractured tubes had been cut approximately 3 inches away from the fracture surface. Greasy deposits were observed covering the black painted surfaces over most of the fractured tube's exterior surface. On the interior of the fractured tube, an accumulation of greasy mostly black deposits of corrosion products and other debris was observed inside the tube piece that remained attached to the foot as shown in the upper right image in figure 2. Similar greasy deposits and accumulations of debris were observed around the inside circumference of the mating side of the fracture as shown in the lower right image in figure 2. A dark rounded film extended across the interior of the fractured tube approximately  $\frac{1}{4}$  inch above the fracture surface, and orange oxide flakes extended radially inward from interior surfaces between the fracture surface and the rounded film.

**Figure 2.** Closer views of the fracture surfaces as received.

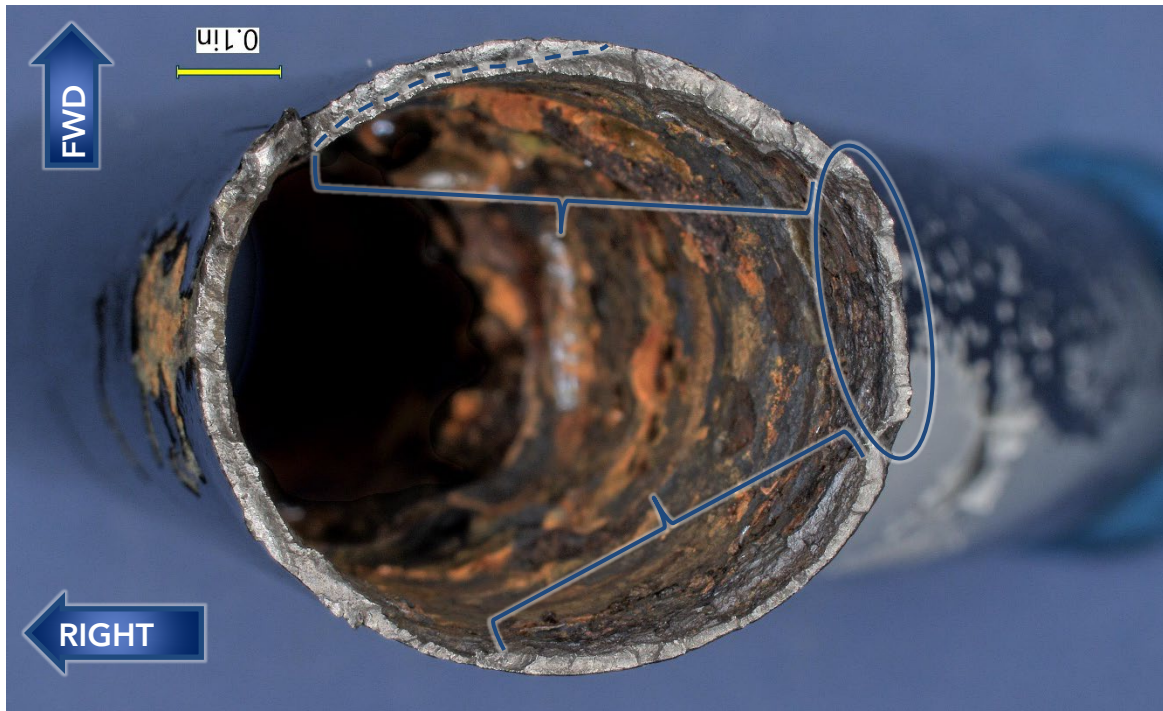
A view of the upper fracture surface after cleaning is shown in figure 3. The interior surface above the fracture was oxidized with black, red, and orange oxides. The tube wall showed thickness loss consistent with corrosion damage, which was most extensive on the left half of the circumference. Figure 4 shows an area of wall loss in the aft left quadrant where the remaining fractured wall thickness was 0.007 inch at the location indicated. In the forward left quadrant shown in figure 5, a pit extended nearly through the tube wall at the location shown with an unlabeled arrow. For comparison, the wall thickness as measured at the cut location on the upper end of the same tube was 0.034 inch.

**Figure 3.** Upper fracture surface after degreasing and ultrasonic cleaning. Brackets indicate multiple fatigue origins extending through thickness or to the fatigue boundary indicated with a dashed line. A circle indicates a damaged area with obliterated fracture features on the left side of the fracture.

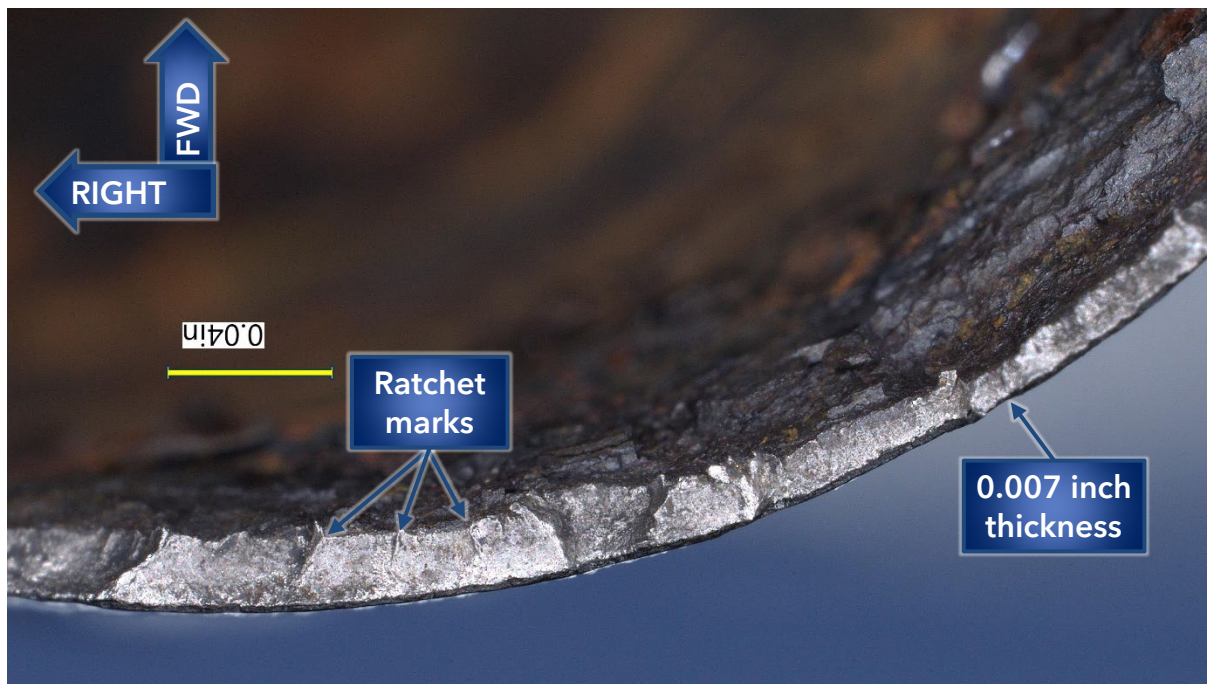
The fracture surface generally showed substantial damage from oxidation and post-fracture contact. However, areas with relatively flat features in planes perpendicular to the tube axis were observed in several locations mostly on the left half of the fracture such as the areas shown in figures 4 and 5. Additional features including radial lines and ratchet marks such as those indicated in figure 4 were also observed in these areas emanating from the interior edge of the fracture. These fracture features were consistent with fatigue initiating from corrosion pits at the interior surface of the tube. The fatigue regions had multiple origins at locations indicated with unlabeled brackets in figure 3. The fatigue regions appeared to extend through the wall thickness in the aft fatigue region and the left half of the forward fatigue region. At the forward right side of the fracture, the fatigue region extended part way through the thickness to the indicated fatigue boundary. The circled area at the left side of the fracture was smeared from post-fracture damage, so the fracture mechanism was undetermined in that area. The remainder of the fracture surface outside of the fatigue boundary and to the right of the fatigue regions had rough features on slant angles consistent with ductile overstress fracture.

**Figure 4.** Portion of the fracture surface with flat fracture features, ratchet marks, and radial features consistent with fatigue with multiple origins at the inside diameter.

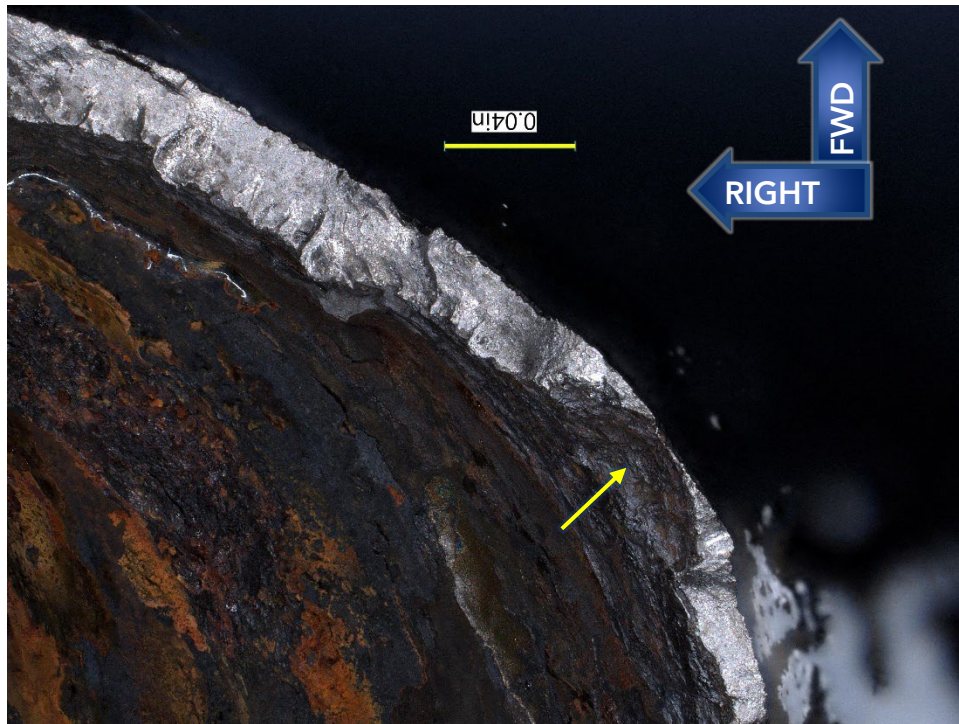
**Figure 5.** Area (indicated with an unlabeled arrow) where wall loss from corrosion extended nearly through the thickness.

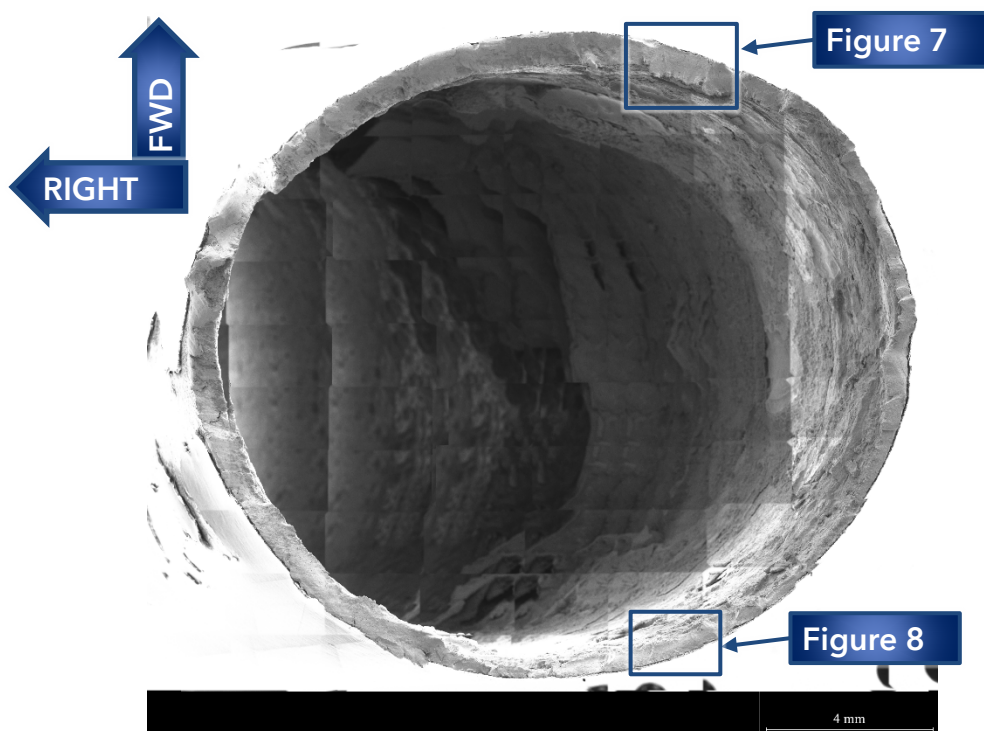
The fracture was further examined using a scanning electron microscope (SEM). A montage of SEM images stitched together to show an overall view of the fracture surface is shown in figure 6, and magnified views of fatigue regions in the indicated areas are shown in figures 7 and 8. Most fine fracture features were obliterated from post fracture oxidation and contact damage. However, radial marks showing fracture propagation initiating from corrosion pits at the interior surface of the tube were observed as shown in figure 7. At the location shown in figure 8, ratchet marks and faint curving crack arrest lines consistent with fatigue were

**Figure 6.** Montage of SEM images stitched together to show an overall view of the fracture surface.

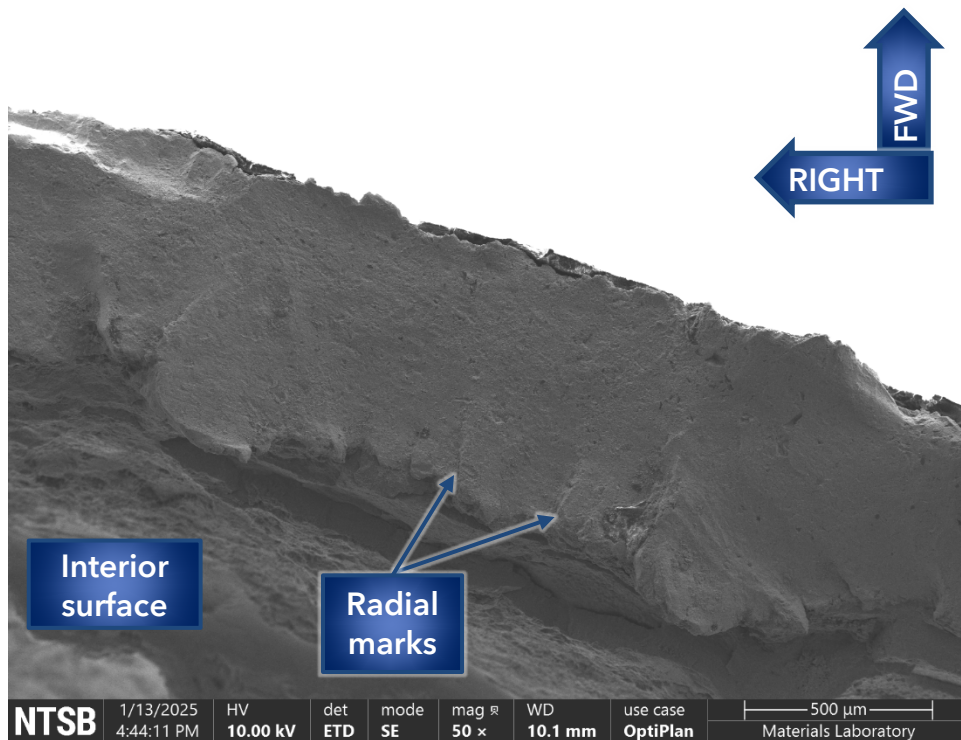
**Figure 7.** SEM image of flat features consistent with fatigue and post-fracture damage with radial features emanating from corrosion pits at the interior surface.

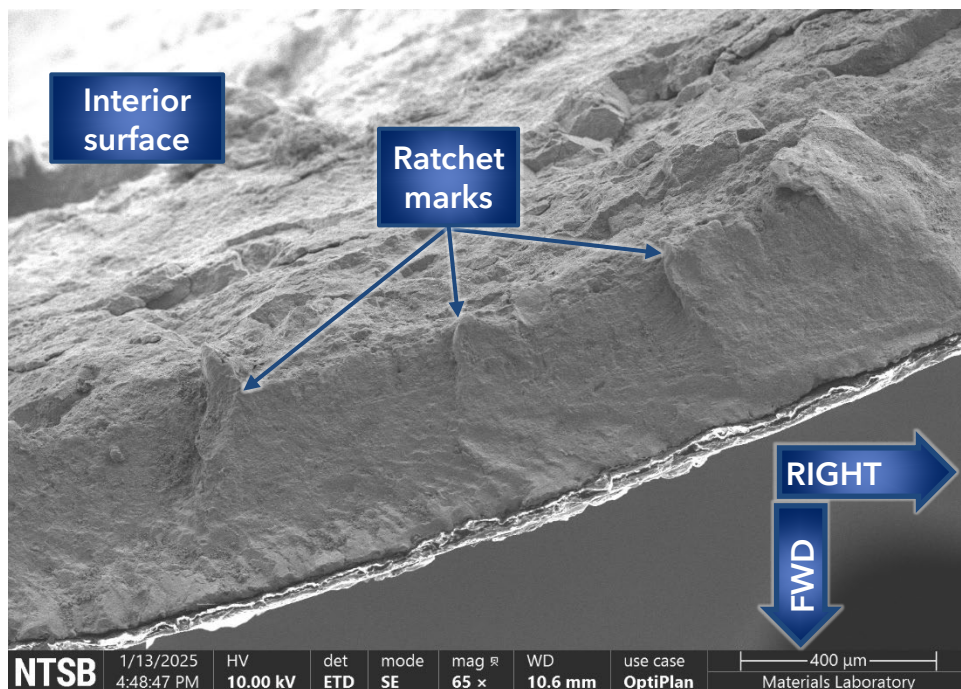
observed. The fatigue region had multiple origins at the interior surface that was roughened and pitted from corrosion.

**Figure 8.** Ratchet marks and curving crack arrest lines consistent with fatigue with multiple origins at the corroded interior surface.

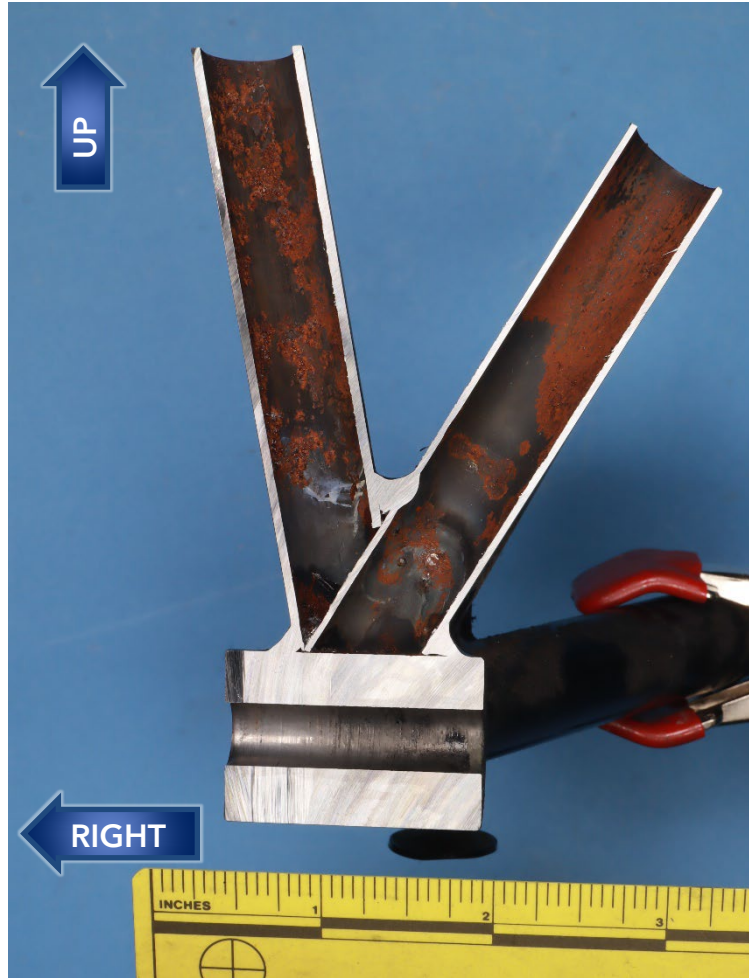
The intact vertical tubes attached to the left attachment foot shown in figure 1 were examined under an optical stereomicroscope, and no evidence of cracks were observed in the painted surfaces. Next, a transverse cut in the vertical plane was made through the center of the left attachment foot and two of the tubes attached to the upper side of the foot. A view of the cut surfaces on the aft piece is shown in figure 9. The interior surfaces of the tubes had dark areas that included longitudinally-oriented linear sliding contact features consistent with original manufacturing interspersed with areas of superficial orange oxides. The walls of both tubes appeared relatively uniform along the length of the cut and showed no evidence of thinning from corrosion.

**Figure 9.** Aft side of the left foot and vertical tube members after cutting to expose the interior surfaces of the vertical tubes.
