# National Transportation Safety Board

CEN24LA344

## EXAMINATION SUMMARY

Location: Rifle, Colorado  
Date: September 8, 2024  
Time: 1533 mountain daylight time  
Airplane: N36008; Bellanca 7GCAA Citabria

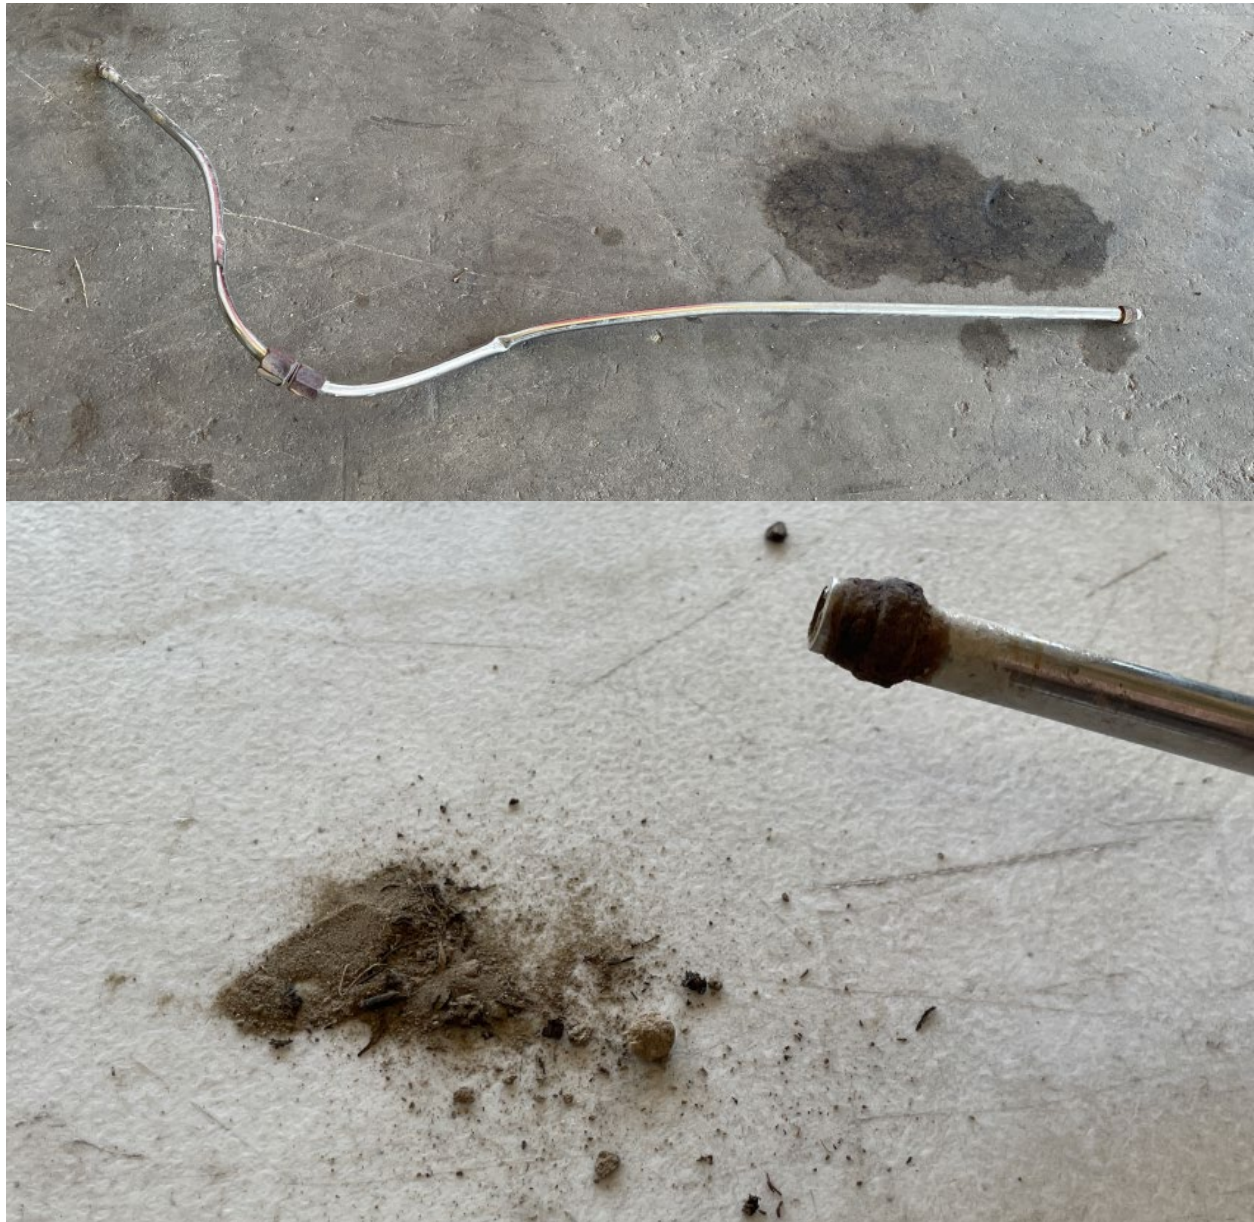
disconnected during the recovery process. Air was blown through the wing fuel lines to the fuel tanks and to the fuel vent – all of which were free of obstructions. The wing tank vent interconnect line was found bent and disconnected and contained a small amount of dirt and organic matter. The dirt in this line was similar to the dirt found in on the airplane and inside the exhaust system from the accident site; therefore, it's likely that the dirt was introduced into the line during the recovery process and was not present before the accident.

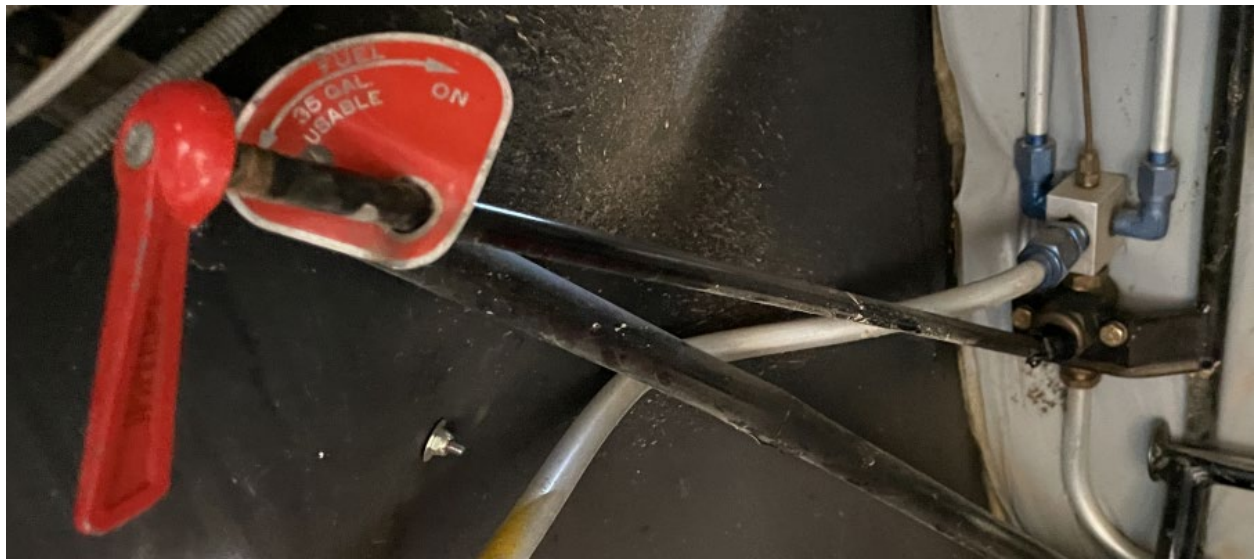
The firewall fuel strainer sustained impact damage and the bowl was loose from the housing. The bowl contained a very small amount of dirt. The quick drain plug was bent slightly from impact damage and would not hold a tight seal. There was no sign of fuel staining on the engine cowling or firewall.

The fuel shutoff handle was found ON and the control rod was slightly bent but remained functional and could be rotated to the ON and OFF positions.

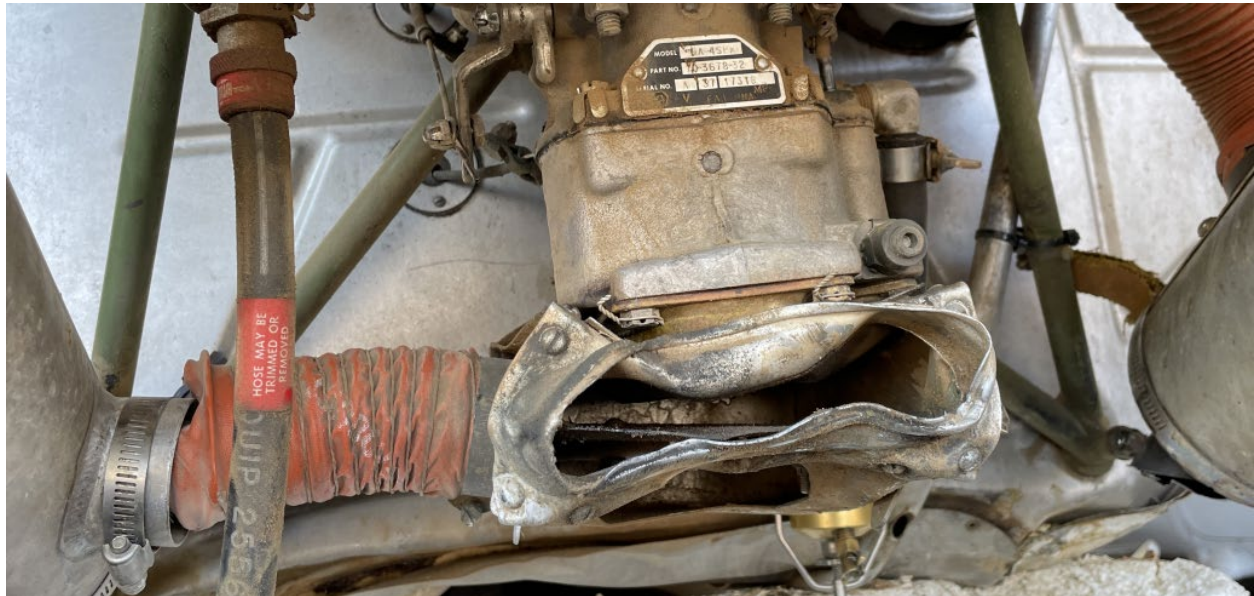
The carburetor remained installed to the bottom of the engine with its corresponding fuel lines installed. Both the throttle linkage and mixture linkage were found secure to the carburetor. The throttle moved through its full range of motion via control knob. The mixture control moved to the full rich position but exhibited some binding when pulled to the idle cutoff position due to bending and damage at the firewall. The carburetor heat control linkage remained secure at the carburetor and was continuous to the cockpit control; however, impact related damage to the airbox precluded the control from being moved through its full range of motion.

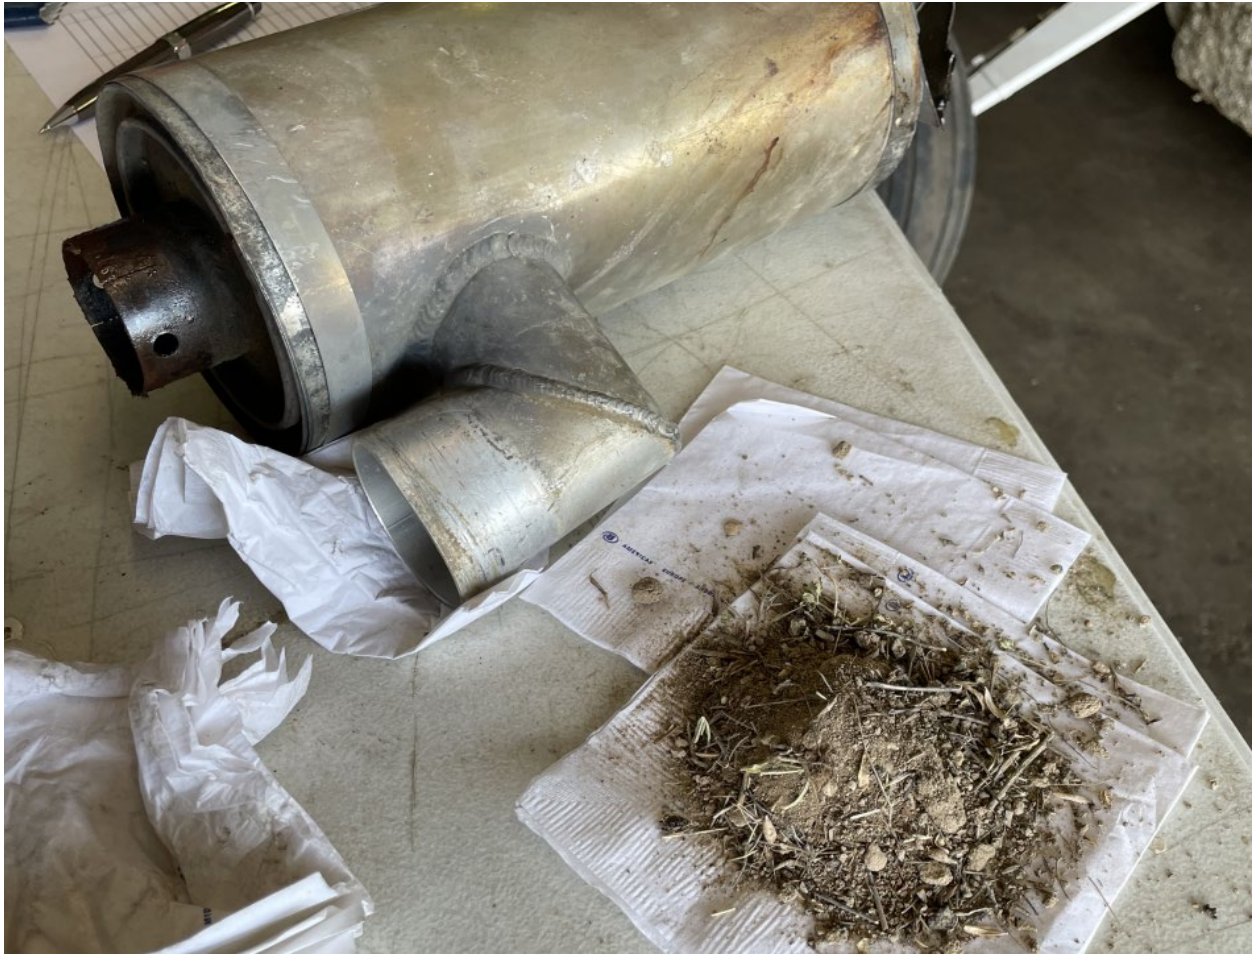
The exhaust system remained installed and sustained minor impact damage at the exhaust pipes from the muffler. The right side muffler was removed, and the internal components were undamaged. The left side muffler was removed and contained a few ounces of dirt and organic matter, but the internal components were undamaged.
