CEN24LA366

## INVESTIGATION PHOTOGRAPHS

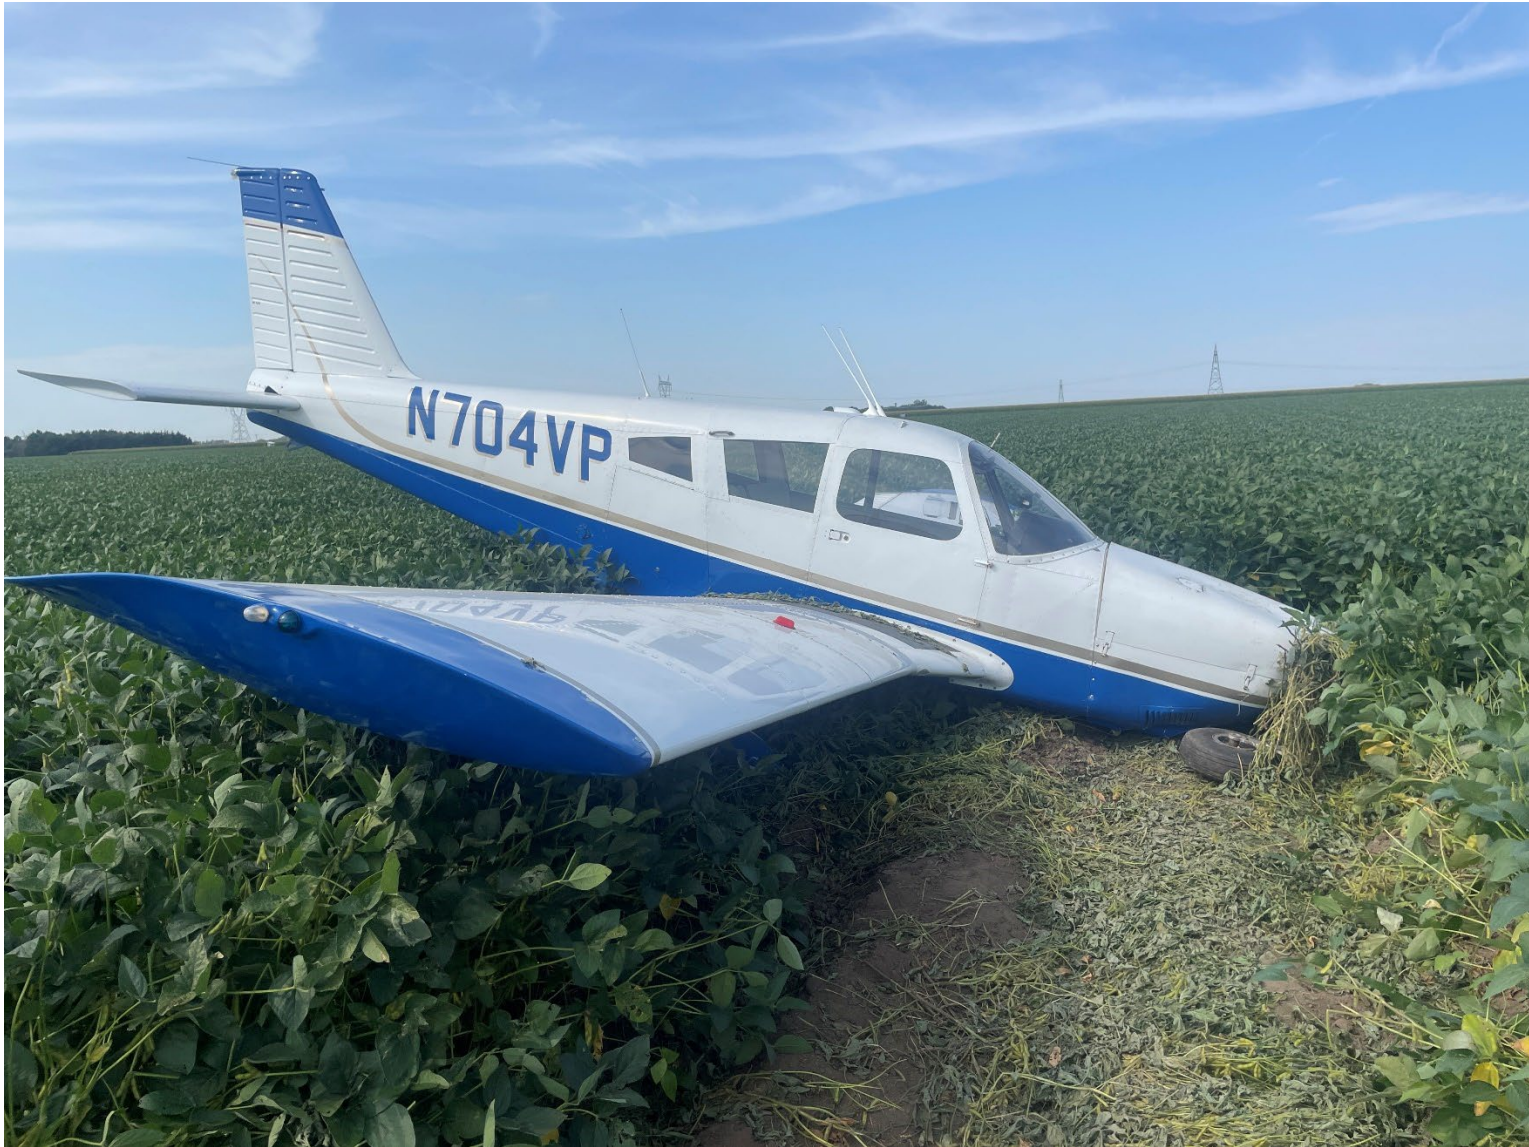
**Photograph 1 - Accident Site (Courtesy of the Federal Aviation Administration)**

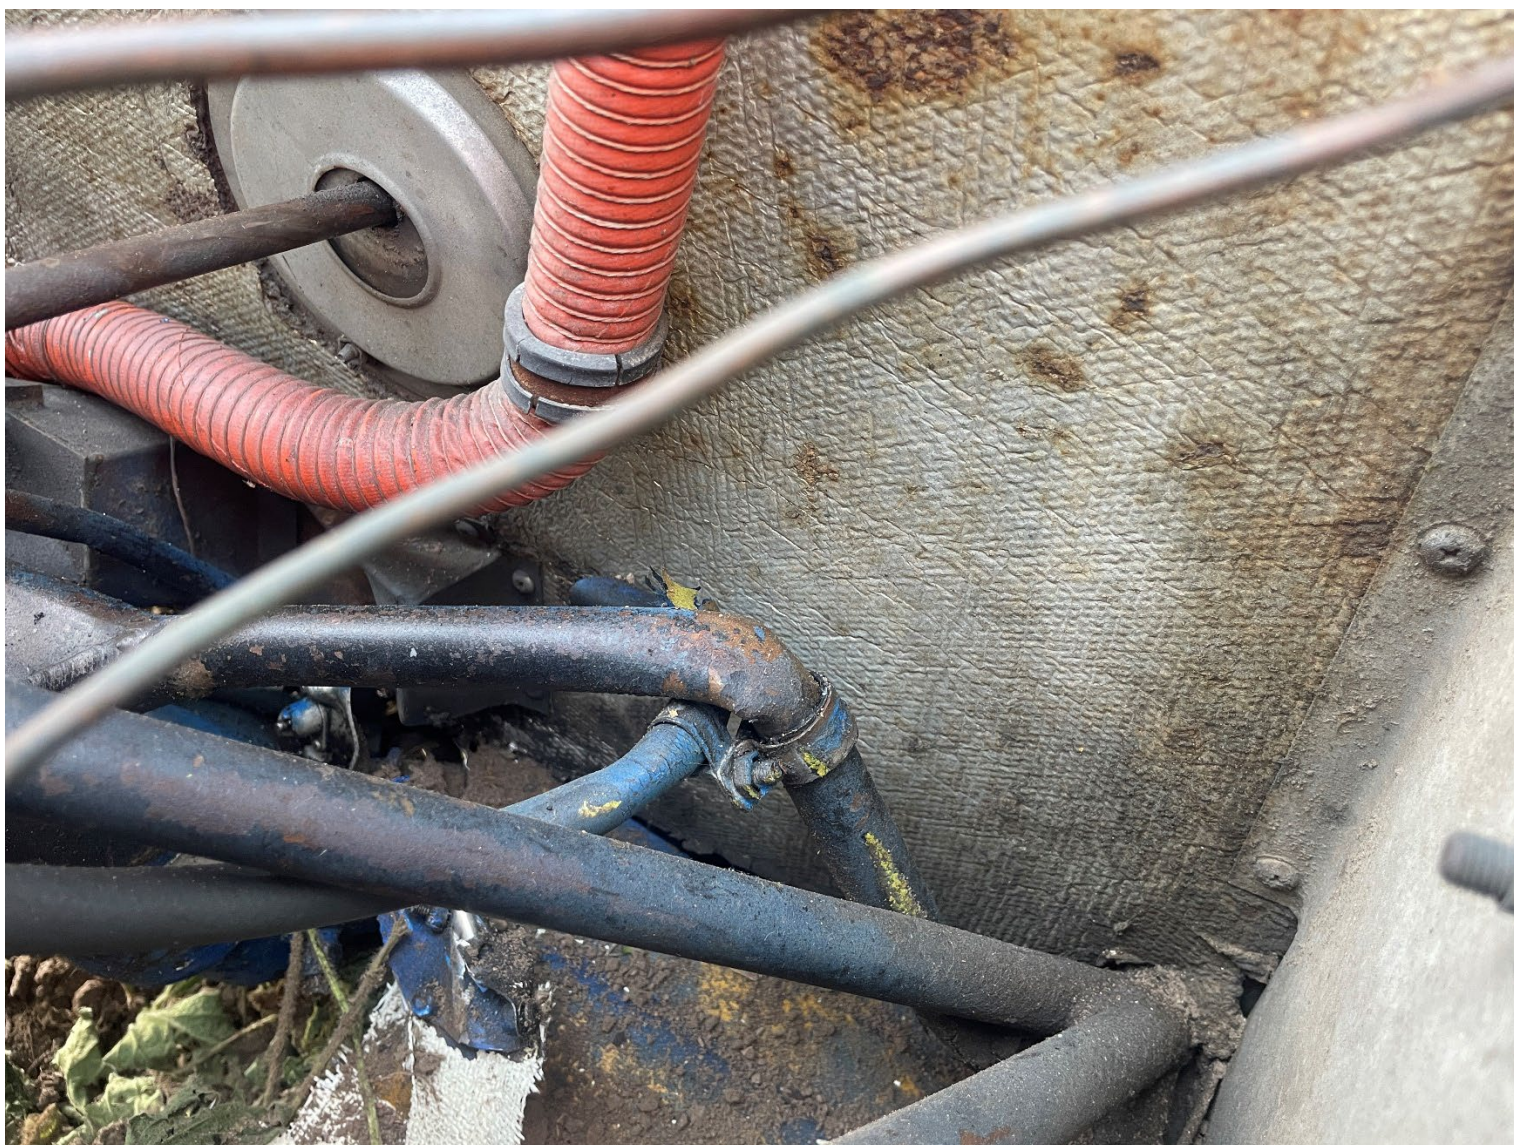
**Photograph 2- Damaged Engine Mount (Courtesy of the Federal Aviation Administration)**
