CEN24LA350

## INVESTIGATION PHOTOGRAPHS

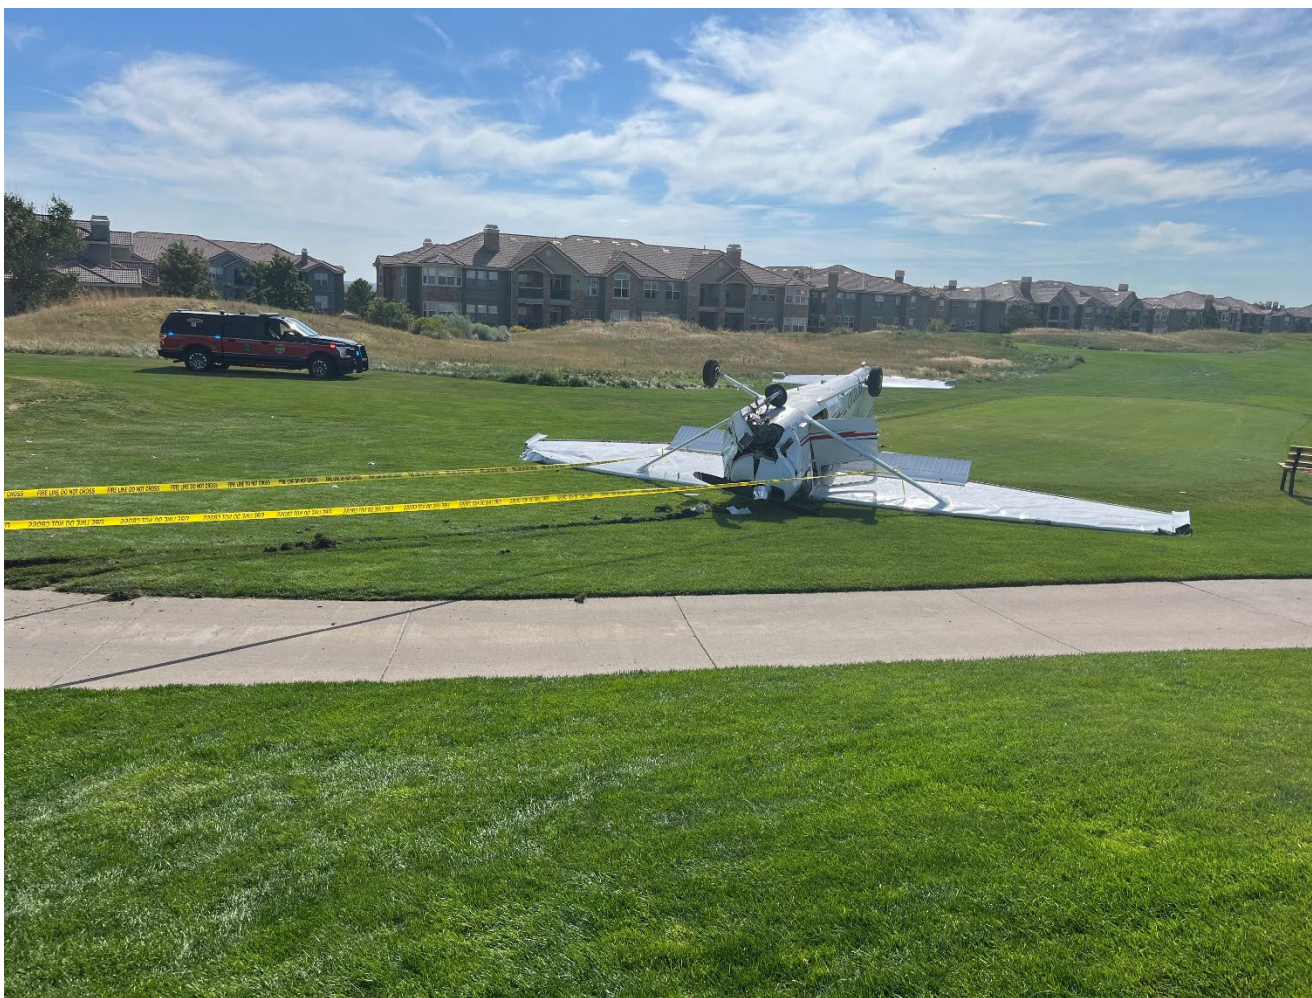
**Photograph 1 - Accident Overview (Courtesy of FAA)**

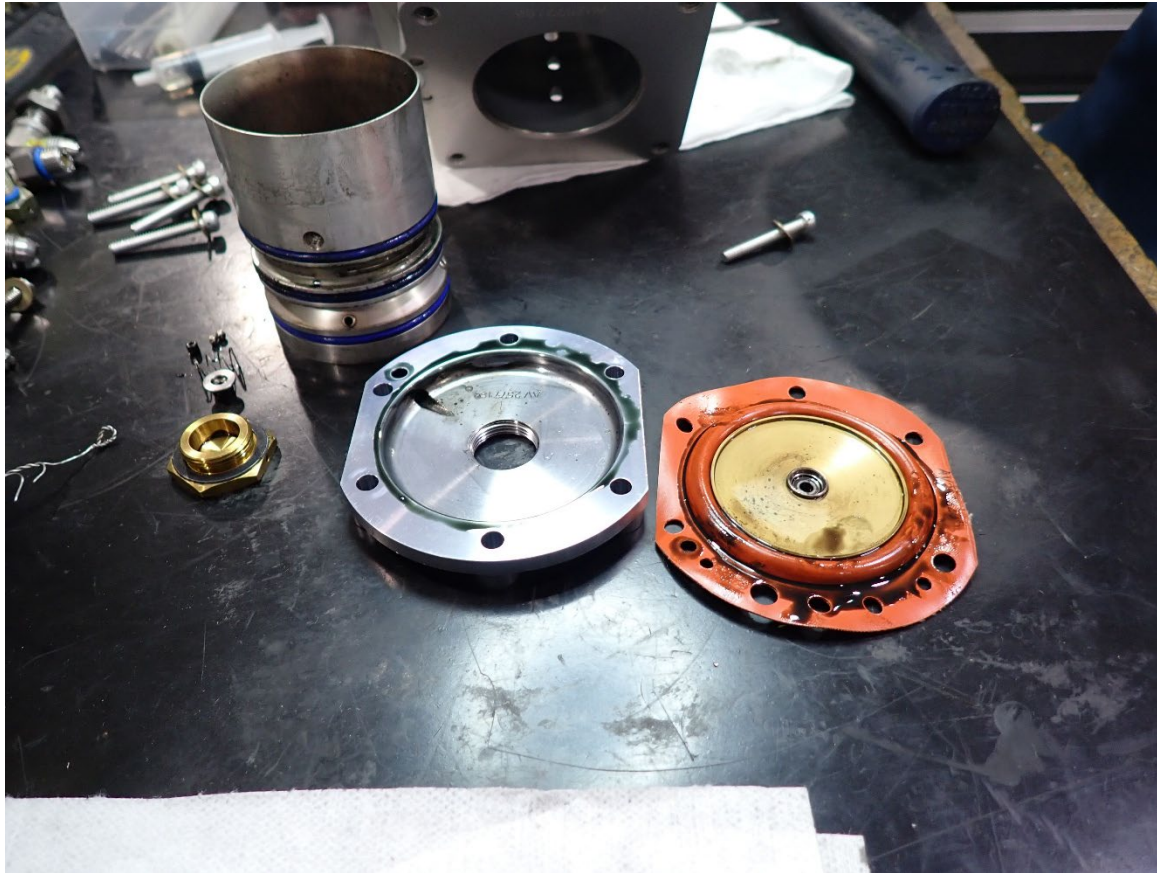
**Photograph 2 - Venturi and Air Diaphragm (Courtesy of FAA)**
