# National Transportation Safety Board

CEN24LA350

## EXAMINATION SUMMARY

Location: Meridian, Colorado  
Date: September 11, 2024  
Time: 0940 mountain daylight time  
Airplane: Cessna 172S, N20747

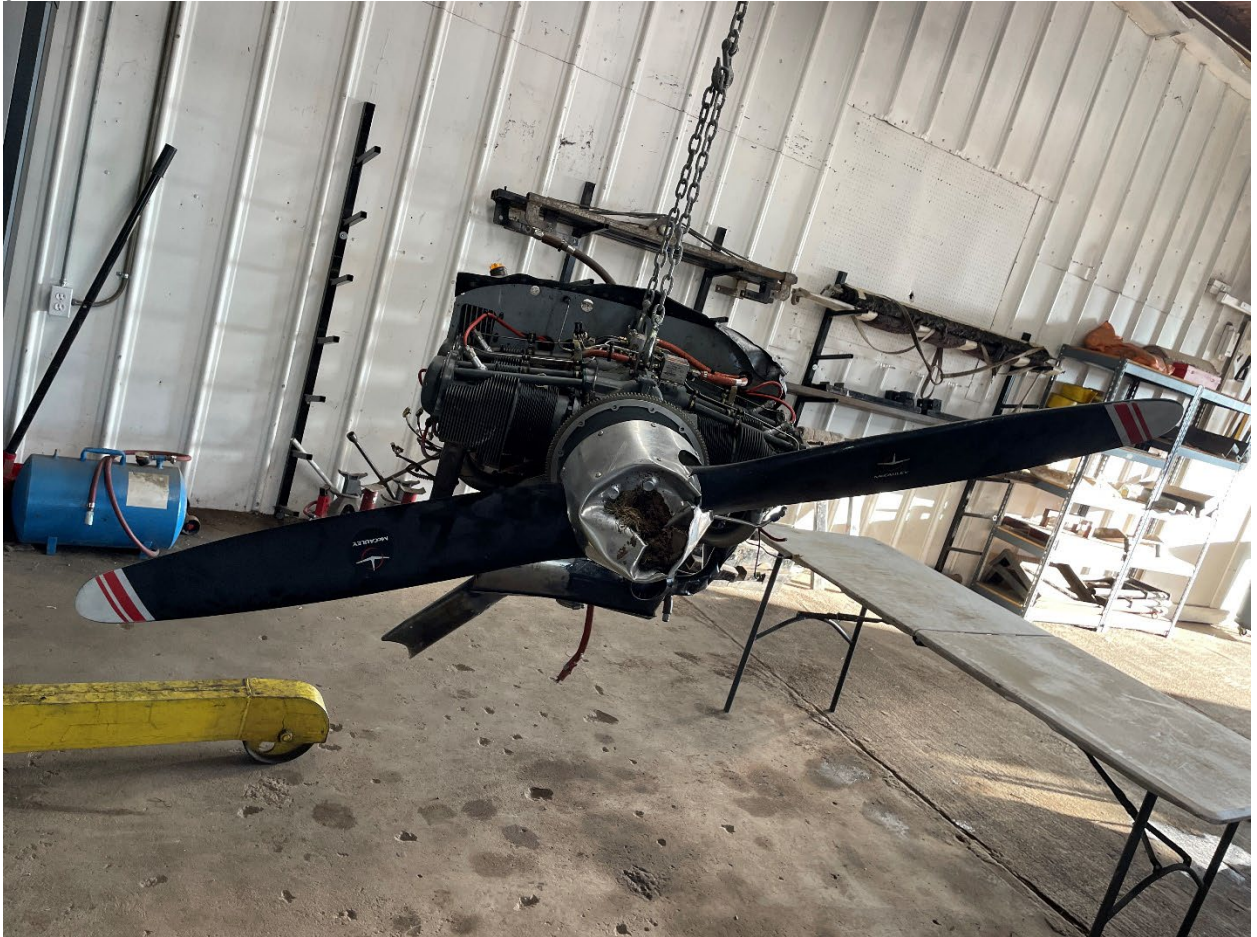
**Figure 1.** Propeller and engine as presented for examination.

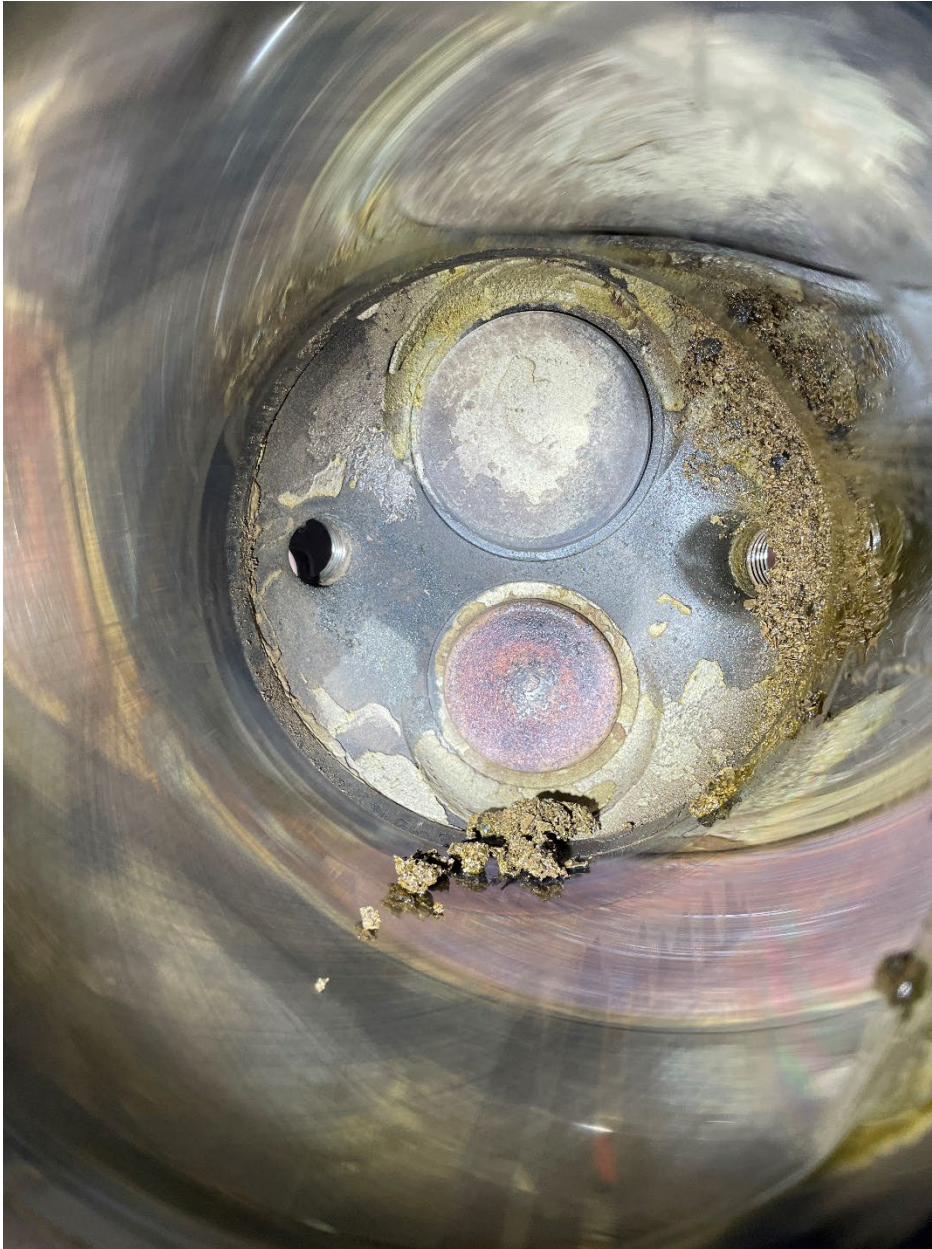
All cylinders were found tightly installed to the engine case. The upper spark plugs, and rocker covers were removed. Suction and compression were felt on all cylinders excluding cylinder number 2 during engine rotation. Cylinder 2 had less compression compared to the other cylinders. Cylinder number 2 was removed and examined. Sand was found inside the cylinder. All other cylinders were borescoped and no abnormalities were found. The cylinder intake flange was impact damaged. All spark plugs were removed and inspected. All spark plugs exhibited normal wear pattern and coloration consistent with normal engine operation.

**Figure 2.** Sand Debris Cylinder number 2

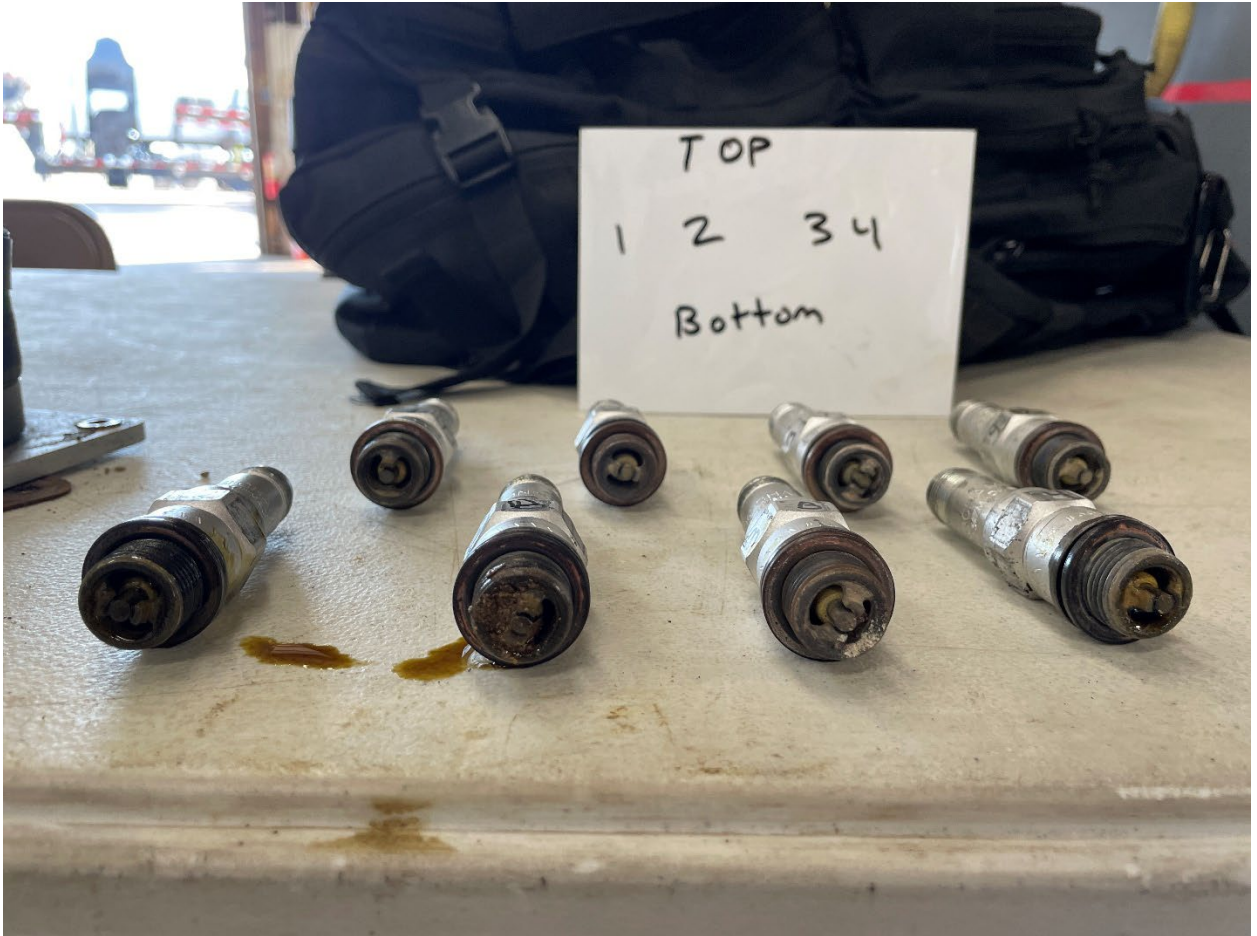
**Figure 3.** Spark plugs
