CEN24LA354

## INVESTIGATION PHOTOGRAPHS

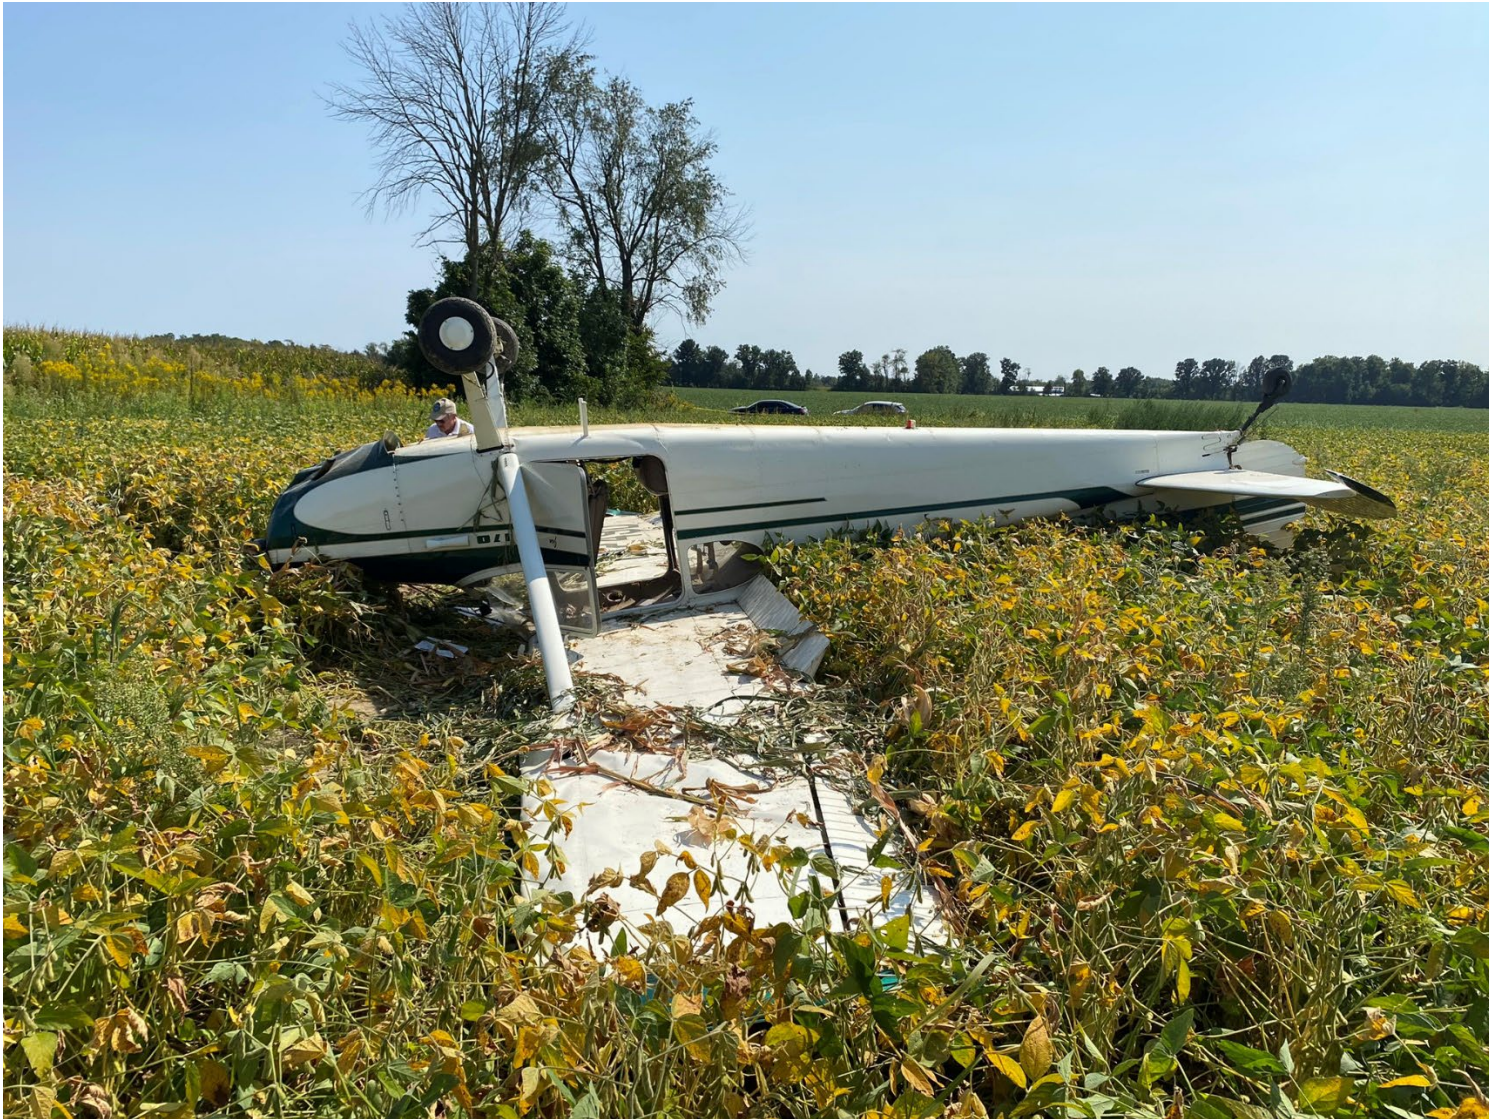
**Photograph 1 - Accident Site (Courtesy of the Federal Aviation Administration)**

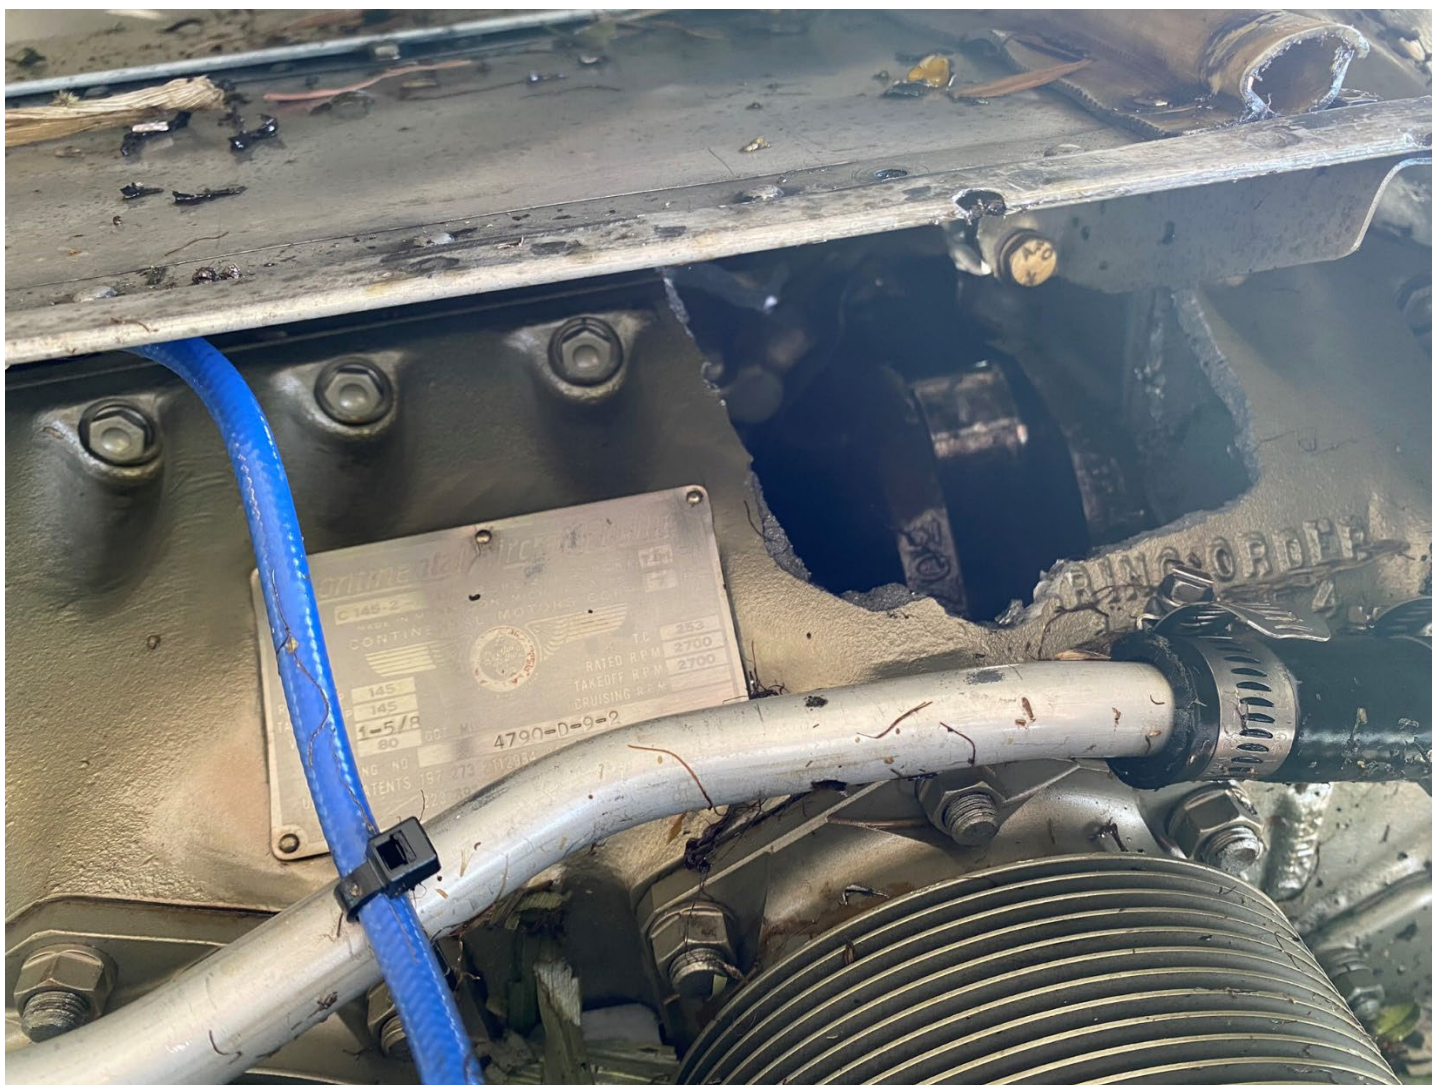
**Photograph 2 - Number 5 Cylinder (Courtesy of the Federal Aviation Administration)**

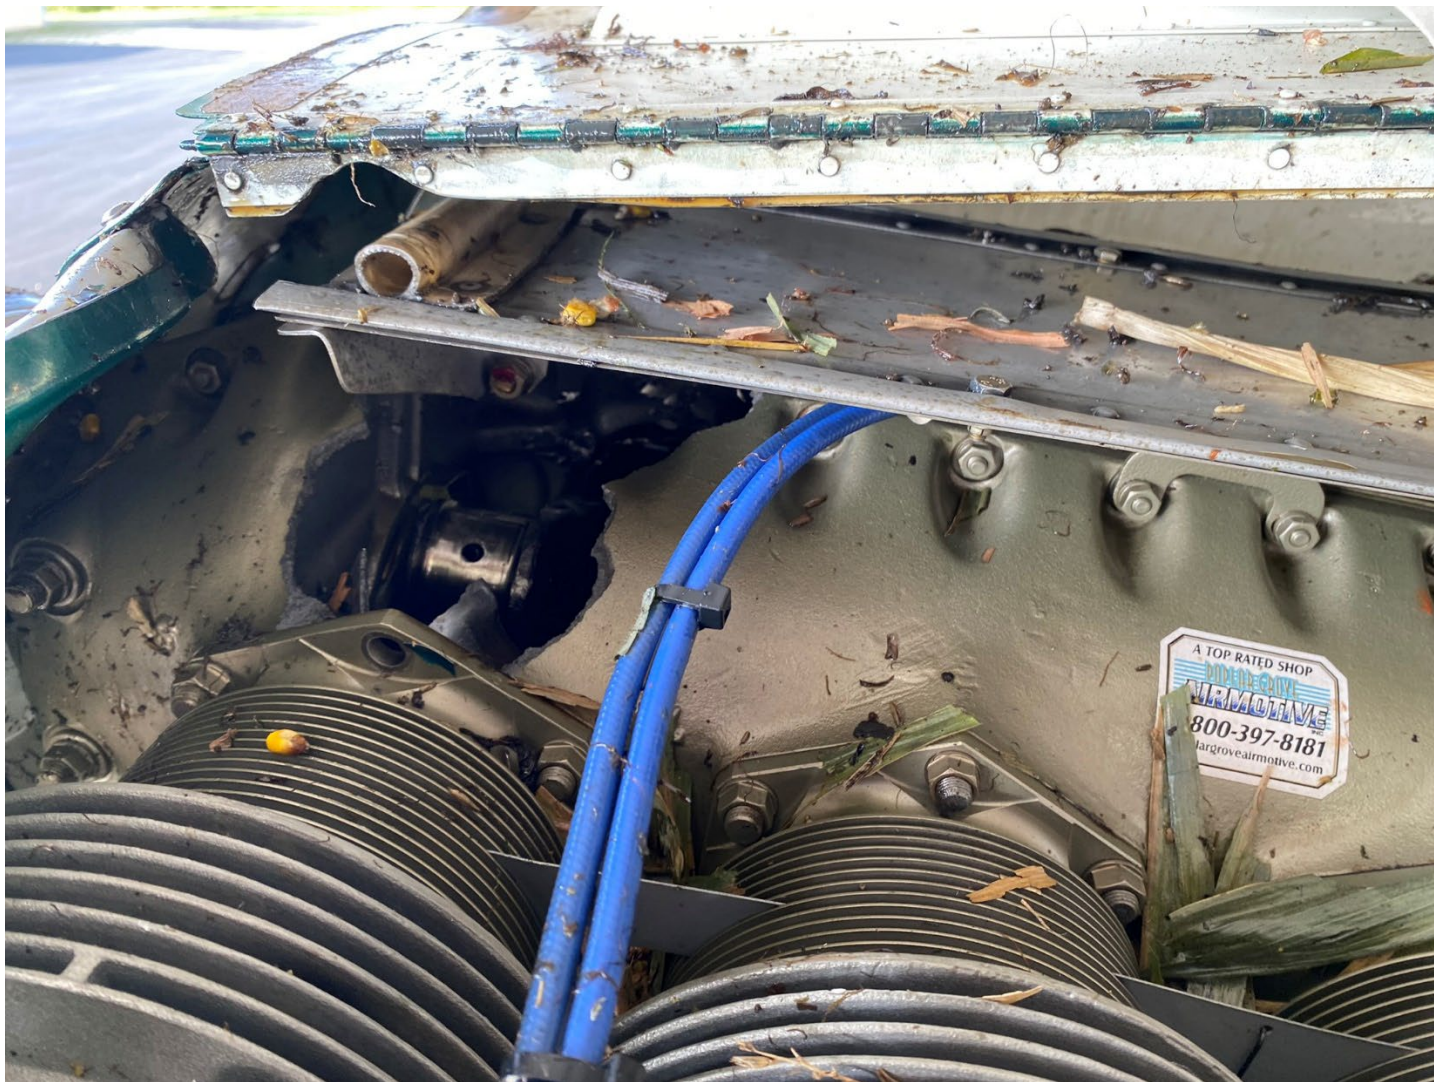
**Photograph 3 - Number 6 Cylinder (Courtesy of the Federal Aviation Administration)**

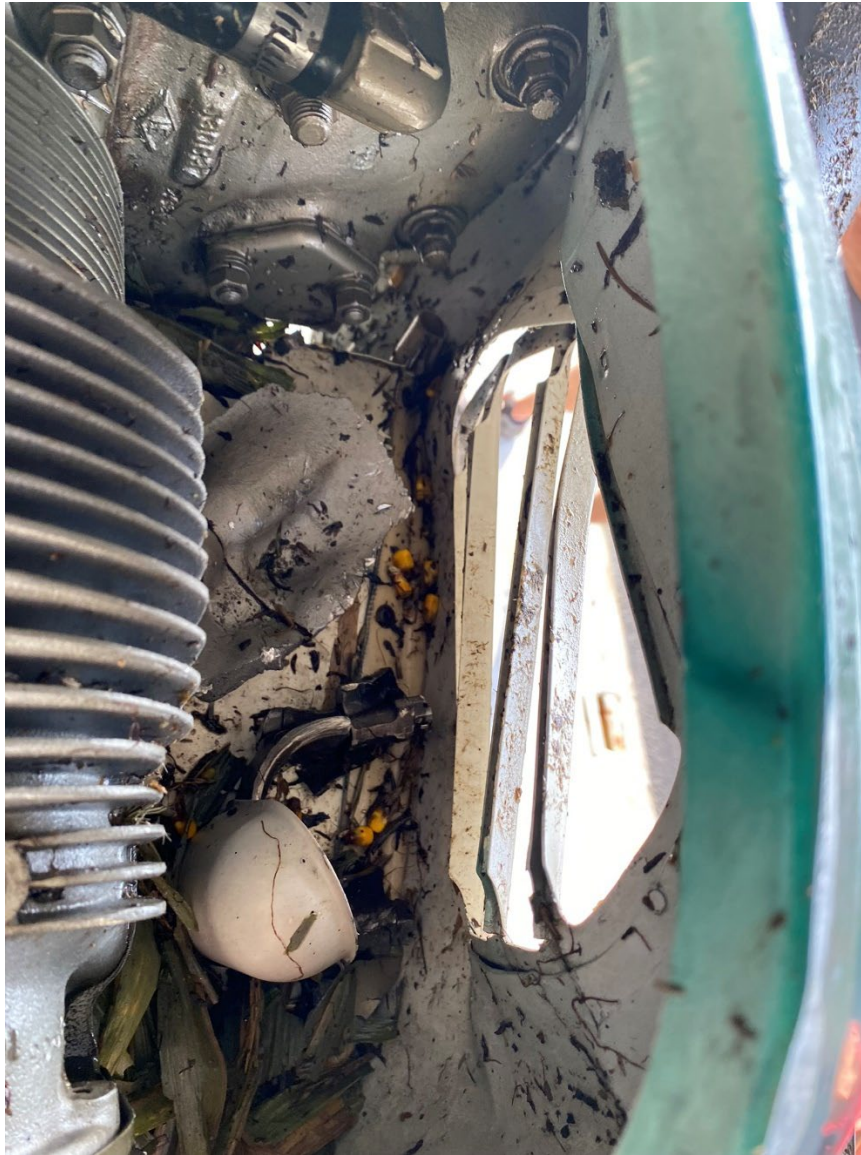
**Photograph 4 - Rod End Cap (Courtesy of the Federal Aviation Administration)**
