# National Transportation Safety Board

CEN24LA354

## **MATERIALS LABORATORY**

Factual Report 25-015

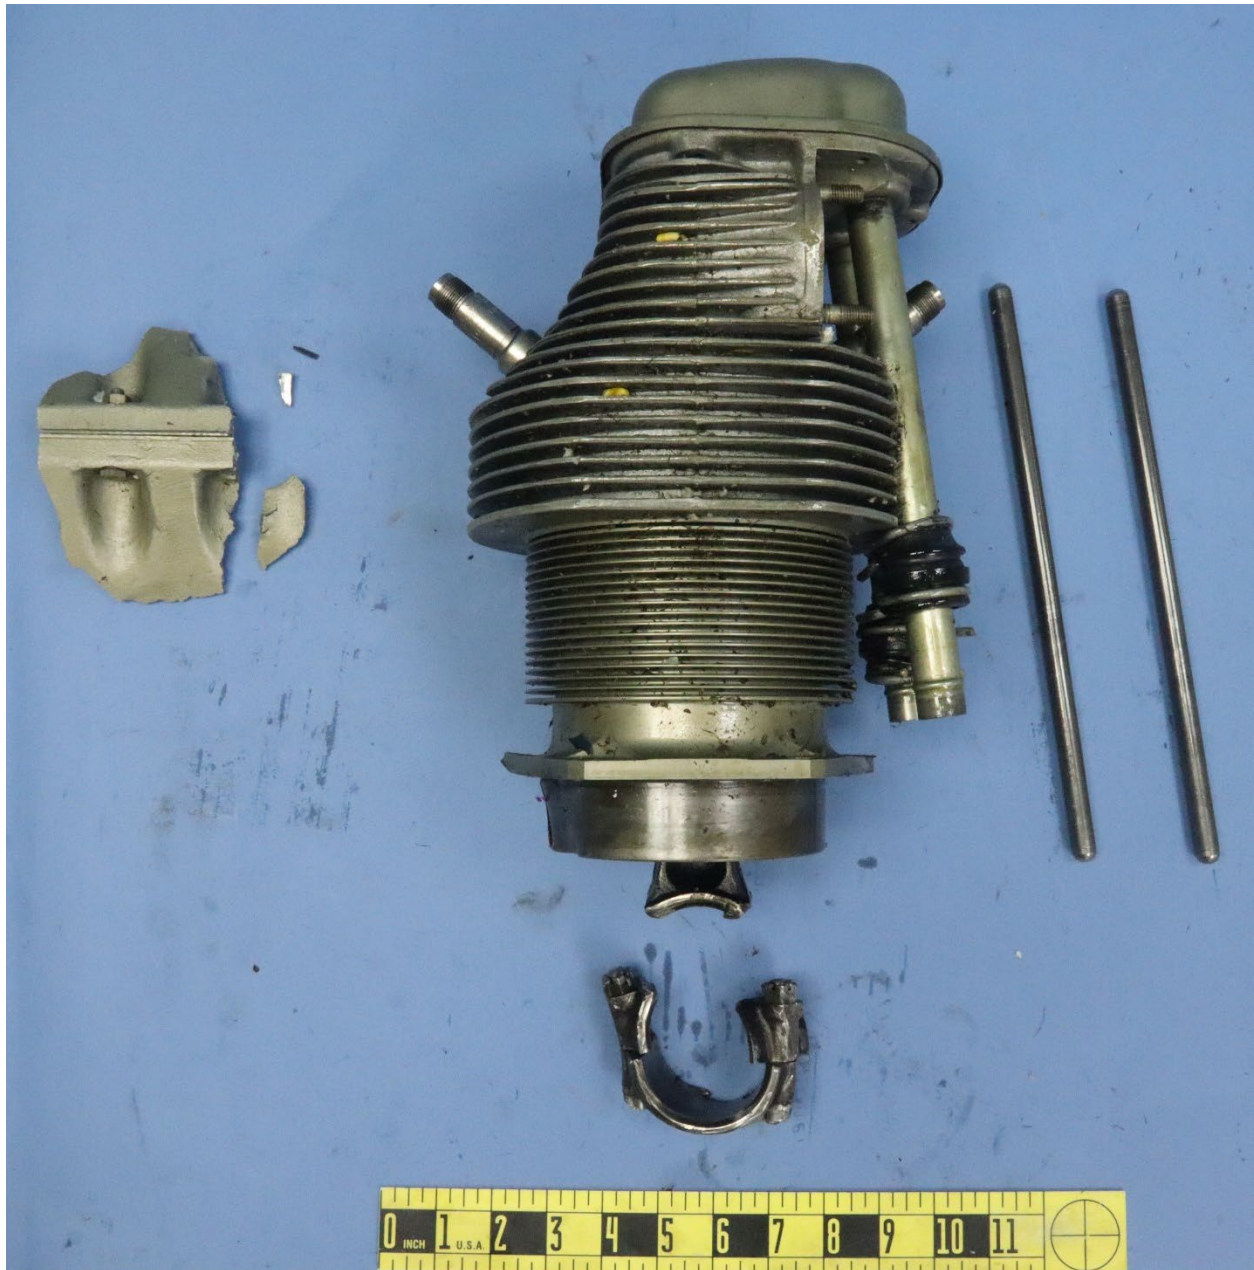
Figure 1 shows the parts received by the Materials Laboratory. These included the cylinder, which still contained a jammed piston and connecting rod assembly, two pushrods, a fragment of the engine case, and the fractured remnant of the lower connecting rod.

Figure 1. The cylinder, disconnected pushrods, and fractured connecting rod and engine case remnant.

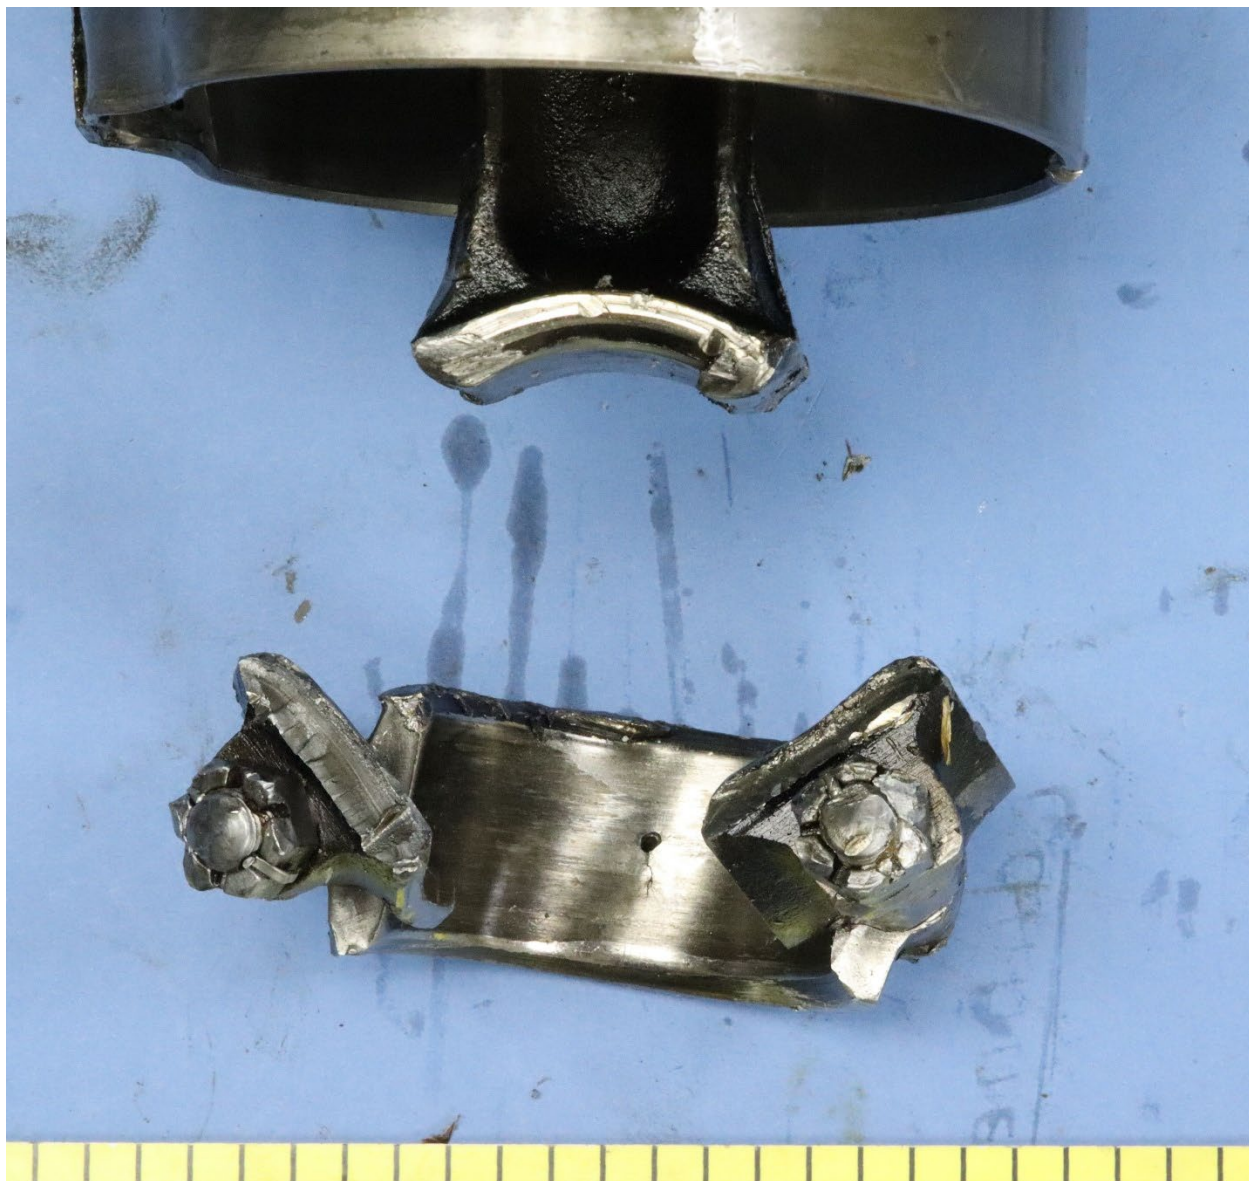
The other fractured parts were the fragments of the connecting rod, which had separated from the rod neck but were connected to the rod cap by attachment bolts (see Figure 2). The upper portions of the connecting rod were still attached to the piston via a piston pin (inside the cylinder). The fracture surfaces of the connecting rod fragments are highlighted in Figure 3.

Figure 2. Opposite sides of the fractured connecting rod.

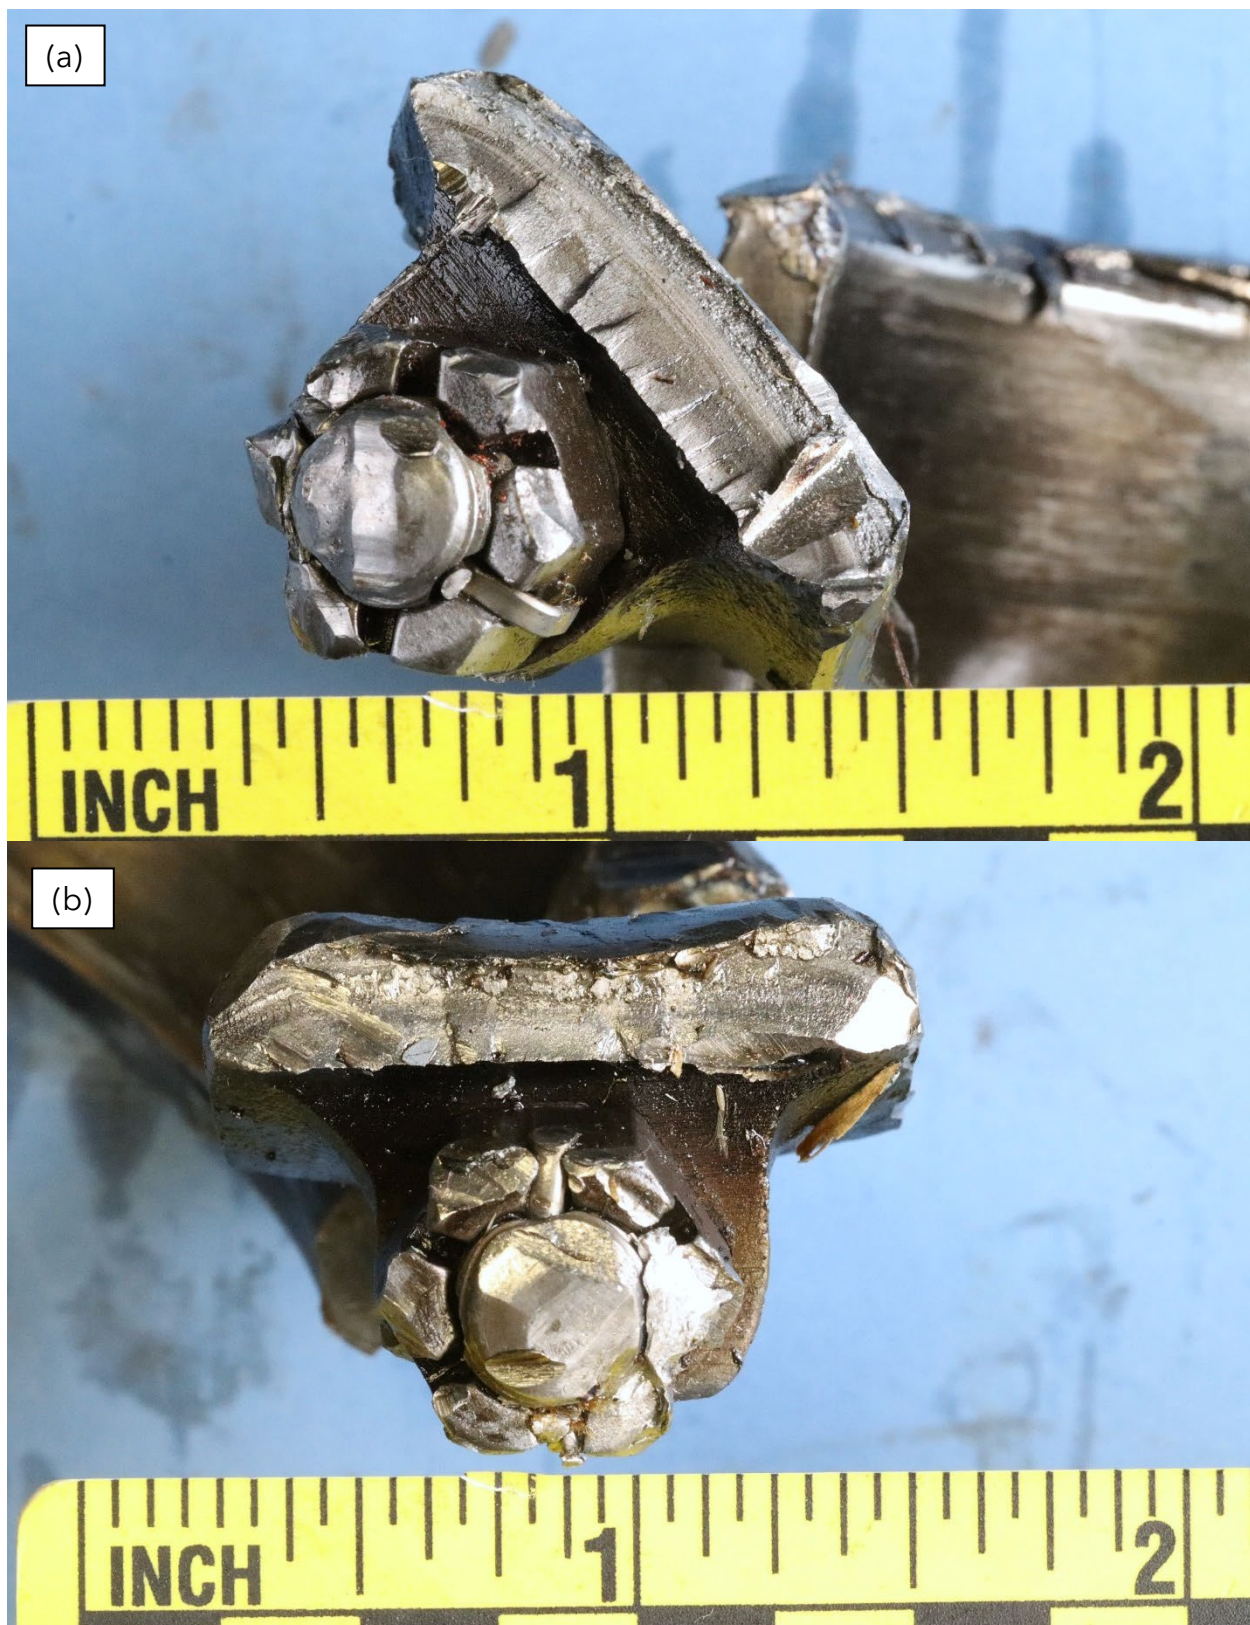
Figure 3. The cap-side connecting rod fracture surfaces, of the (a) left fracture in Figure 2 and (b) the right fracture from Figure 2, which exhibited more post-fracture damage.

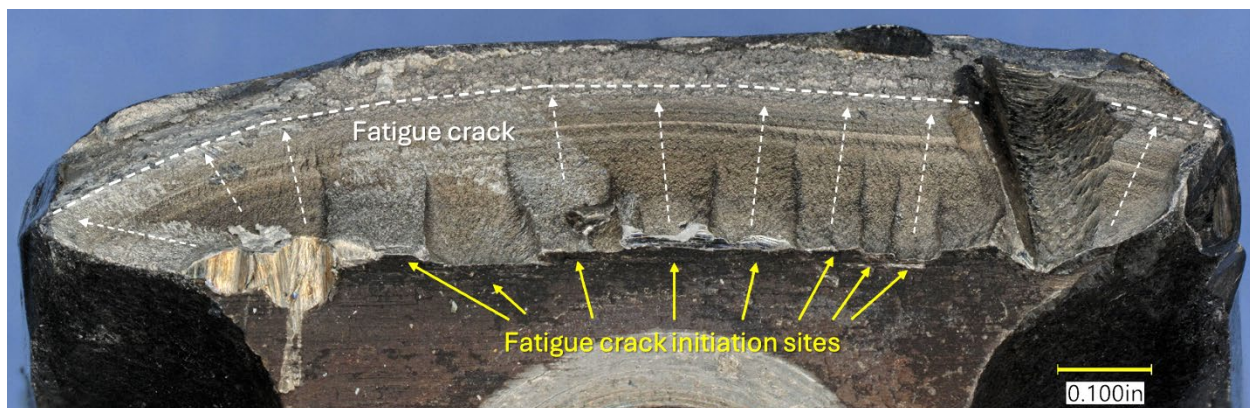
As shown in Figure 4, both fracture surfaces of the connecting rod remnants exhibited crack arrest marks, consistent with progressive cracking. There were also multiple ratchet marks, indicative of multiple crack initiation sites. The general crack growth direction is annotated on Figure 4. As shown in Figure 5, these initiation sites were located along the outer surface, facing toward the attachment bolt nuts (or opposite the inner bearing surfaces facing the crankshaft journal).

Figure 4. Montage of the left connecting rod fracture surface, annotated to show the region of fatigue cracking, crack growth direction, and several of the initiation sites.

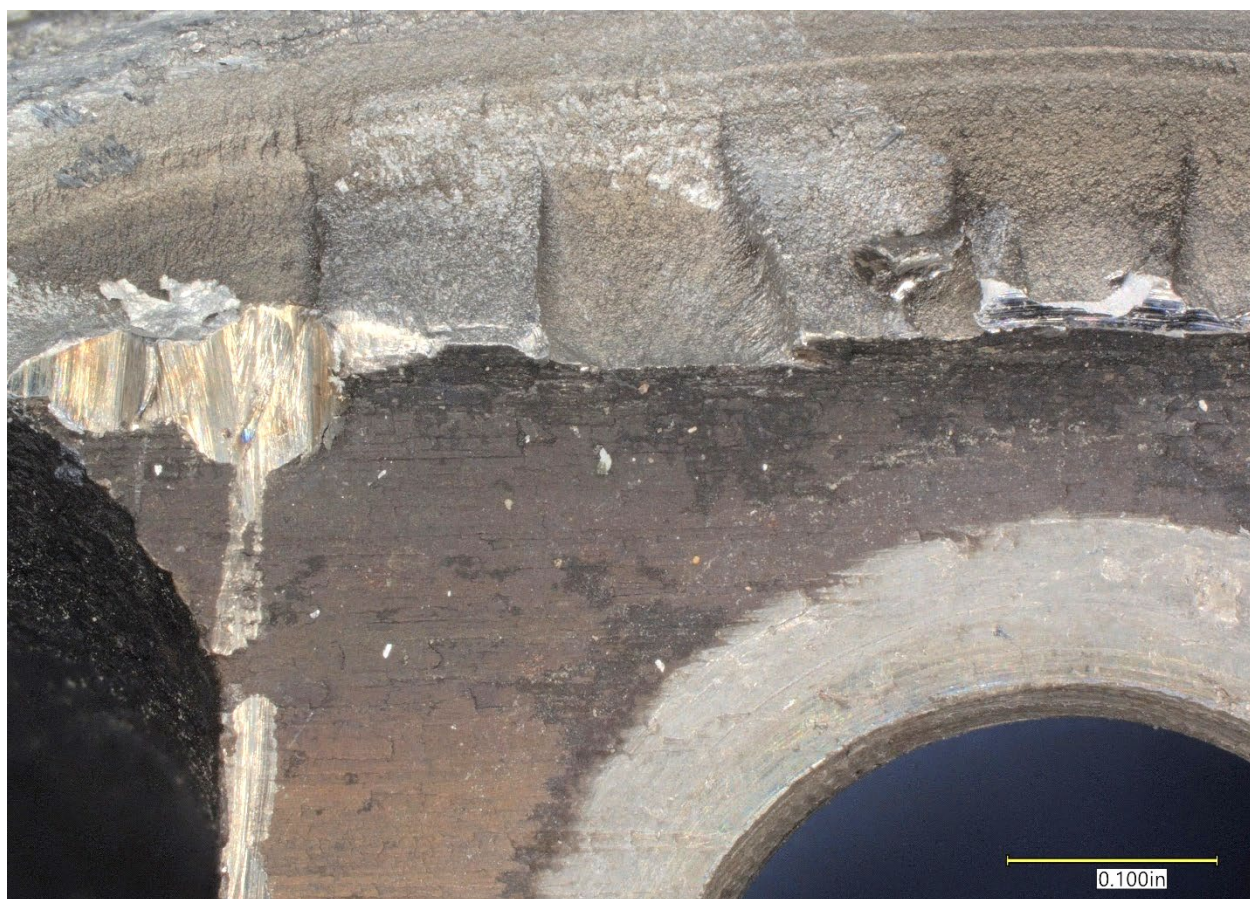
Figure 5. Closer view of several of the initiation sites from the left of Figure 4, separated by vertical ratchet marks.

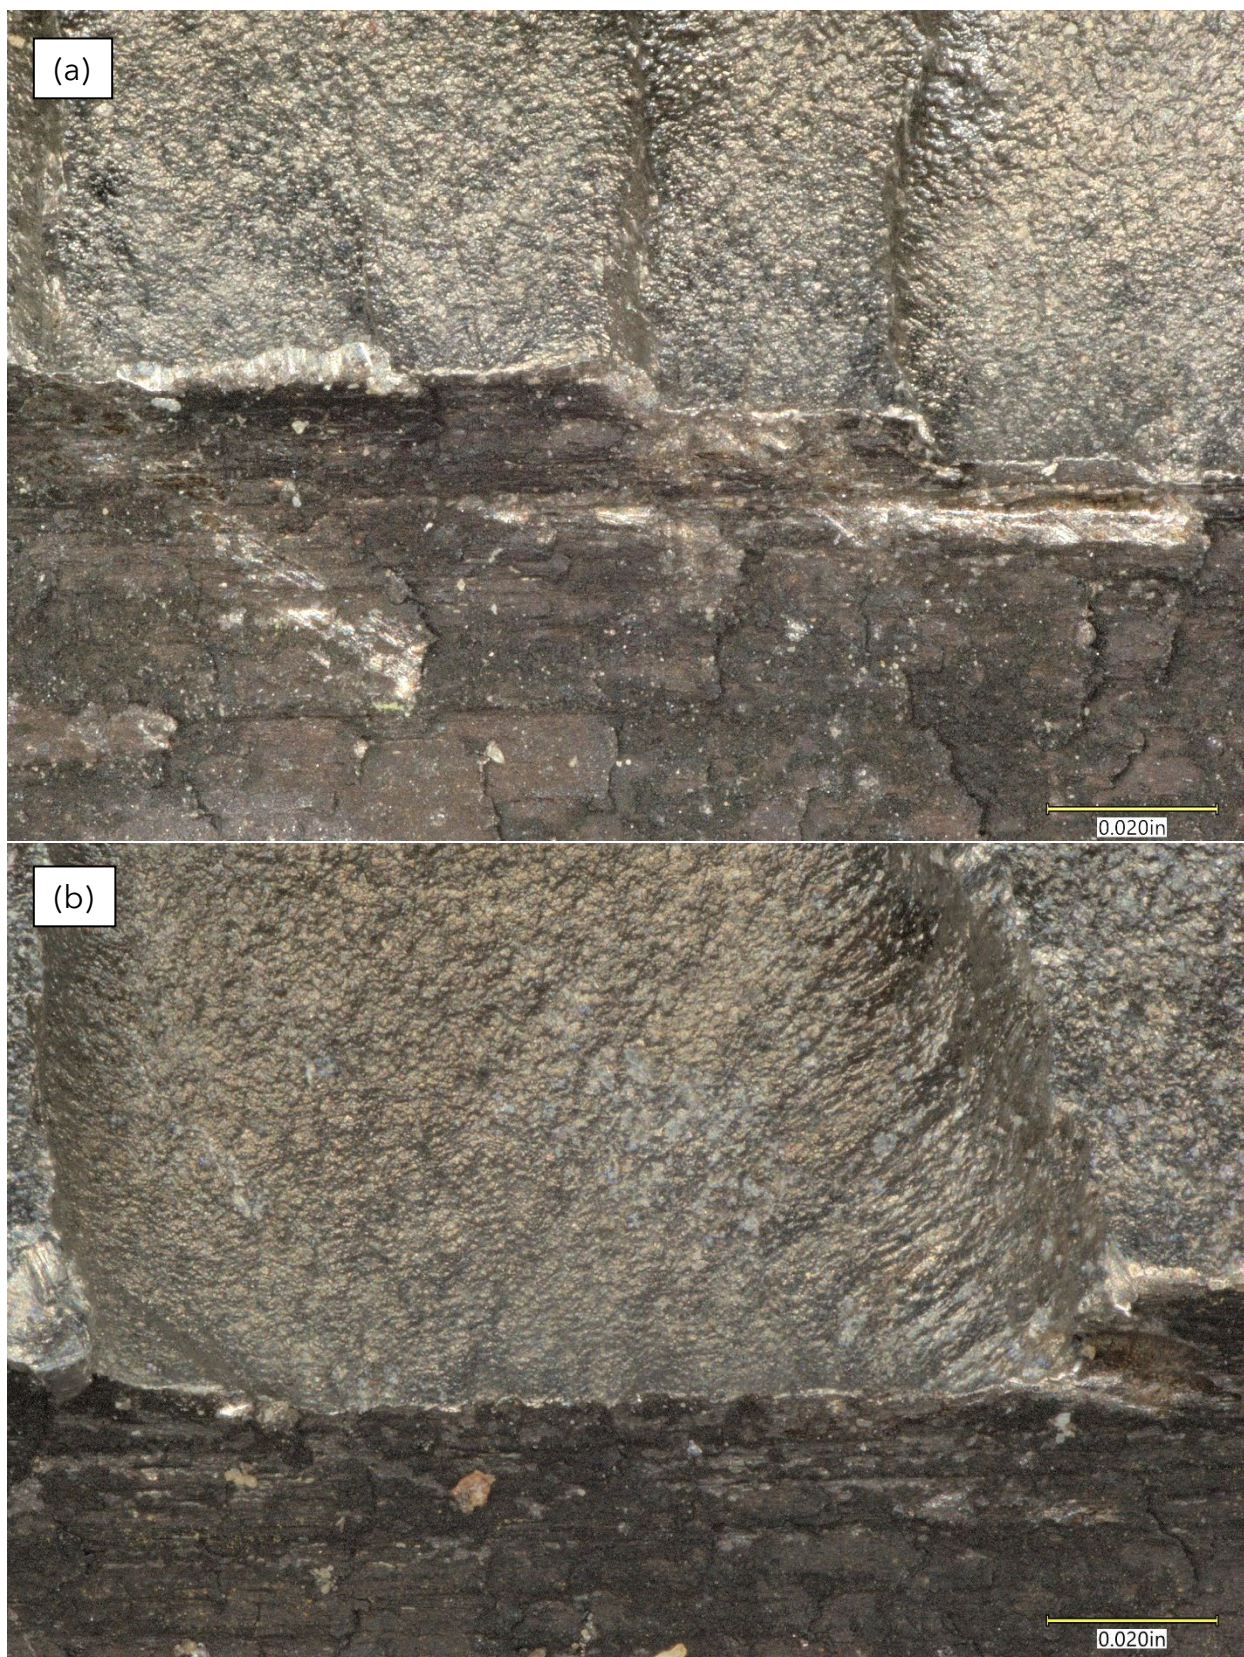
Most of these initiation sites had been damaged from post-fracture smearing, as typified in Figure 6a. However, three sites (towards the right in Figure 4) had not been battered, and they displayed river patterns and crack arrest marks emanating from the fracture edge (Figure 6b).

Figure 6. Closer views of (a) several of the crack initiation sites from Figure 5, and (b) a closer view of the central initiation site in 6a.

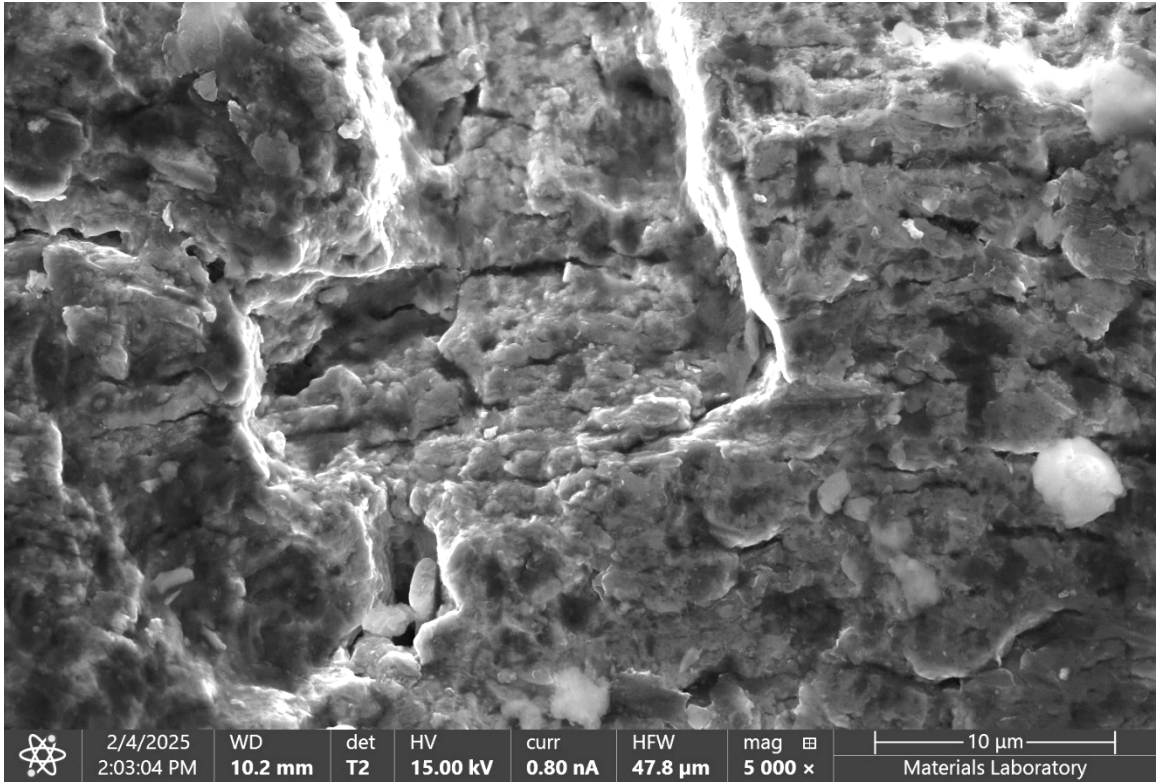
Figure 7 shows a view of the surface exhibiting crack arrest marks. This figure reveals striations consistent with fatigue crack propagation. Much of the fracture surface had been damaged, as indicated by the flat smearing regions shown in Figure 8. The thin area of the fracture surface outside the fatigue cracking, as annotated in Figure 4, exhibited dimpled rupture, as illustrated in Figure 9.

Figure 7. Secondary electron (SE) micrograph of fatigue striations on the rod fracture surface.

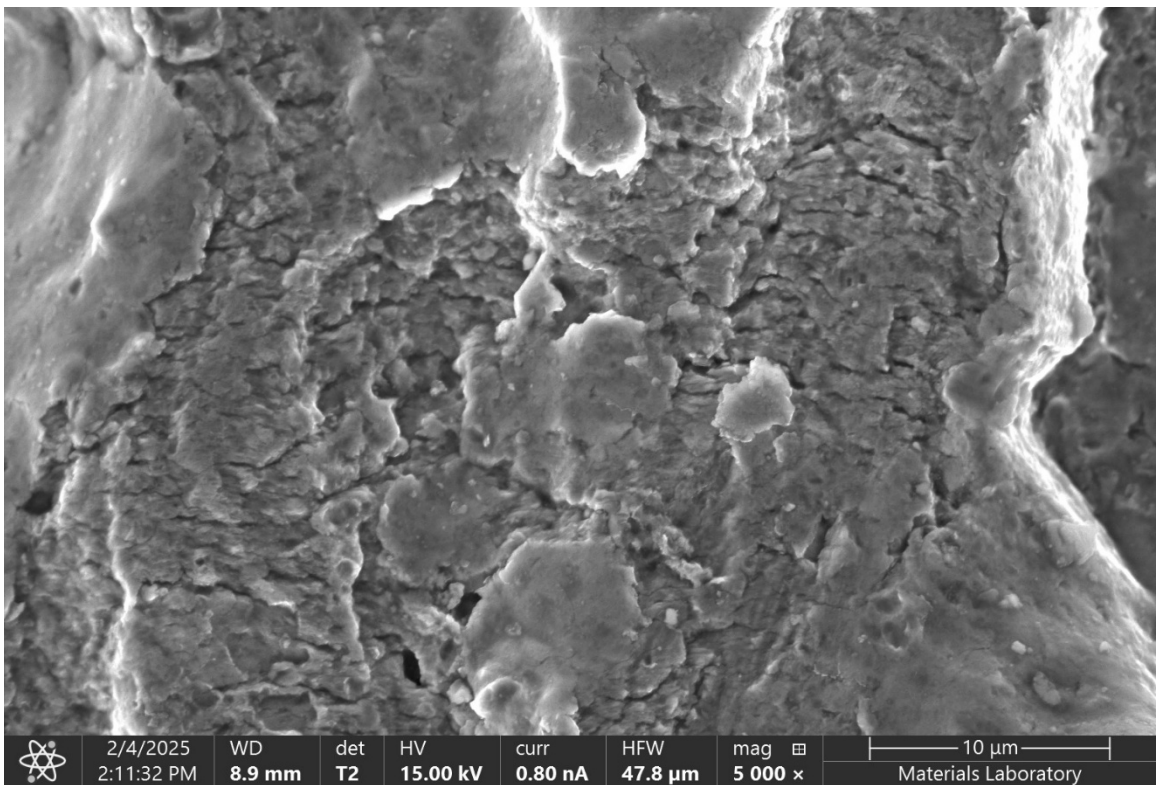
Figure 8. SE micrograph of striations amidst smearing damage, near the crack initiation area.

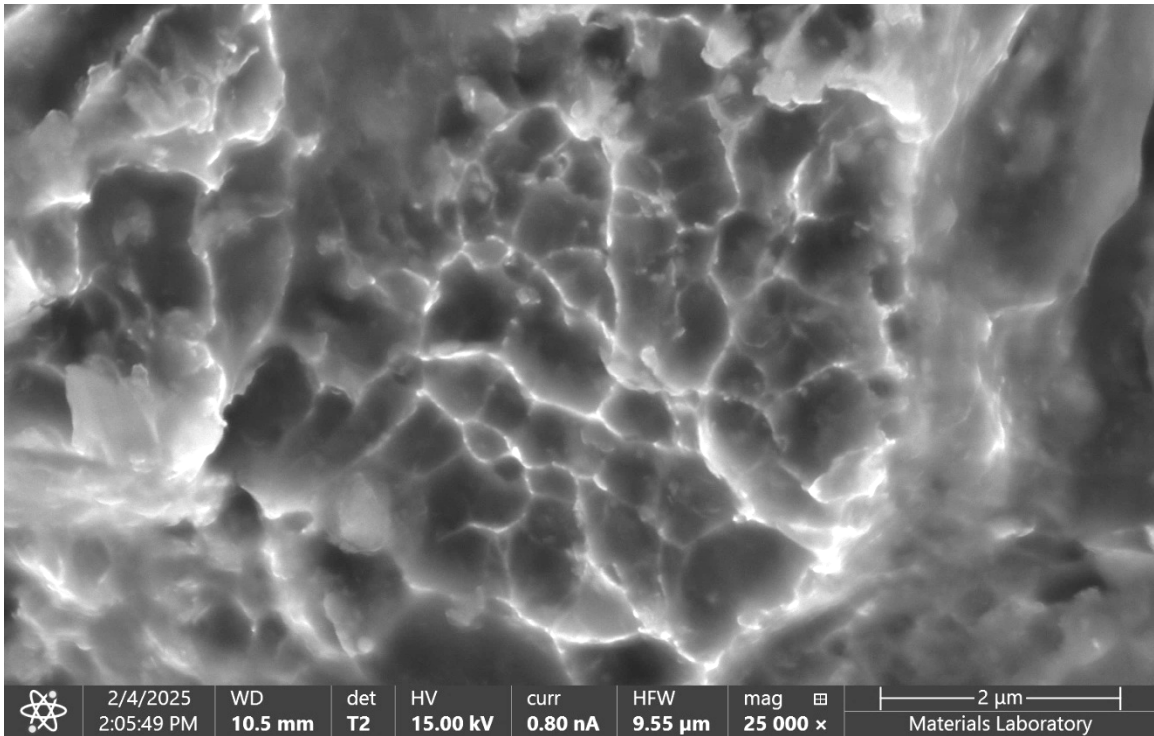
Figure 9. SE micrograph of dimpled rupture on the connecting rod fracture regions outside of the fatigue cracking.

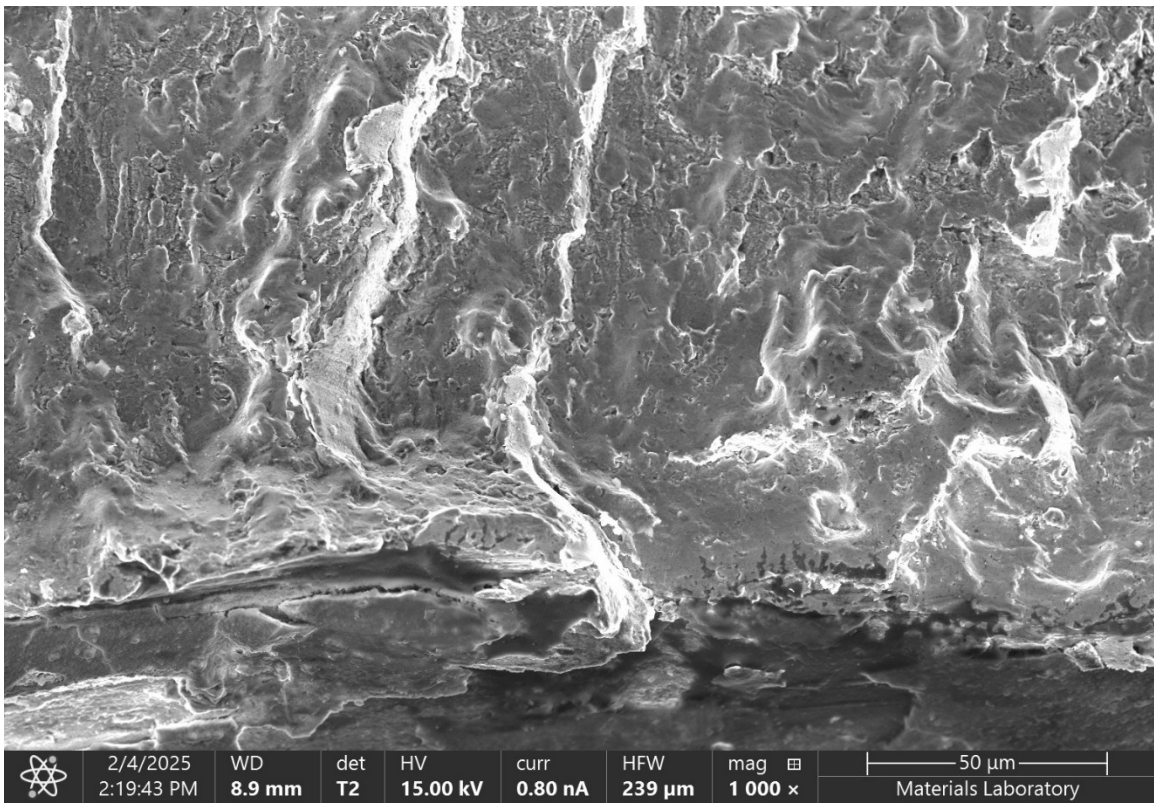
The crack initiation region from Figure 6b is shown in Figure 10. This location exhibited smaller ratchet marks and small smearing areas on the fracture surface. There were no material defects at the initiation site, such as inclusions or pits.

Likewise, no indications of mechanical defects, such as gouges or rub marks, were observed.

Figure 10. SE micrograph of undamaged crack initiation sites on the fracture surface edge.

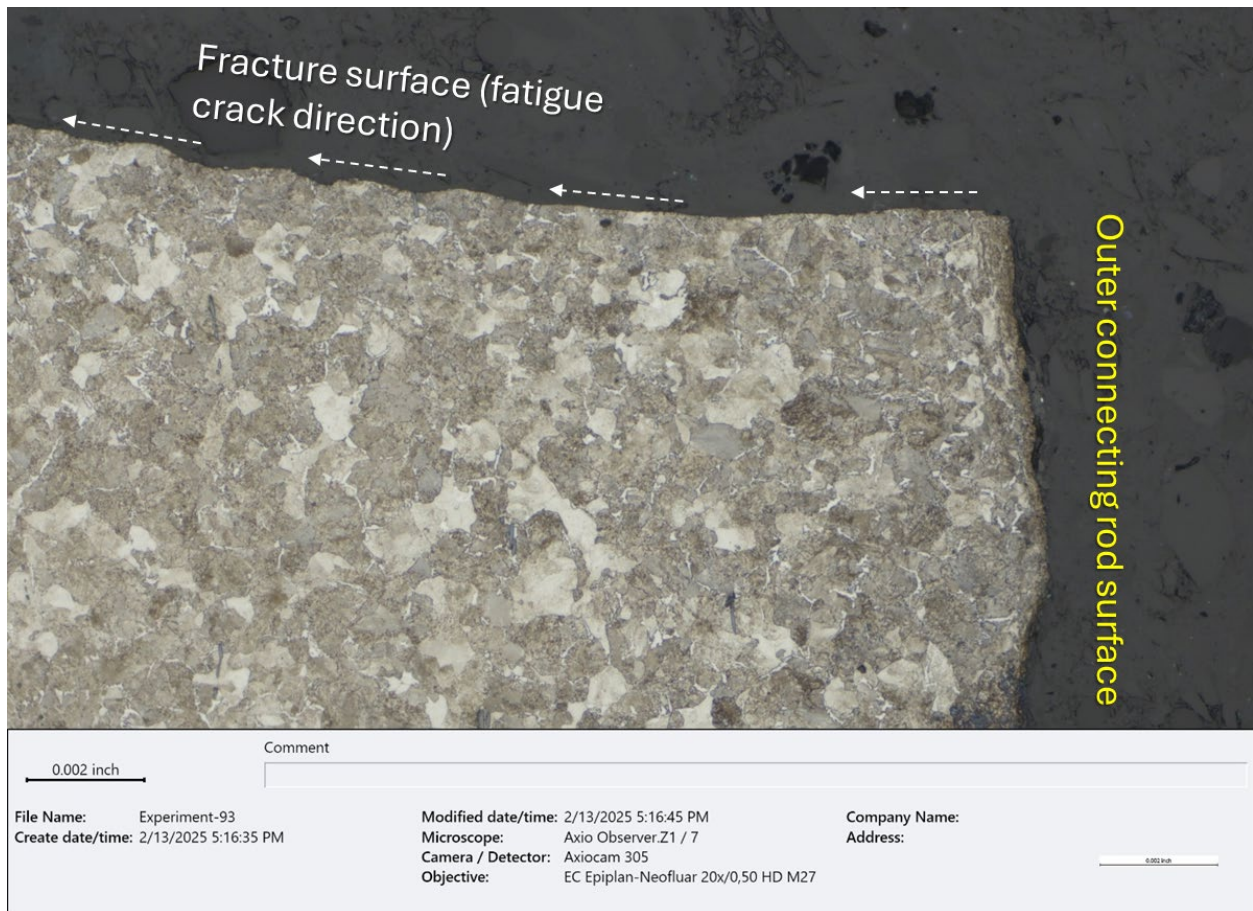
The connecting rod fracture surface was cross-sectioned, mounted, polished, and etched with a 2% Nital solution.<sup>3</sup> Figure 11 shows a typical view of the section through the fracture surface, which was generally flat with no indications of secondary or branched cracking. The outer connecting rod surface did not exhibit any areas of additional cracking below the fracture.

Figure 11. Bright-field (BF) optical micrograph of a cross section of the fracture surface through the initiation region (~25X, etched 2% Nital).

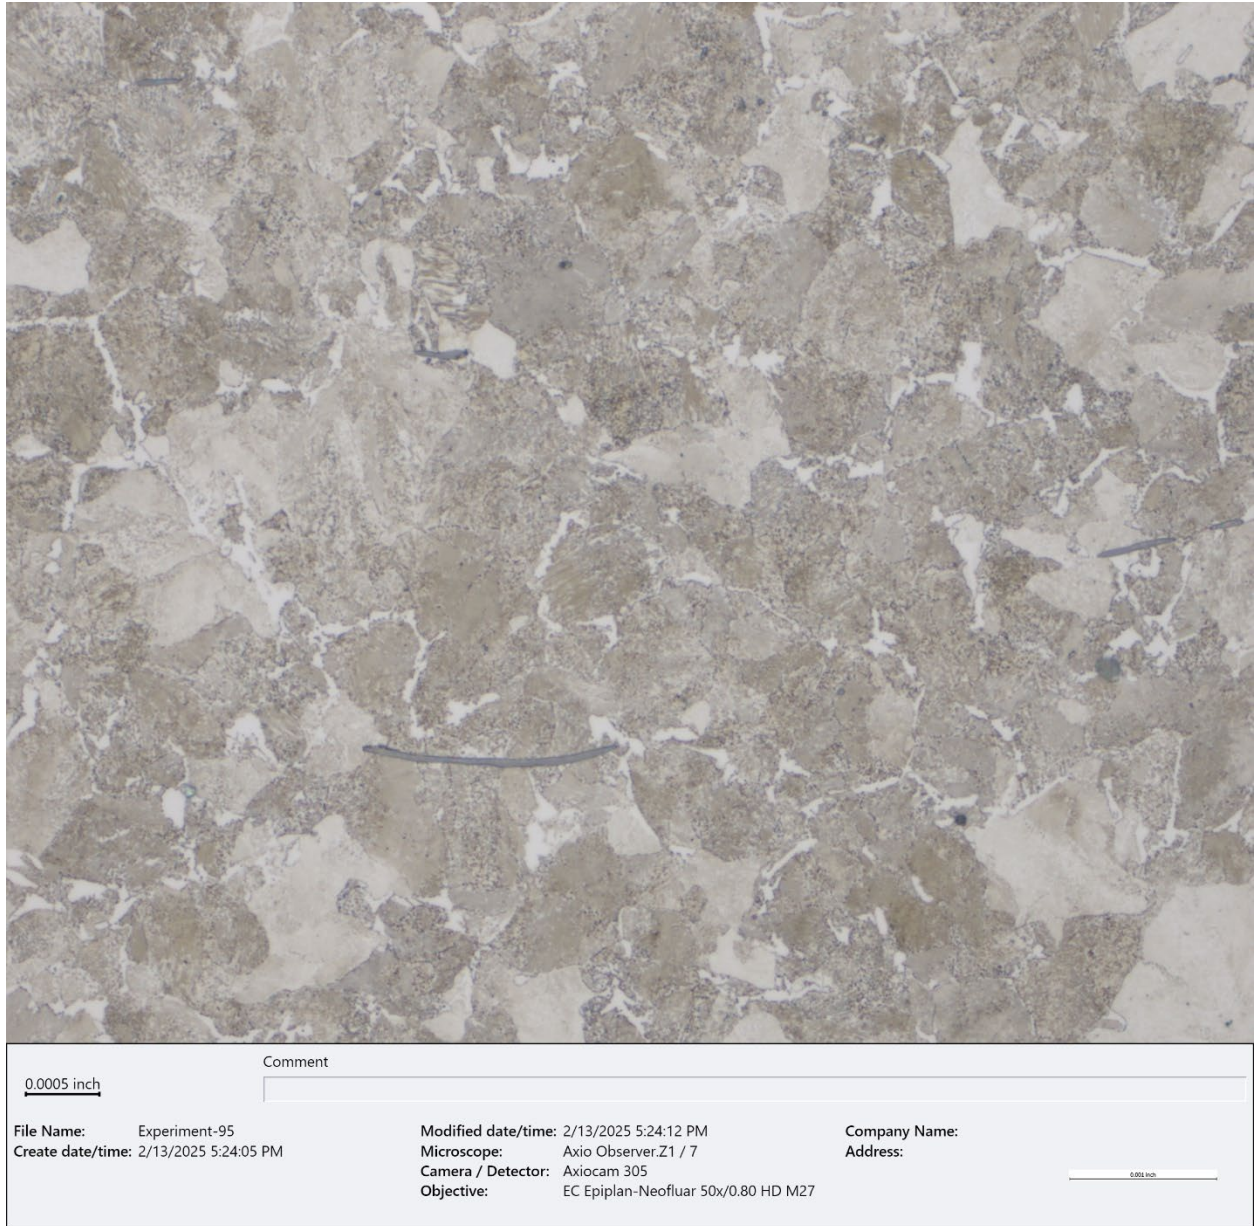
The microstructure near the outer rod surface was finer than in the interior core (see Figure 12). Both exhibited features consistent with tempered martensite, which is typical for this material and its hardness.

Figure 12. BF optical micrograph of a typical area of the connecting rod microstructure, located away from the fracture surface (~625X, etched 2% Nital).
