CEN24LA357

## INVESTIGATION PHOTOGRAPHS

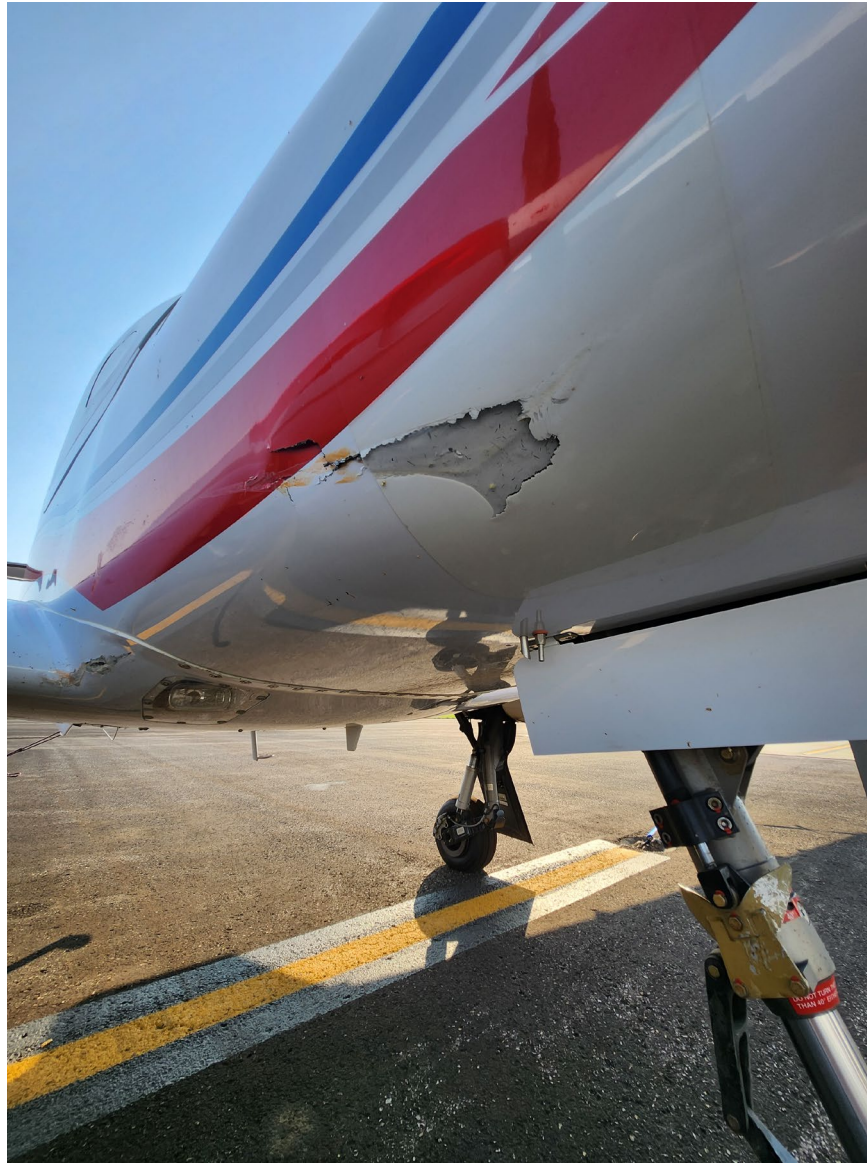
**Photograph 1 - Fuselage Damage (Courtesy of Airport Manager)**

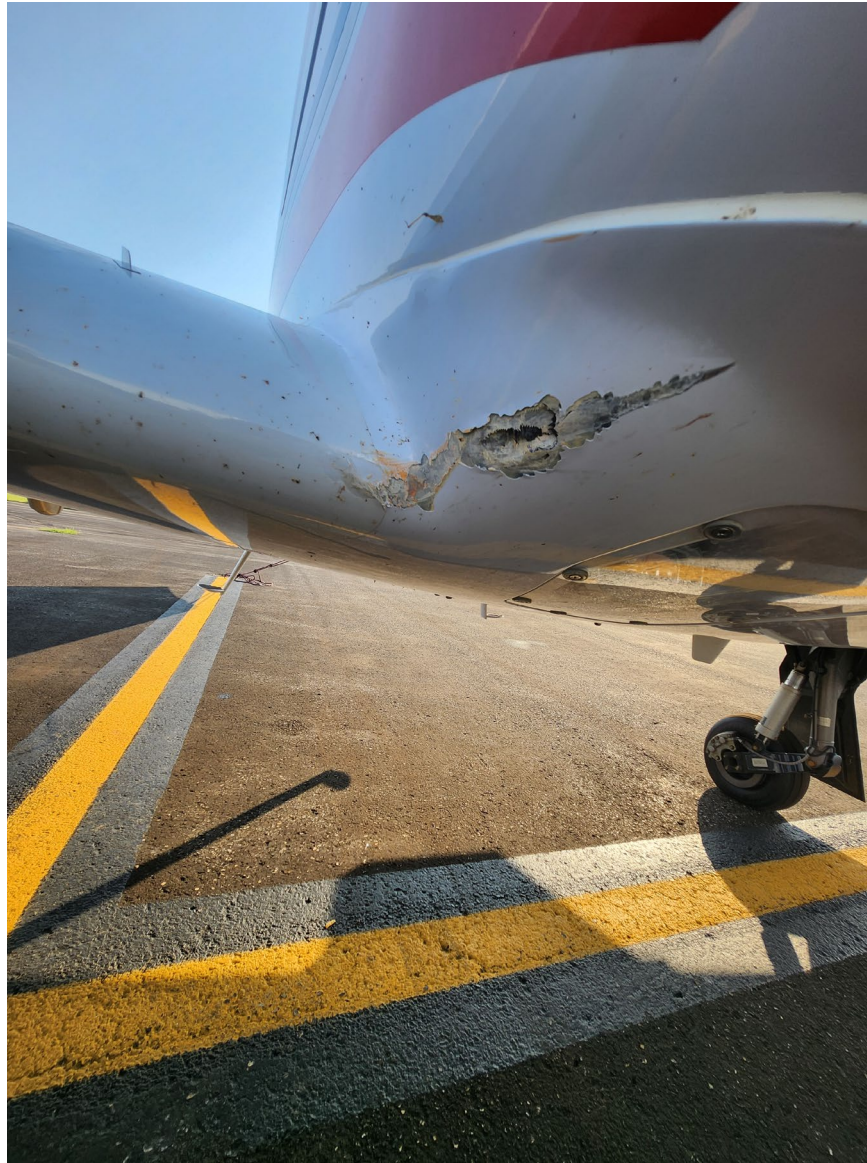
**Photograph 2 - Fuselage Damage (Courtesy of Airport Manager)**

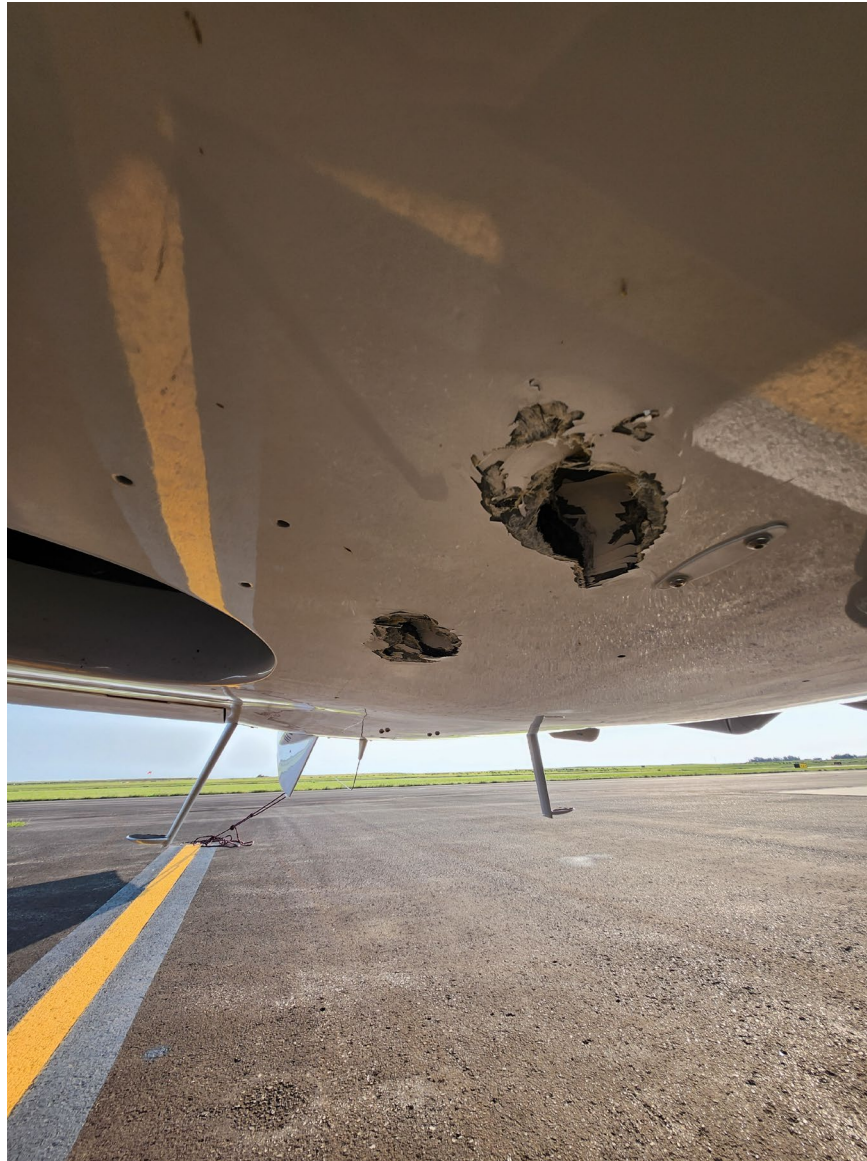
**Photograph 3 - Lower Fuselage (Courtesy of Airport Manager)**

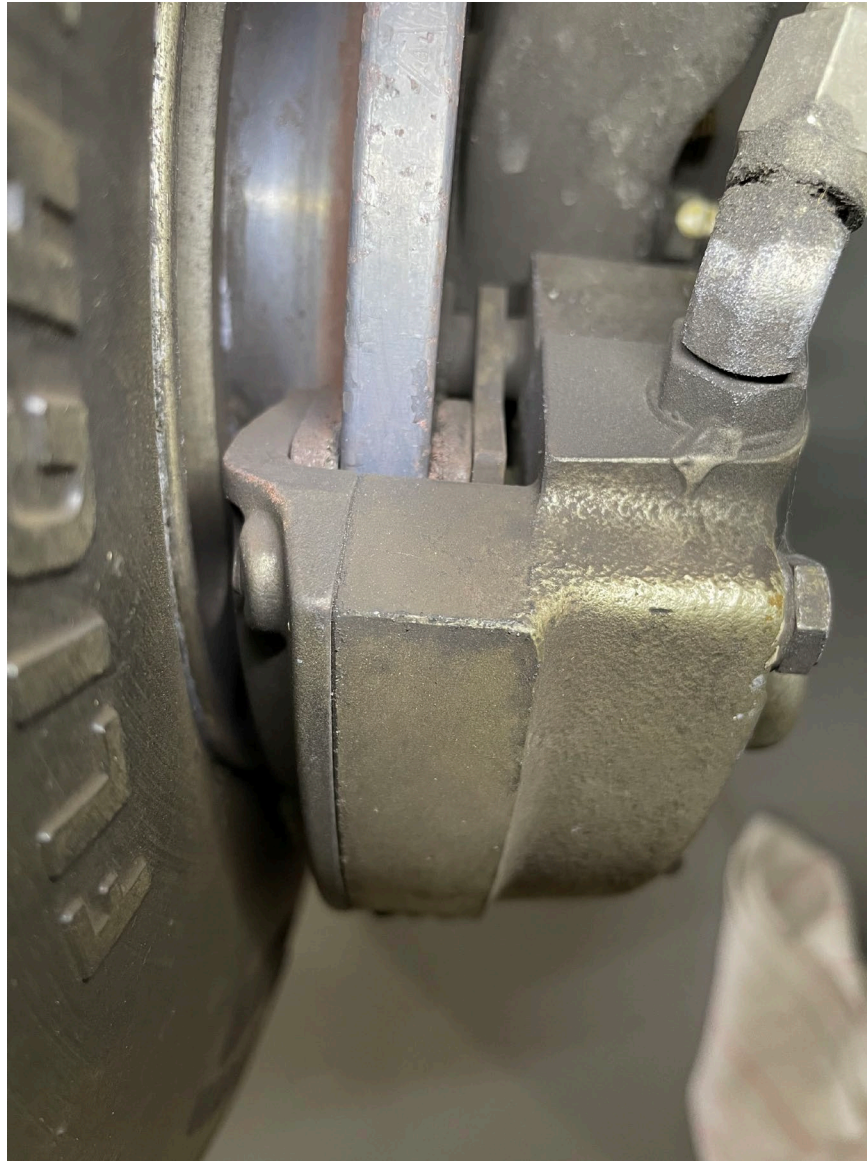
**Photograph 4 - Left Brake Assembly (Courtesy of Kent Picard)**

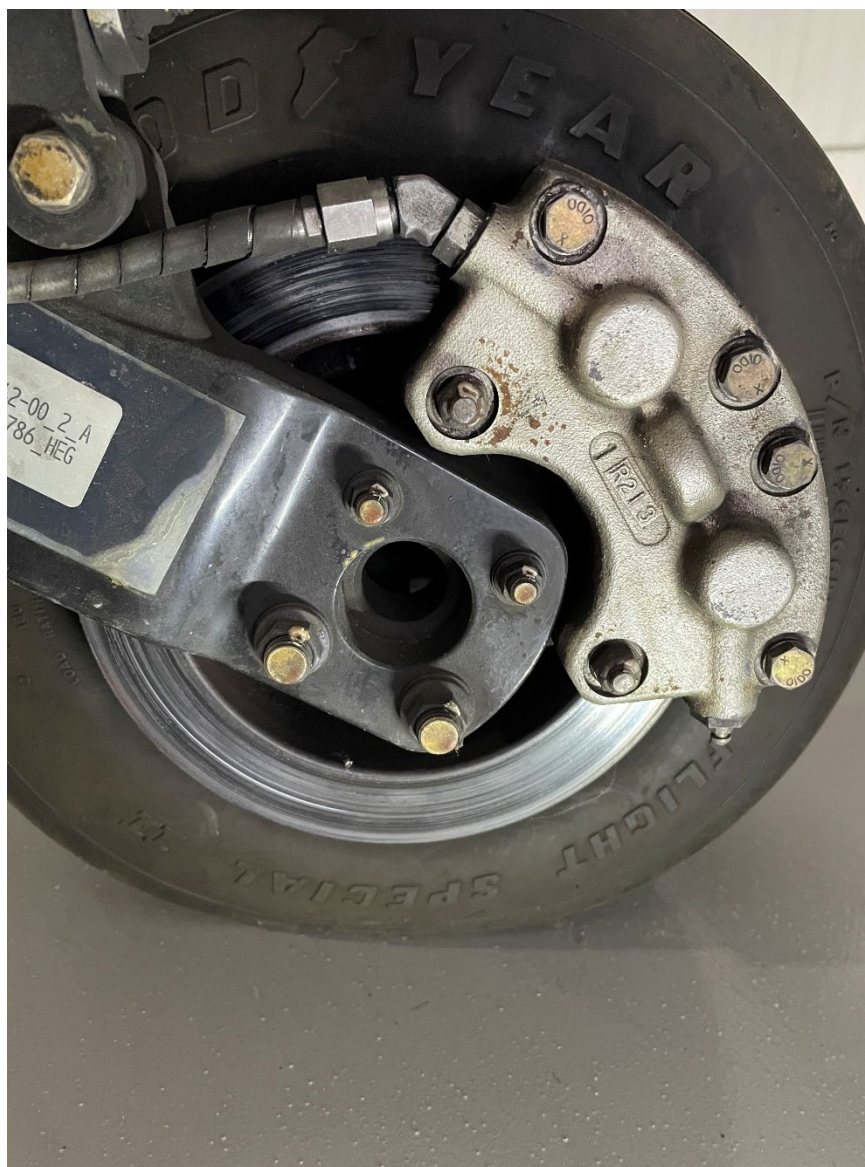
**Photograph 5 - Right Brake Assembly (Courtesy of Kent Picard)**

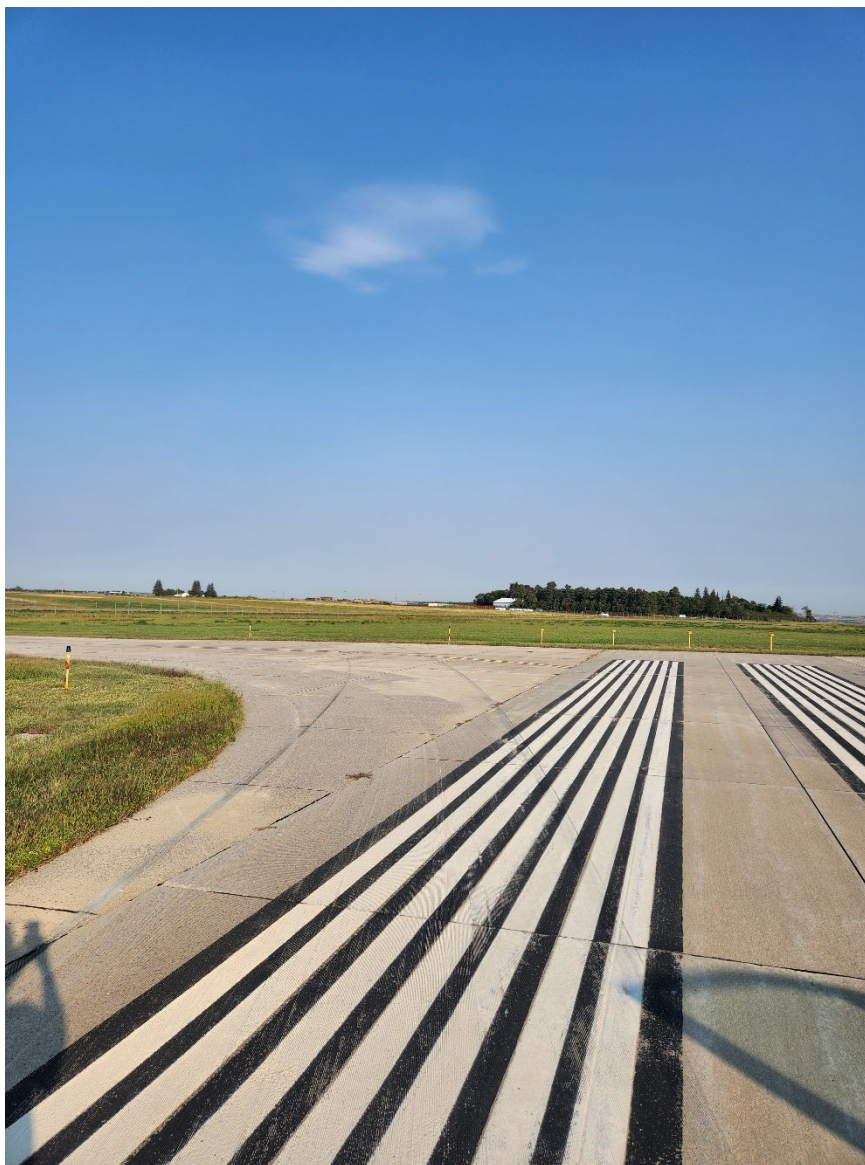
**Photograph 6 - Skid marks (Courtesy of Airport Manager)**
