# National Transportation Safety Board

Office of Research and Engineering

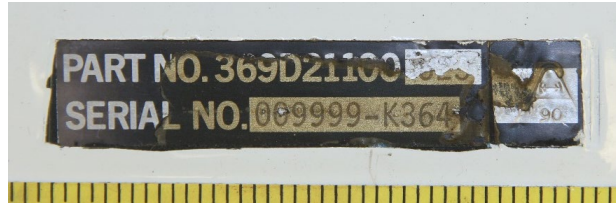
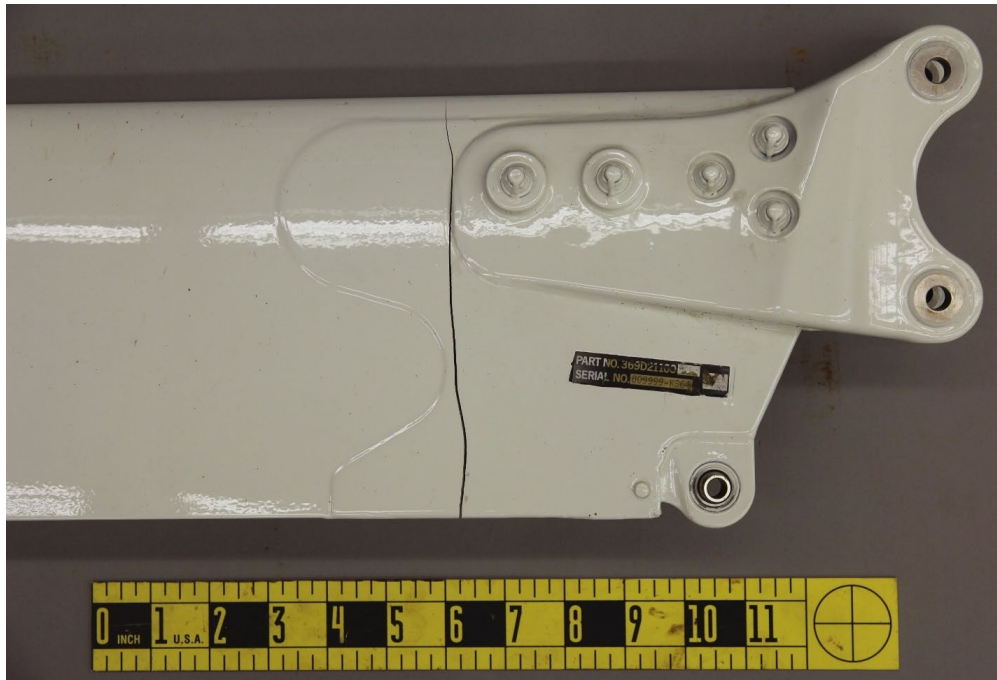
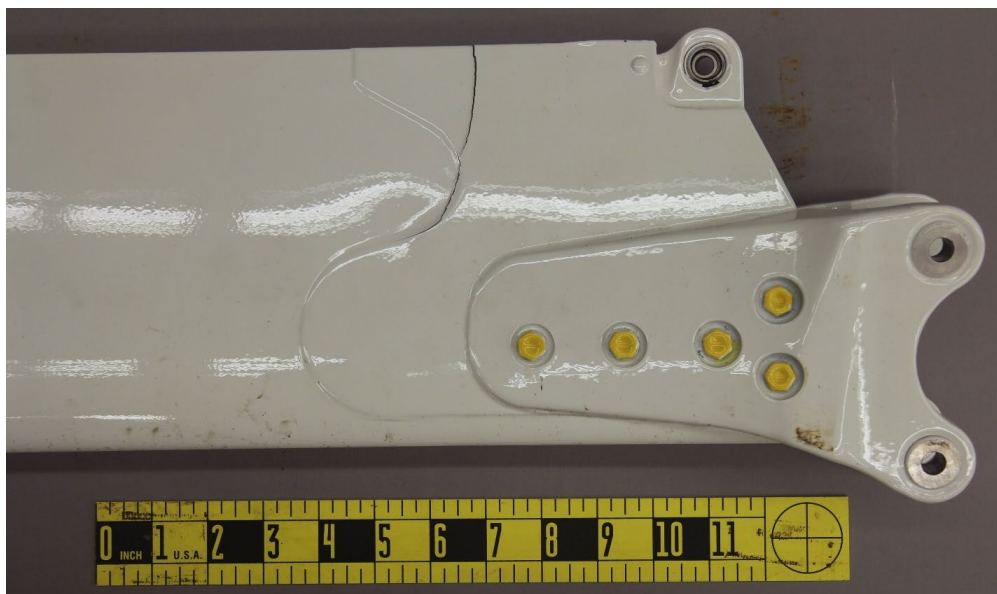
**Figure 3.** Close-up photos of the bottom and top surfaces of the -K364 blade with a crack through most of the blade.

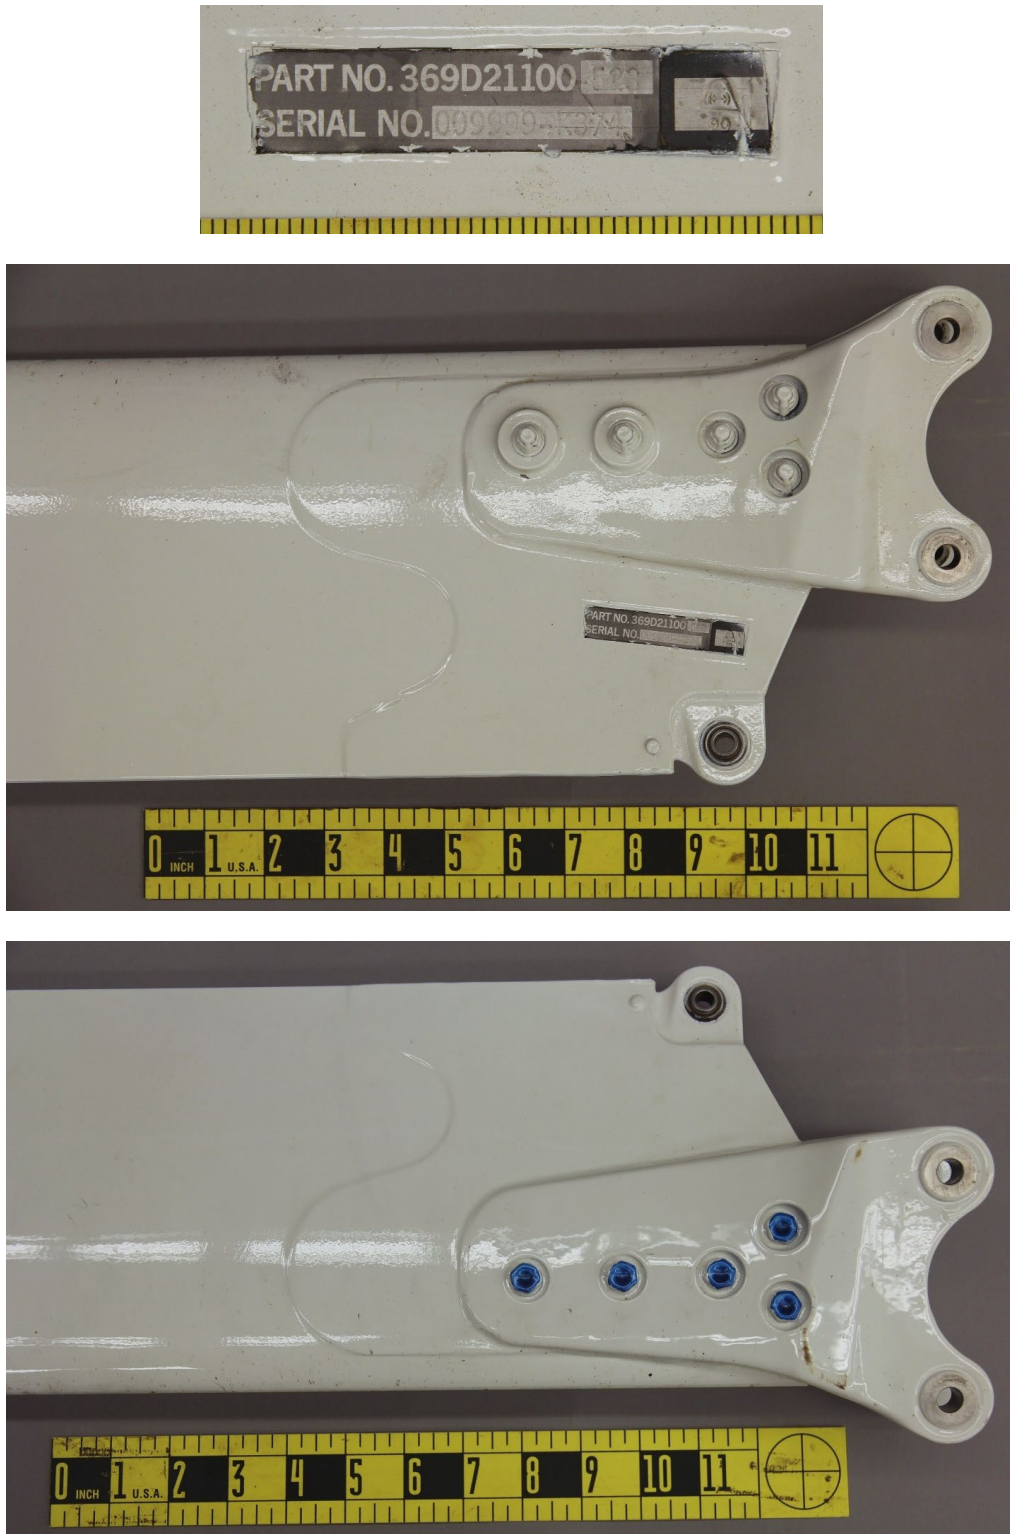
**Figure 4.** Close-up photos of the bottom and top surfaces of the -K374 blade.

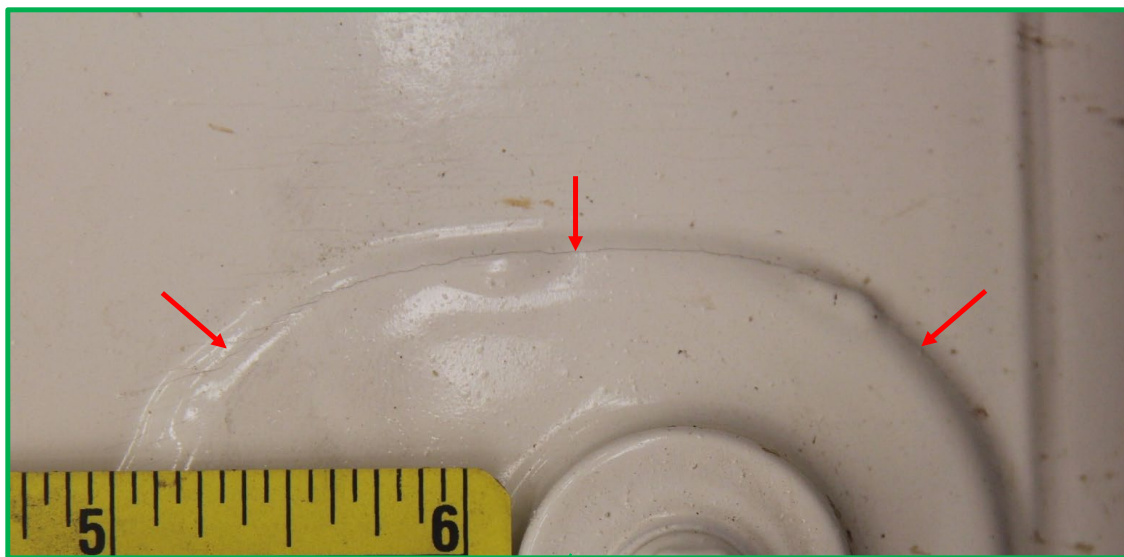
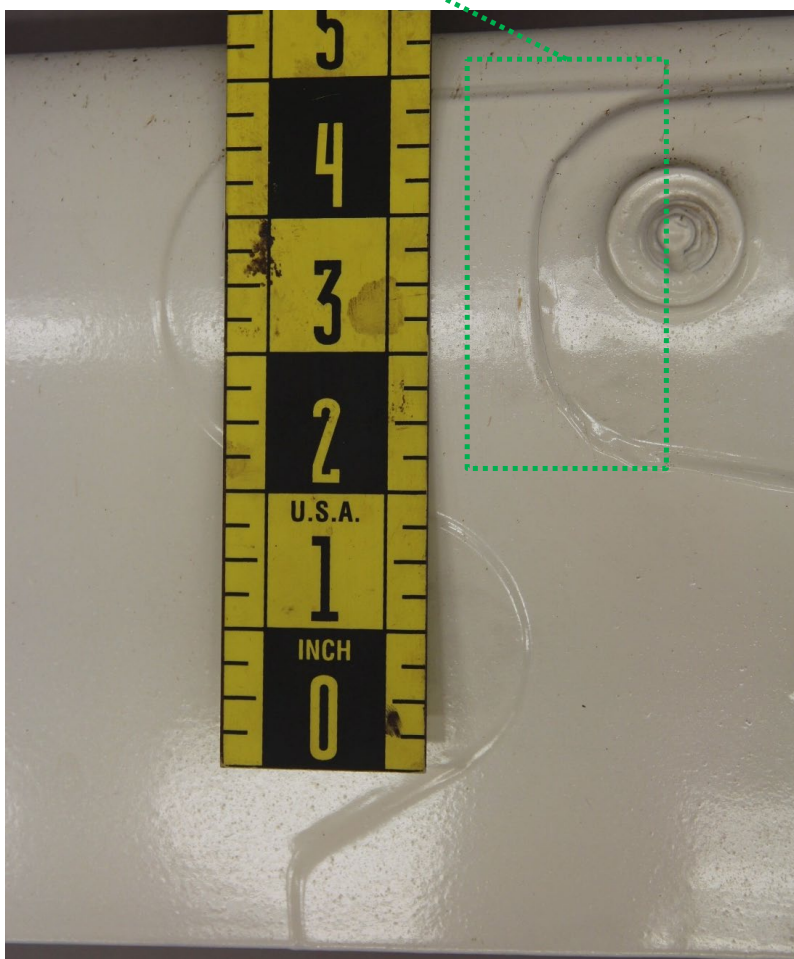
**Figure 9.** Macro photos of the bottom surface of the -K358 blade with a crack (red arrows) in the doubler paint at the root of the fitting.

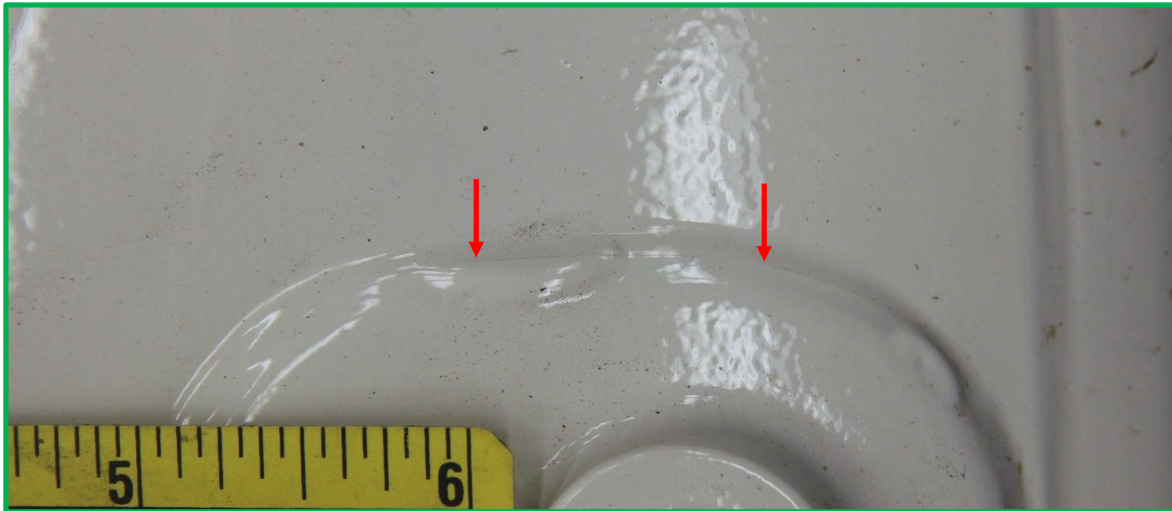
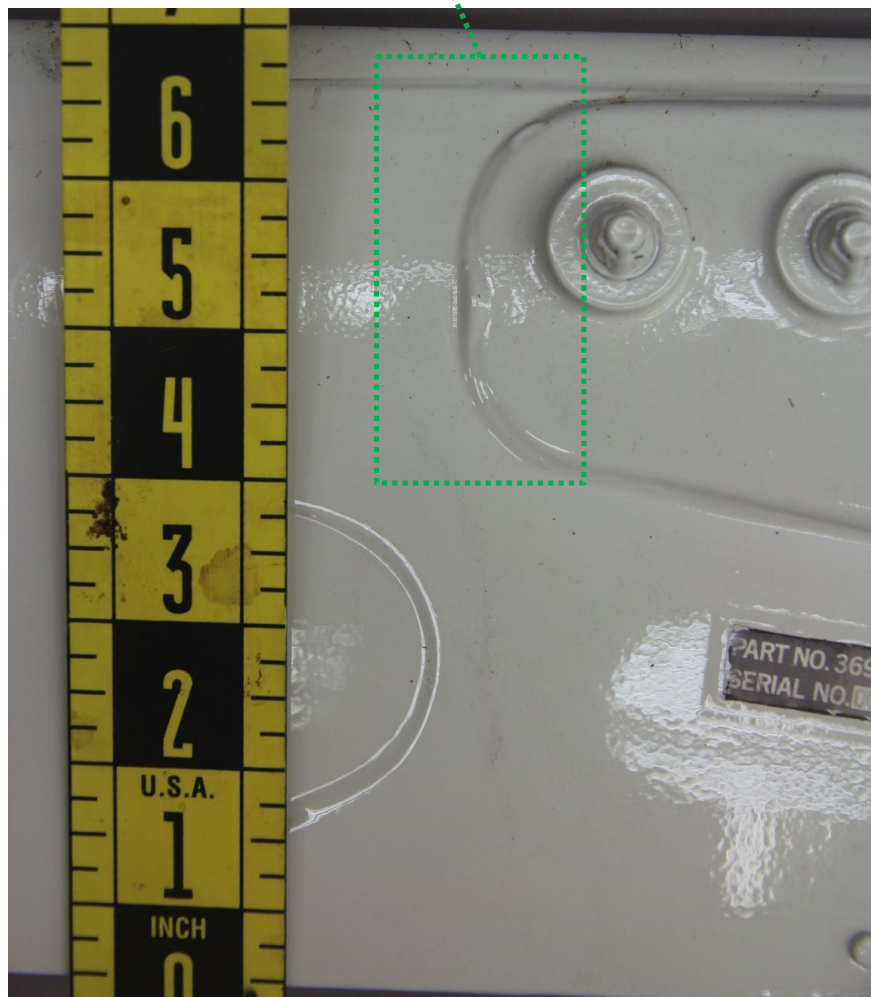
**Figure 10.** Macro photos of the bottom surface of the -K374 blade with a crack (red arrows) in the doubler paint at the root of the fitting.

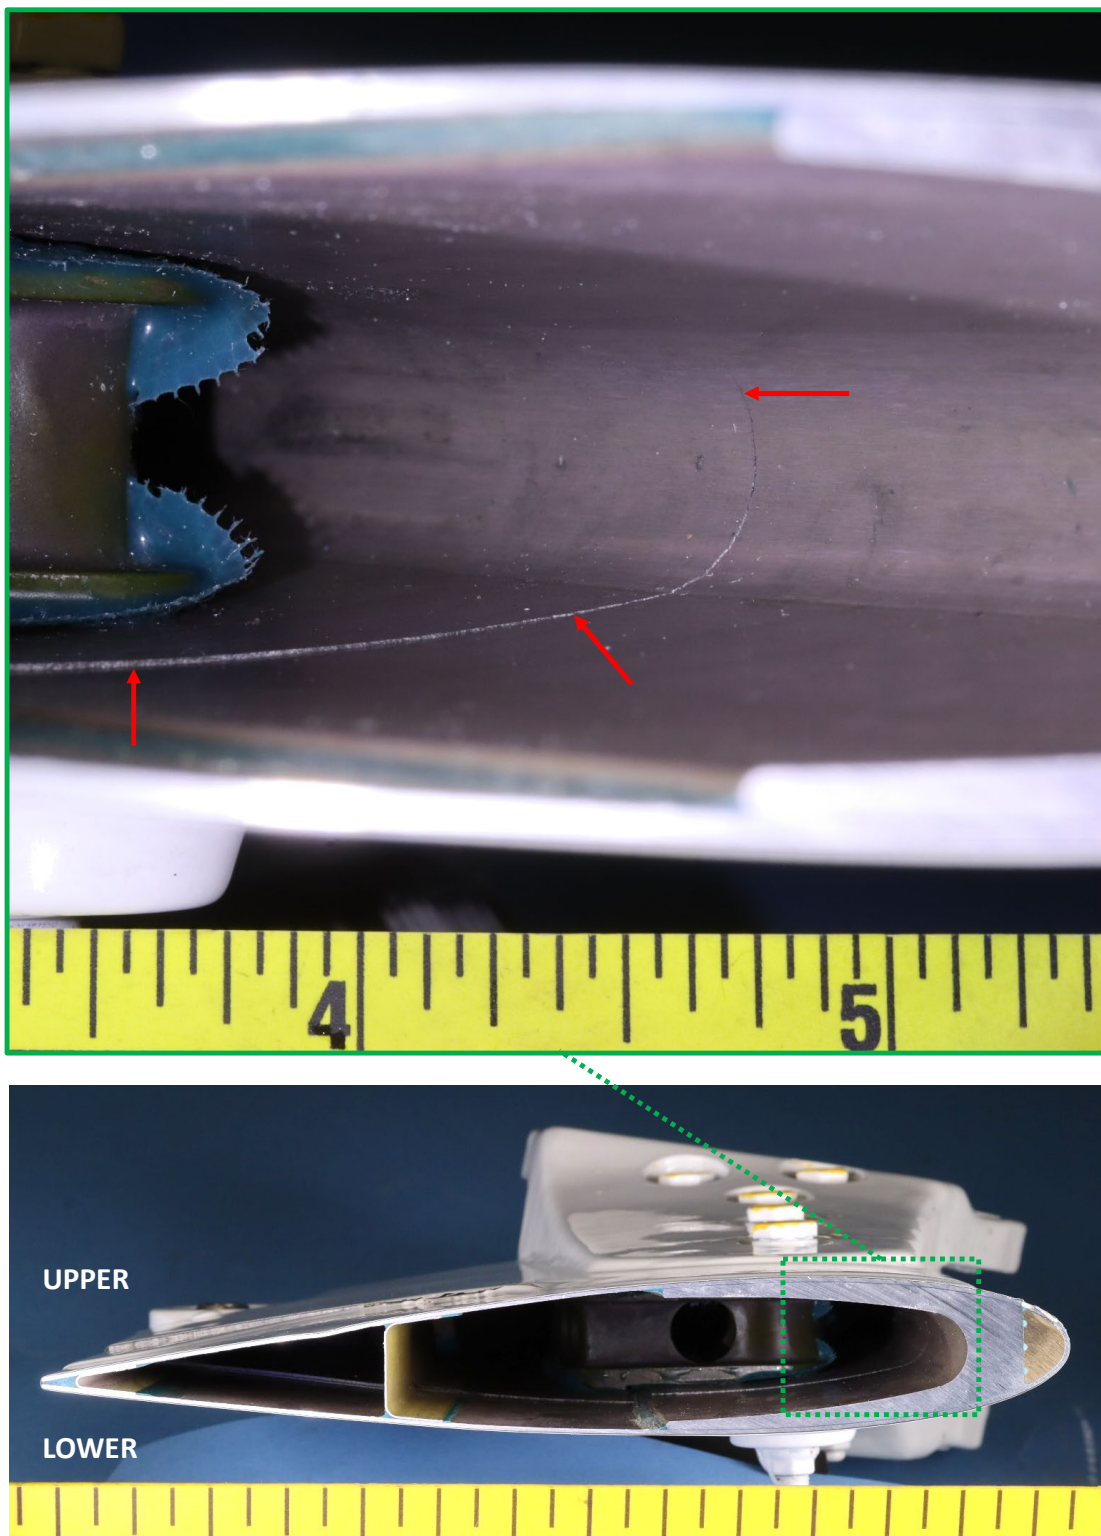
**Figure 11.** Macro photos of the internal cavity of the -K364 blade after mechanical exposure in the laboratory. The red arrows point to the crack visible on the inner surface.

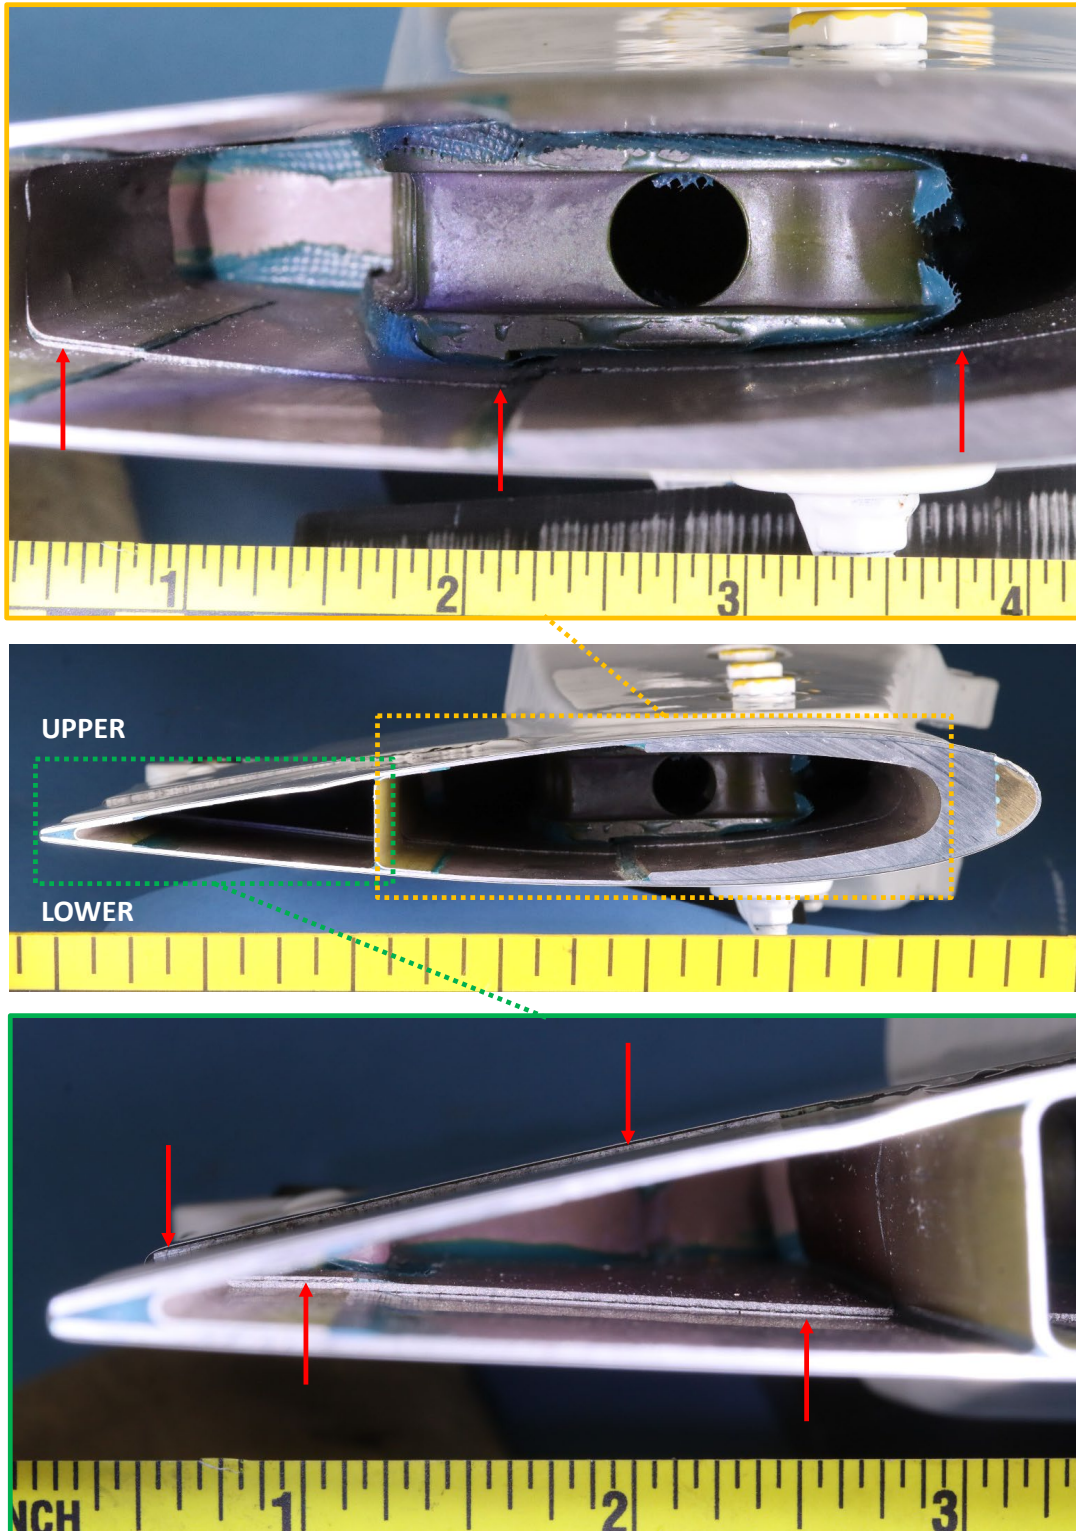
**Figure 12.** Macro photos of the internal cavity of the -K364 blade after mechanical exposure in the laboratory. The red arrows point to the crack visible on the inner surface.

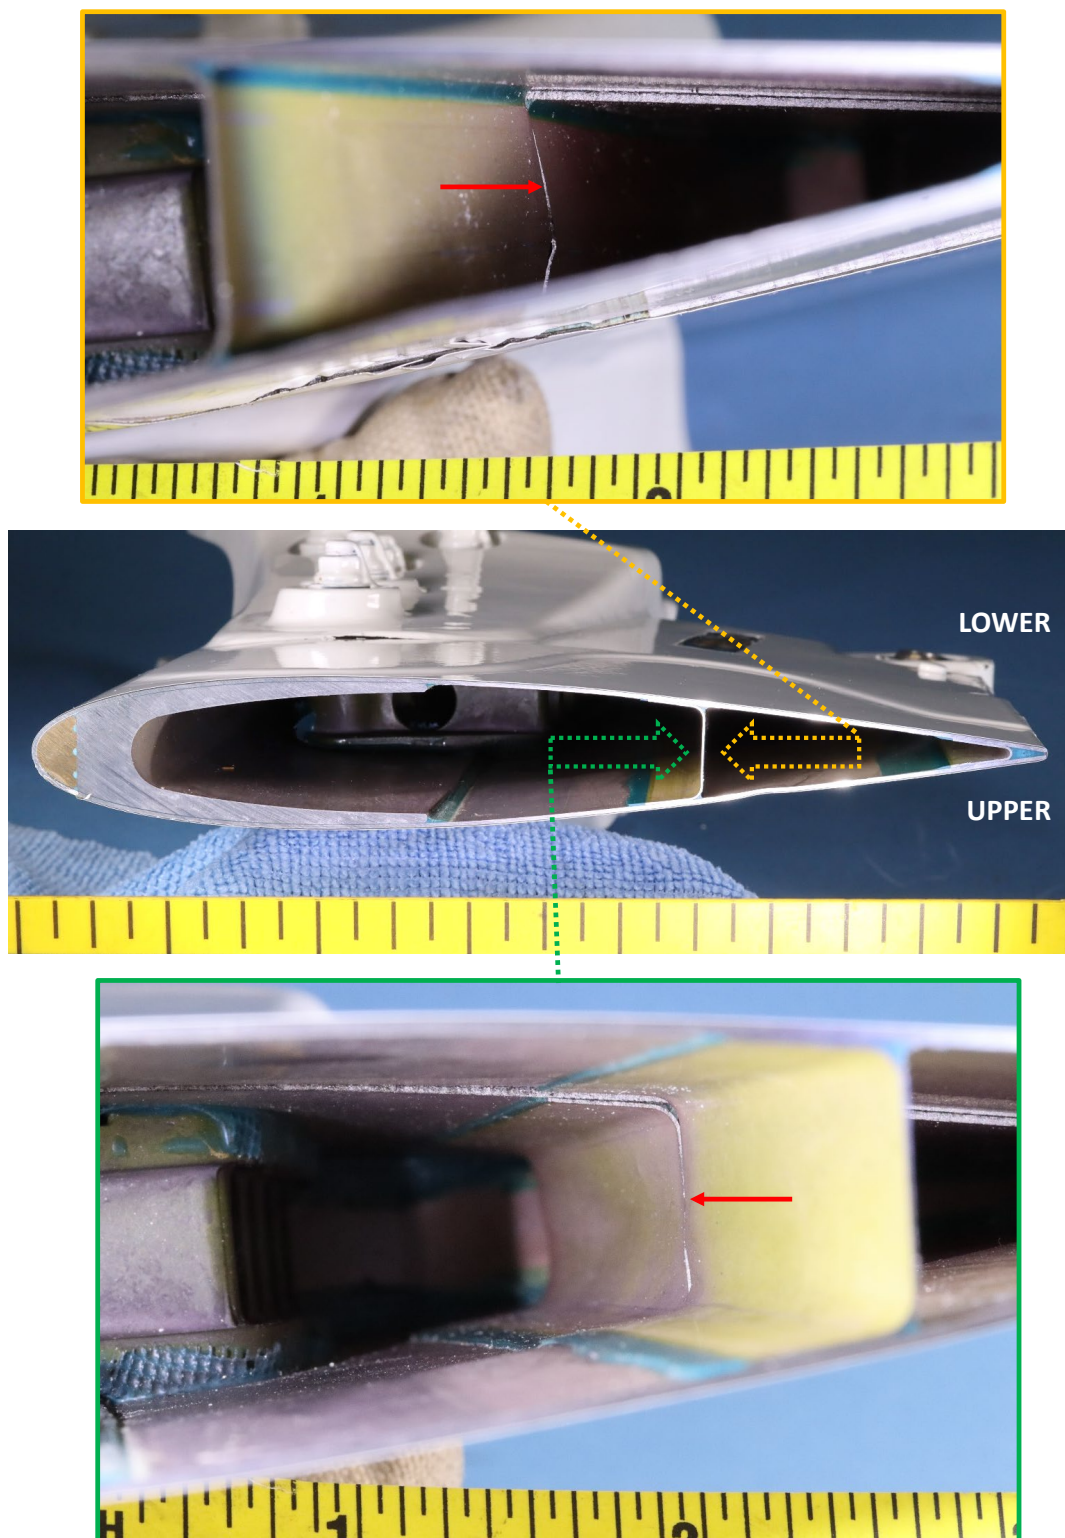
**Figure 13.** Macro photos of the internal cavity of the -K364 blade after mechanical exposure in the laboratory. The red arrows point to the crack visible on the inner stiffener.

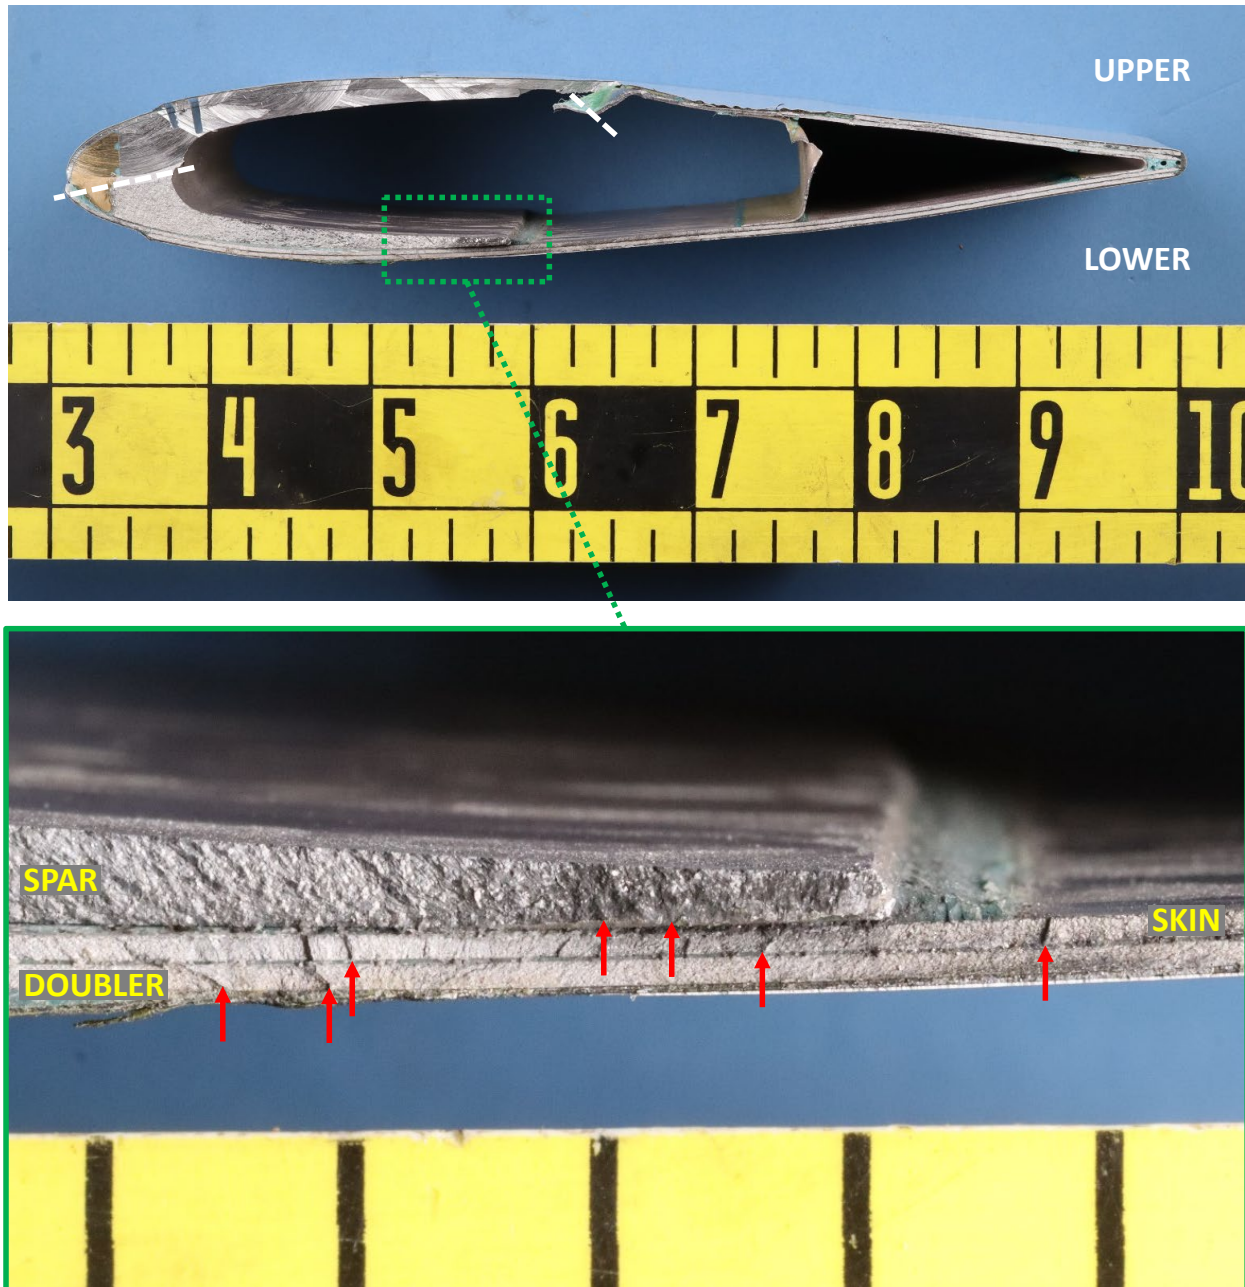
**Figure 14.** Macro photos of the fracture surface of the crack in the -K364 blade after mechanical exposure in the laboratory. Numerous ratchet marks (red arrows) were observed on the fracture surfaces.

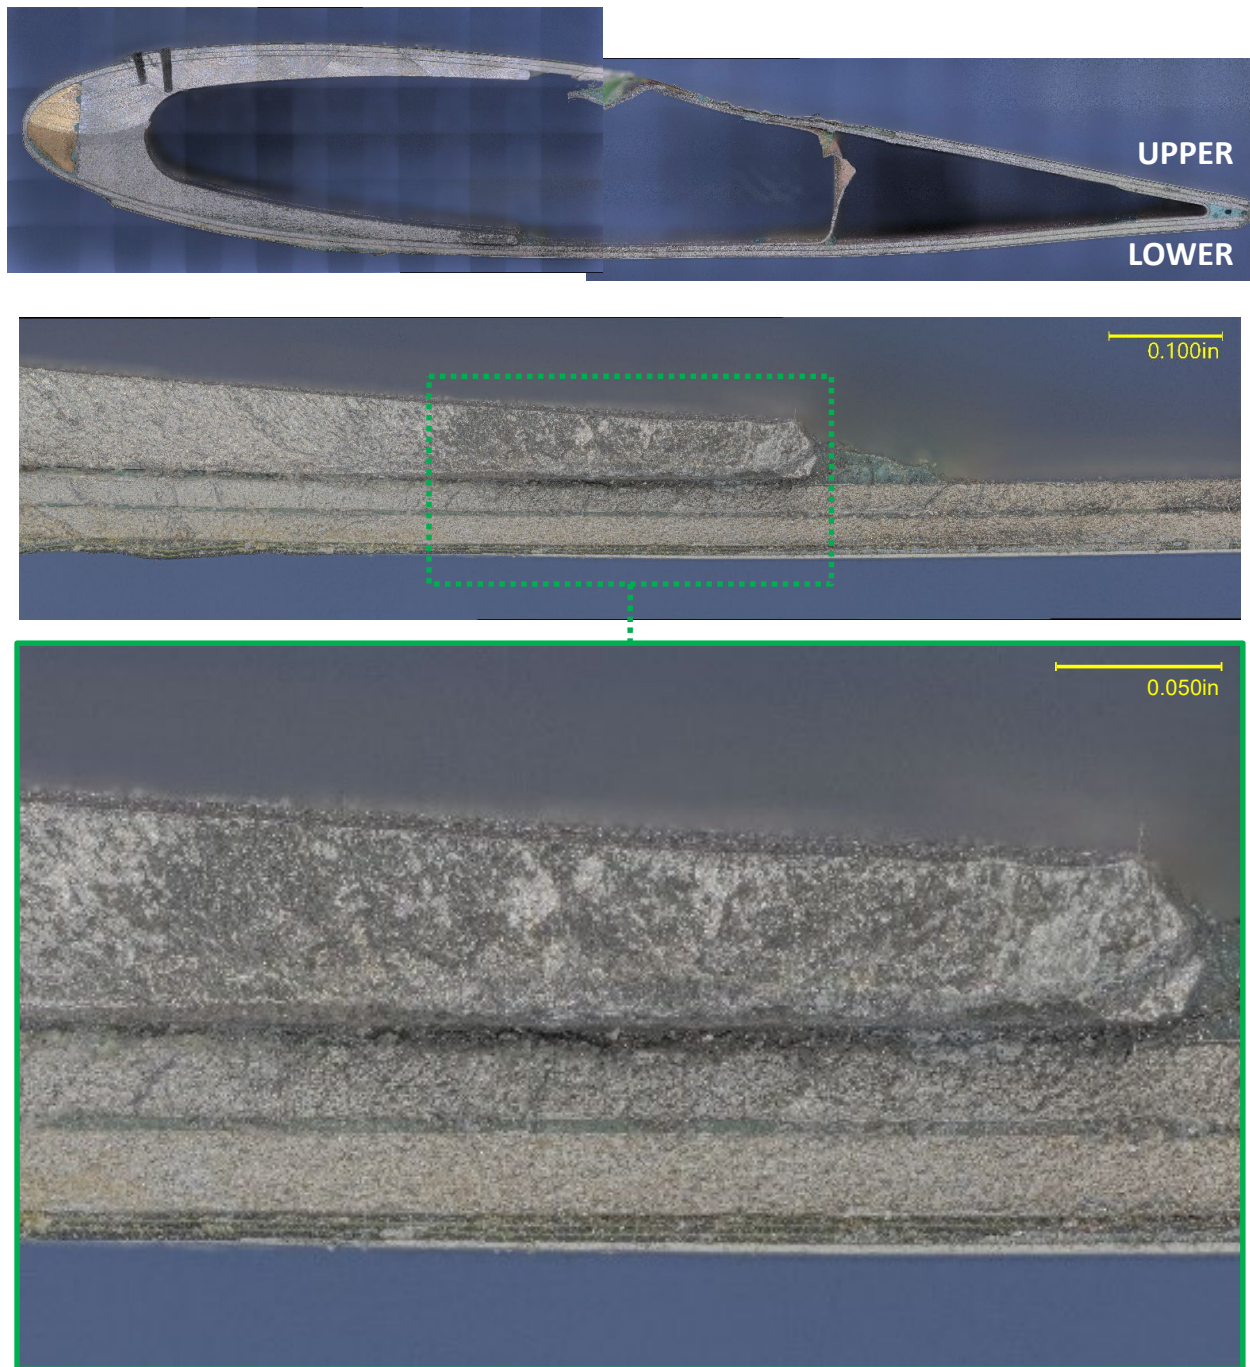
**Figure 15.** Digital microscope images of the fracture surface of the crack in the -K364 blade after mechanical exposure in the laboratory.

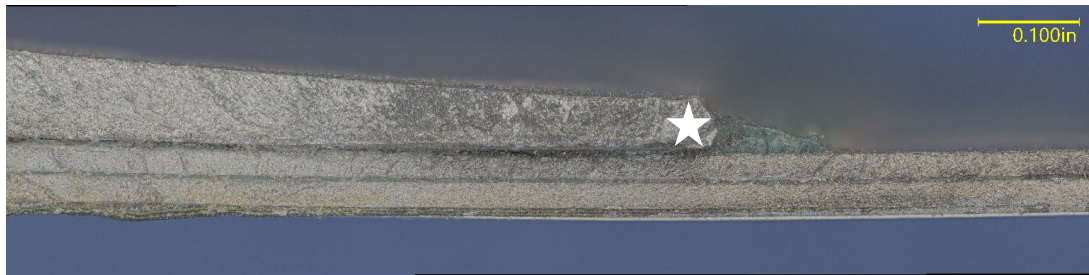
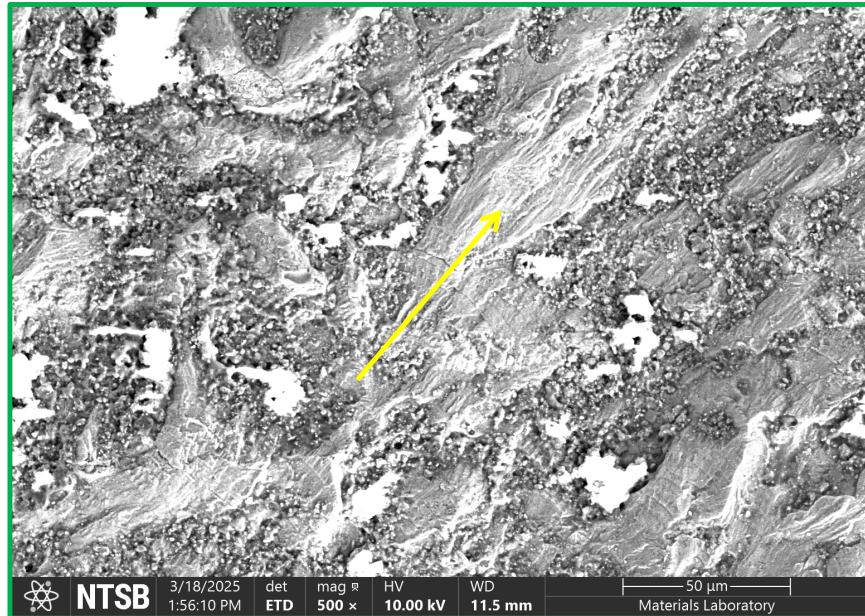
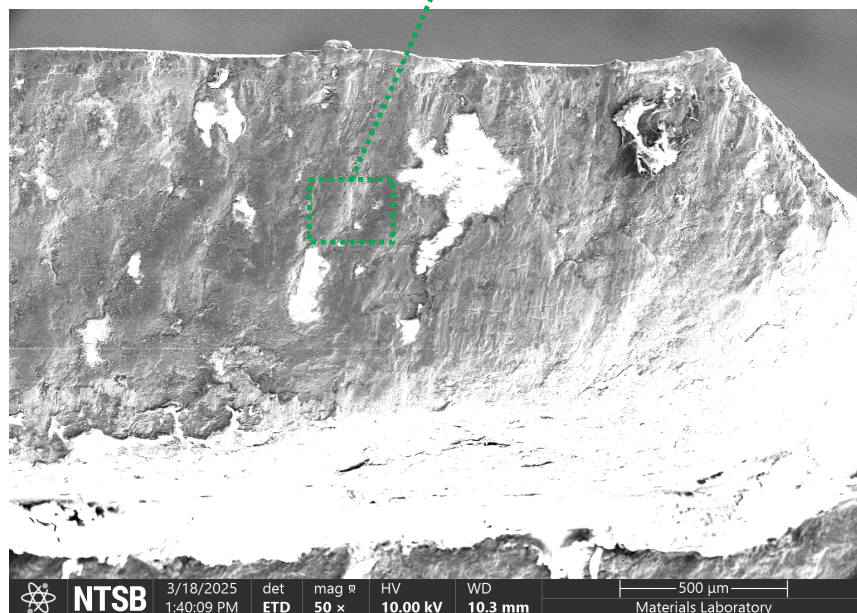
**Figure 16.** Digital microscope (top) and SEM (middle and bottom) images of the fracture surface of the crack in the -K364 blade after mechanical exposure in the laboratory. The white star in the digital microscope image indicates the location of the SEM images. The yellow arrow indicates the direction of crack propagation.

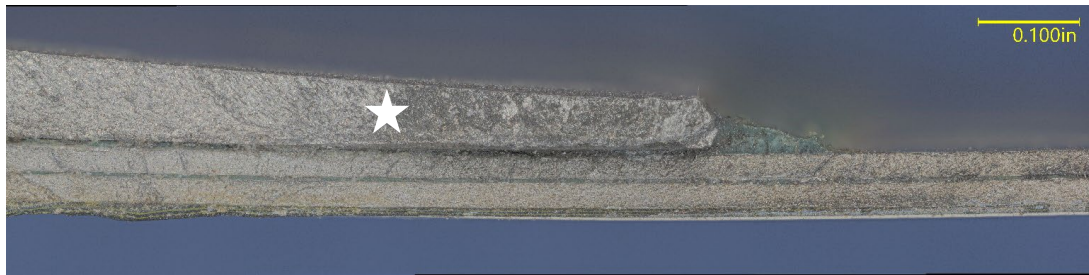
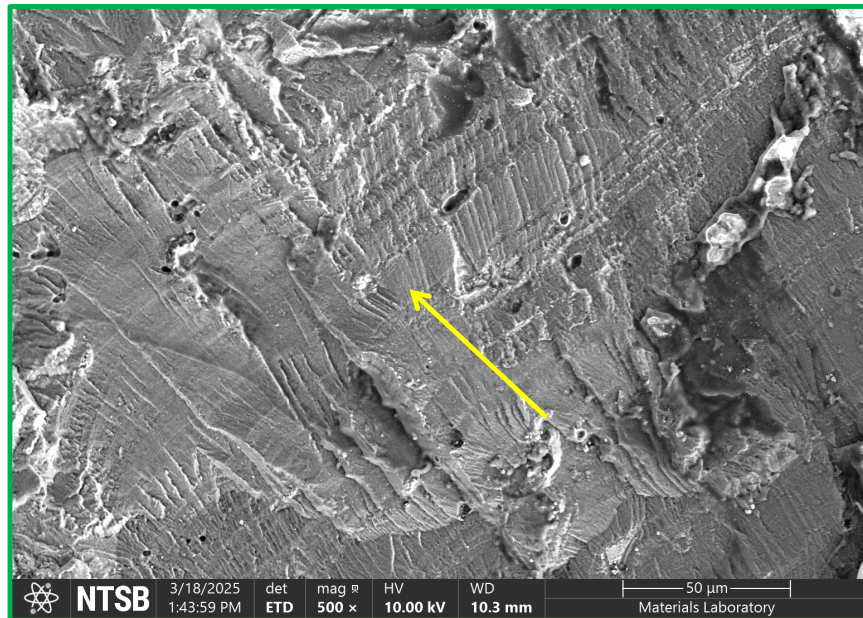
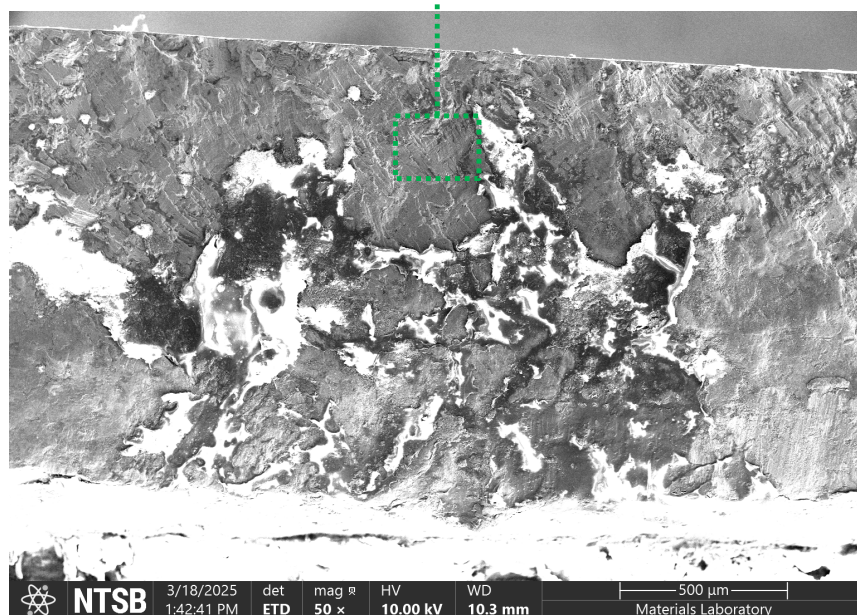
**Figure 17.** Digital microscope (top) and SEM (middle and bottom) images of the fracture surface of the crack in the -K364 blade after mechanical exposure in the laboratory. The white star in the digital microscope image indicates the location of the SEM images. The yellow arrow indicates the direction of crack propagation.

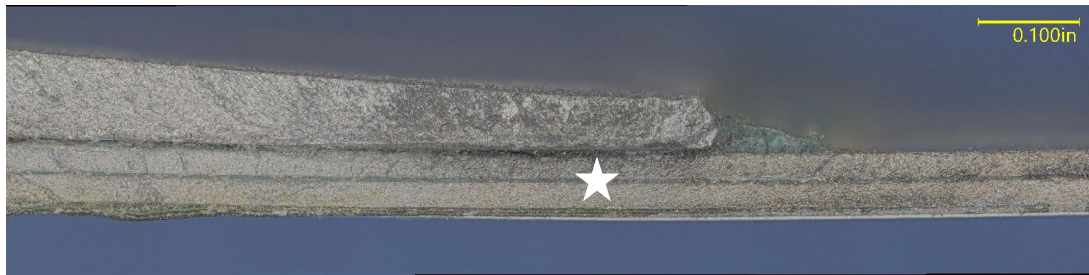
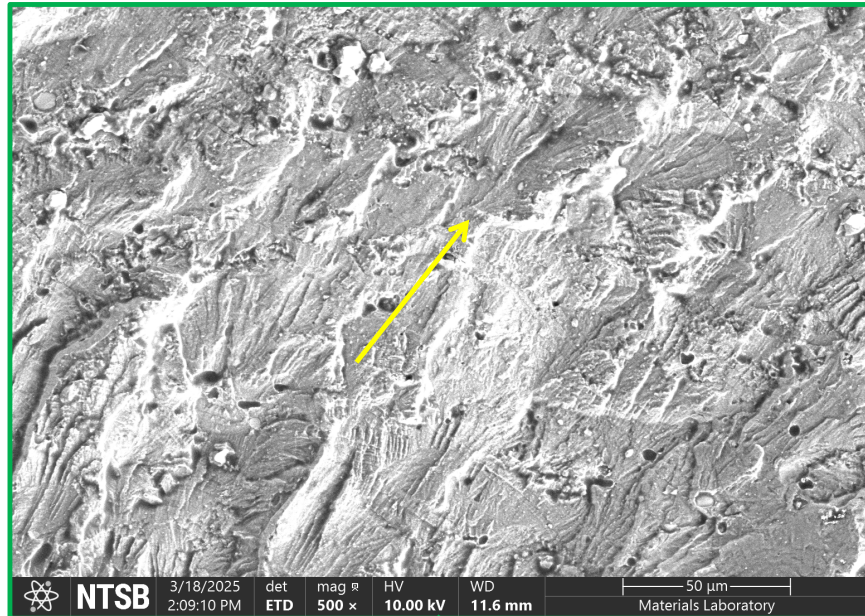
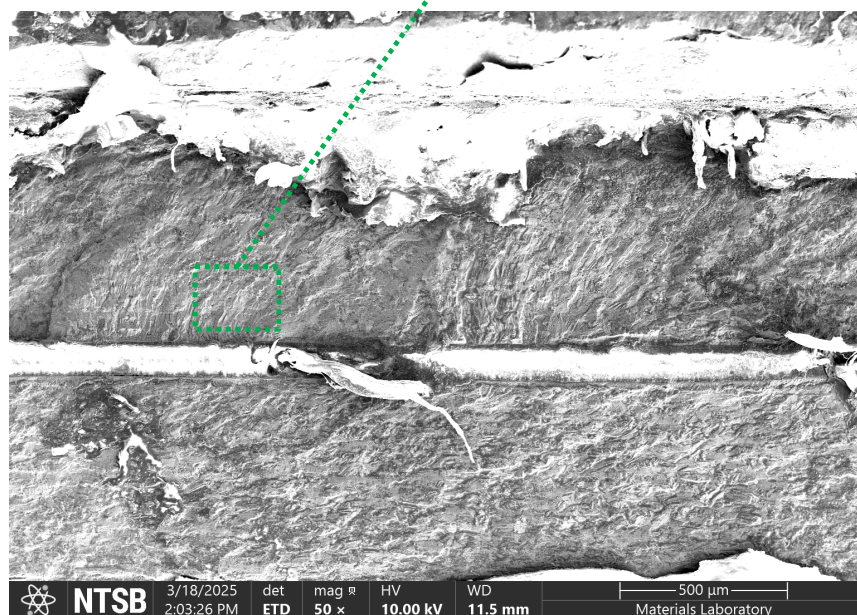
**Figure 18.** Digital microscope (top) and SEM (middle and bottom) images of the fracture surface of the crack in the -K364 blade after mechanical exposure in the laboratory. The white star in the digital microscope image indicates the location of the SEM images. The yellow arrow indicates the direction of crack propagation.

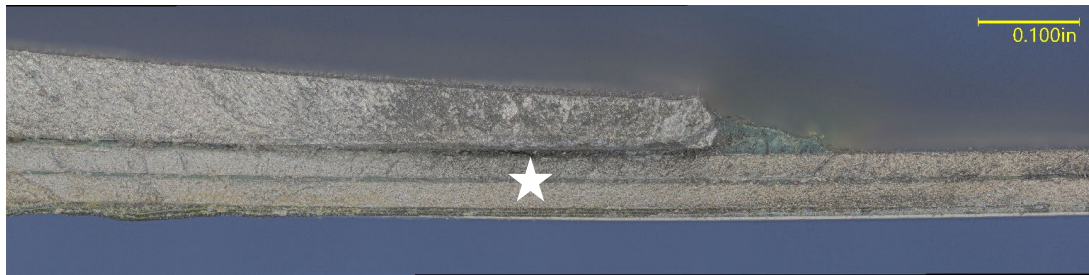
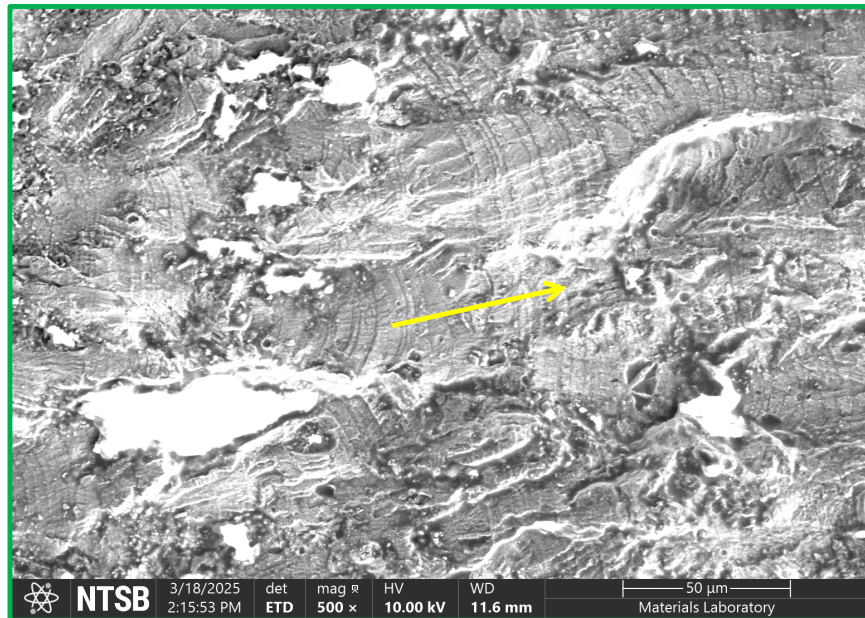
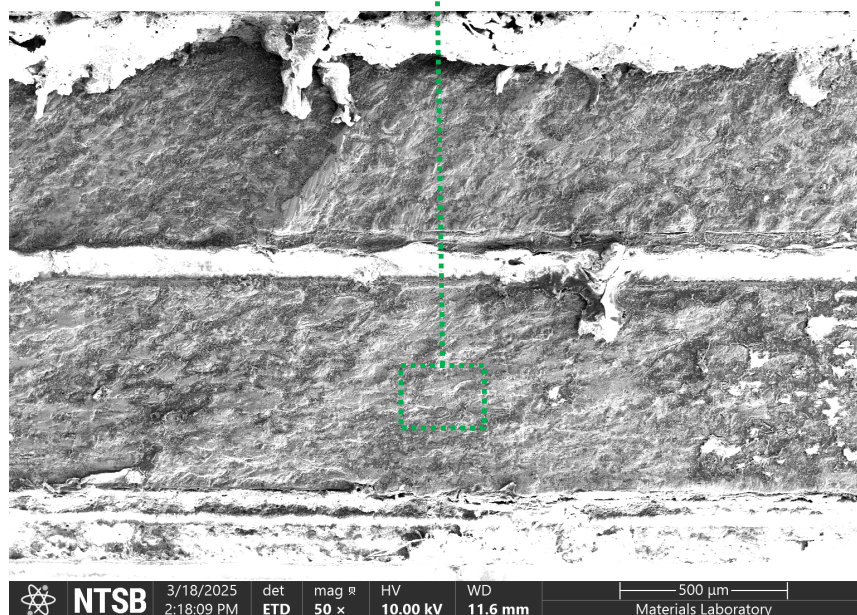
**Figure 19.** Digital microscope (top) and SEM (middle and bottom) images of the fracture surface of the crack in the -K364 blade after mechanical exposure in the laboratory. The white star in the digital microscope image indicates the location of the SEM images. The yellow arrow indicates the direction of crack propagation.

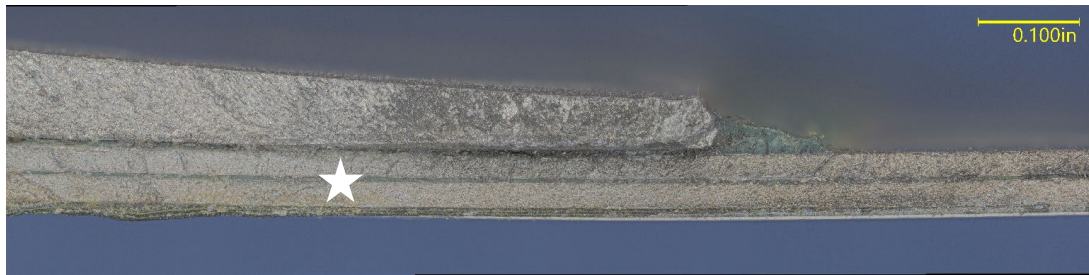
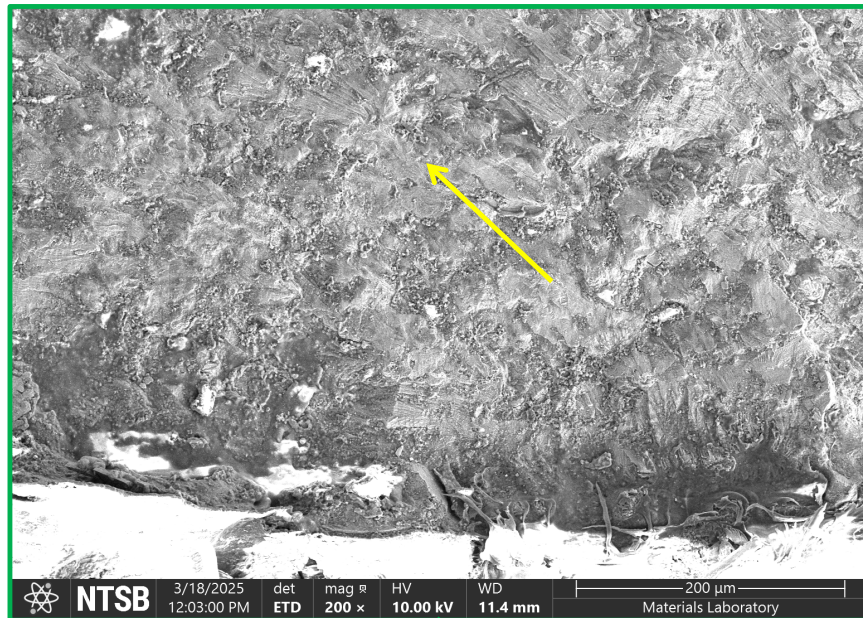
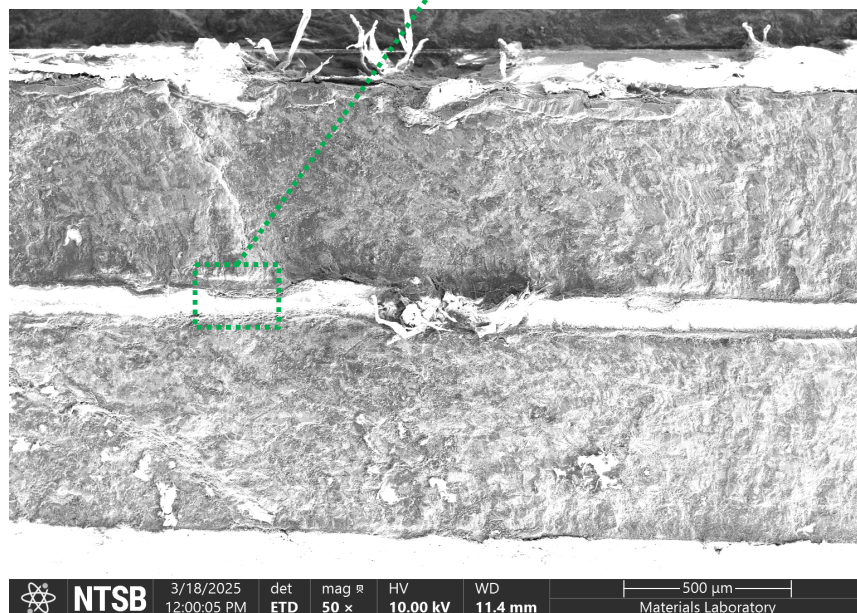
**Figure 20.** Digital microscope (top) and SEM (middle and bottom) images of the fracture surface of the crack in the -K364 blade after mechanical exposure in the laboratory. The white star in the digital microscope image indicates the location of the SEM images. The yellow arrow indicates the direction of crack propagation.

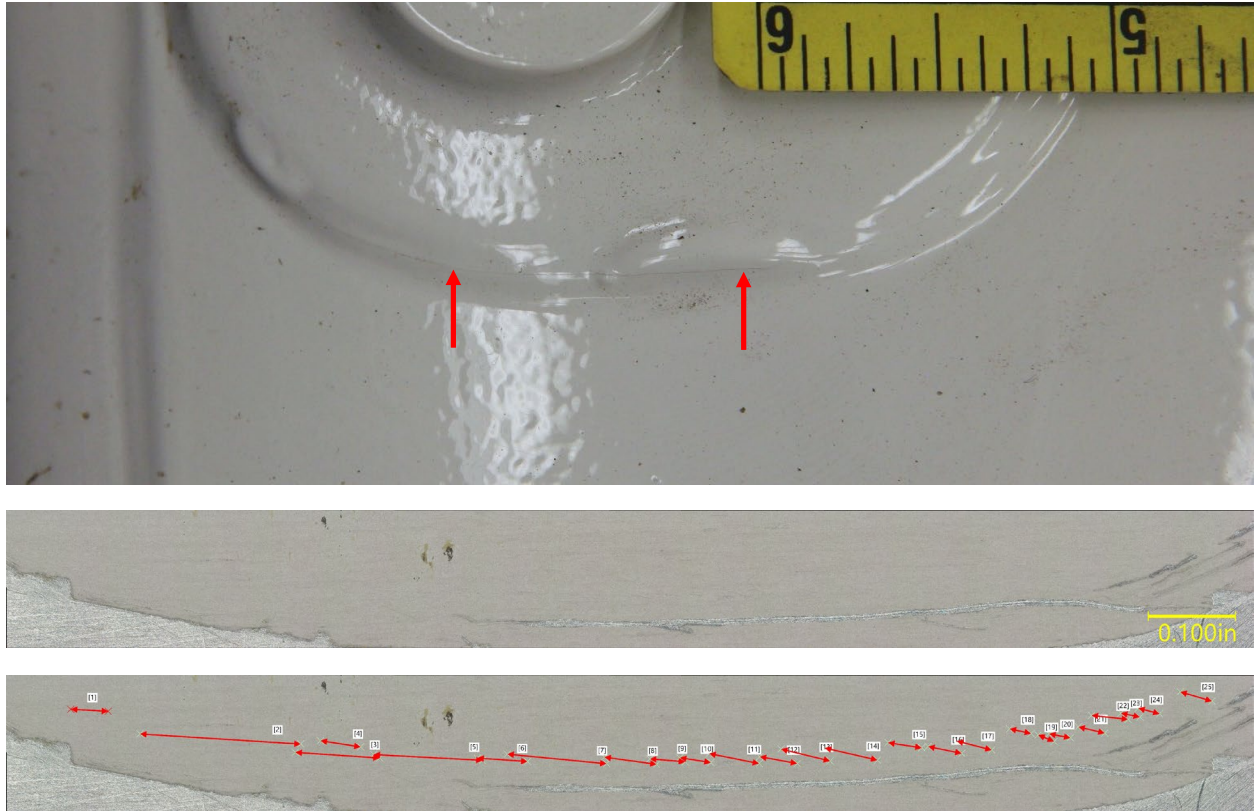
**Figure 21.** (Top) Macro photo of the bottom surface of the -K374 blade with a crack (red arrows) in the doubler paint at the root of the fitting. (Bottom) Digital microscope image of the doubler surface after paint and fitting removal. The red arrows indicate individual cracks observed in the doubler under the fitting.
