# National Transportation Safety Board

Office of Research and Engineering

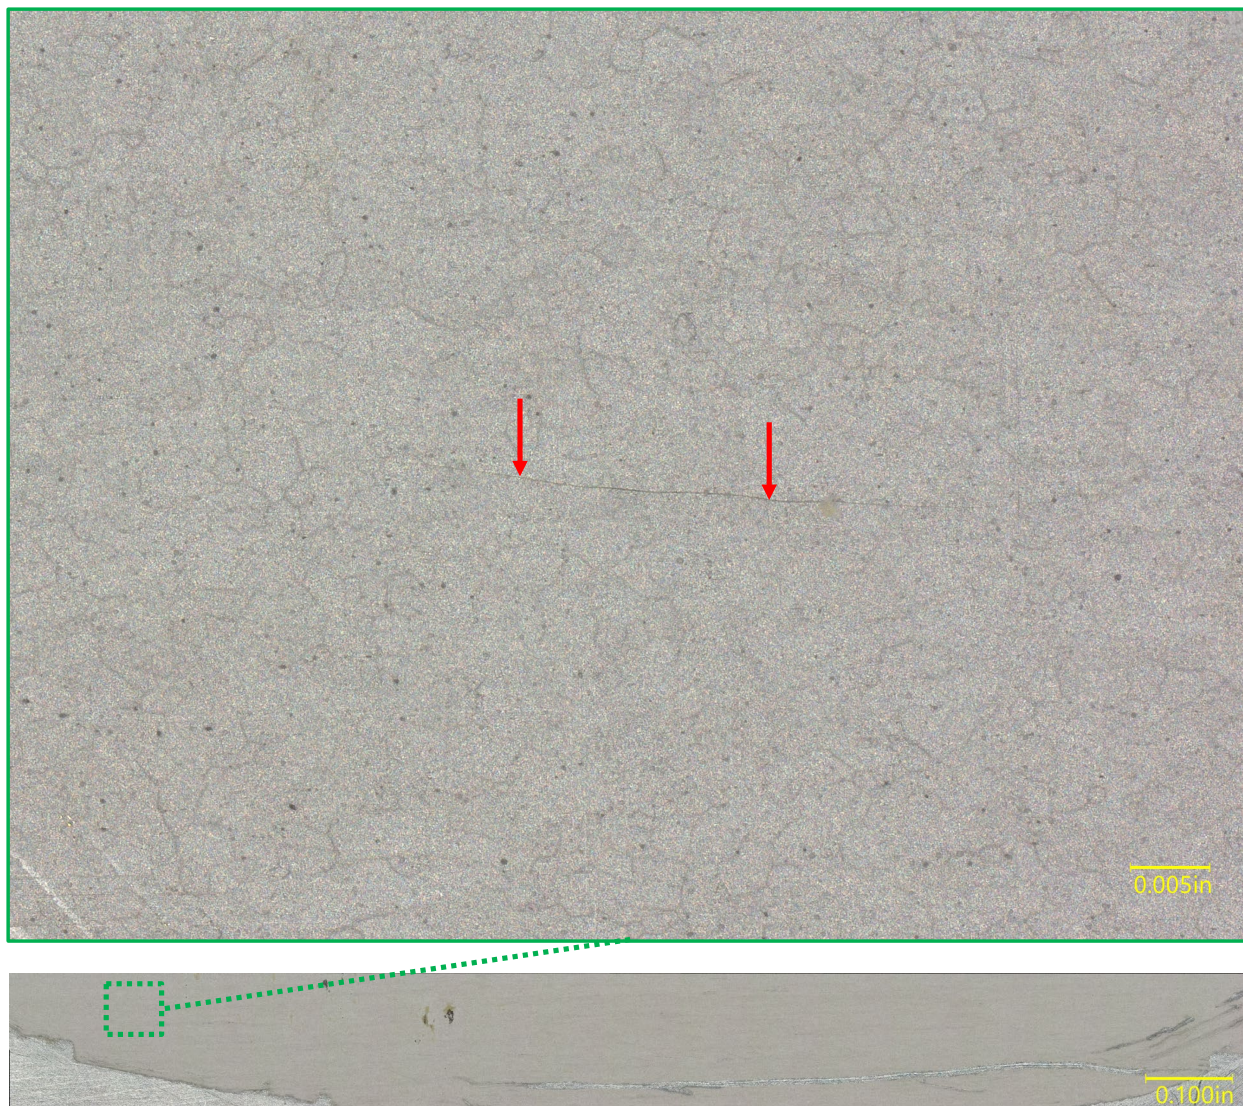
**Figure 22.** Digital microscope images of the -K374 blade doubler surface after paint and fitting removal. The red arrows indicate a crack observed in the doubler under the fitting.

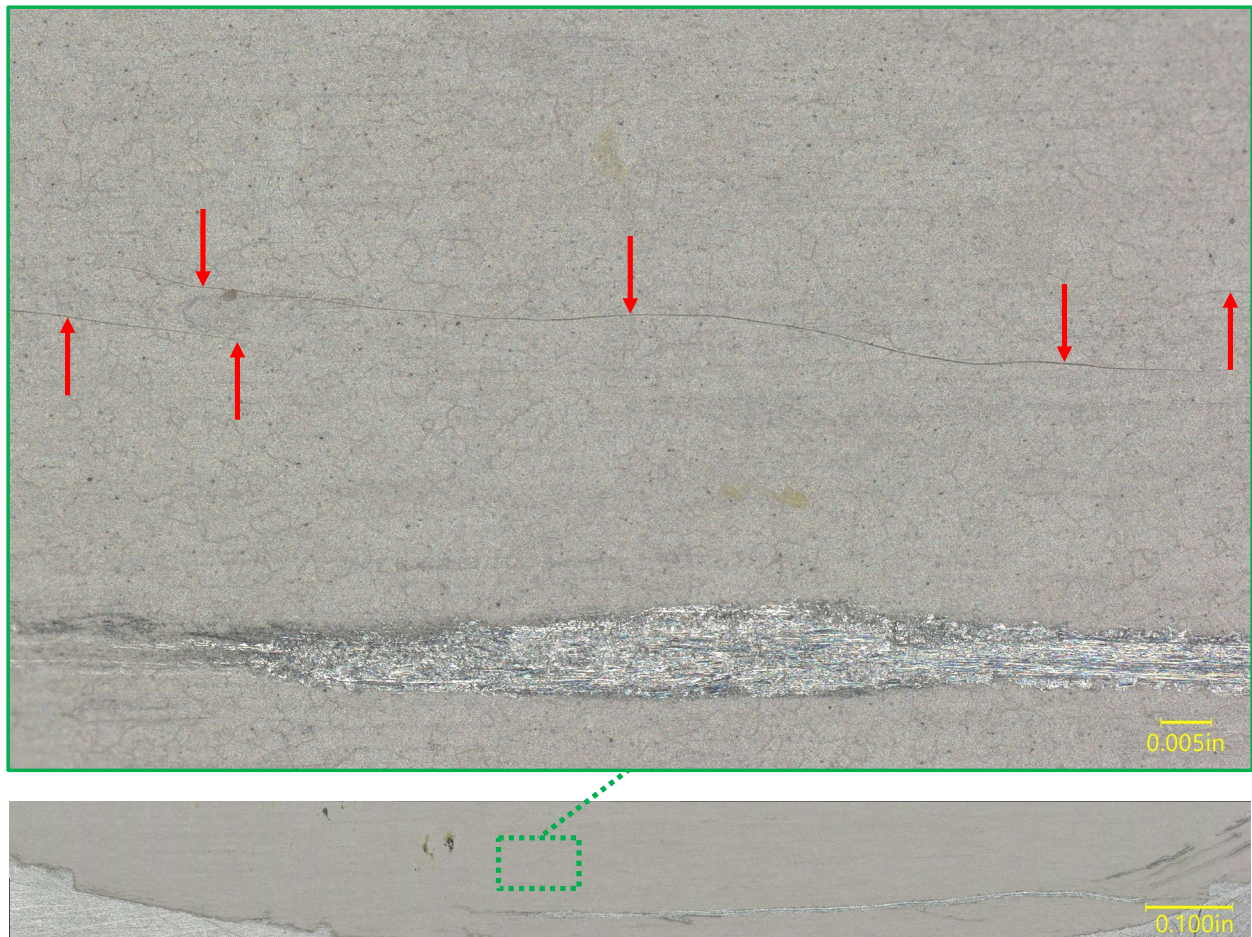
**Figure 23.** Digital microscope images of the -K374 blade doubler surface after paint and fitting removal. The red arrows indicate cracks observed in the doubler under the fitting.

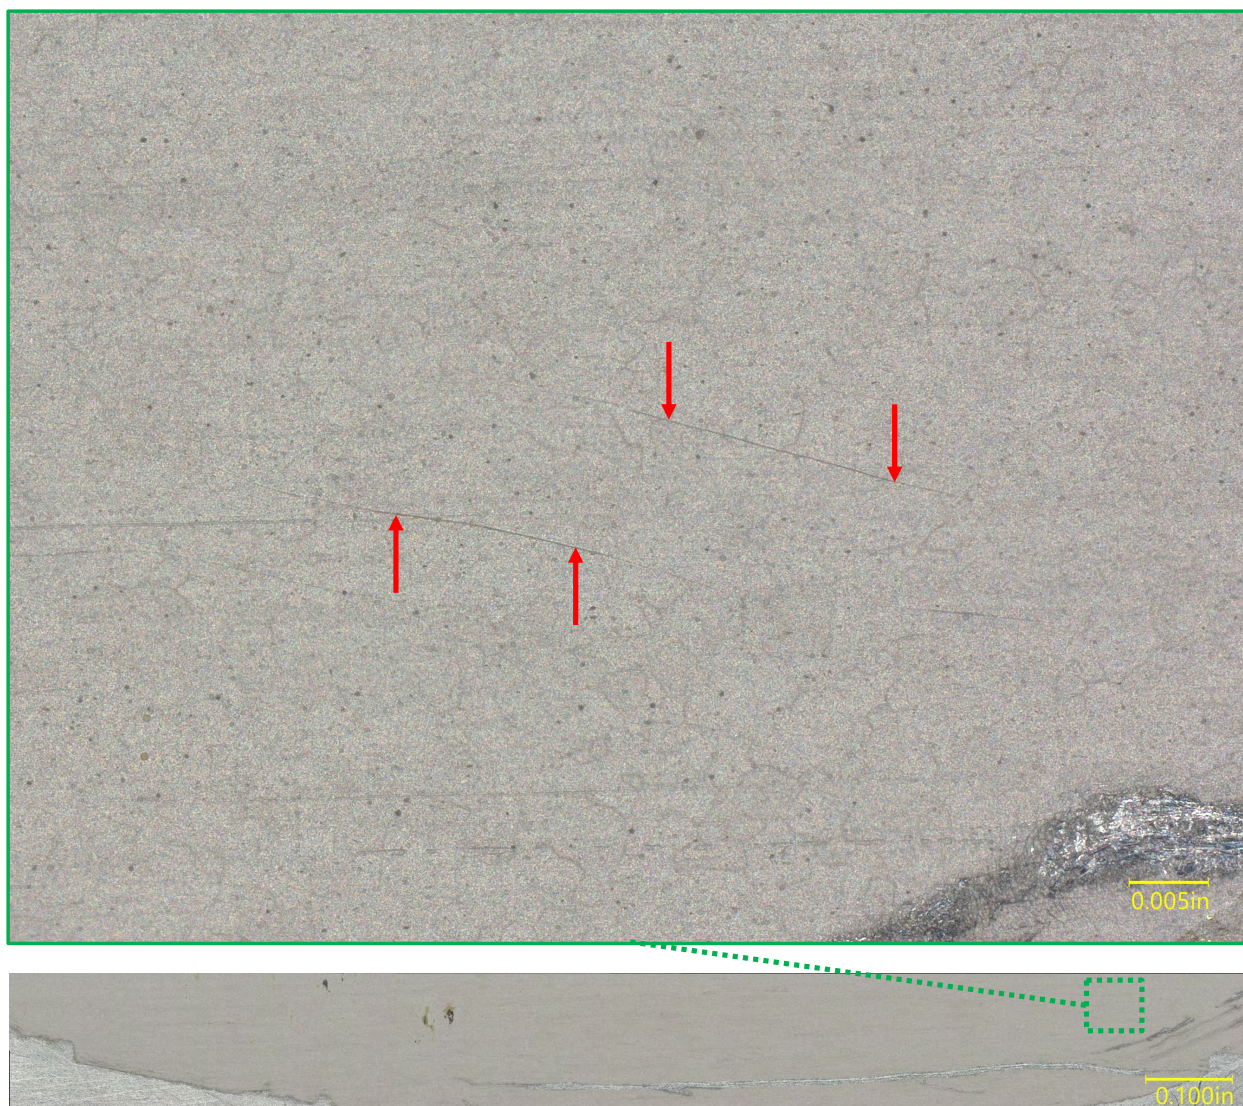
**Figure 24.** Digital microscope images of the -K374 blade doubler surface after paint and fitting removal. The red arrows indicate cracks observed in the doubler under the fitting.

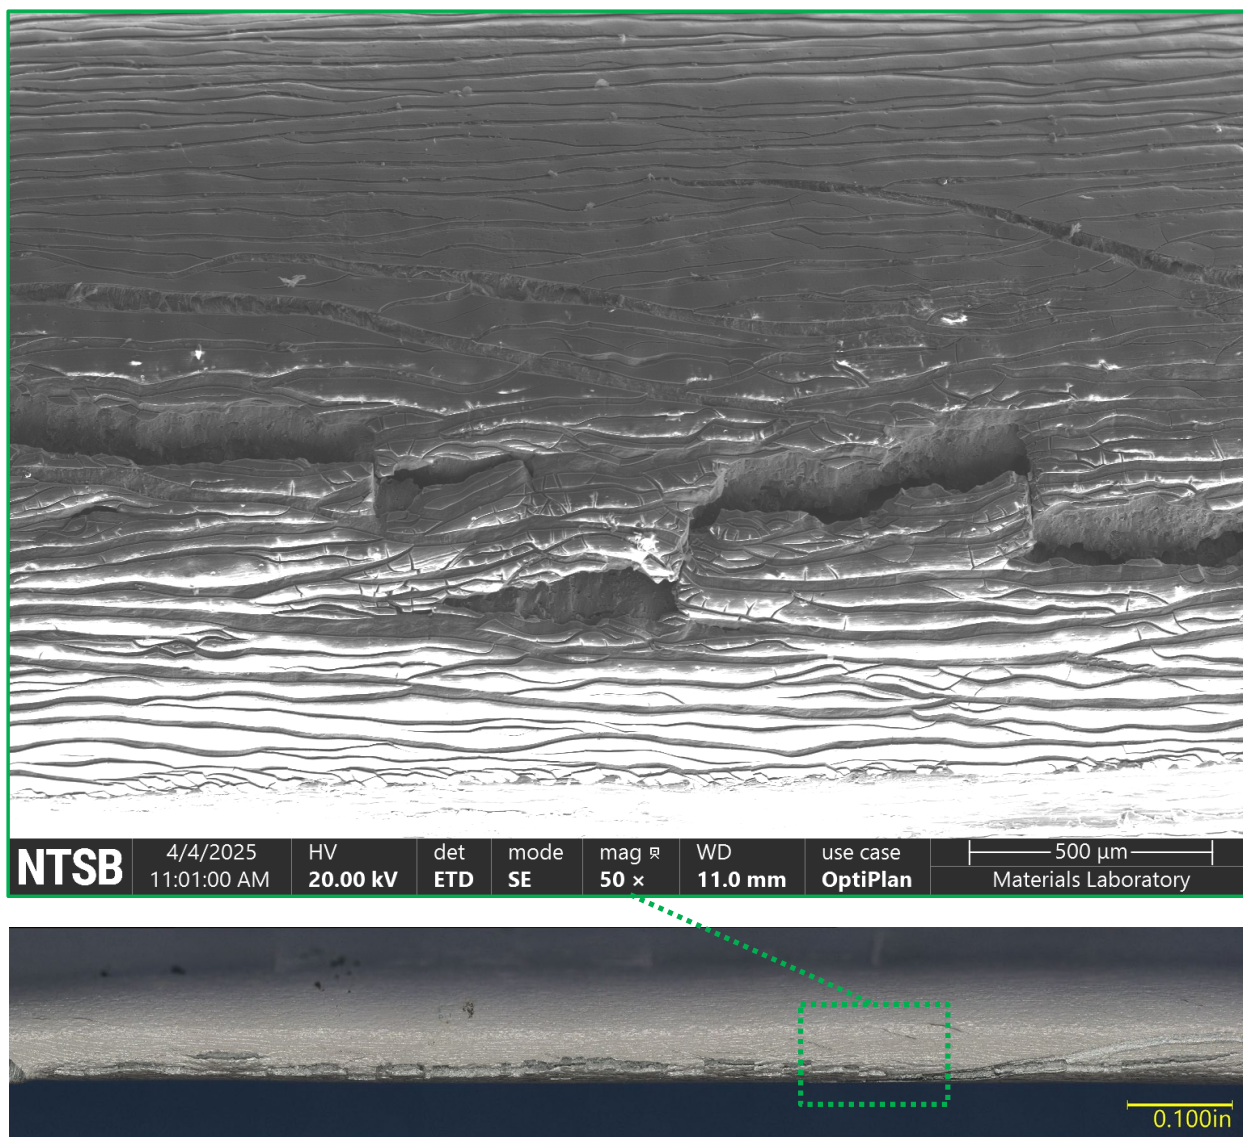
**Figure 25.** (Top) SEM and (bottom) digital microscope images of the -K374 blade doubler surface after mechanical exposure of the cracks in the doubler.

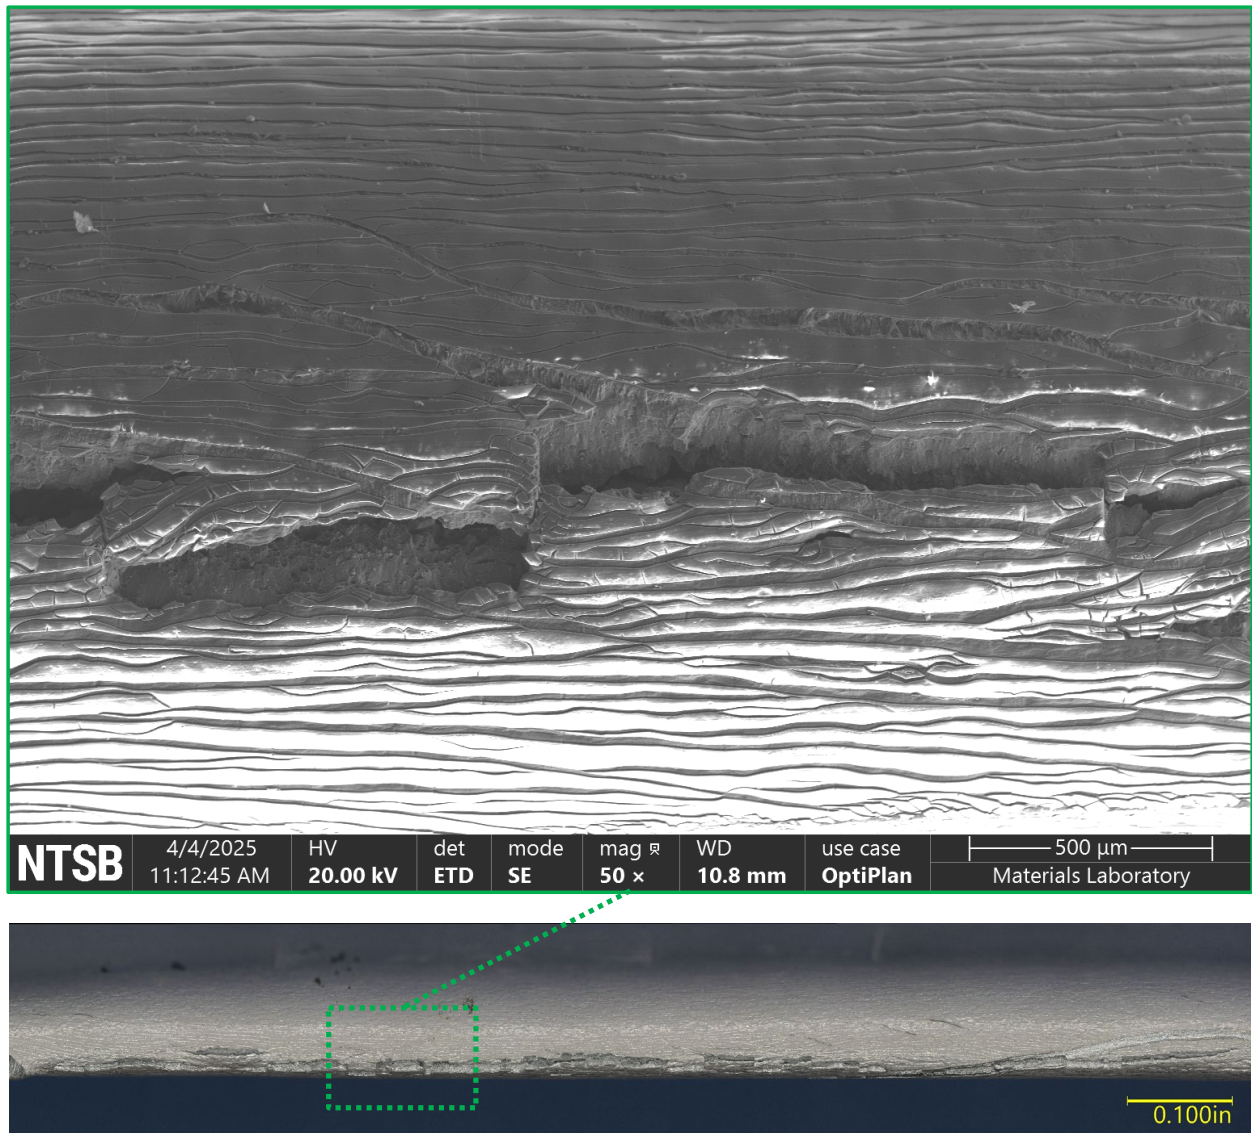
**Figure 26.** (Top) SEM and (bottom) digital microscope images of the -K374 blade doubler surface after mechanical exposure of the cracks in the doubler.

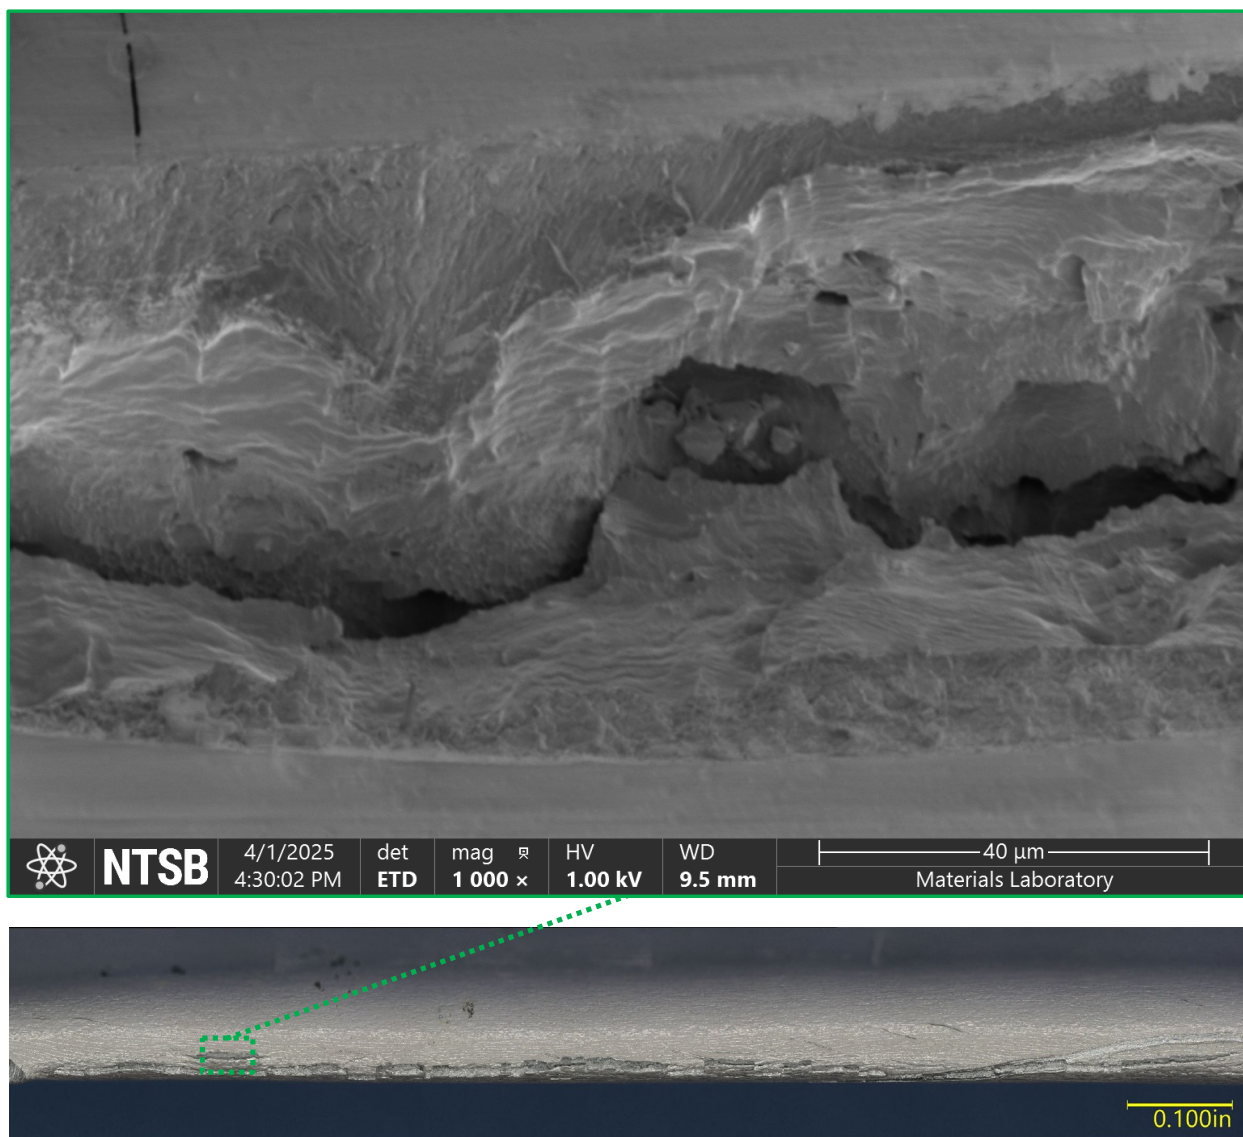
**Figure 27.** (Top) SEM and (bottom) digital microscope images of the -K374 blade doubler surface after mechanical exposure of the cracks in the doubler.

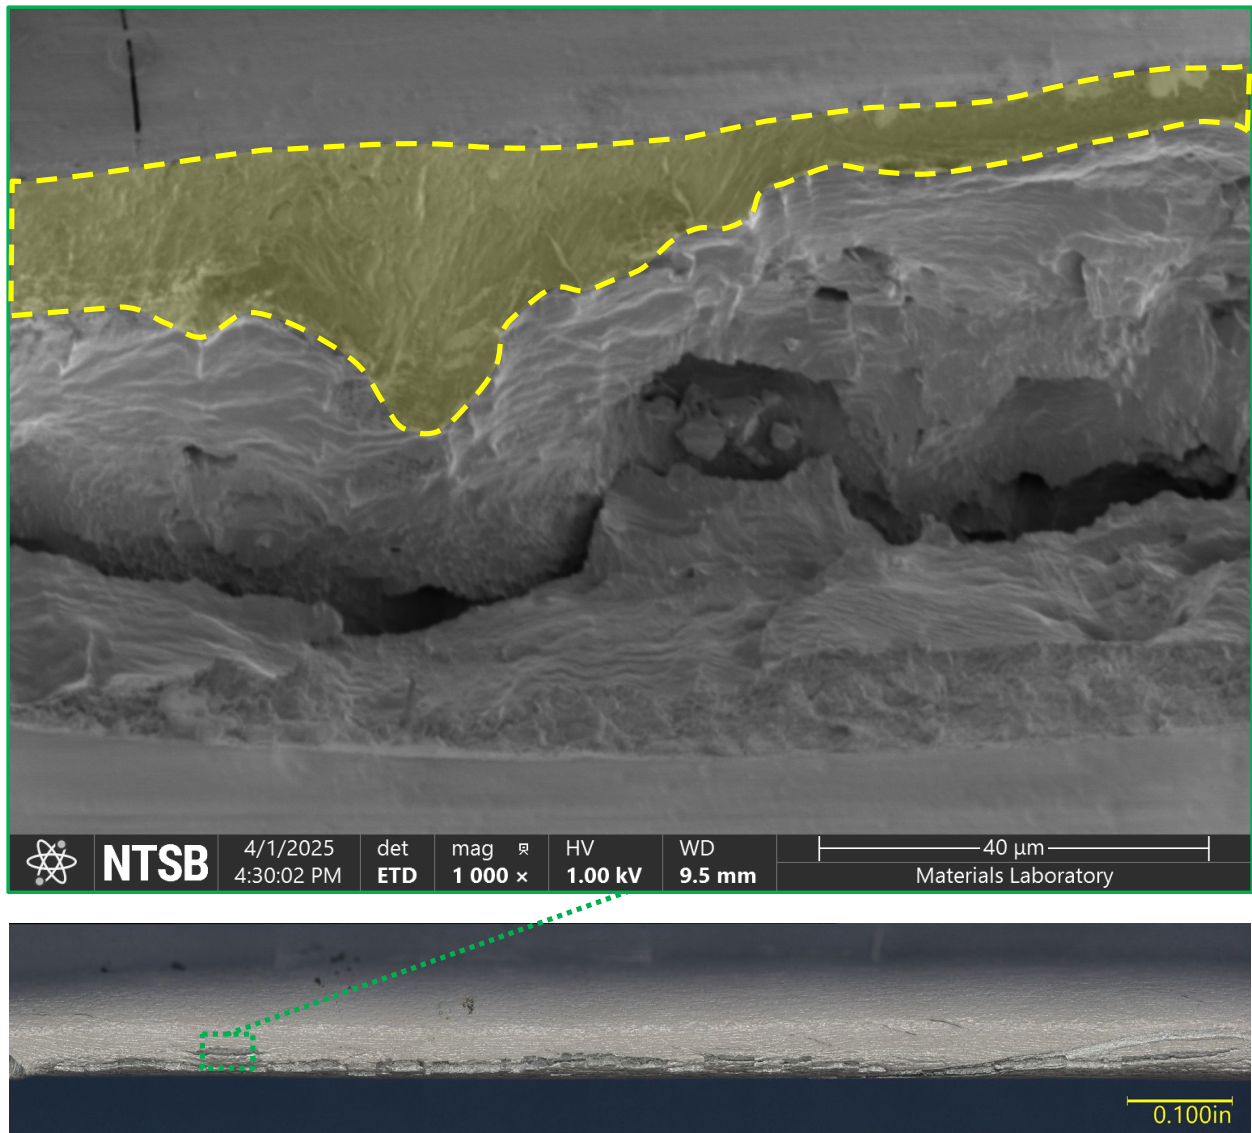
**Figure 28.** (Top) SEM and (bottom) digital microscope images of the -K374 blade doubler surface after mechanical exposure of the cracks in the doubler. The figure is the same as Figure 27 but includes a highlight of the fatigue portion of the top fracture surface (yellow area).

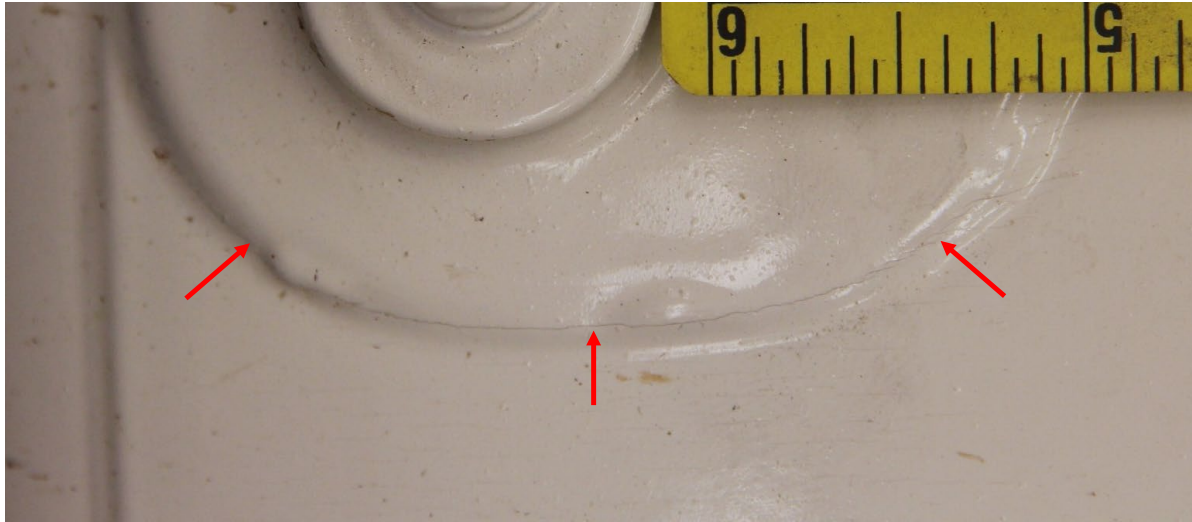
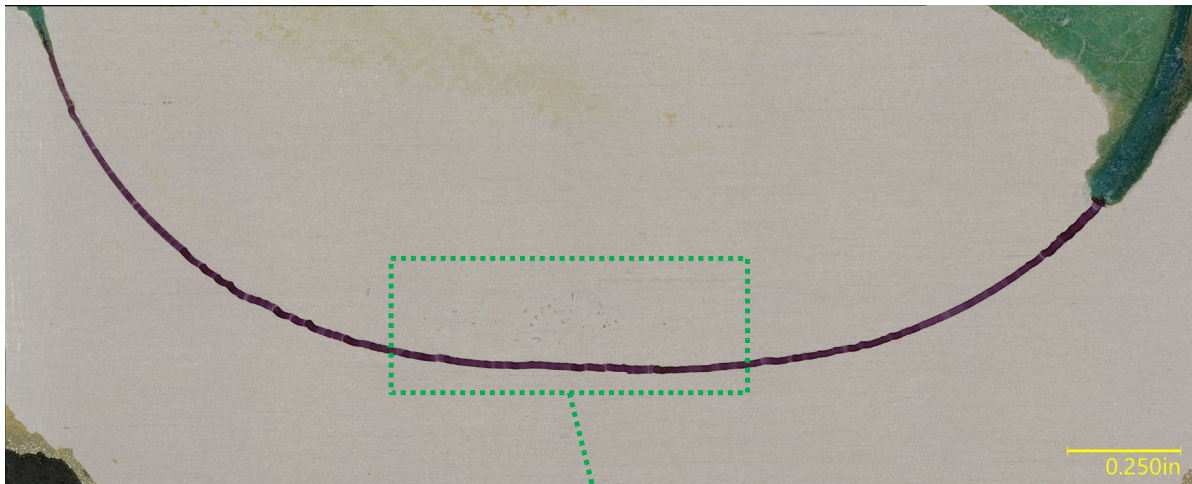
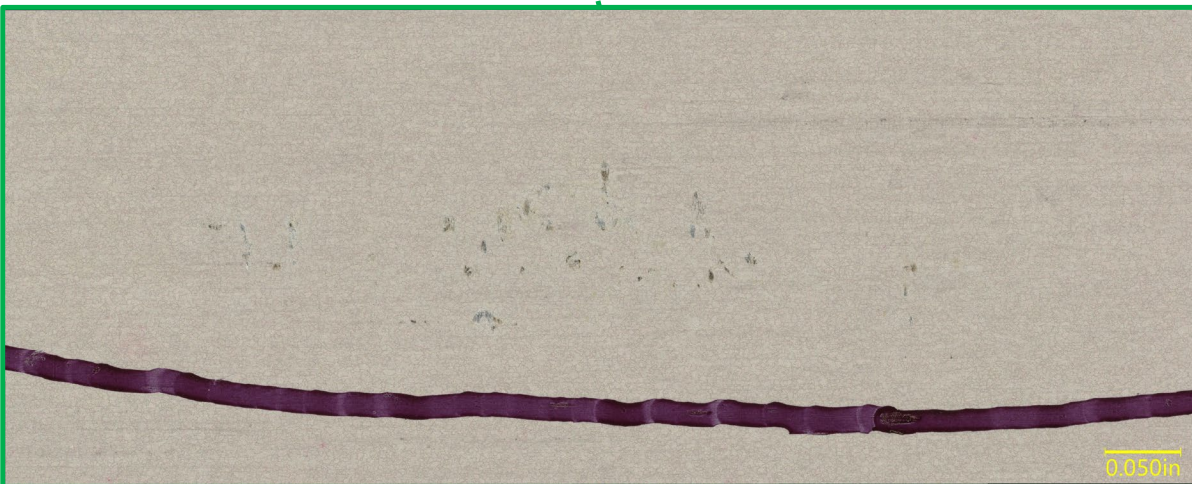
**Figure 29.** (Top) Macro photo of the bottom surface of the -K358 blade with a crack (red arrows) in the doubler paint at the root of the fitting. (Bottom) Digital microscope image of the doubler surface after paint and fitting removal. The black line indicates the profile edge of where the fitting mated.

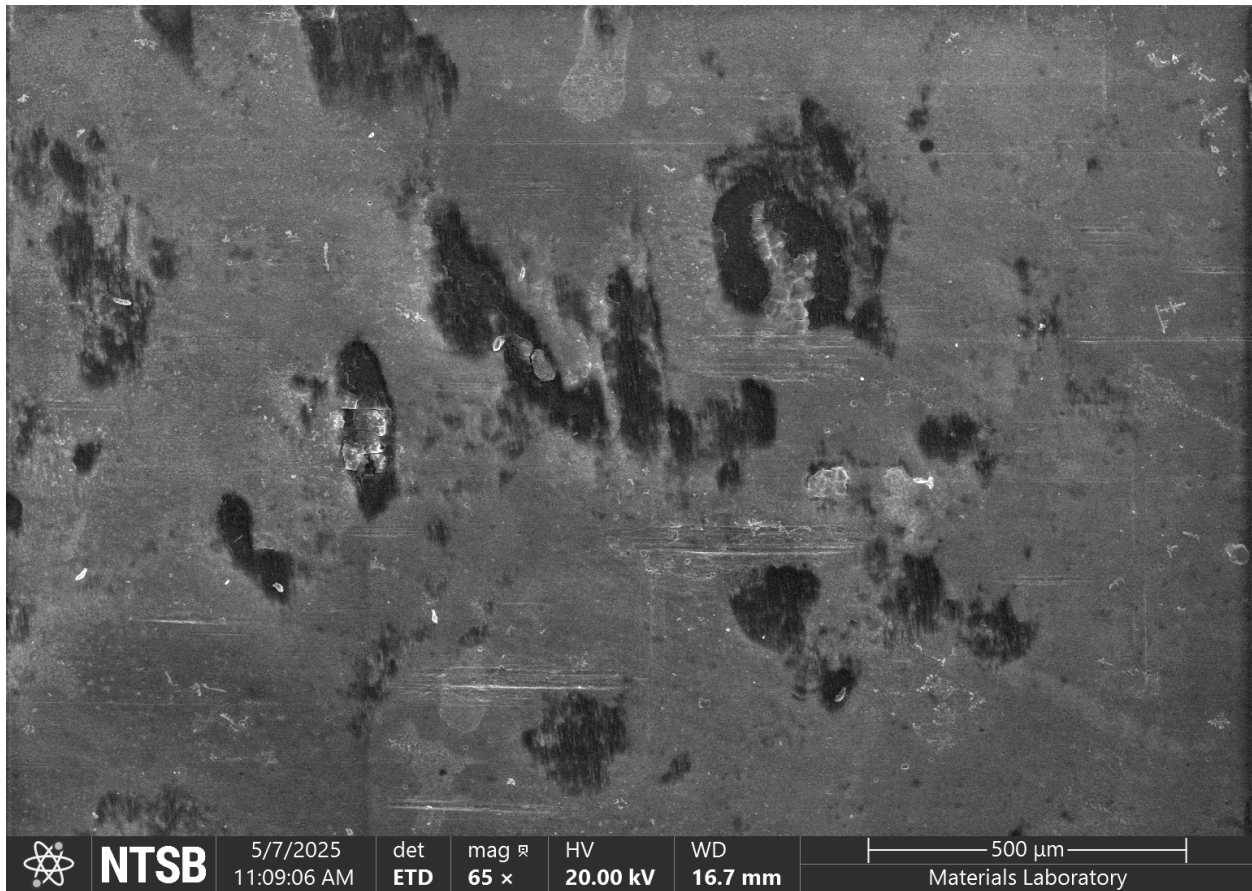
**Figure 30.** SEM image of some of the randomly scattered indents filled with debris on the doubler surface under where the fitting mated on blade -K358.
