# SERVICE BULLETIN

DATE: 4 FEBRUARY 2004

## MAIN ROTOR BLADE ASSEMBLY TORQUE EVENT INSPECTION

\* Supersedes Service Bulletin SB369H-245R1, SB369D-201R1, SB369E-095R1, SB369F-079R1, SB500N-023R1, SB600N-031R1, dated 24 July 2001. This revision adds cross-reference blade information, revises the aircraft affected (369H/HE/HS/HM series helicopters are no longer affected), and adds additional inspection instructions.

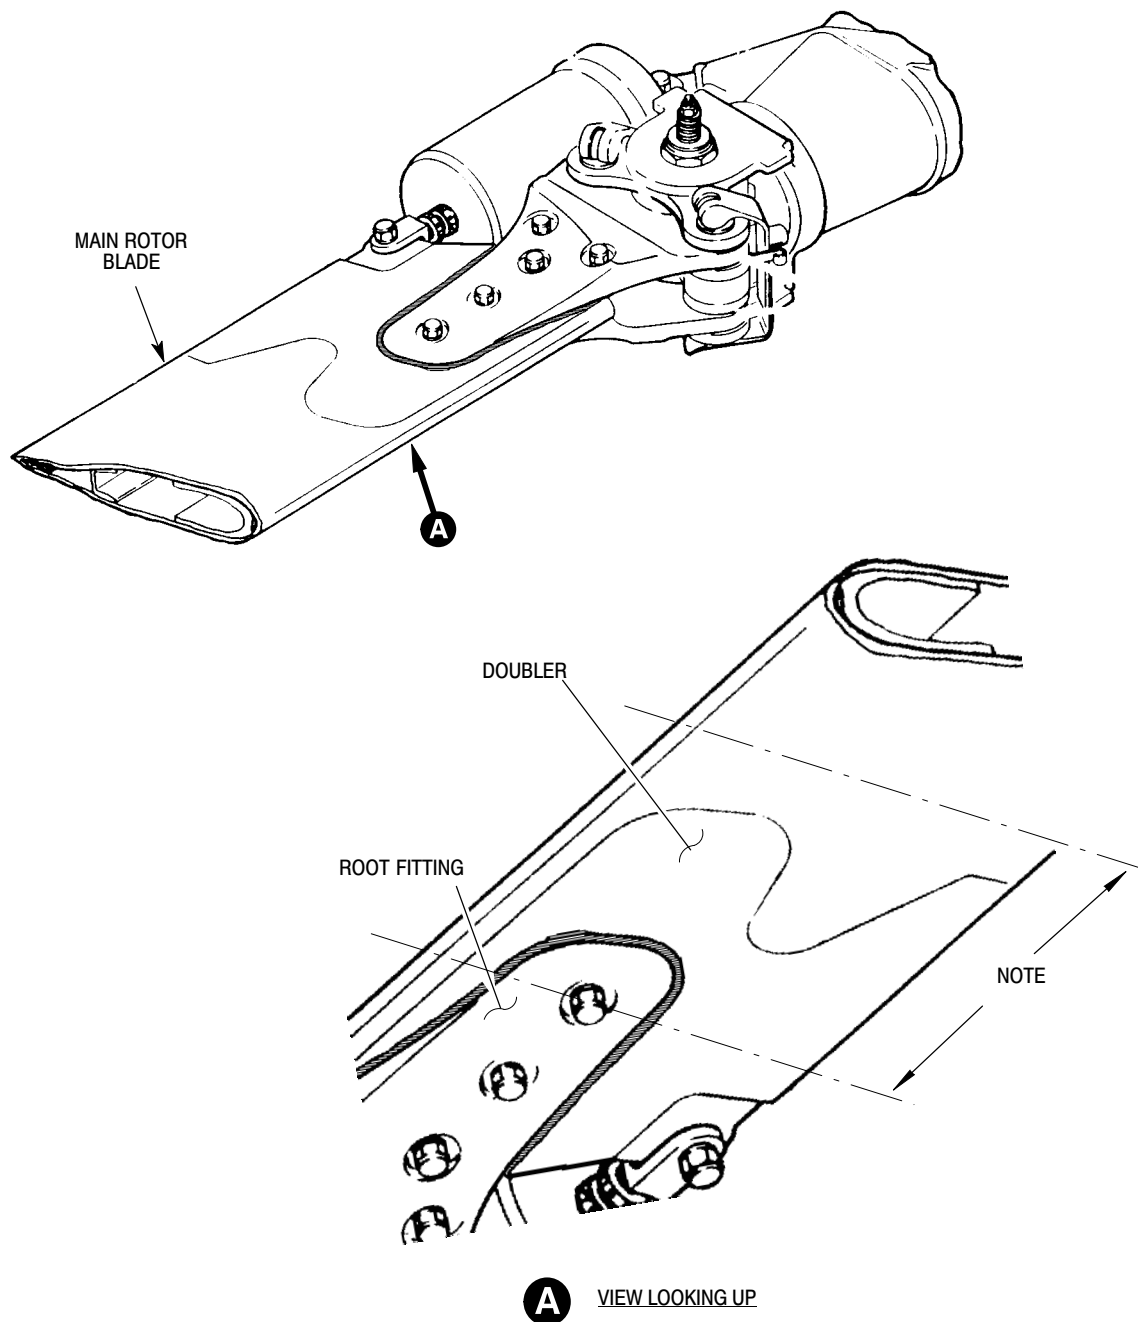
**Figure 1. Main Rotor Blade Torque Event Inspection**

Some operators have experienced cracking of main rotor blades. These cracked blades have been associated with a high number of torque events/external lifts per hour which exceed the original design fatigue spectrum. This bulletin references criteria to assist operators in understanding their level of usage, the impact of that usage on the main rotor blade life and the corresponding inspections required to locate cracks that might occur. Failure to comply with this bulletin may result in the loss of a main rotor blade.

**NOTE:**  
USING BRIGHT LIGHT AND 10X MAGNIFYING GLASS, INSPECT FOR CHORDWISE CRACKS PROTRUDING FROM UNDER ROOT FITTING AND DOUBLER.

- (3). When inspecting bottom side of blade, using bright light and 10x magnifying glass, inspect for chordwise cracks protruding from under root fitting and doubler.
