National Transportation Safety Board

CEN24LA359

## **INVESTIGATION PHOTOGRAPHS**

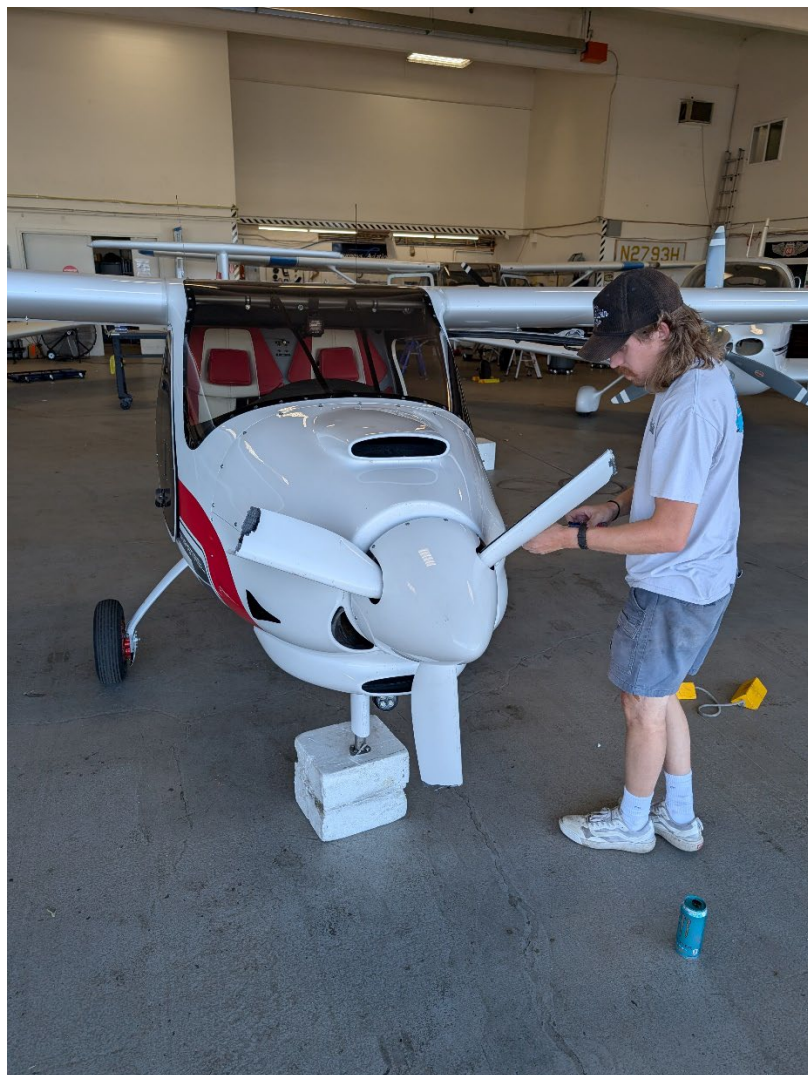
**Photograph 1 - Accident airplane propeller and nose landing gear damage (Courtesy of FAA)**

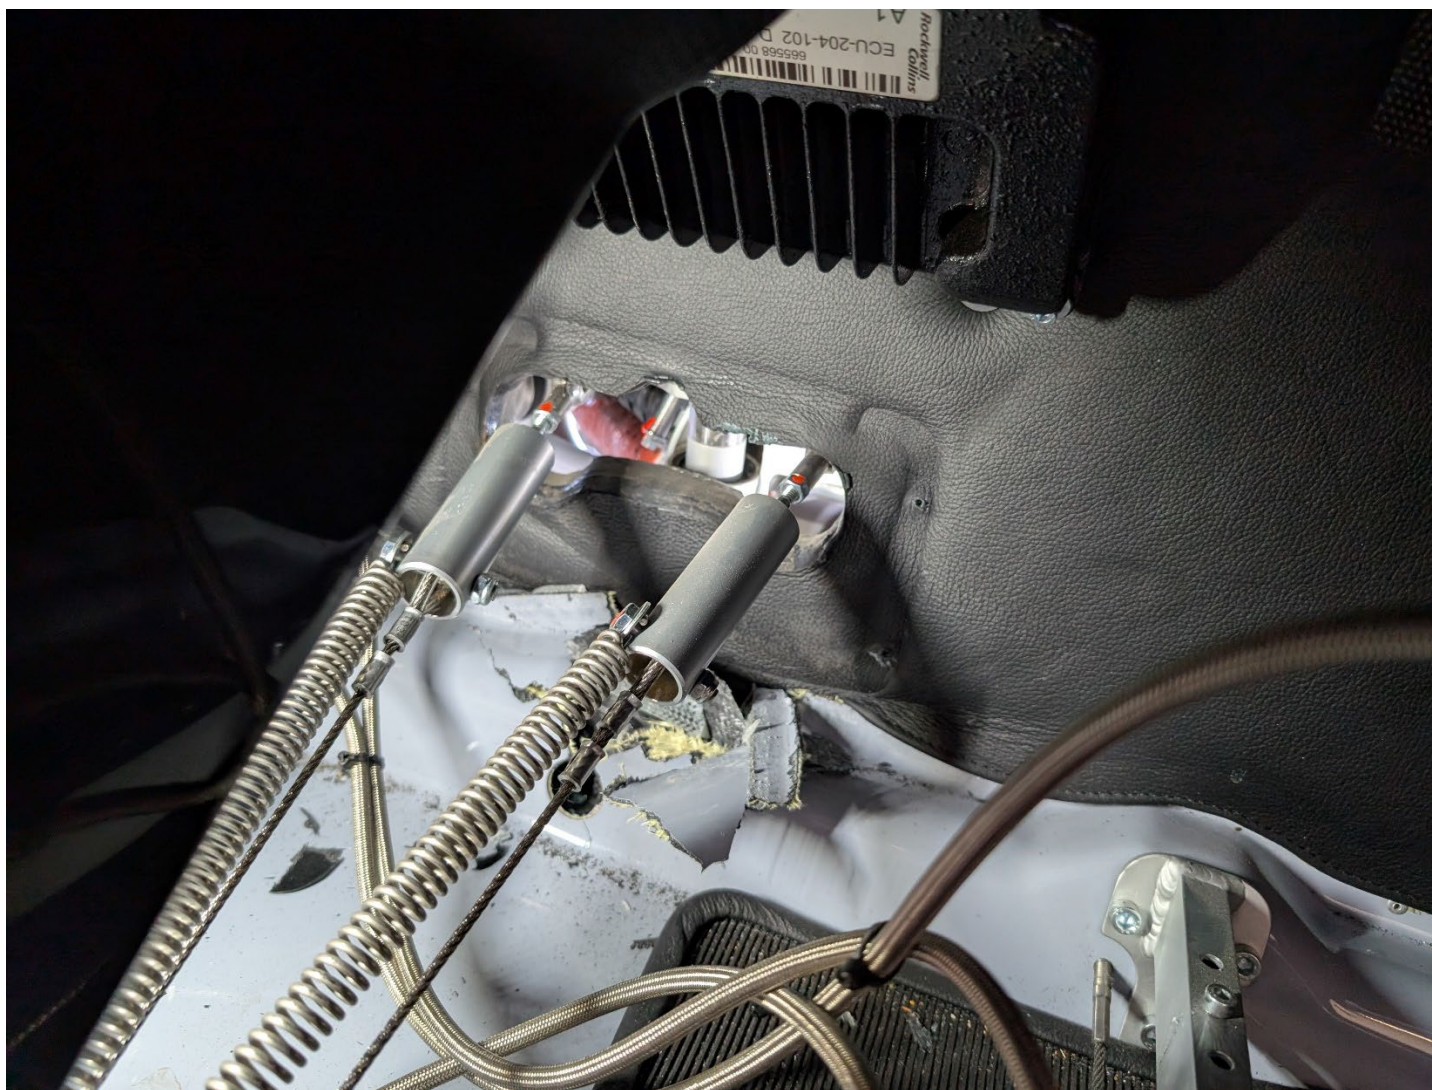
**Photograph 3 - Composite damage (Courtesy of FAA)**
