Mitchell Gallo  
Senior Aerospace Engineer  
Aviation Safety - Central Region

**Subject:** CEN24LA366, Record of Aircraft Examination

The aircraft was examined under the supervision of Ian Mullins with Ernest Hall, Textron Aviation, at AMF Aviation on May 21, 2024.

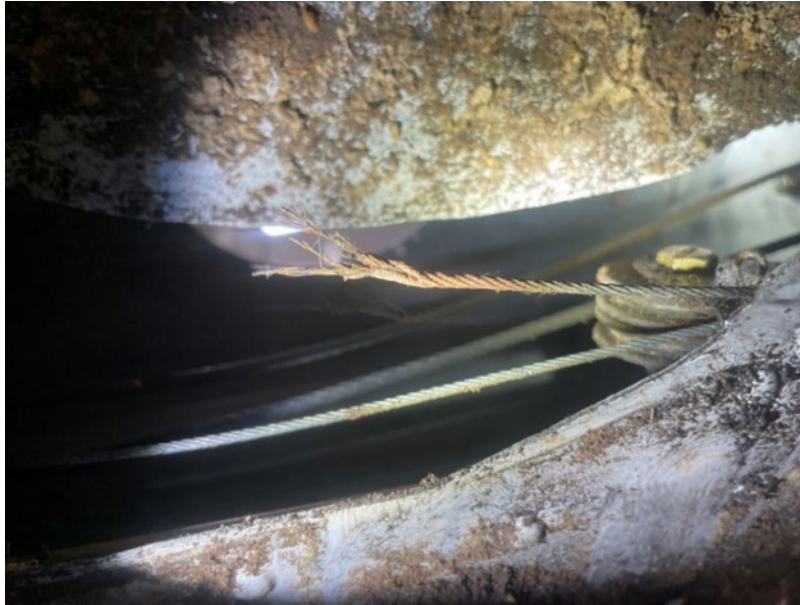
Figure 1 - Elevator Trim Control Cable

The elevator trim control cable, shown in Figure 1, was found separated in the area underneath the cockpit seats. The cable separation exhibited rust, a flat spot, and witness marks, which were shiny in appearance.

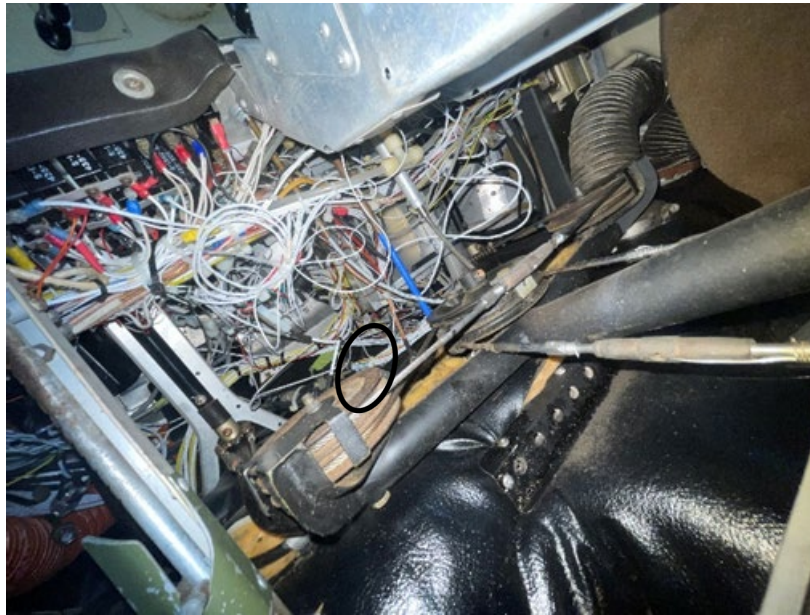
Figure 2 - Instrument Panel Wiring with Wire Chaffing (Shown in the Black Circle)

The instrument panel wiring, shown in Figure 2, near the control column had excess length and wiring that was within ½ inch of the flight control cables and pulleys. One of the wires, near a pulley, exhibited chaffing.

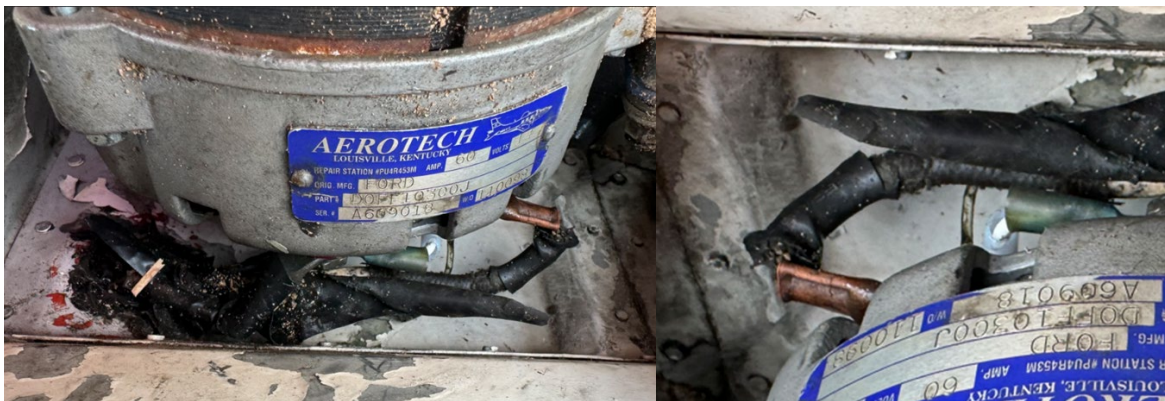
Figure 3 - Aircraft Alternator and Terminal Connection

The alternator, shown in Figure 3, had power and ground wires that were frayed and covered with electrical tape. One terminal fell off the alternator when it was disconnected from the alternator during the examination. Figure 4 further shows the condition of the wiring leading to the alternator. According to an aircraft logbook entry dated May 22, 2024, states the alternator was removed for overhaul and then reinstalled onto the aircraft.

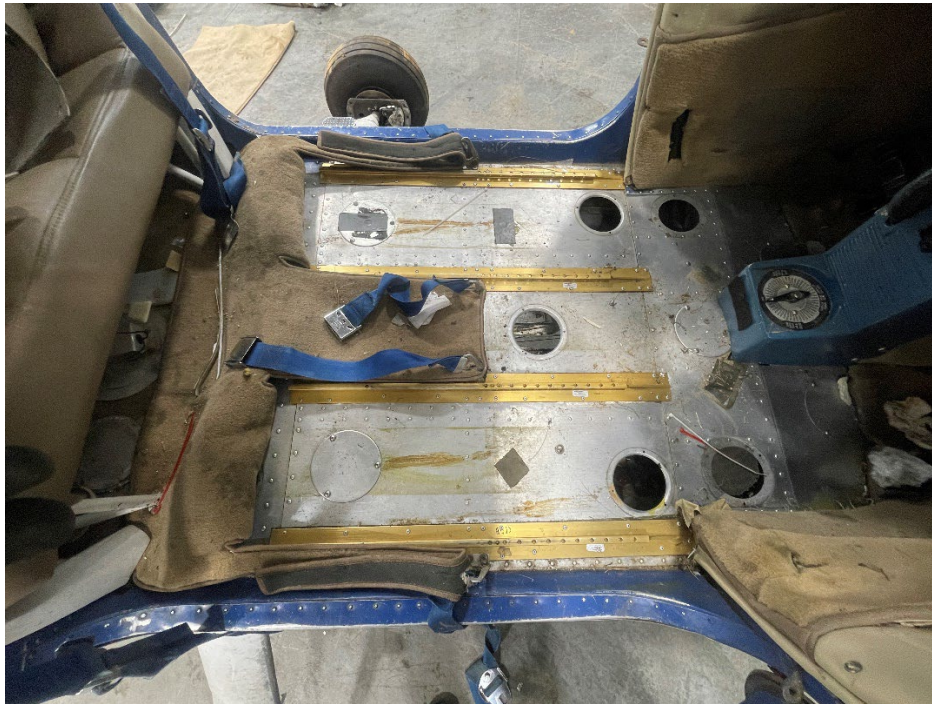
Figure 5 - Seat Tracks with Blind Rivets

The cockpit seat rails were intact and secure. The rivets used to secure the seat rails, shown in Figure 5, were blind rivets and not solid rivets, which would have afforded greater strength. An aircraft logbook entry dated on April 9, 2024, states that the cockpit seat rails had been replaced with McFarlane seat rail part numbers: MC0511243-4, -5, and -6, and installed with CherryMAX blind rivets.

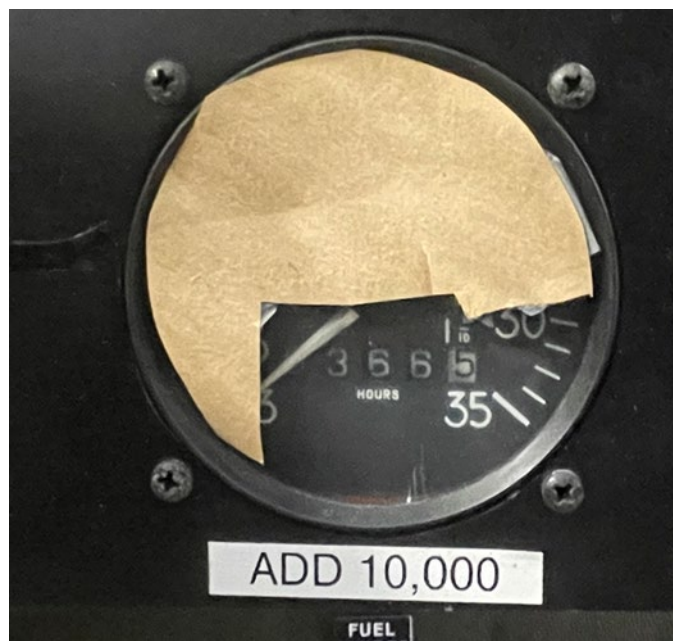
Figure 6 - Aircraft Tachometer

The NTSB Form 6120 submitted by the pilot reported an aircraft total time at the time of the accident as 10,360 hours. The tachometer, shown in Figure 6, was partially covered and indicated 366.5 with a label below the tachometer that stated to "ADD 10000".
