National Transportation Safety Board

CEN24LA370

## **INVESTIGATION PHOTOGRAPHS**

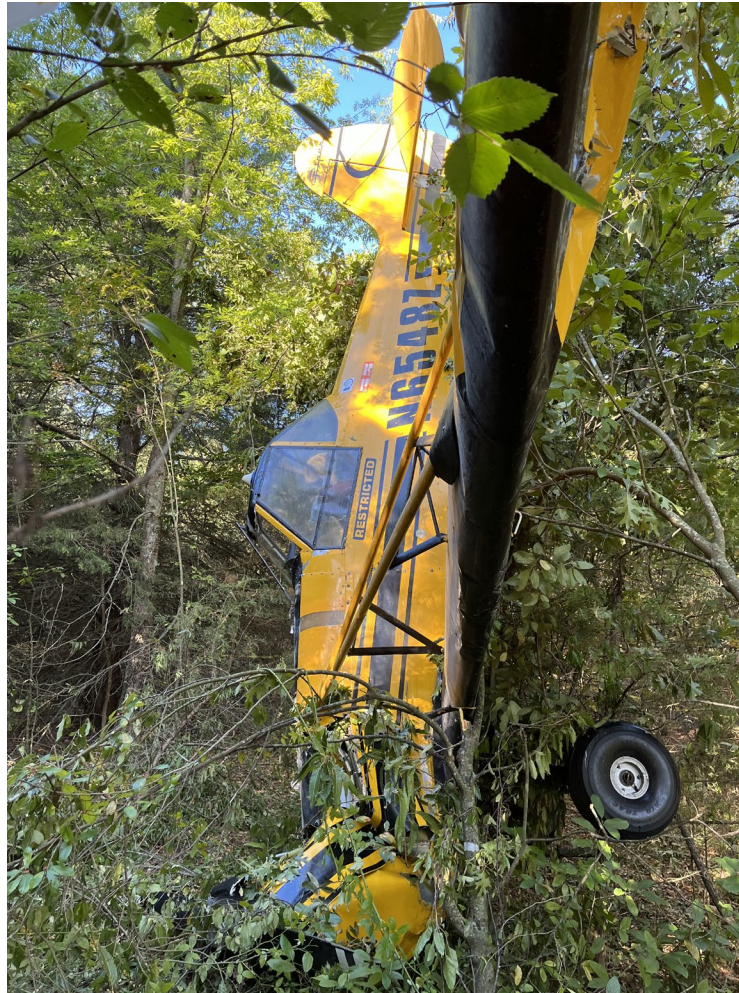
**Photograph 1 - Fuselage damage (Courtesy of FAA)**

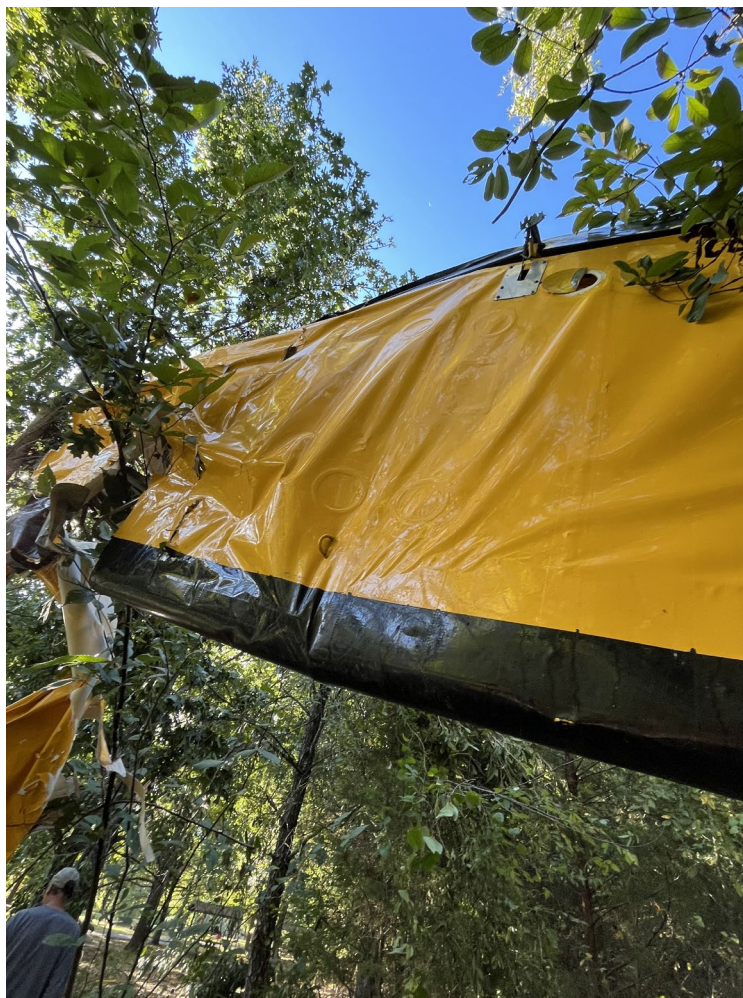
**Photograph 2 - Left wind damage (Courtesy of FAA)**

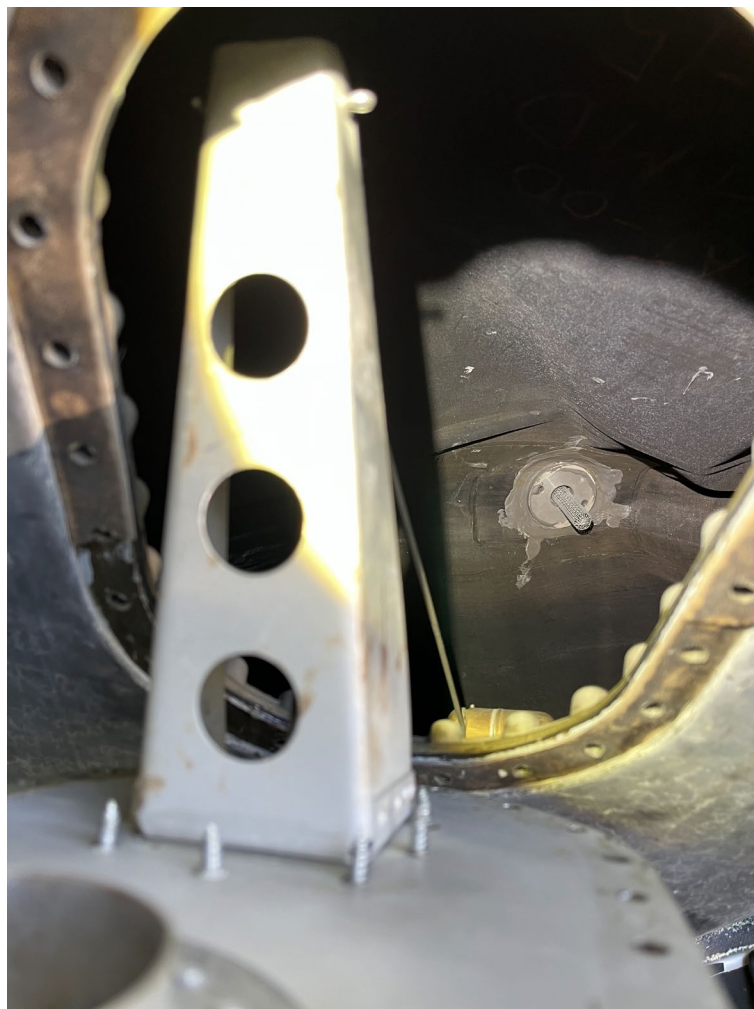
**Photograph 3 - Fuel tank interior (Courtesy of FAA)**
