To: Andrew Finne, NTSB

Inspection report for CEN24LA378 on Piper PA32-300, serial number 32-7840130, N31407 and Lycoming IO-540-K1G5, serial number L-18003-48A. Tach time was 3504.00.

Inspection was conducted on November 21, 2024, at the Tuscola Area Airport (KCFS) with FAA PMI Bruce Arthurs and OJT Inspector Alfred Wright from the EMI FSDO.

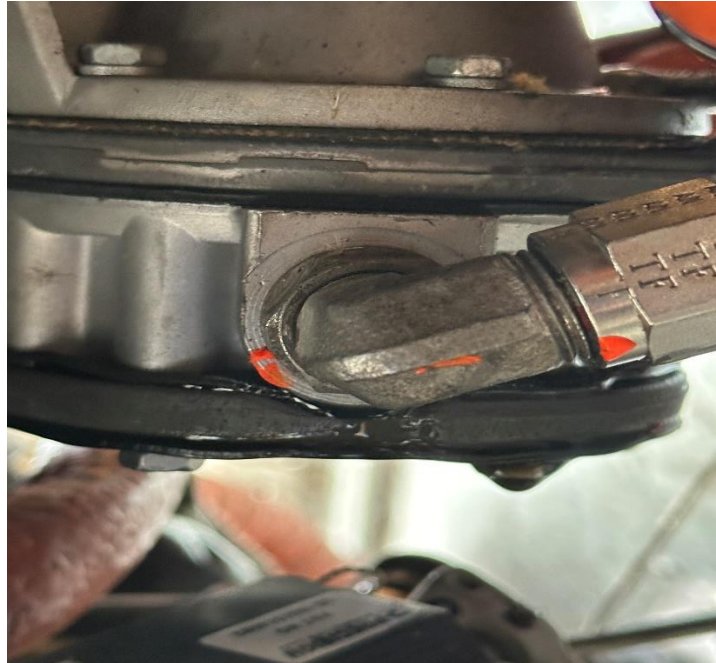
Inspection of the engine fuel system also found the part number 72377, 90-degree elbow in the engine driven fuel pump outlet could be rotated in the fuel pump with the hose attached, the jam nut was not tightened.

Engine Driven Fuel Pump Fitting with Loose Jam Nut

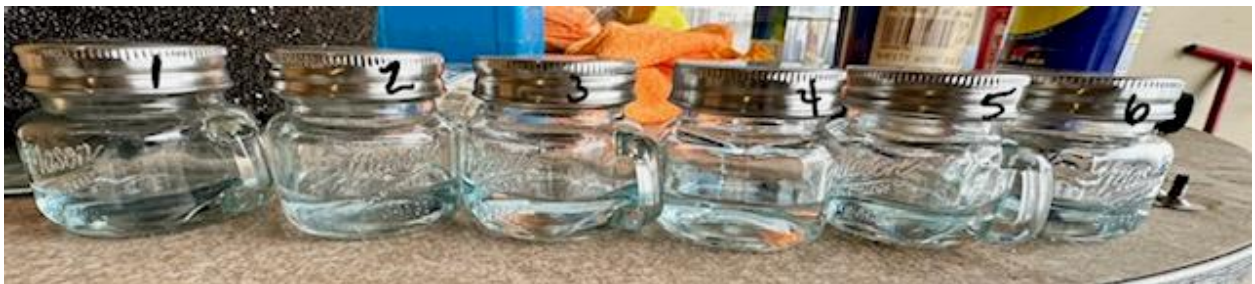
The fuel injection nozzles were removed for inspection and flow check, nozzles were clean and clear. #4 injector nozzle was found finger tight in the cylinder. When the electric fuel pump was turned on no fuel flowed from the injectors and a fuel leak was observed at the fuel servo. (Video of leak was texted to Investigator Finne) The fuel pump was shut off and I found the B-Nut on the line from the fuel servo to the flow divider was loose at the fuel servo fitting. Hose part number LW-13175-4-340. It took 1 – 1.5 turns to tighten the connection. The fuel pump was turned back on, no leak was observed and fuel flowed from all 6 injector nozzles evenly. Fuel was collected in glass jars.

Fuel Nozzle Flow Check

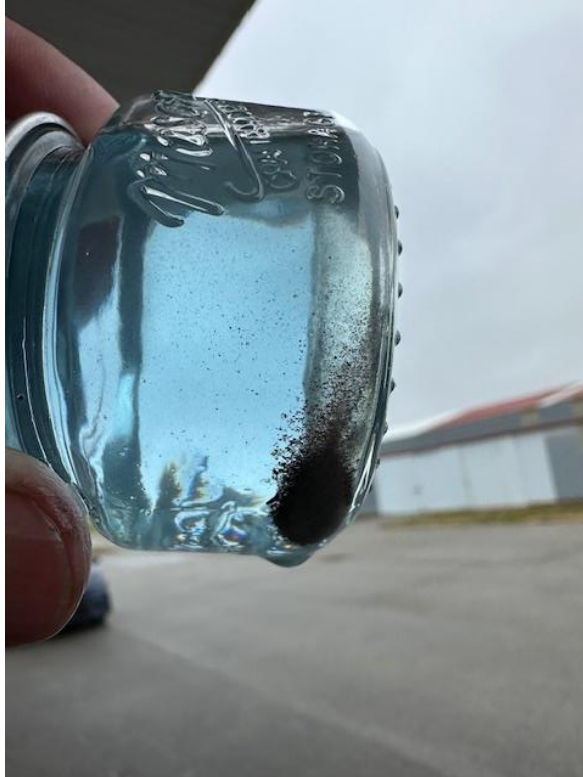
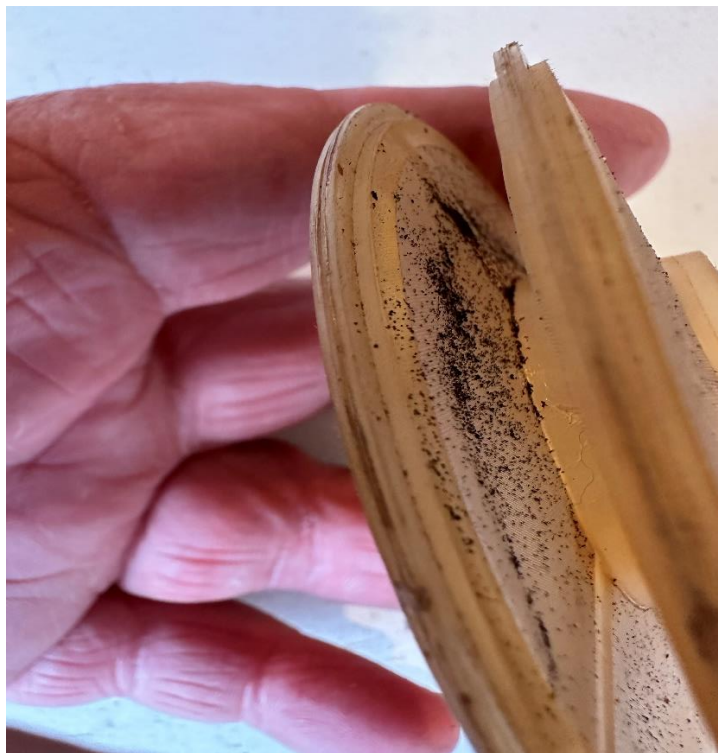
Fuel was drained from the strainer and a small amount of black colored contaminants was observed. Sample was saved. The strainer screen was removed, and the same black colored contaminants were present.

Fuel Strainer Debris

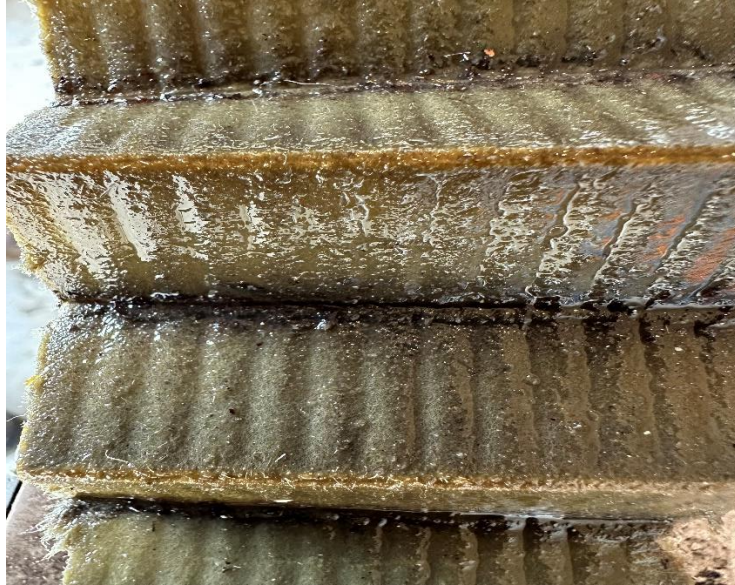
Dipstick showed 10 quarts of clean oil in the engine. A sample of oil was drained from the oil sump drain valve and no contaminants observed. The oil filter was removed and cut open. The filter element had some contaminants in the pleats.

Debris in Oil Filter Element

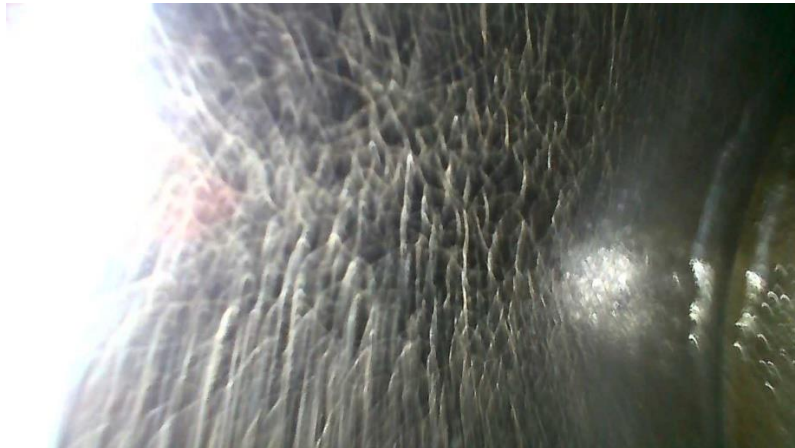
The cylinders were inspected with a borescope, all showed crackling in chrome plating.

Crackling in Cylinder wall, found in all cylinders

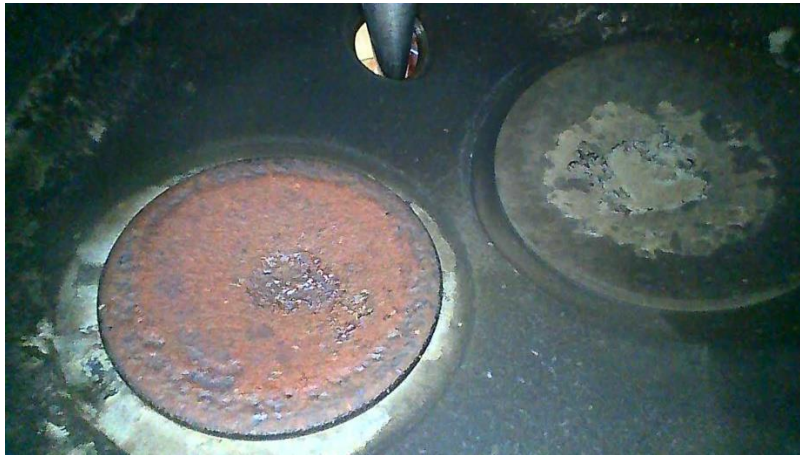
- #1-cylinder 5/80, prop was pulled through several times and compression did not improve. Air leakage could not be heard and when pulling prop through to determine compression stroke with finger over upper plug hole, suction and compression could barely be felt.
- #2-cylinder 72/80
- #3-cylinder 72/80
- #4-cylinder 50/80 with air hear blowing out of exhaust system
- #5-cylinder 32/80 air leakage could not be heard.
- #6-cylinder 41/80 with air blowing out of exhaust system

- #1-cylinder exhaust valve appears to be pitted on face and edge of valve. Seat shows signs of leakage.
- #2-cylinder and valve faces looked normal.
- #3-cylinder and valve faces looked normal.
- #4-cylinder exhaust valve shows signs of leakage at seat.
- #5-cylinder piston top was oil soaked; exhaust valve was reddish in color with oil stain on lower surface of valve face. Valve seat shows signs of leakage.
- #6-cylinder exhaust valve face was severely pitted and worn, valve seat showed evidence of leakage.

#1 Cylinder Valves

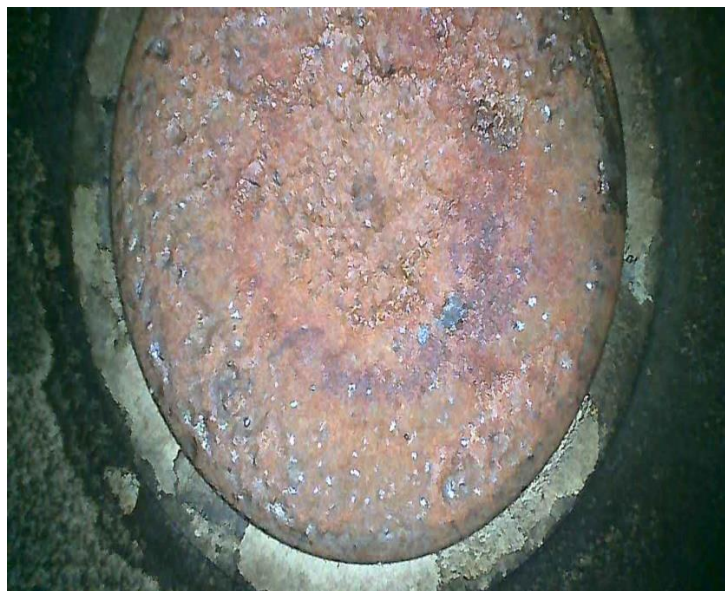
#6 Cylinder Exhaust Valve
