National Transportation Safety Board  
Office of Aviation Safety  
Washington, DC 20594

CEN24MA111

**OPERATIONS AND HUMAN PERFORMANCE GROUP FACTUAL REPORT**

Location: Halloran Springs, California  
Date: February 9, 2024  
Time: 2208 Pacific standard time  
0608 Universal coordinated time  
Helicopter: N130CZ / EC-130B4

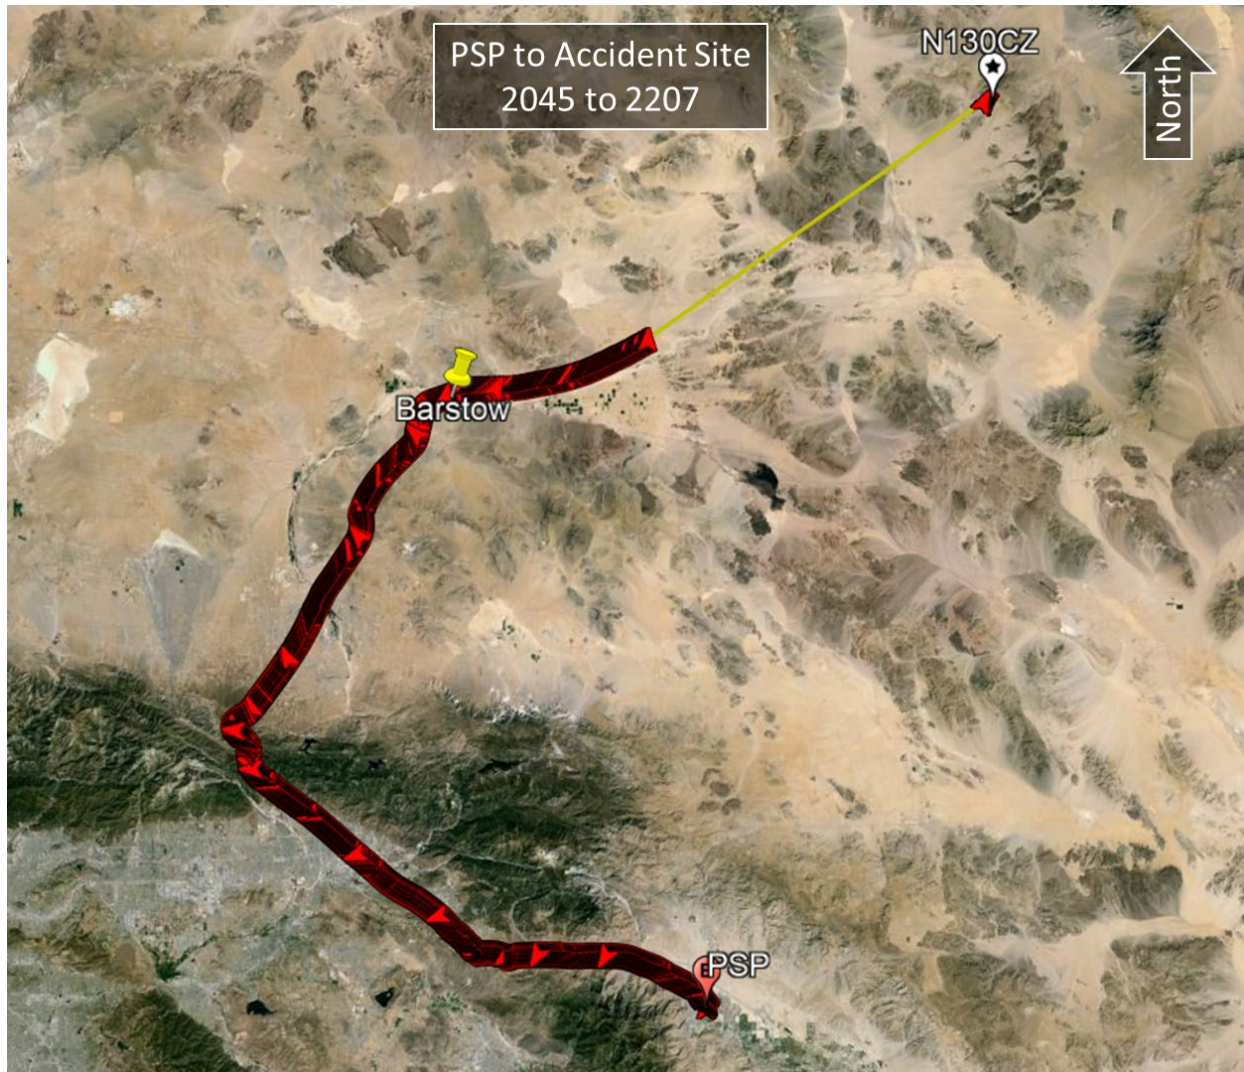
The helicopter followed I-15 toward the destination of BVU. The altitude of the helicopter varied between 3,300 to 5,300 ft msl. ADS-B data was lost while the helicopter was about 24 miles east of Barstow, California, around 2146 (see figure 5). The ADS-B gap was about 47.5 statute miles long. ADS-B data resumed at 2206:46, near the Halloran Springs freeway exit west of the accident location. The last ADS-B data points for the flight tracked east-southeast, gradually descended in altitude, and increased in ground speed. The last ADS-B data point captured the helicopter at 2207:05 about 1,709 ft west of the accident site, about 4,475 ft msl or about 1,188 ft above ground level (agl). The helicopter was equipped with Spidertracks<sup>17</sup> that captured the entire flight and showed that in the area not tracked by ADS-B, the helicopter continued to follow the I-15 freeway from altitudes that ranged from about 4,712 ft to about 2,199 ft (about 1,172 ft agl). The flight route is shown in figures 6 through 10.

Figure 3. Google Earth image showing the accident flight and the area of missing ADS-B data.

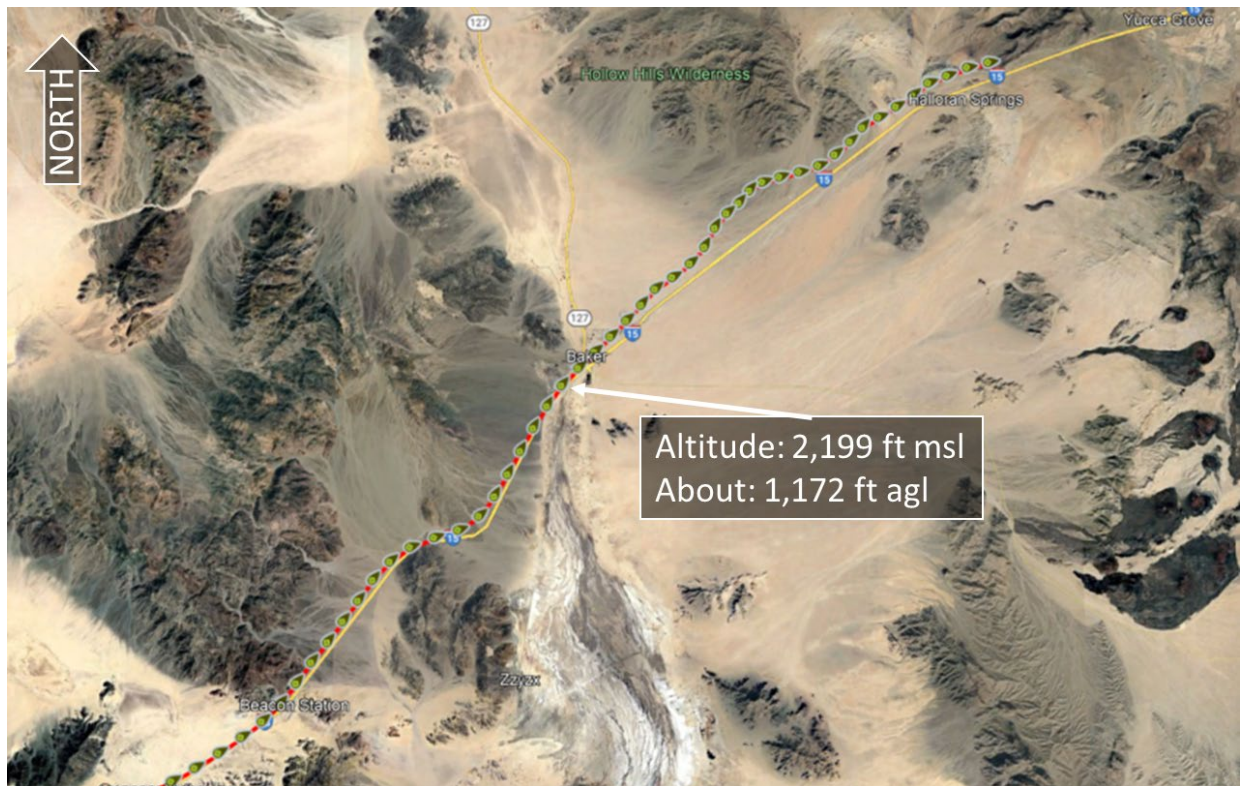
Figure 6. Google Earth Image showing lowest altitude recorded by Spidertracks.

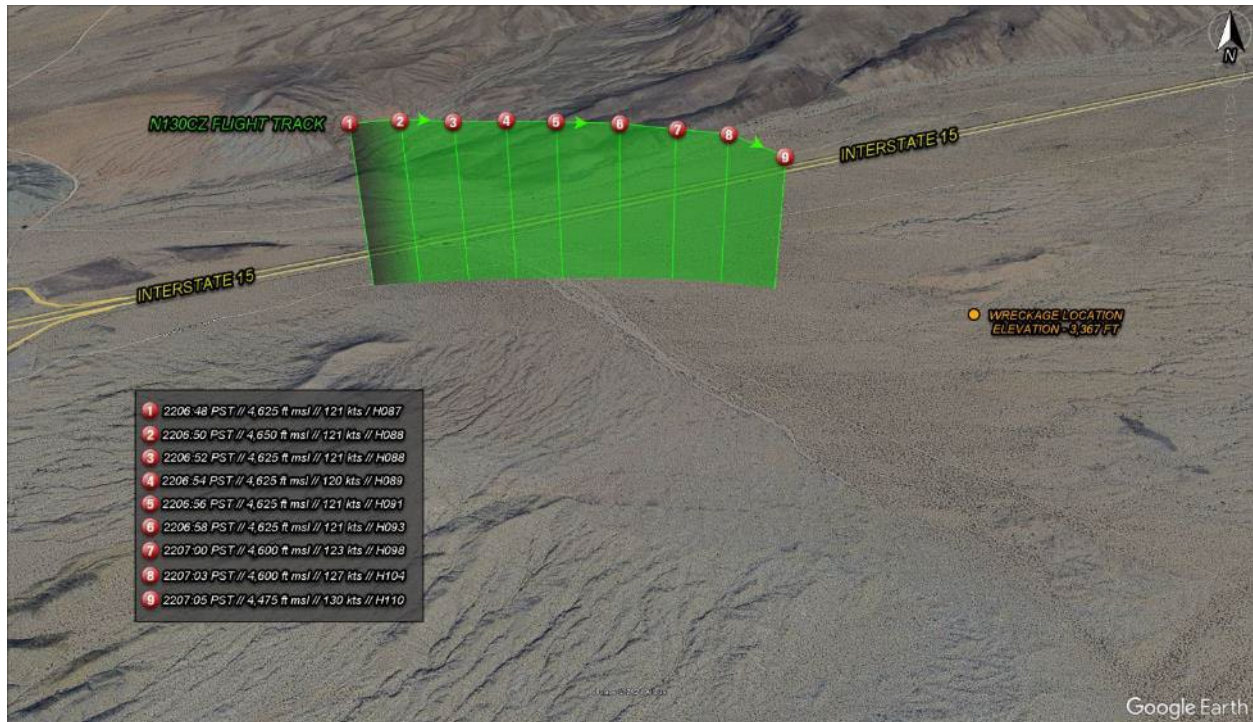
Figure 7. Google Earth image showing the final ADS-B data points along with altitude, groundspeed, and heading.

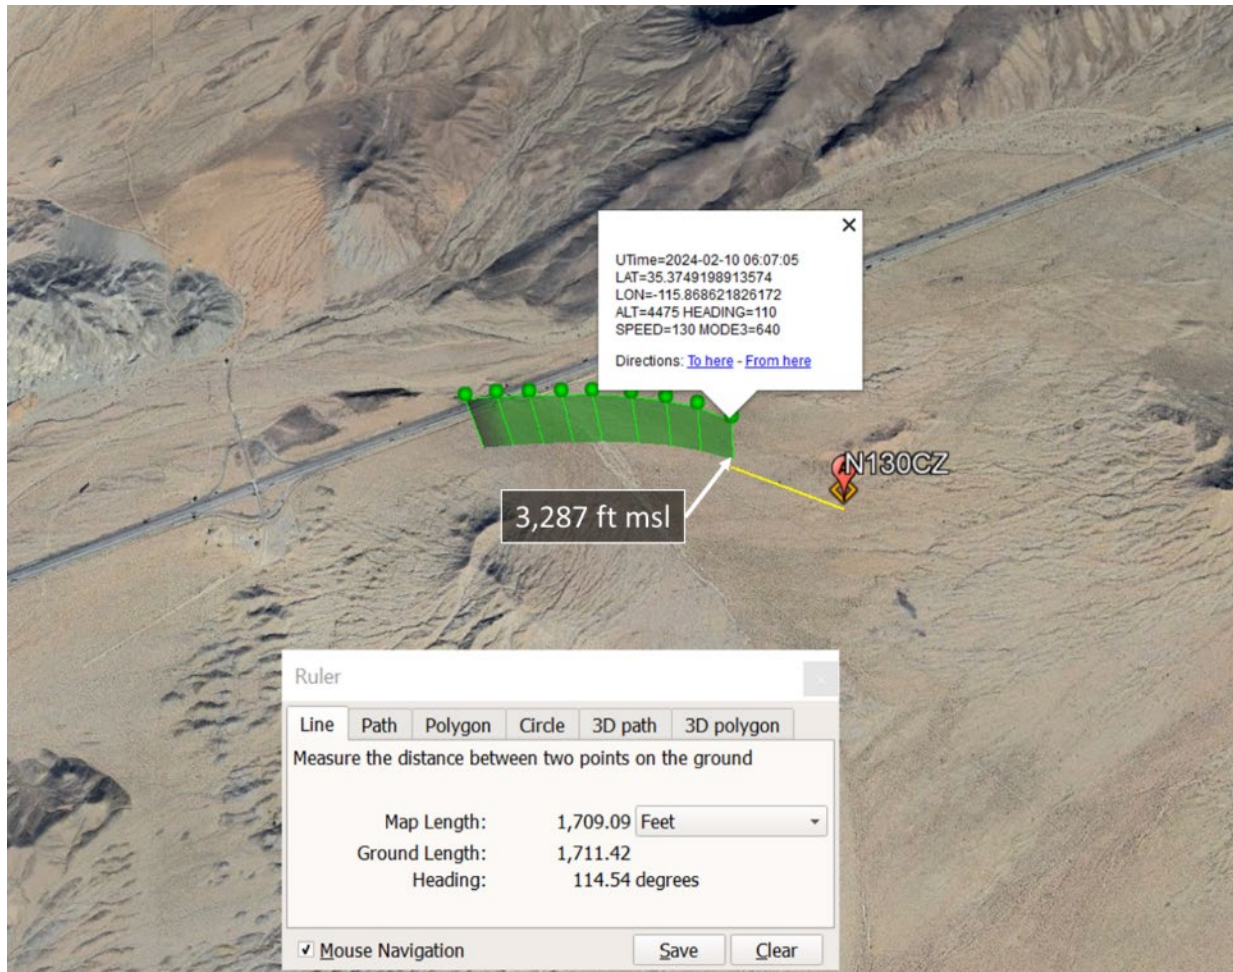
Figure 8. Google Earth image showing the last ADS-B data point. 1,709 ft west of the accident site at an elevation of about 1,188 ft agl.

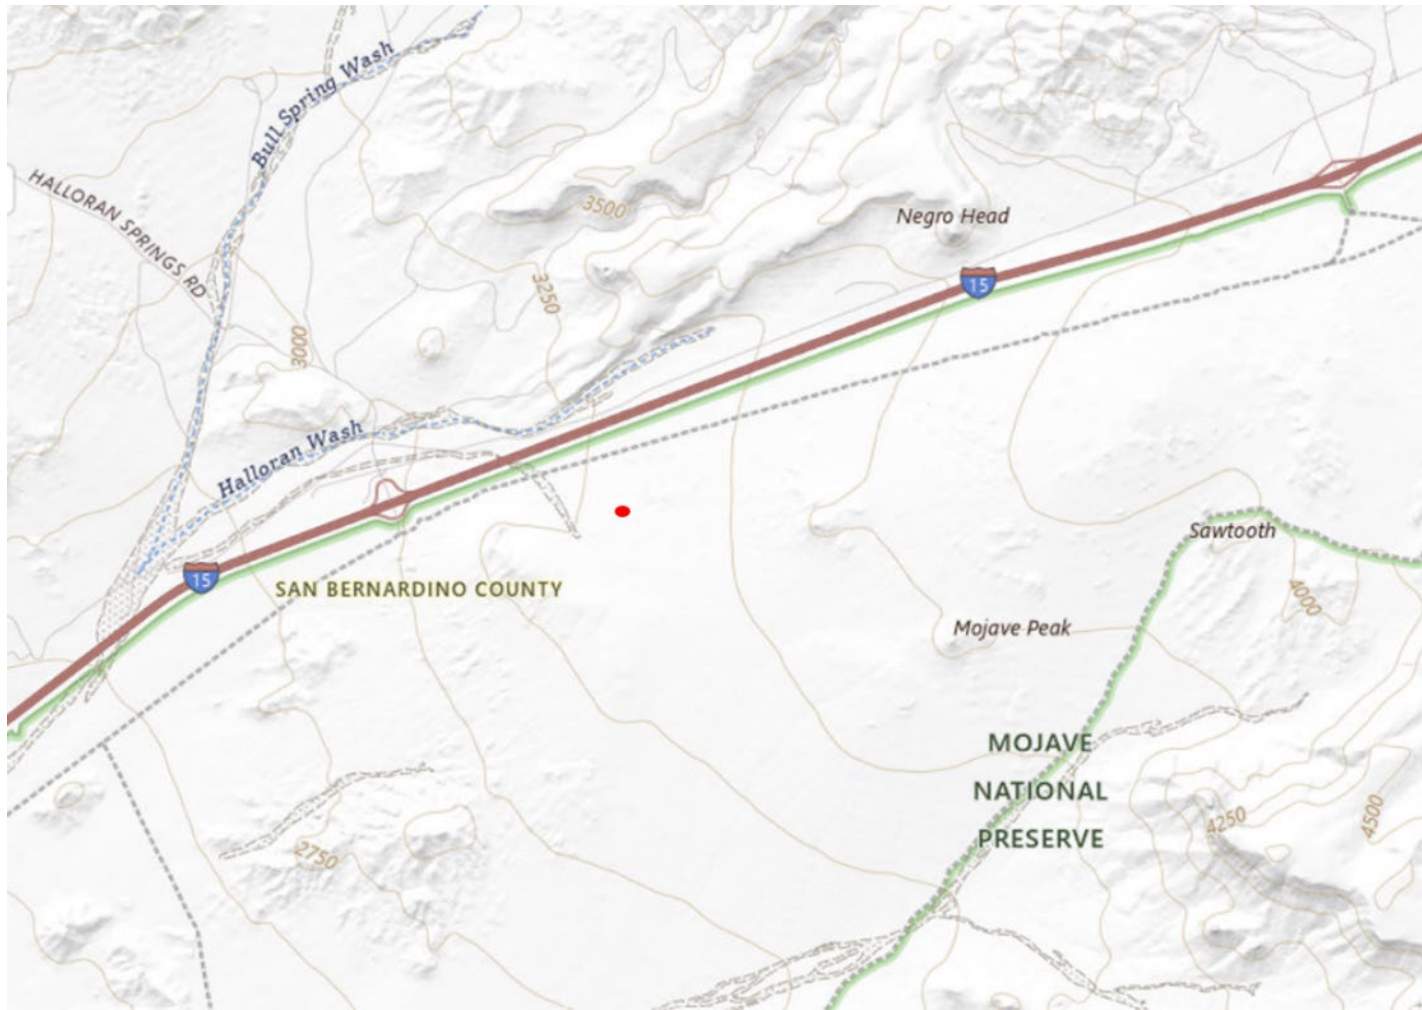
The accident occurred in the Mojave Desert, about 1.6 miles northeast of the Halloran Springs Exit off I-15. The terrain was composed of rolling hills with sparse vegetation of about 4 ft to 6 ft in height. A review of the surrounding area revealed that the Halloran Wash was located north of and ran paralleled to I-15. Topographic features show that the terrain north and south of the wash increased in elevation, in addition to the elevation generally increasing from west to east. Figures 11 and 12 show the Halloran Wash and elevation changes.

Figure 9. Topographic map showing elevation contour lines. The red dot is the approximate location of the wreckage.

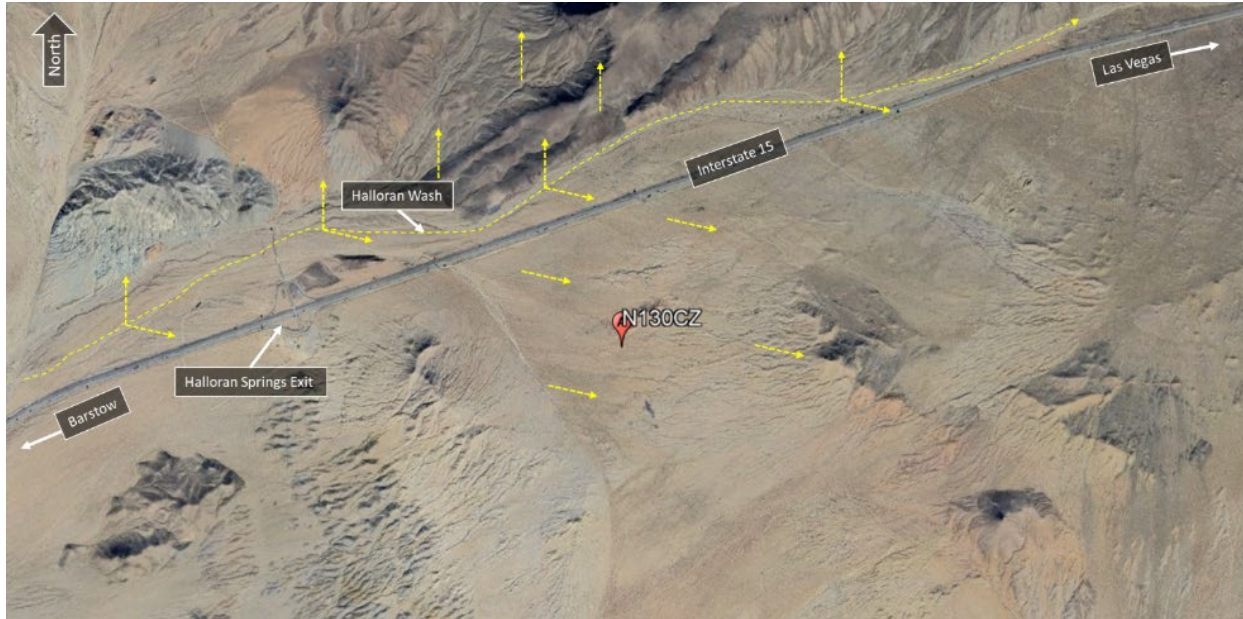
Figure 10. Google Earth image showing the features of the terrain surrounding the wreckage. The broken yellow arrows point in the direction of the rising terrain.
