# National Transportation Safety Board

Office of Research and Engineering

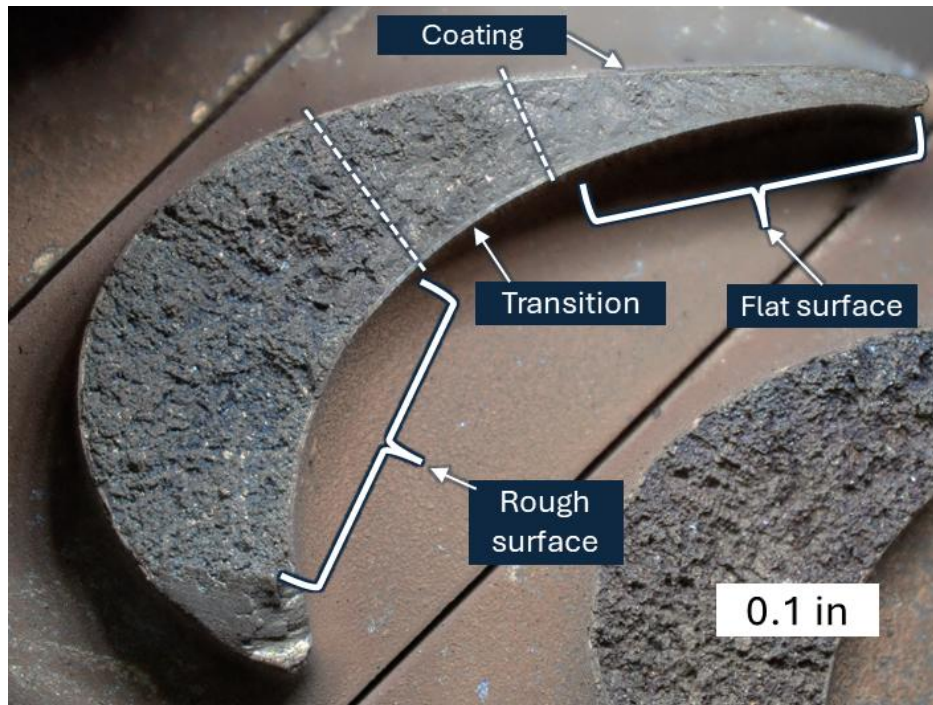
**Figure 4.** Magnified fracture surface of blade 28.

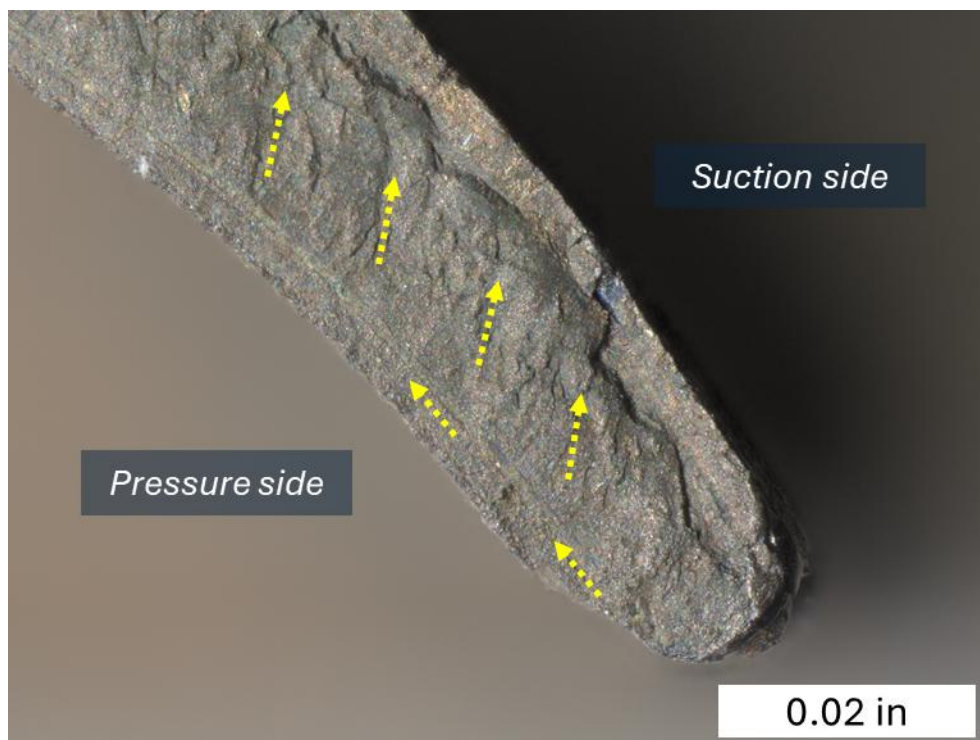
**Figure 5.** River marks near the trailing edge of the blade. Yellow arrows show the direction of crack growth indicated by the river marks.

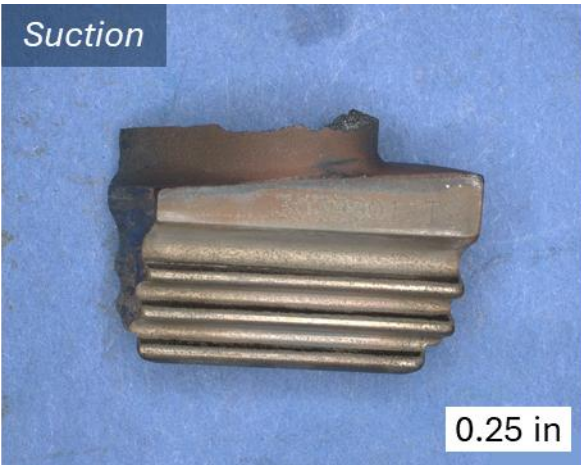
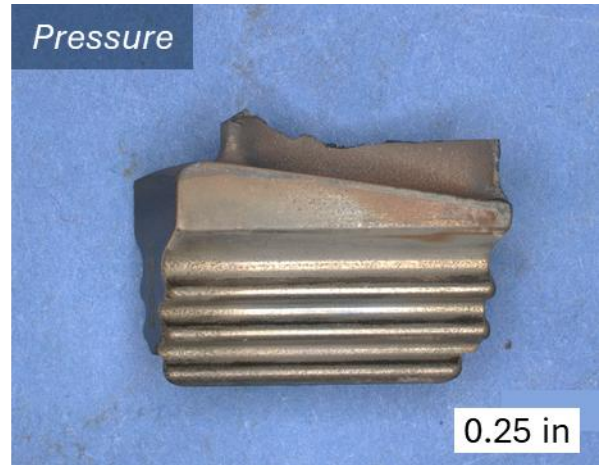
**Figure 6.** (Left) Suction side and (right) pressure side of blade 28 after removal from the turbine disk.

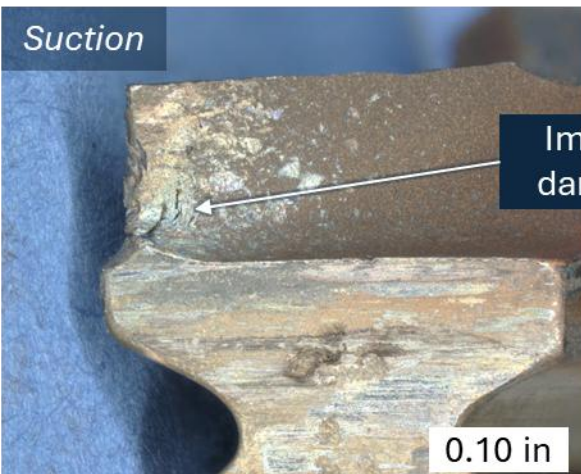
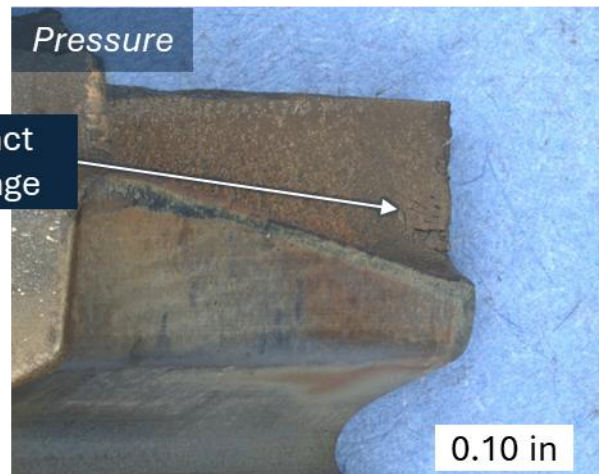
**Figure 7.** Magnified images of the trailing edge of blade 28 showing impact damage. (Left) Suction side. (Right) Pressure side.

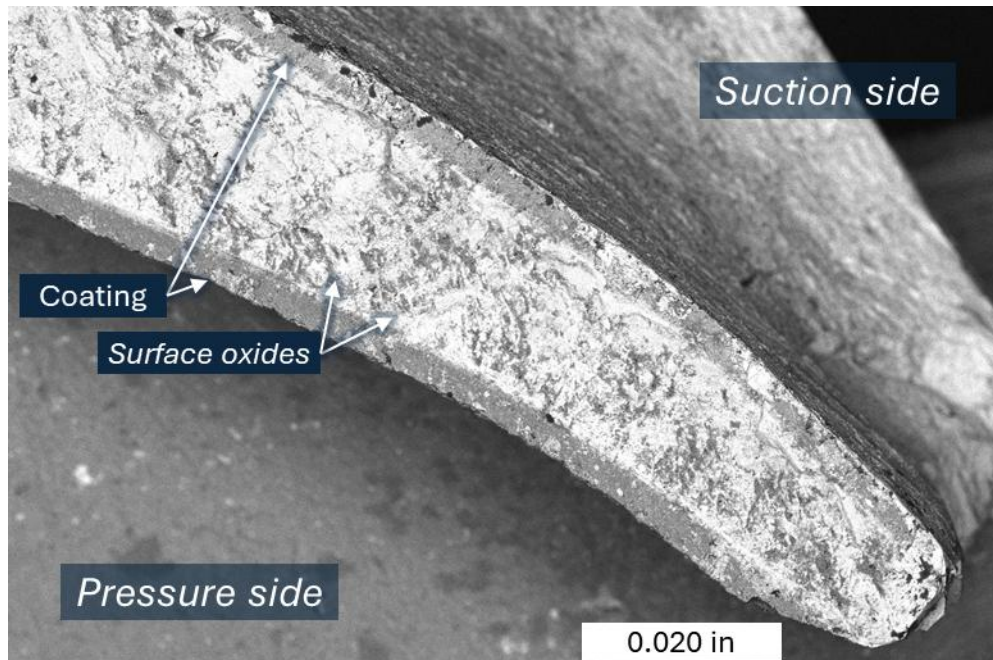
**Figure 8.** BSE micrograph of the fracture surface near the trailing edge of blade 28. Surface oxides appeared as dark patches.

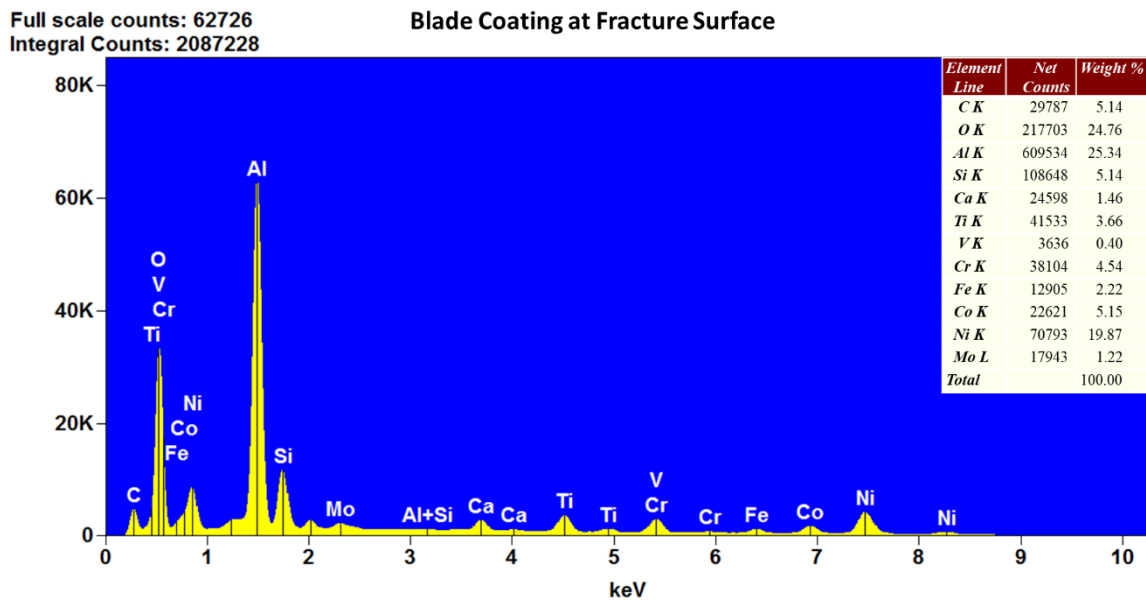
**Figure 9.** EDS spectrum of the coating layer at the fracture surface.

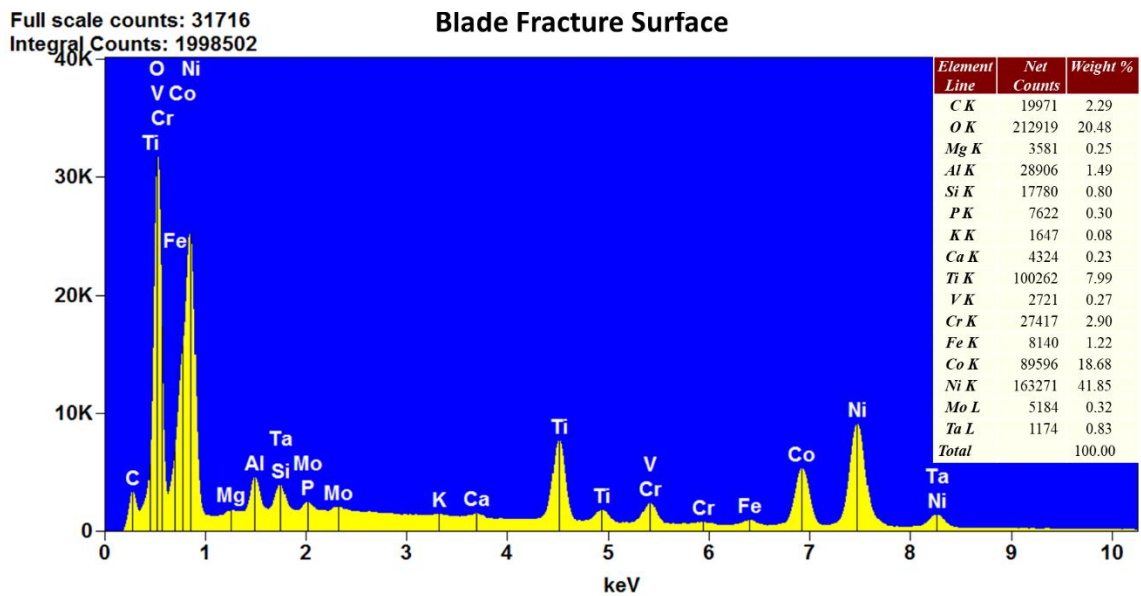
**Figure 10.** EDS spectrum of the blade fracture surface.

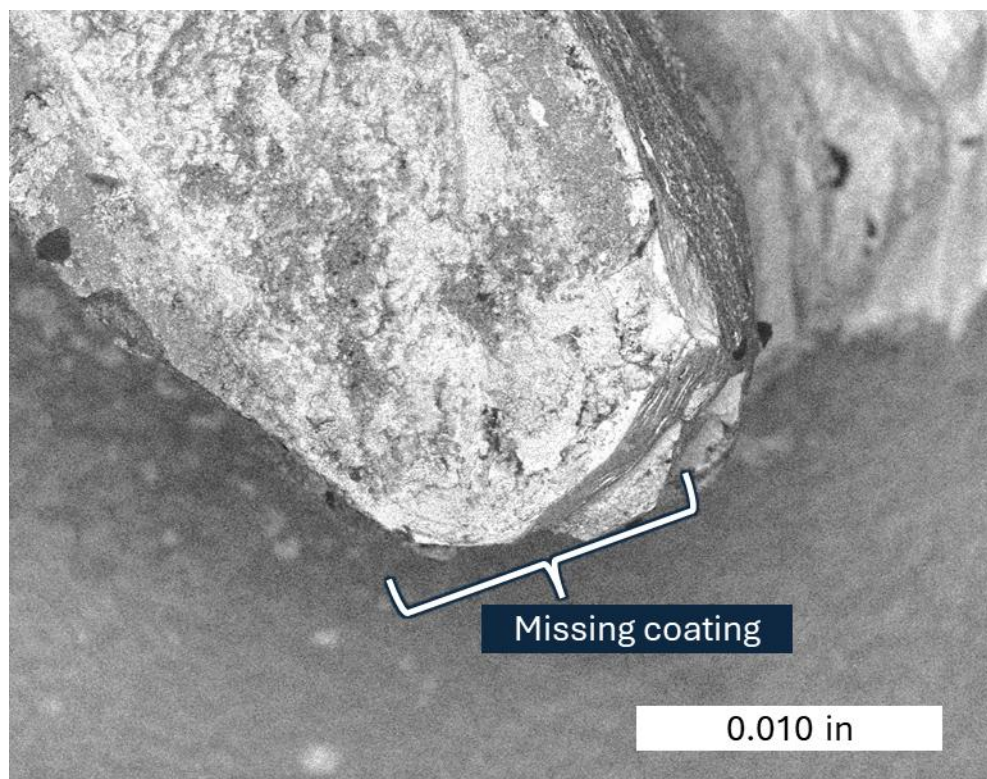
**Figure 11.** A section of coating missing at the trailing edge of the blade.

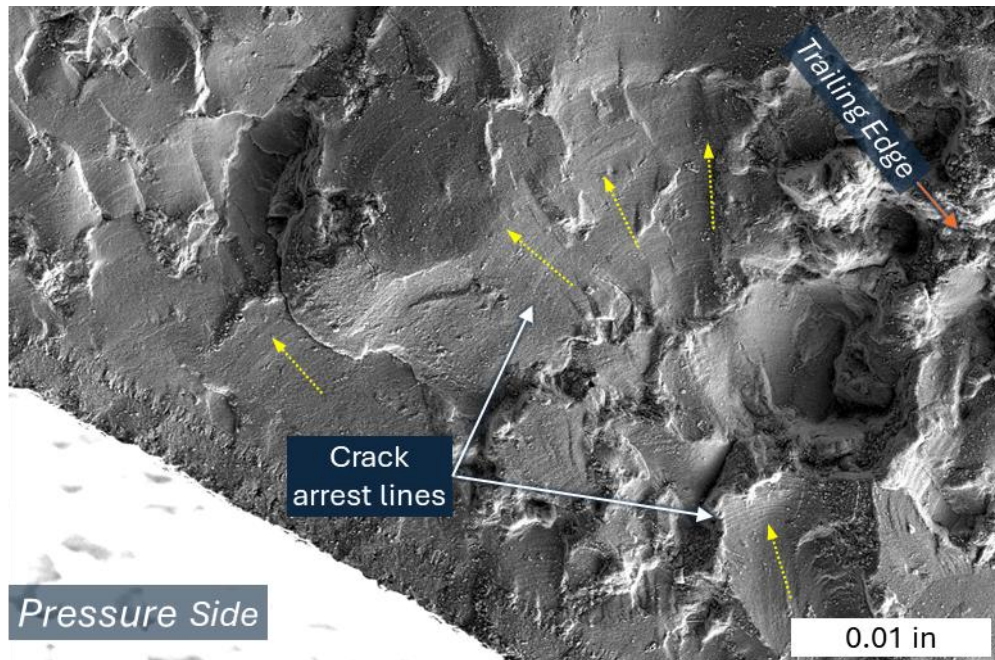
**Figure 12.** Crack arrest lines on the fracture surface emanated away from the trailing edge (not pictured). Yellow arrows show the crack growth direction as indicated by the arrest lines.

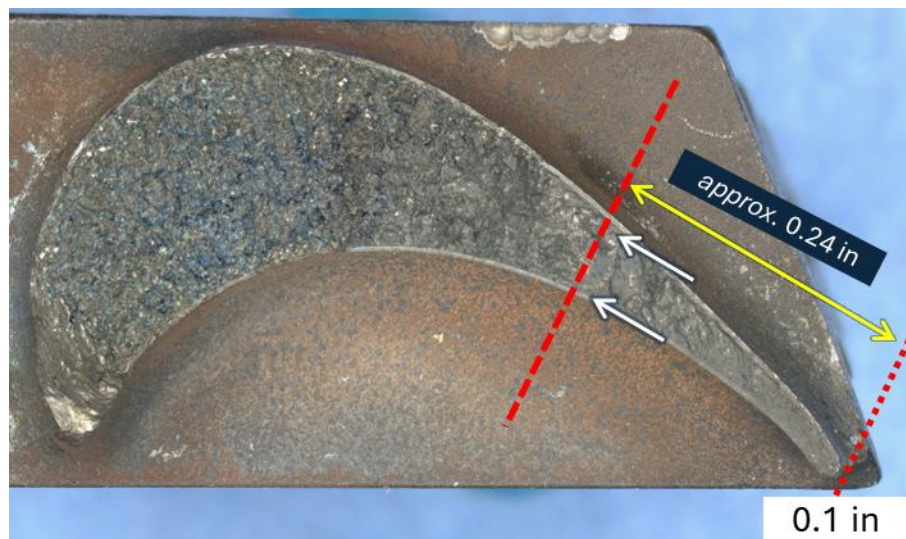
**Figure 13.** Blade 28 cut location for viewing the microstructure. Blade 29 was sectioned in the same location.

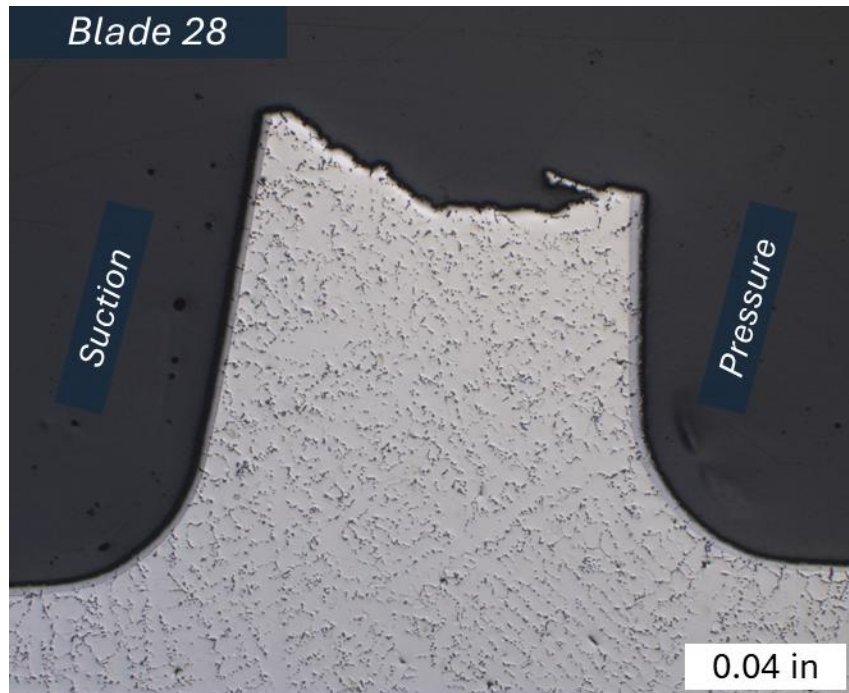
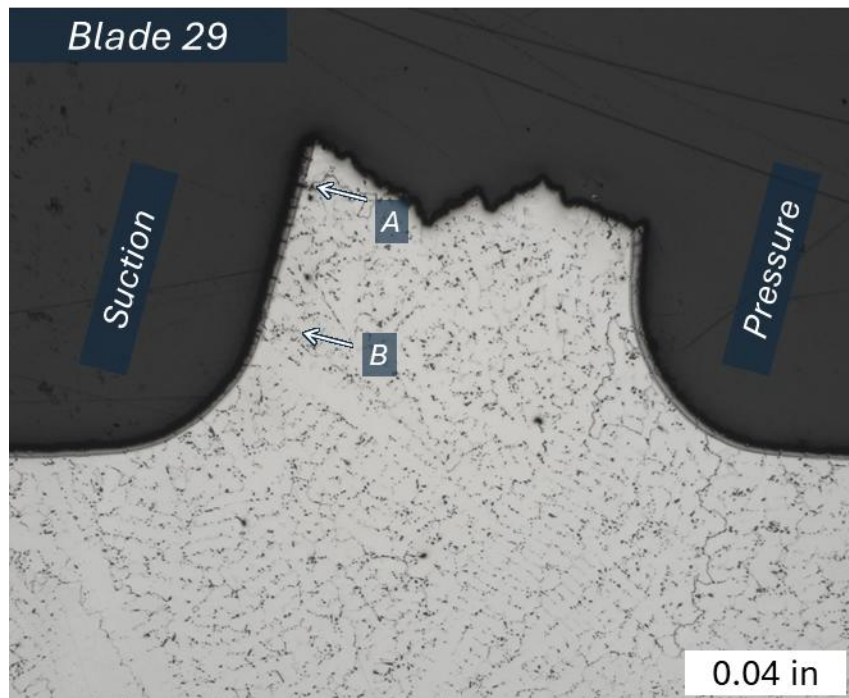
**Figure 14.** Cross-sectioned micrographs of (top) blade 28 and (bottom) blade 29. Locations indicated in blade 29 are magnified in Figure 17. (Unetched)

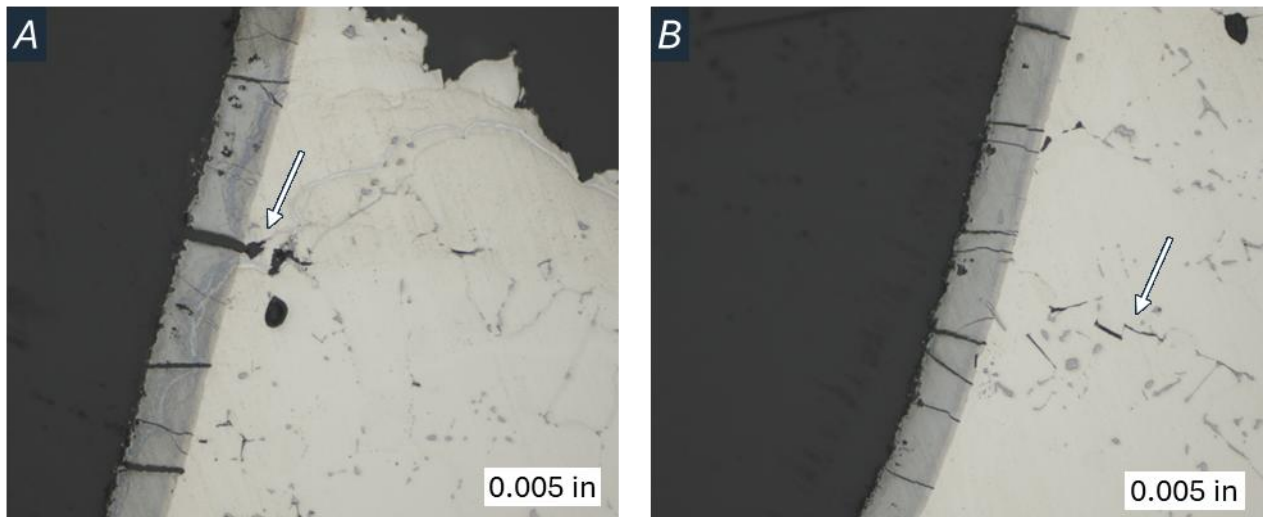
**Figure 17.** Surface cracks in the blade material seen on the suction side of blade 29. Locations referenced in Figure 14. (Unetched)

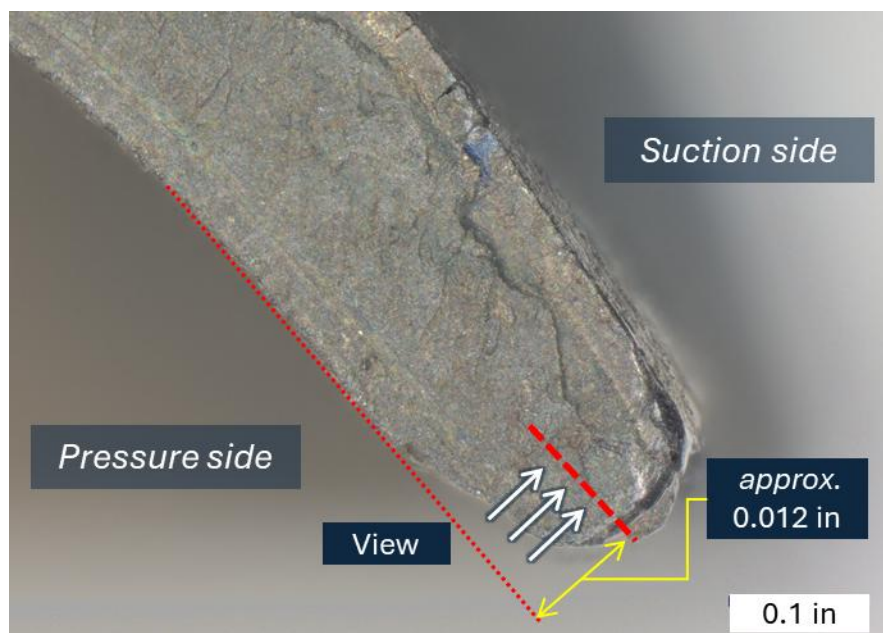
**Figure 18.** Blade 28 cross-section location for viewing the microstructure at the trailing edge.

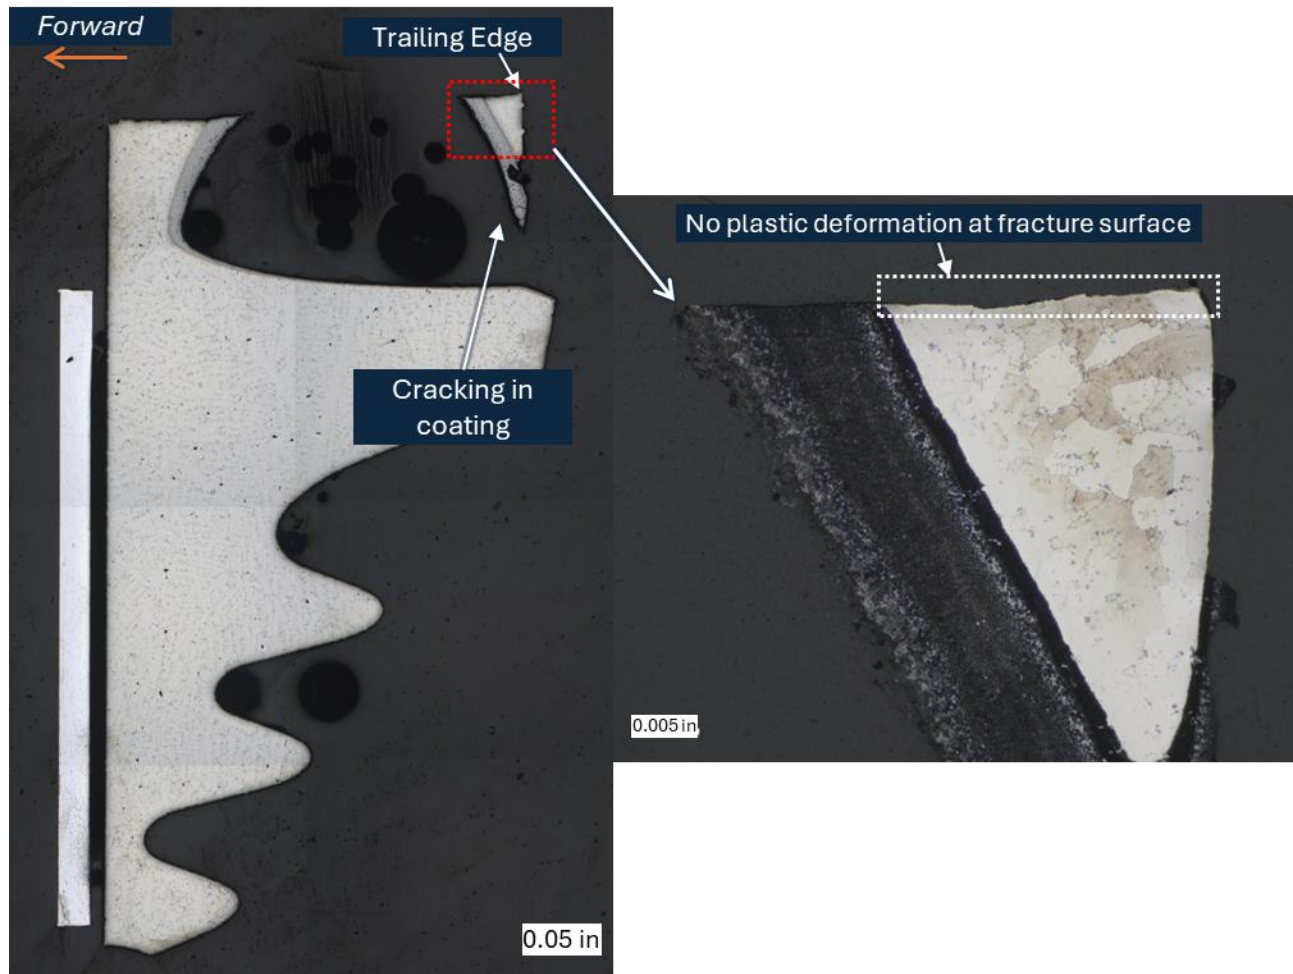
**Figure 19.** (Left) Optical micrograph of Blade 28 at the trailing edge (Unetched). (Right) The callout image shows the blade after etching with Kalling's reagent.

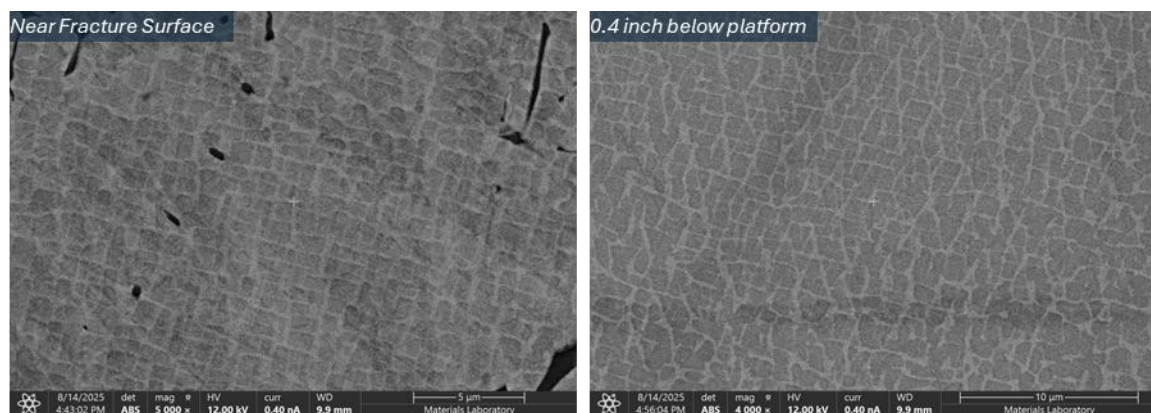
**Figure 20.** (Left) BSE image of the microstructure of blade 28 near the fracture surface. Black areas are the high-titanium phase. (Right) BSE image of blade 28 below the blade platform. (Unetched)
