# ANSI/TIA-222-H Maintenance Inspection Report

TX189B0-A  
Ennis Street

920-ft Guyed Tower  
(1003-ft Overall Height w/ Top Appurtenance)

**Tower Engineering Professionals Project Number**  
**341446.973739**

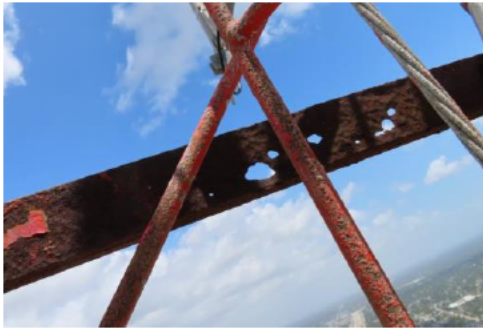
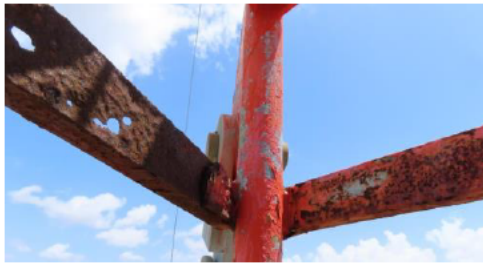
| Priority Rating | Item No. |
|---|---|
| Critical | 1 |

| Priority Rating | Item No. |
|---|---|
| <b>Deficiency:</b><br>Severe corrosion and pitting was observed on the bandings at the 750-ft guy level. Section loss was observed on the banding on the CA face. | |

| Priority Rating | Item No. |
|---|---|
| <b>Recommendation:</b><br>Replace the guy banding members. | |

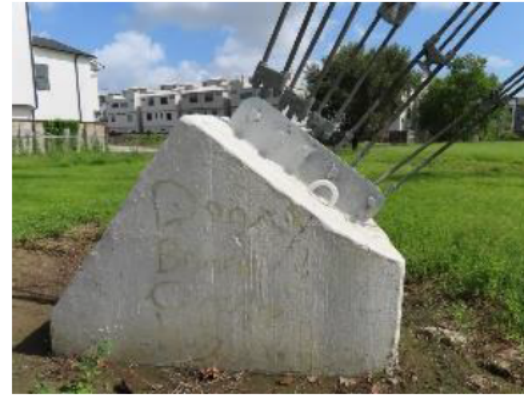
| Priority Rating | Item No. |
|---|---|
| Standard | 2 |

| Priority Rating | Item No. |
|---|---|
| <b>Deficiency:</b><br>The guy anchors are not grounded; however, insulators are installed on the guy wires. | |

| Priority Rating | Item No. |
|---|---|
| <b>Recommendation:</b><br>If required, install new grounding conductors at each guy anchor per the Motorola R56 standard and ensure they are properly bonded to the grounding electrode system. | |

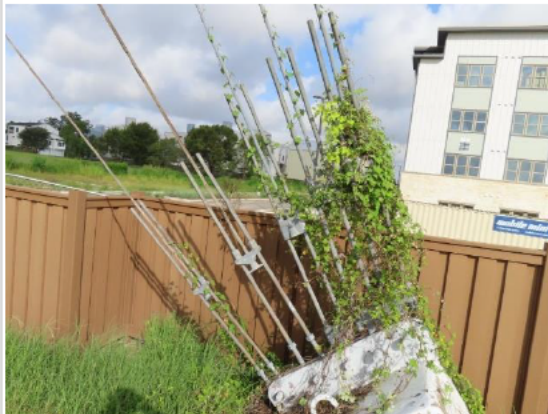
| Priority Rating | Item No. |
|---|---|
| Standard | 3 |

| Priority Rating | Item No. |
|---|---|
| <b>Deficiency:</b><br>Excessive vegetative growth observed at anchor AA. | |

| Priority Rating | Item No. |
|---|---|
| <b>Recommendation:</b><br>Remove the vegetation and spray to prevent future growth. | |

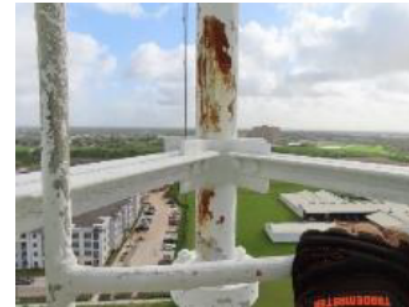
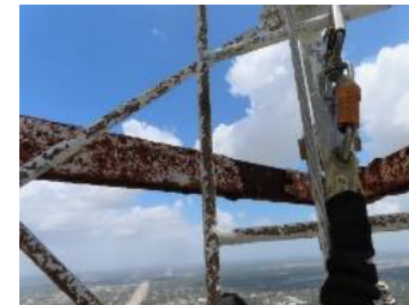
| Priority Rating | Item No. |
|---|---|
| <b>Deficiency:</b><br>Corrosion was observed in the following locations: <ul style="list-style-type: none"> <li>• A, B and C anchors.</li> <li>• A-leg at 55-ft.</li> <li>• C-leg at 101-ft.</li> <li>• A and B-legs at 163-ft.</li> <li>• Side light hardware at 486-ft and 763-ft.</li> <li>• CA face diagonal at 655-ft</li> <li>• Guy wire banding at 750-ft and 900-ft</li> </ul> | |

| Priority Rating | Item No. |
|---|---|
| <b>Recommendation:</b><br>Thoroughly clean all areas of corrosion and apply two coats of a brush-on cold galvanizing compound containing at least 95% zinc. | |

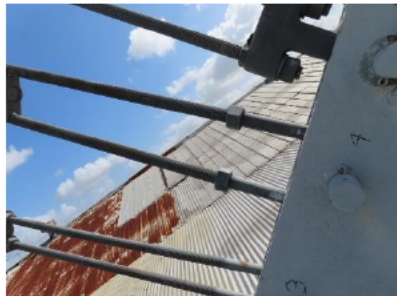
| | <table><tr><th>Priority Rating</th><th>Item No.</th></tr><tr><td>Standard</td><td>5</td></tr></table> | Priority Rating | Item No. | Standard | 5 | | <table><tr><th>Priority Rating</th><th>Item No.</th></tr><tr><td>Standard</td><td>6</td></tr></table> | Priority Rating | Item No. | Standard | 6 |
|---|---|---|---|---|---|---|---|---|---|---|---|
| | <p><b>Deficiency:</b><br/>Loose nuts were observed on the vari-grips in the following locations:</p> <ul style="list-style-type: none"><li>• Anchor BB; GL4</li><li>• Anchor CC; GL3 &amp; GL4</li></ul> | | <p><b>Deficiency:</b><br/>Corrosion was observed on the guy anchor hardware at anchor BB.</p> | | | | | | | | |

| | <table><tr><th>Priority Rating</th><th>Item No.</th></tr><tr><td>Standard</td><td>5</td></tr></table> | Priority Rating | Item No. | Standard | 5 | | <table><tr><th>Priority Rating</th><th>Item No.</th></tr><tr><td>Standard</td><td>6</td></tr></table> | Priority Rating | Item No. | Standard | 6 |
|---|---|---|---|---|---|---|---|---|---|---|---|
| | <p><b>Recommendation:</b><br/>Tighten the loose nuts to a snug tight condition.</p> | | <p><b>Recommendation:</b><br/>Thoroughly clean all areas of corrosion and apply two brush coats of a cold galvanizing compound containing at least 95% zinc. If during this process any section loss is observed, replace the hardware with one of equal size and grade.</p> | | | | | | | | |

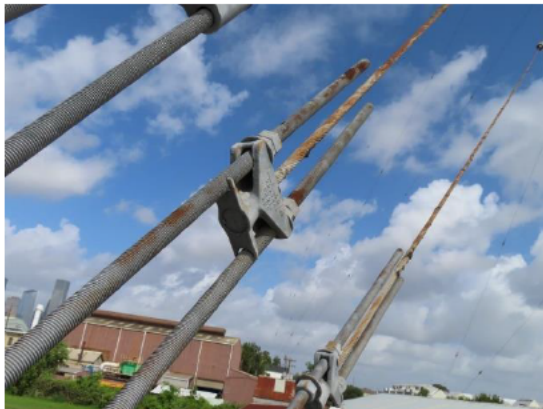
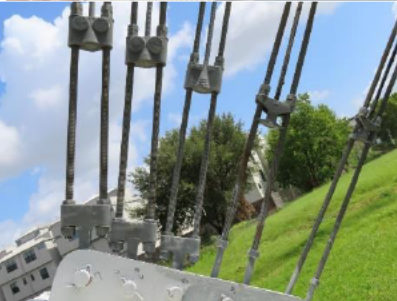
| Priority Rating | Item No. | Summary of Deficiencies & Recommendations |
|---|---|---|
| Standard | 6 | <b>Deficiency:</b><br>Corrosion was observed on the guy anchor hardware at anchor BB. |

| Priority Rating | Item No. | Summary of Deficiencies & Recommendations |
|---|---|---|
| | | <b>Recommendation:</b><br>Thoroughly clean all areas of corrosion and apply two brush coats of a cold galvanizing compound containing at least 95% zinc. If during this process any section loss is observed, replace the hardware with one of equal size and grade. |

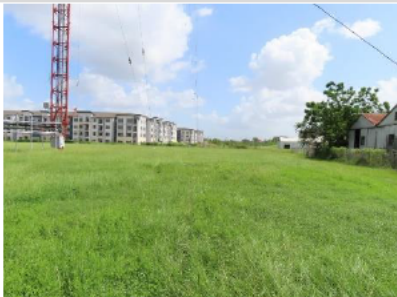
| | <table><tr><th>Priority Rating</th><th>Item No.</th></tr><tr><td>Standard</td><td>7</td></tr></table> | Priority Rating | Item No. | Standard | 7 | | <table><tr><th>Priority Rating</th><th>Item No.</th></tr><tr><td>Standard</td><td>8</td></tr></table> | Priority Rating | Item No. | Standard | 8 |
|---|---|---|---|---|---|---|---|---|---|---|---|
| | <p><b>Deficiency:</b><br/>Overgrown vegetation was observed in the tower compound.</p> | | <p><b>Deficiency:</b><br/>Insufficient serving was observed on the bottom safety cable termination.</p> | | | | | | | | |

| | <table><tr><th>Priority Rating</th><th>Item No.</th></tr><tr><td>Standard</td><td>7</td></tr></table> | Priority Rating | Item No. | Standard | 7 | | <table><tr><th>Priority Rating</th><th>Item No.</th></tr><tr><td>Standard</td><td>8</td></tr></table> | Priority Rating | Item No. | Standard | 8 |
|---|---|---|---|---|---|---|---|---|---|---|---|
| | <p><b>Recommendation:</b><br/>Remove the vegetation and spray to prevent future growth.</p> | | <p><b>Recommendation:</b><br/>Install galvanized wire serving on the bottom safety cable termination to prevent unraveling.</p> | | | | | | | | |

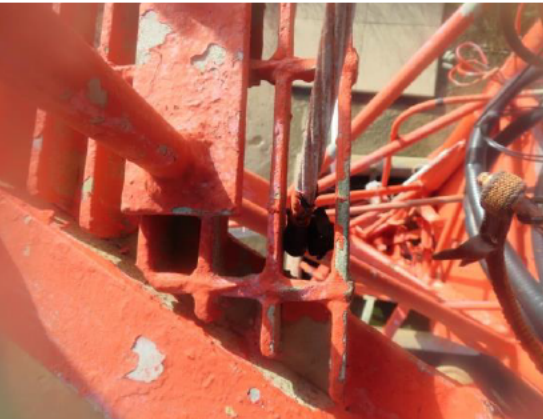
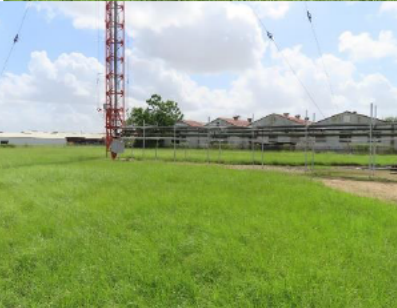
| Priority Rating | Item No. | Summary of Deficiencies & Recommendations |
|---|---|---|
| Standard | 8 | <b>Deficiency:</b><br>Insufficient serving was observed on the bottom safety cable termination. |

| Priority Rating | Item No. | Summary of Deficiencies & Recommendations |
|---|---|---|
| | | <b>Recommendation:</b><br>Install galvanized wire serving on the bottom safety cable termination to prevent unraveling. |

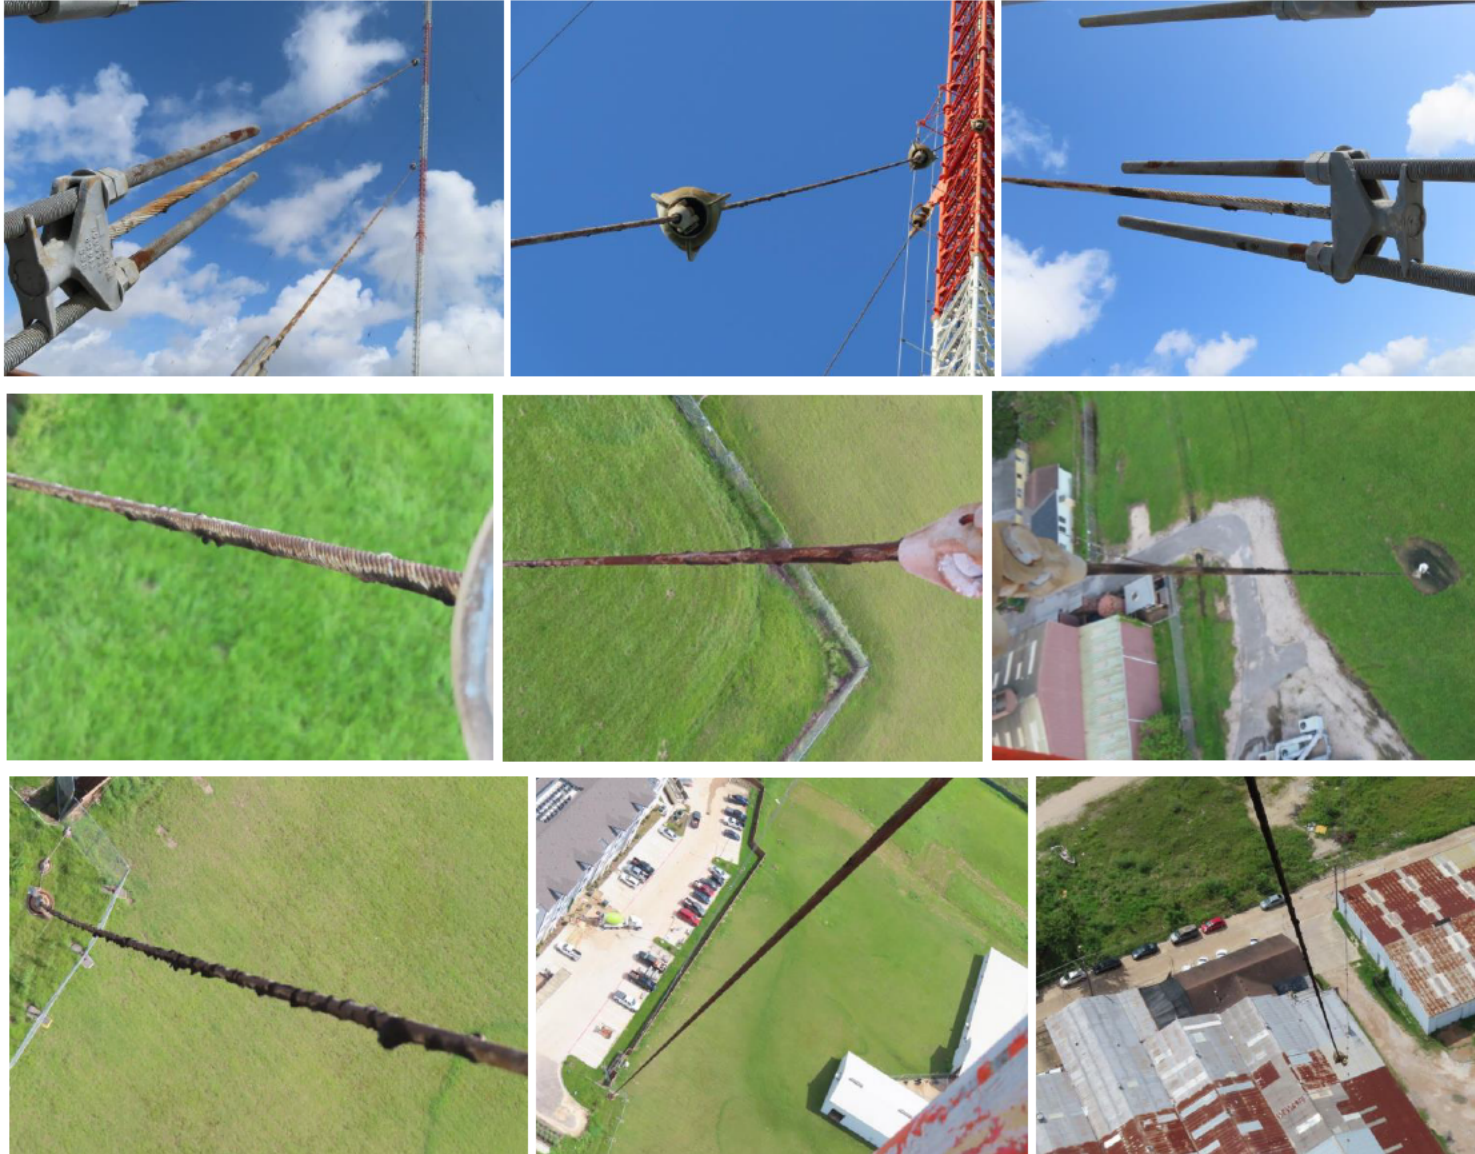
| Priority Rating | Item No. |
|---|---|
| Critical | 9 |

| Priority Rating | Item No. |
|---|---|
| <b>Deficiency:</b><br>Significant corrosion and swelling was observed on the GL1, GL2, GL3, and GL4 guy wires. | |

| Priority Rating | Item No. |
|---|---|
| <b>Recommendation:</b><br>Replace the guy wires. | |

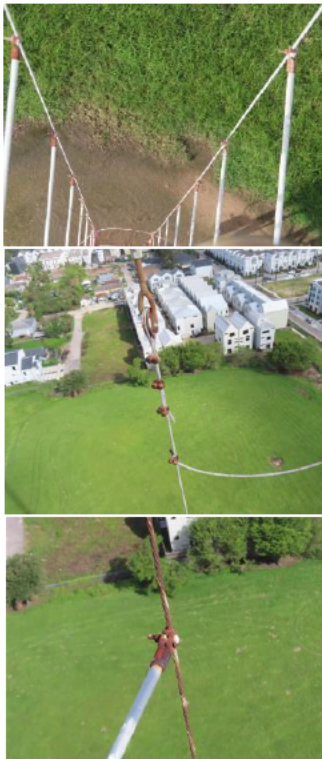
| | <table><tr><th>Priority Rating</th><th>Item No.</th></tr><tr><td>Standard</td><td>10</td></tr></table> <p><b>Deficiency:</b><br/>Corrosion was observed on the detuner cable &amp; hardware throughout the tower.</p> <p><b>Recommendation:</b><br/>Replace the corroded cable clamps. Monitor the cable corrosion during the next inspection cycle. If conditions worsen and/or pitting and section loss is observed, the detuner cable(s) should be replaced. Thoroughly clean all other areas of corrosion and apply two brush coats of a cold galvanizing compound containing at least 95% zinc. If during this process any section loss is observed, replace the hardware with one of equal size and grade.</p> | Priority Rating | Item No. | Standard | 10 | | <table><tr><th>Priority Rating</th><th>Item No.</th></tr><tr><td>Standard</td><td>11</td></tr></table> <p><b>Deficiency:</b><br/>Unsecured feedlines were observed in the following locations:</p> <ul style="list-style-type: none"><li>• (1) FH 1-1/4; CA face; 145-ft to 170-ft</li><li>• (1) FH 7/8; AB face; 365-ft to 550-ft</li></ul> <p><b>Recommendation:</b><br/>Properly secure the feedlines to the tower per the manufacturer's specifications.</p> | Priority Rating | Item No. | Standard | 11 |

| <b>Priority Rating</b> | <b>Item No.</b> | <b>Summary of Deficiencies &amp; Recommendations</b> |
|---|---|---|
| | | <b>Recommendation:</b><br>Replace the corroded cable clamps. Monitor the cable corrosion during the next inspection cycle. If conditions worsen and/or pitting and section loss is observed, the detuner cable(s) should be replaced. Thoroughly clean all other areas of corrosion and apply two brush coats of a cold galvanizing compound containing at least 95% zinc. If during this process any section loss is observed, replace the hardware with one of equal size and grade. |

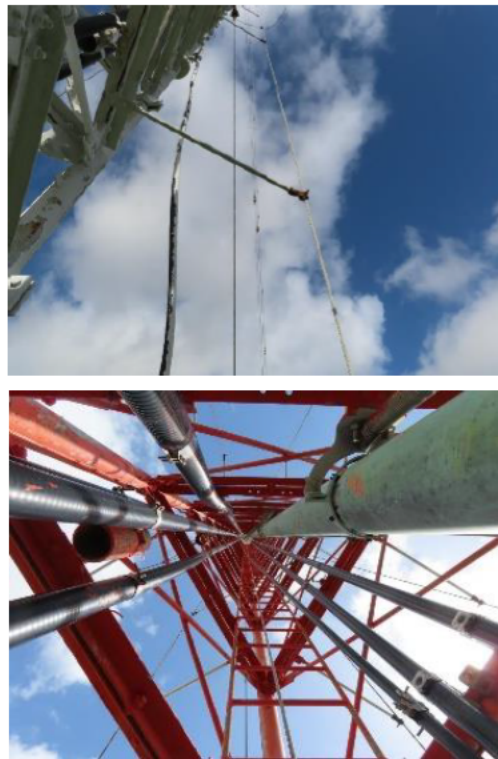
| <b>Priority Rating</b> | <b>Item No.</b> | <b>Summary of Deficiencies &amp; Recommendations</b> |
|---|---|---|
| Standard | 11 | <b>Deficiency:</b><br>Unsecured feedlines were observed in several locations. See deficiency list for details. |

| <b>Priority Rating</b> | <b>Item No.</b> | <b>Summary of Deficiencies &amp; Recommendations</b> |
|---|---|---|
| | | <b>Recommendation:</b><br>Properly secure the feedlines to the tower per the manufacturer's specifications. |

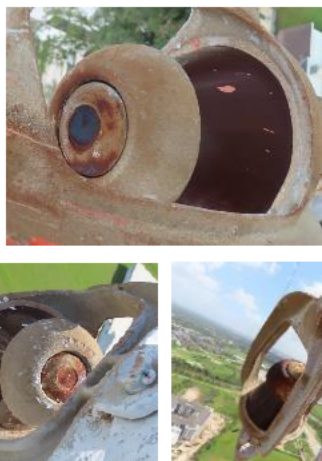
| | <table><tr><th>Priority Rating</th><th>Item No.</th></tr><tr><td>Standard</td><td>10</td></tr></table> <p><b>Deficiency:</b><br/>Corrosion was observed on the detuner cable &amp; hardware throughout the tower.</p> <p><b>Recommendation:</b><br/>Replace the corroded cable clamps. Monitor the cable corrosion during the next inspection cycle. If conditions worsen and/or pitting and section loss is observed, the detuner cable(s) should be replaced. Thoroughly clean all other areas of corrosion and apply two brush coats of a cold galvanizing compound containing at least 95% zinc. If during this process any section loss is observed, replace the hardware with one of equal size and grade.</p> | Priority Rating | Item No. | Standard | 10 | | <table><tr><th>Priority Rating</th><th>Item No.</th></tr><tr><td>Standard</td><td>11</td></tr></table> <p><b>Deficiency:</b><br/>Unsecured feedlines were observed in the following locations:</p> <ul style="list-style-type: none"><li>• (1) FH 1-1/4; CA face; 145-ft to 170-ft</li><li>• (1) FH 7/8; AB face; 365-ft to 550-ft</li></ul> <p><b>Recommendation:</b><br/>Properly secure the feedlines to the tower per the manufacturer's specifications.</p> | Priority Rating | Item No. | Standard | 11 |
|---|---|---|---|---|---|---|---|---|---|---|---|
| | <table><tr><th>Priority Rating</th><th>Item No.</th></tr><tr><td>Standard</td><td>12</td></tr></table> <p><b>Deficiency:</b><br/>Corrosion was observed on the guy wire hardware at GL2, GL3, and GL4.</p> <p><b>Recommendation:</b><br/>Monitor the corrosion during the next inspection cycle. If conditions worsen and/or pitting and section loss is observed, the hardware should be replaced.</p> | Priority Rating | Item No. | Standard | 12 | | <table><tr><th>Priority Rating</th><th>Item No.</th></tr><tr><td>Standard</td><td>13</td></tr></table> <p><b>Deficiency:</b><br/>Unused hardware was observed at 225-ft on the BC face and at 659-ft on the A-leg.</p> <p><b>Recommendation:</b><br/>Remove the unused hardware from the tower.</p> | Priority Rating | Item No. | Standard | 13 |

| <b>Priority Rating</b> | <b>Item No.</b> | <b>Summary of Deficiencies &amp; Recommendations</b> |
|---|---|---|
| | | <b>Recommendation:</b><br>Monitor the corrosion during the next inspection cycle. If conditions worsen and/or pitting and section loss is observed, the hardware should be replaced. |

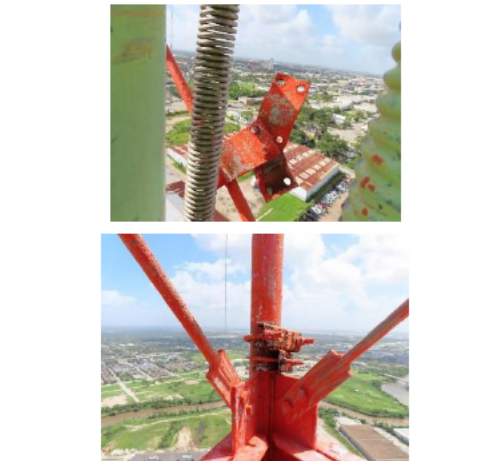
| <b>Priority Rating</b> | <b>Item No.</b> | <b>Summary of Deficiencies &amp; Recommendations</b> |
|---|---|---|
| Standard | 13 | <b>Deficiency:</b><br>Unused hardware was observed at 225-ft on the BC face and at 659-ft on the A-leg. |

| <b>Priority Rating</b> | <b>Item No.</b> | <b>Summary of Deficiencies &amp; Recommendations</b> |
|---|---|---|
| | | <b>Recommendation:</b><br>Remove the unused hardware from the tower. |

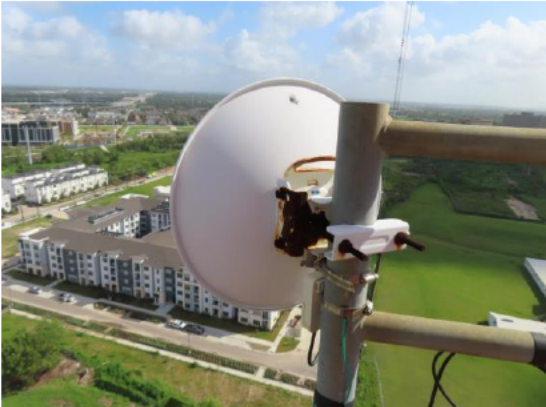
| | <table><tr><th>Priority Rating</th><th>Item No.</th></tr><tr><td>Standard</td><td>14</td></tr></table> <p><b>Deficiency:</b><br/>Corrosion was observed on the mount at 230-ft on the A-leg.</p> <p><b>Recommendation:</b><br/>Notify the equipment owner. All areas of corrosion should be thoroughly cleaned and treated with two coats of a brush-on cold galvanizing compound containing at least 95% zinc. If during this process any section loss is observed, the appurtenance or hardware should be replaced with one of equal size and grade.</p> | Priority Rating | Item No. | Standard | 14 | | <table><tr><th>Priority Rating</th><th>Item No.</th></tr><tr><td>Standard</td><td>15</td></tr></table> <p><b>Deficiency:</b><br/>Corrosion was observed on the reinforcement welds at 430-ft on the A-leg and C-leg, possibly failing visual inspection per AWS D1.1.</p> <p><b>Recommendation:</b><br/>A licensed CWI should inspect the welds to determine if they pass visual inspection per AWS D1.1 and determine the appropriate course of action. If the welds pass visual inspection, they should be thoroughly cleaned and treated with two coats of a brush-on cold galvanizing compound containing at least 95% zinc.</p> | Priority Rating | Item No. | Standard | 15 |

| <b>Priority Rating</b> | <b>Item No.</b> | <b>Summary of Deficiencies &amp; Recommendations</b> |
|---|---|---|
| | | <b>Recommendation:</b><br>Notify the equipment owner. All areas of corrosion should be thoroughly cleaned and treated with two coats of a brush-on cold galvanizing compound containing at least 95% zinc. If during this process any section loss is observed, the appurtenance or hardware should be replaced with one of equal size and grade. |

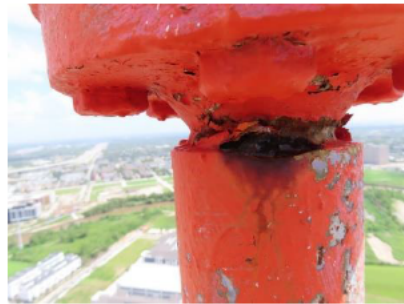
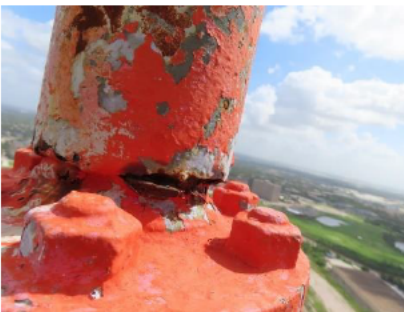
| <b>Priority Rating</b> | <b>Item No.</b> | <b>Summary of Deficiencies &amp; Recommendations</b> |
|---|---|---|
| Standard | 15 | <b>Deficiency:</b><br>Corrosion was observed on the reinforcement welds at 430-ft on the A-leg and C-leg, possibly failing visual inspection per AWS D1.1. |

| <b>Priority Rating</b> | <b>Item No.</b> | <b>Summary of Deficiencies &amp; Recommendations</b> |
|---|---|---|
| | | <b>Recommendation:</b><br>A licensed CWI should inspect the welds to determine if they pass visual inspection per AWS D1.1 and determine the appropriate course of action. If the welds pass visual inspection, they should be thoroughly cleaned and treated with two coats of a brush-on cold galvanizing compound containing at least 95% zinc. |

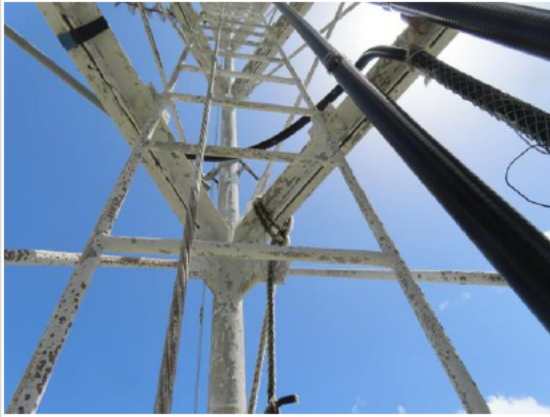
| Priority Rating | Item No. | Summary of Deficiencies & Recommendations |
|---|---|---|
| Standard | 17 | <b>Deficiency:</b><br>An abandoned rope was observed on the AB face at 652-ft. |

| Priority Rating | Item No. | Summary of Deficiencies & Recommendations |
|---|---|---|
| | | <b>Recommendation:</b><br>Remove the rope from the tower. |

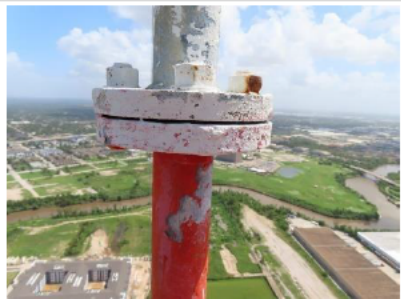
| Priority Rating | Item No. | Summary of Deficiencies & Recommendations |
|---|---|---|
| Standard | 18 | <b>Deficiency:</b><br>Gaps ranging in size from 1/8" to 1/4" were observed between the flanges on the all legs at 640-ft. |

| | <table><tr><th>Priority Rating</th><th>Item No.</th></tr><tr><td>Standard</td><td>18</td></tr></table> <p><b>Deficiency:</b><br/>Gaps ranging in size from 1/8" to 1/4" were observed between the flanges on the all legs at 640-ft.</p> | Priority Rating | Item No. | Standard | 18 | | <table><tr><th>Priority Rating</th><th>Item No.</th></tr><tr><td>Standard</td><td>19</td></tr></table> <p><b>Deficiency:</b><br/>Corrosion was observed on the 7/8"Ø x 3-1/2" flange bolts from 640-ft to 730-ft and from 820-ft to 880-ft.</p> | Priority Rating | Item No. | Standard | 19 |

| Priority Rating | Item No. | Summary of Deficiencies & Recommendations |
|---|---|---|
| | | <b>Recommendation:</b><br>Monitor the flange gaps during the next inspection cycle. If the conditions worsen and gaps exceeding 1/4" are observed, consult with a structural engineer licensed in the State of Texas to determine the appropriate course of action. |

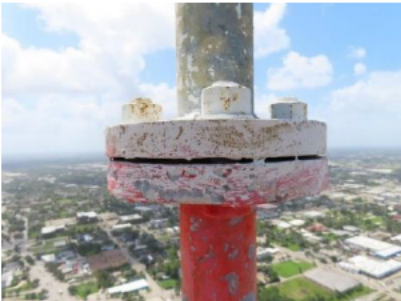
| Priority Rating | Item No. | Summary of Deficiencies & Recommendations |
|---|---|---|
| Standard | 19 | <b>Deficiency:</b><br>Corrosion was observed on the 7/8"Ø x 3-1/2" flange bolts from 640-ft to 730-ft and from 820-ft to 880-ft. |

| | <table><tr><th>Priority Rating</th><th>Item No.</th></tr><tr><td>Standard</td><td>18</td></tr></table> <p><b>Deficiency:</b><br/>Gaps ranging in size from 1/8" to 1/4" were observed between the flanges on the all legs at 640-ft.</p> | Priority Rating | Item No. | Standard | 18 | | <table><tr><th>Priority Rating</th><th>Item No.</th></tr><tr><td>Standard</td><td>19</td></tr></table> <p><b>Deficiency:</b><br/>Corrosion was observed on the 7/8"Ø x 3-1/2" flange bolts from 640-ft to 730-ft and from 820-ft to 880-ft.</p> | Priority Rating | Item No. | Standard | 19 |
|---|---|---|---|---|---|---|---|---|---|---|---|
| | <p><b>Recommendation:</b><br/>Monitor the flange gaps during the next inspection cycle. If the conditions worsen and gaps exceeding 1/4" are observed, consult with a structural engineer licensed in the State of Texas to determine the appropriate course of action.</p> | | <p><b>Recommendation:</b><br/>Thoroughly clean all areas of corrosion and apply two coats of a brush-on cold galvanizing compound containing at least 95% zinc. If during this process any section loss is observed, replace the entire A325 bolt assembly.</p> | | | | | | | | |

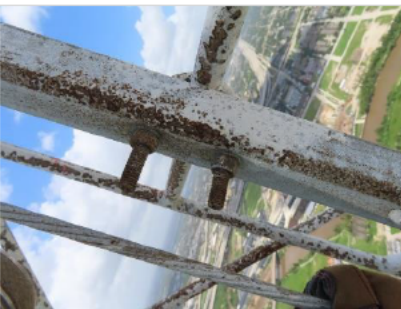
| | <table><tr><th>Priority Rating</th><th>Item No.</th></tr><tr><td>Standard</td><td>18</td></tr></table> <p><b>Deficiency:</b><br/>Gaps ranging in size from 1/8" to 1/4" were observed between the flanges on the all legs at 640-ft.</p> | Priority Rating | Item No. | Standard | 18 | | <table><tr><th>Priority Rating</th><th>Item No.</th></tr><tr><td>Standard</td><td>19</td></tr></table> <p><b>Deficiency:</b><br/>Corrosion was observed on the 7/8"Ø x 3-1/2" flange bolts from 640-ft to 730-ft and from 820-ft to 880-ft.</p> | Priority Rating | Item No. | Standard | 19 |
|---|---|---|---|---|---|---|---|---|---|---|---|
| | <table><tr><th>Priority Rating</th><th>Item No.</th></tr><tr><td>Standard</td><td>20</td></tr></table> <p><b>Deficiency:</b><br/>Corrosion was observed on hardware at the top safety cable assembly.</p> | Priority Rating | Item No. | Standard | 20 | | <table><tr><th>Priority Rating</th><th>Item No.</th></tr><tr><td>Standard</td><td>21</td></tr></table> <p><b>Deficiency:</b><br/>The rubber grommet for the top safety climb housing was observed to be damaged.</p> | Priority Rating | Item No. | Standard | 21 |

| Priority Rating | Item No. | Summary of Deficiencies & Recommendations |
|---|---|---|
| | | <b>Recommendation:</b><br>Thoroughly clean all areas of corrosion and apply two brush coats of a cold galvanizing compound containing at least 95% zinc. If during this process any section loss is observed, replace the hardware with one of equal size and grade. |

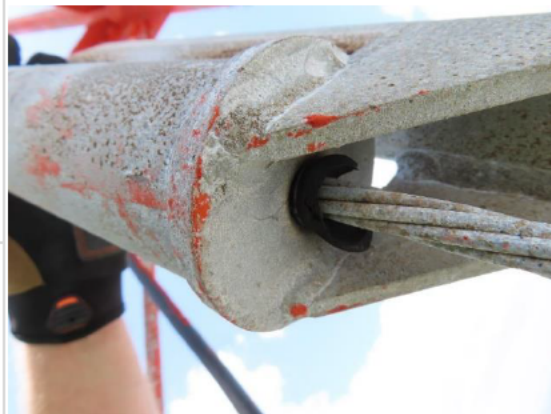
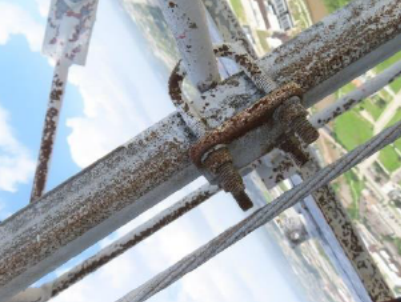
| Priority Rating | Item No. | Summary of Deficiencies & Recommendations |
|---|---|---|
| Standard | 21 | <b>Deficiency:</b><br>The rubber grommet for the top safety climb housing was observed to be damaged. |

| | <table><tr><th>Priority Rating</th><th>Item No.</th></tr><tr><td>Standard</td><td>18</td></tr></table> <p><b>Deficiency:</b><br/>Gaps ranging in size from 1/8" to 1/4" were observed between the flanges on the all legs at 640-ft.</p> | Priority Rating | Item No. | Standard | 18 | | <table><tr><th>Priority Rating</th><th>Item No.</th></tr><tr><td>Standard</td><td>19</td></tr></table> <p><b>Deficiency:</b><br/>Corrosion was observed on the 7/8"Ø x 3-1/2" flange bolts from 640-ft to 730-ft and from 820-ft to 880-ft.</p> | Priority Rating | Item No. | Standard | 19 |
|---|---|---|---|---|---|---|---|---|---|---|---|
| | <p><b>Recommendation:</b><br/>Thoroughly clean all areas of corrosion and apply two brush coats of a cold galvanizing compound containing at least 95% zinc. If during this process any section loss is observed, replace the hardware with one of equal size and grade.</p> | | <p><b>Recommendation:</b><br/>Replace the grommet per the manufacturer's specifications.</p> | | | | | | | | |

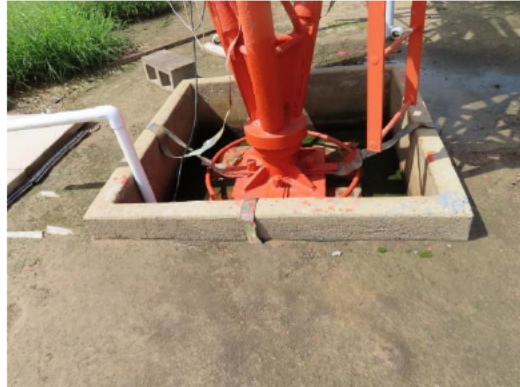
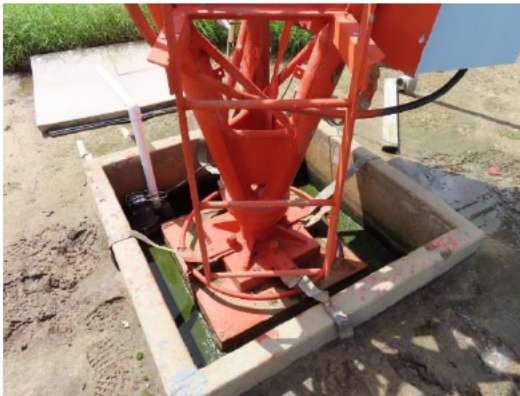
| Priority Rating | Item No. |
|---|---|
| Standard | 22 |

**Deficiency:**  
The grounding conductor straps at the base of the tower are not routed efficiently in a downward-flowing path.

**Recommendation:**  
Install new grounding conductors with exothermic connections to the tower legs, utilizing the shortest and straightest downward-flowing path toward the earth and the grounding electrode system per Motorola R56 standards.

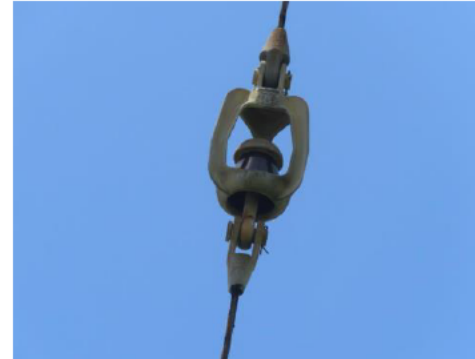
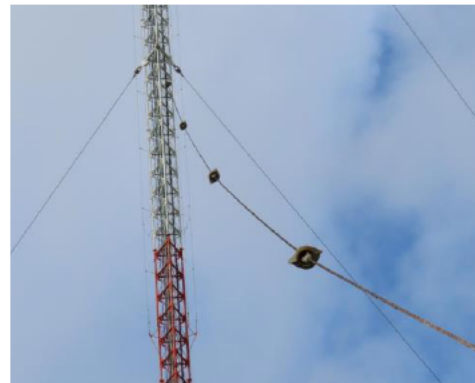
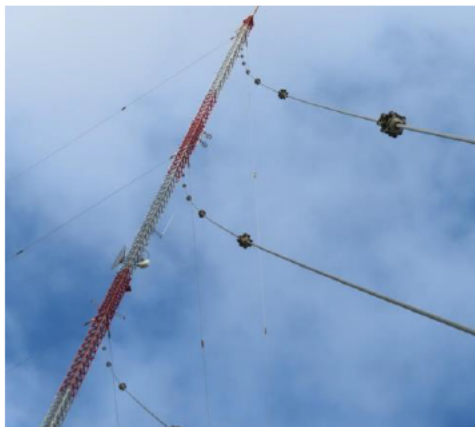
| Priority Rating | Item No. |
|---|---|
| Standard | 23 |

**Deficiency:**  
TEP could not properly measure the guy wire tensions via standard tension measurement methods due to the large wire sizes and insulators installed on the guy wires.

**Recommendation:**  
A return visit should be coordinated with the appropriate hydraulic tools and equipment to perform guy tension measurements. If necessary, re-tension the guy wires to within recommended limits while ensuring twist & plumb are also within recommended limits.
