National Transportation Safety Board  
Office of Aviation Safety  
Washington, DC 20594

CEN25FA019

## **OPERATIONS GROUP FACTUAL REPORT**

Location: Houston, Texas  
Date: October 20, 2024  
Time: 1951 central daylight time  
0051 Coordinated universal time (October 21, 2024)  
Helicopter: N881KE / Robinson R-44 Raven II

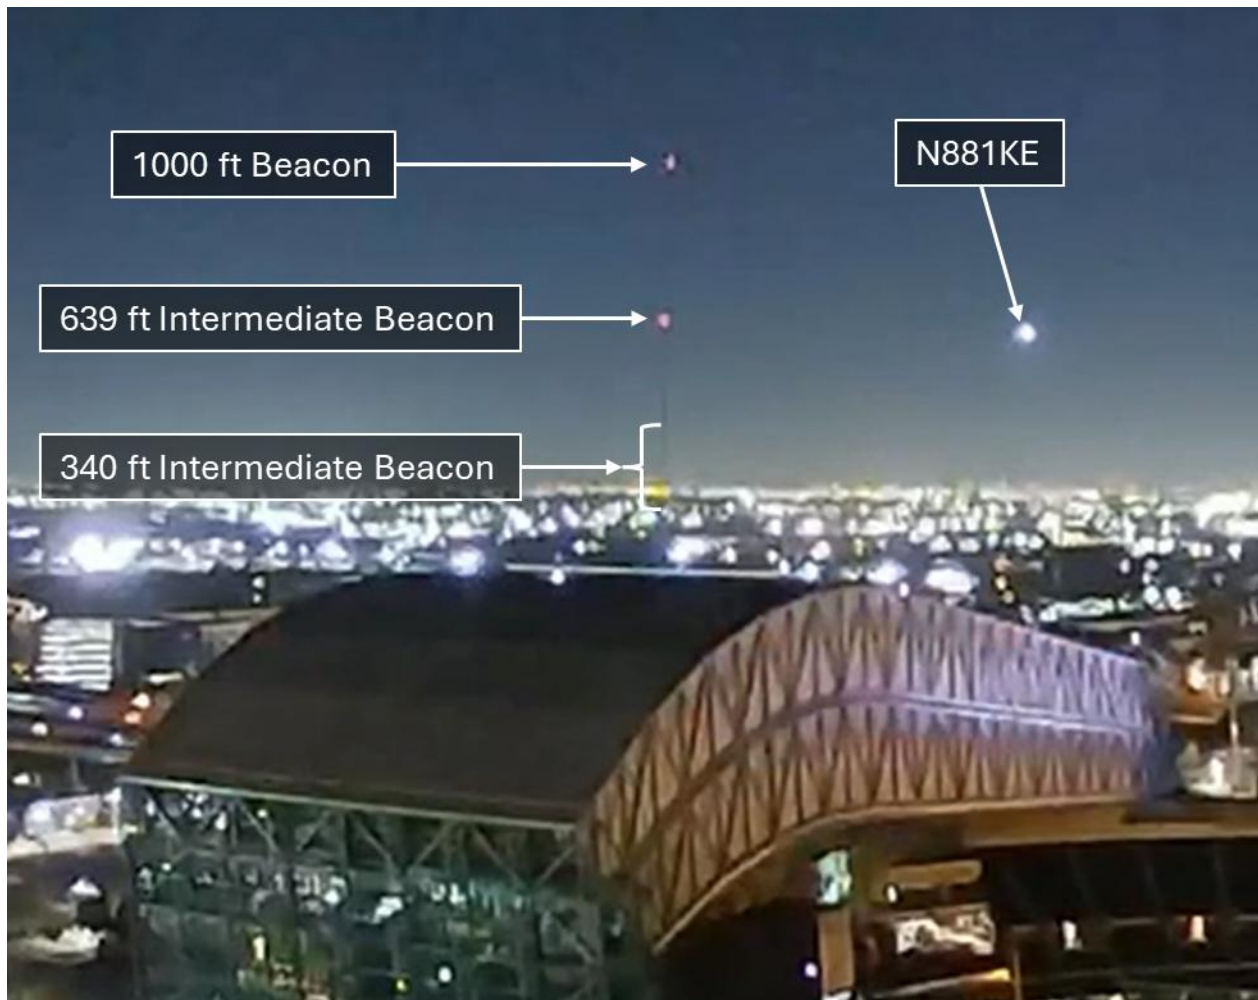
A video camera, located near Daikin Park (formerly Minute Maid Park) recorded the park's rooftop in the foreground and the radio tower in view. The accident helicopter, seen as a bright light, moved toward the radio tower. Two sets of red beacons were seen as they flashed in unison on the radio tower, a top set and an intermediate set. (figure 2). A lower set of intermediate beacons were not seen in the video.

Figure 2. Image captured from a video showing the radio tower, the beacons, and the accident helicopter.

The video showed the helicopter moving toward the radio tower. At 0:00:44 video time, the light of the helicopter extinguished followed immediately by a bright flash that occurred below the top beacon. The radio tower and the bright flash then fell out of view behind the rooftop of the park.

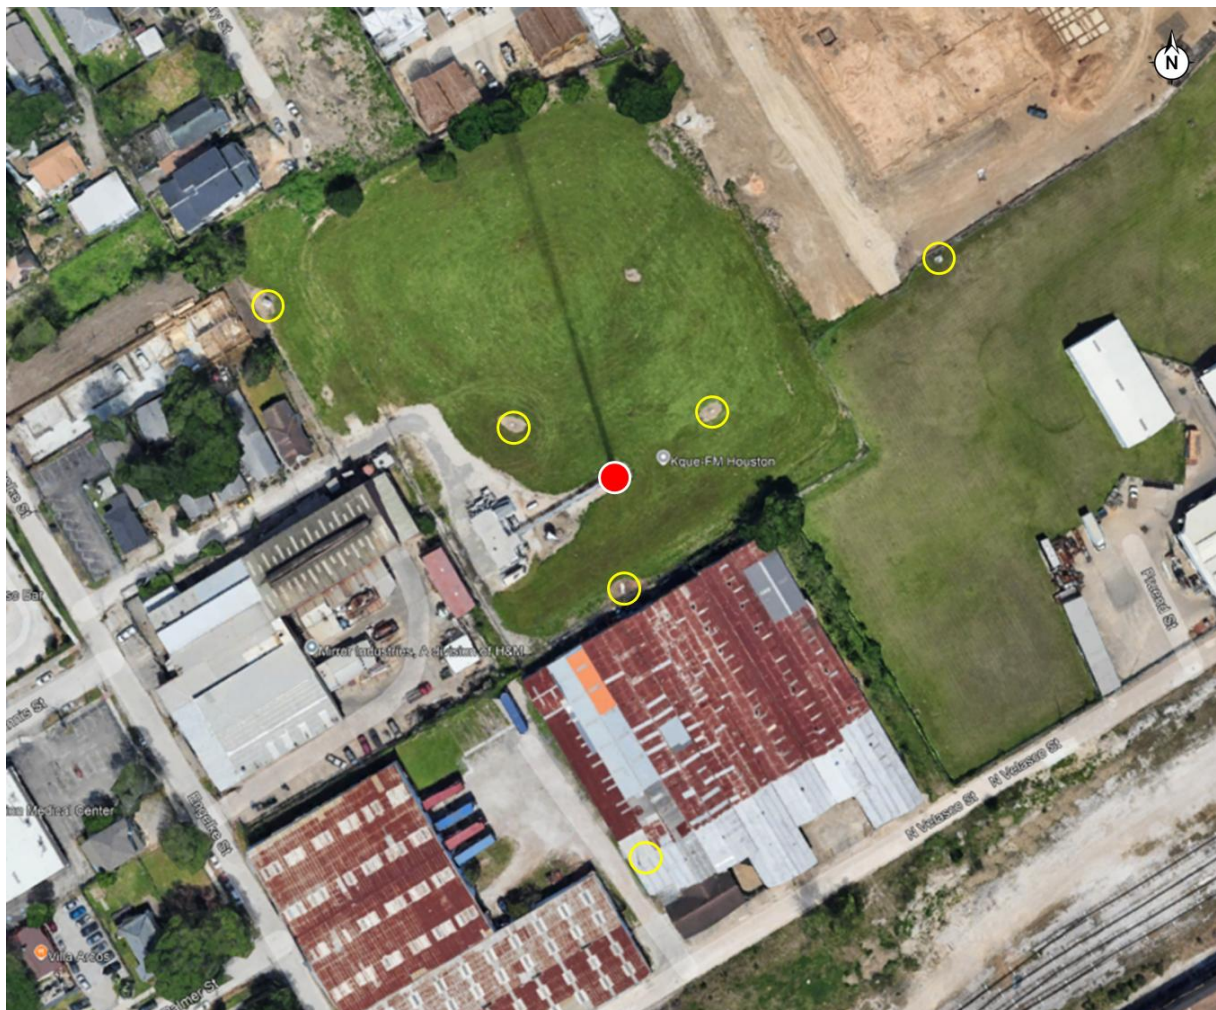
The helicopter impacted terrain on the southeast corner of a level and open field, covered with a short layer of grass. The radio tower and support cables lay strewn on the field. The helicopter came to rest among the fallen structure of the radio tower, near  $29^{\circ}45.43' - 95^{\circ}20.3'$  ( $29.757248 - 95.338352$ ) at an elevation of about 36 ft msl. Commercial buildings were located near the southeast and southwest corners of the field. A building, located on the field southwest of the radio tower was connected by wiring to the radio tower (figure 3). Additional information about the radio tower is included later in this report.

Figure 3. Image of the accident site. The red circle identifies the location of the radio tower. The yellow circles identify the anchoring points for the guy wires for the radio tower.

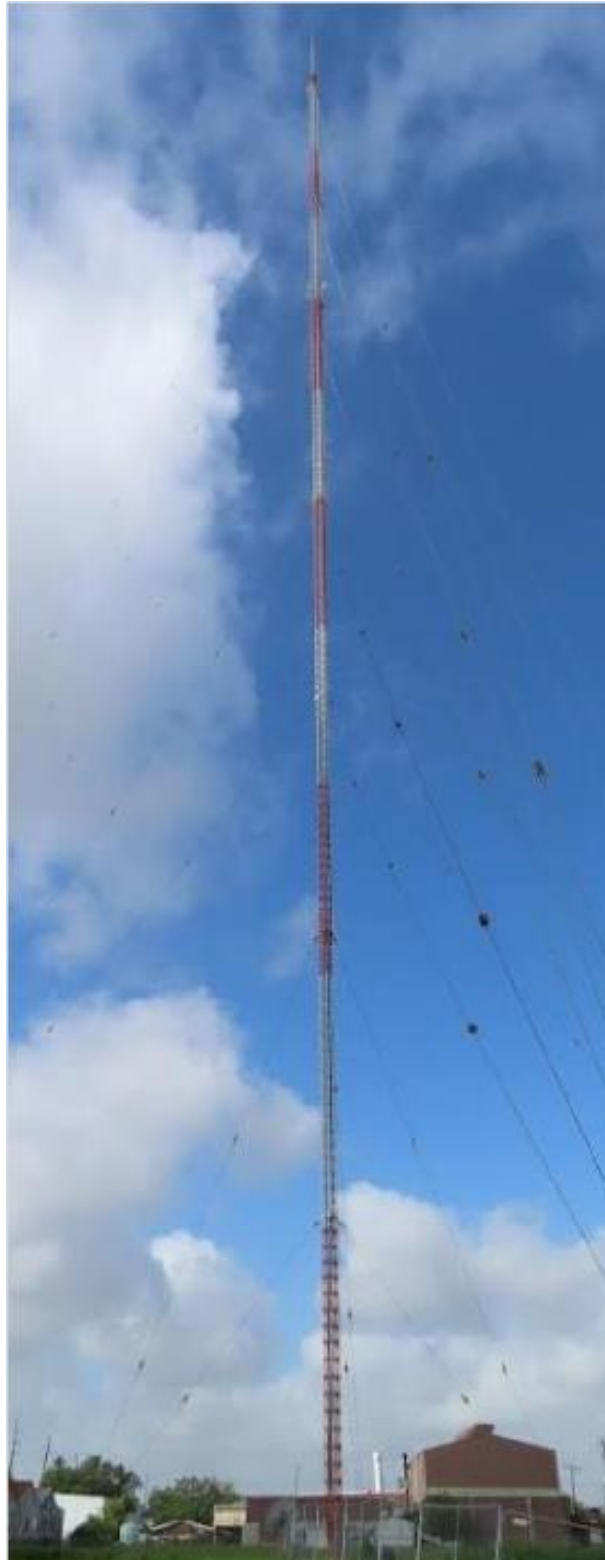
According to a Maintenance Inspection Report (MIR), dated August 5, 2024, the radio tower was 920 ft tall, and an overall height of 1003 ft with top appurtenance. Two sets of guy wires extended from the radio tower. The inner set extended out from the

radio tower about 100 ft. The outer set extended out from the radio tower about 340 ft. The radio tower appeared to be painted in alternating colors of white and aviation orange. Figure 7.

Figure 7. Image of the accident radio tower, courtesy of the owner.

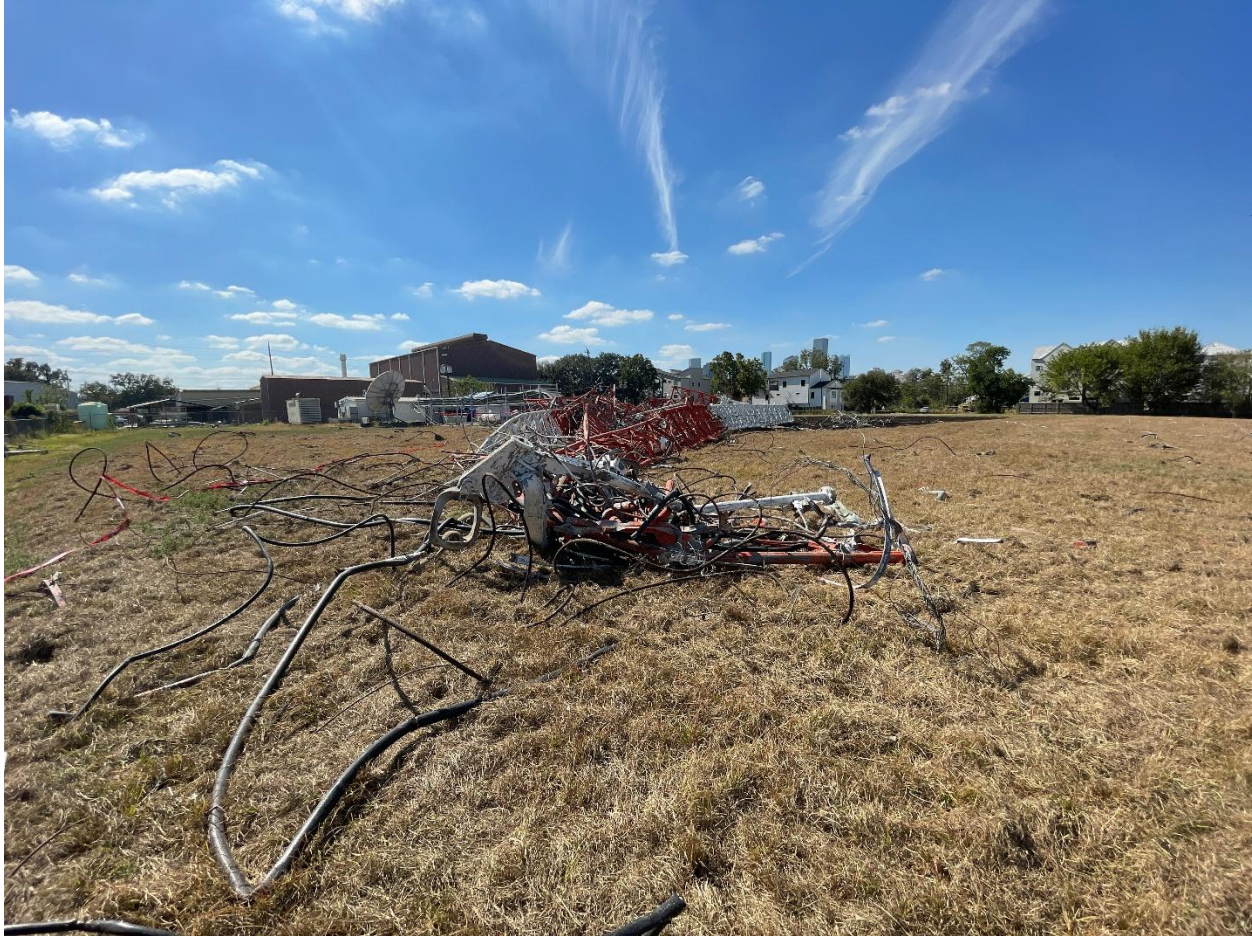
Figure 8. Postaccident image of the radio tower.

Postaccident visual examination of the radio tower revealed bending and deformation of the entire structure. Some thermal damage was evident on some of the structure. Sections of the helicopter were trapped within the bends of the radio tower. A significant impact mark was observed about 100 ft from the top of the radio tower, consistent with an impact from an object.

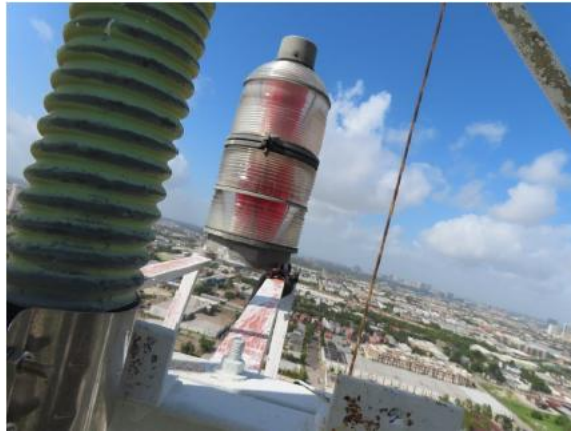
According to the MIR, the radio tower had beacons at 340 ft, 639 ft, and 1,000 ft levels. The lights were Hughey & Phillips, type: L-864 Flash Head. Examination of the radio tower debris revealed shattered red and white glass debris but no intact lamps. Multiple videos revealed that the top beacon at 1,000 ft, and the intermediate beacon at 639 ft, illuminated and flashed red, in unison, at a rate of about 30 times per minute. The intermediate beacon at 340 ft was not seen in the videos.

According to the MIR, the photograph shown in figure 11 is a beacon from the 639 ft elevation.

Figure 11. Image of one of the beacons attached to the radio tower. Photo courtesy of the owner.

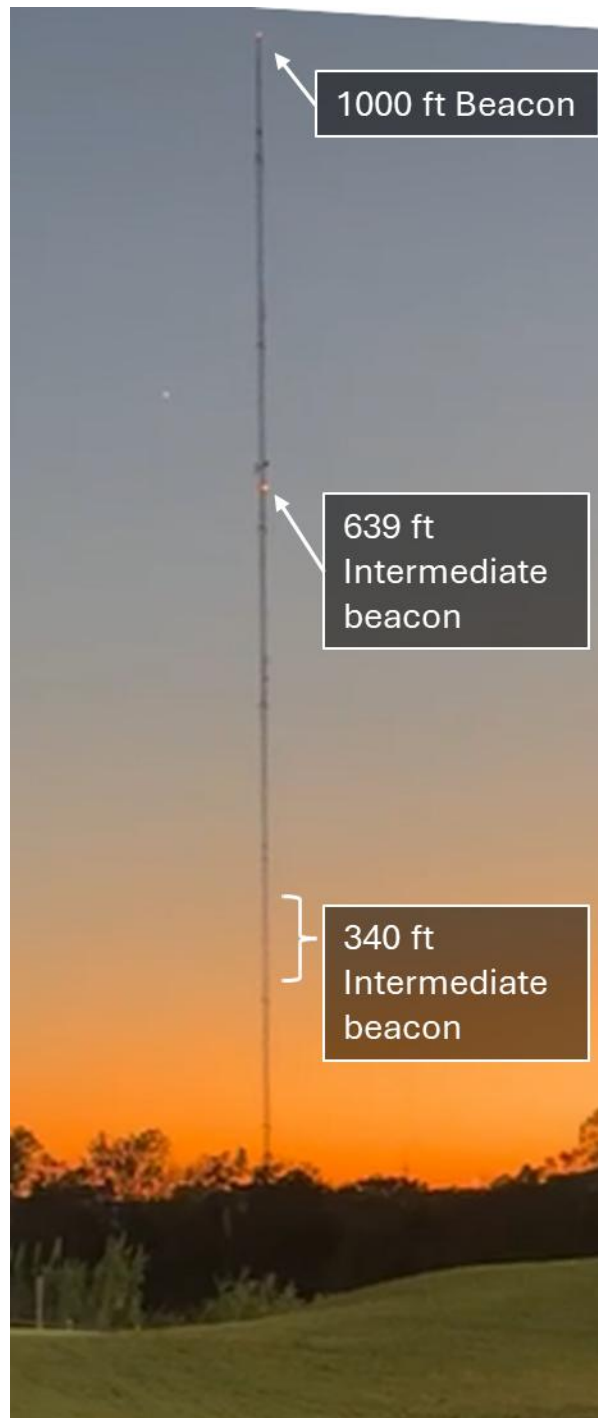
An image captured from a video taken near the accident site showed the top beacon and the 639 ft intermediate beacons as they flashed in unison (figure 12).

Figure 12. Image captured from a video showing the radio tower with the top beacon and 639 ft intermediate beacons illuminated. Courtesy of a witness.

Calculations from the video mentioned in paragraph 1.2 revealed that the beacons flashed in unison at a rate of about 30 flashes per minute.
