CEN25FA281

## INVESTIGATION PHOTOGRAPHS

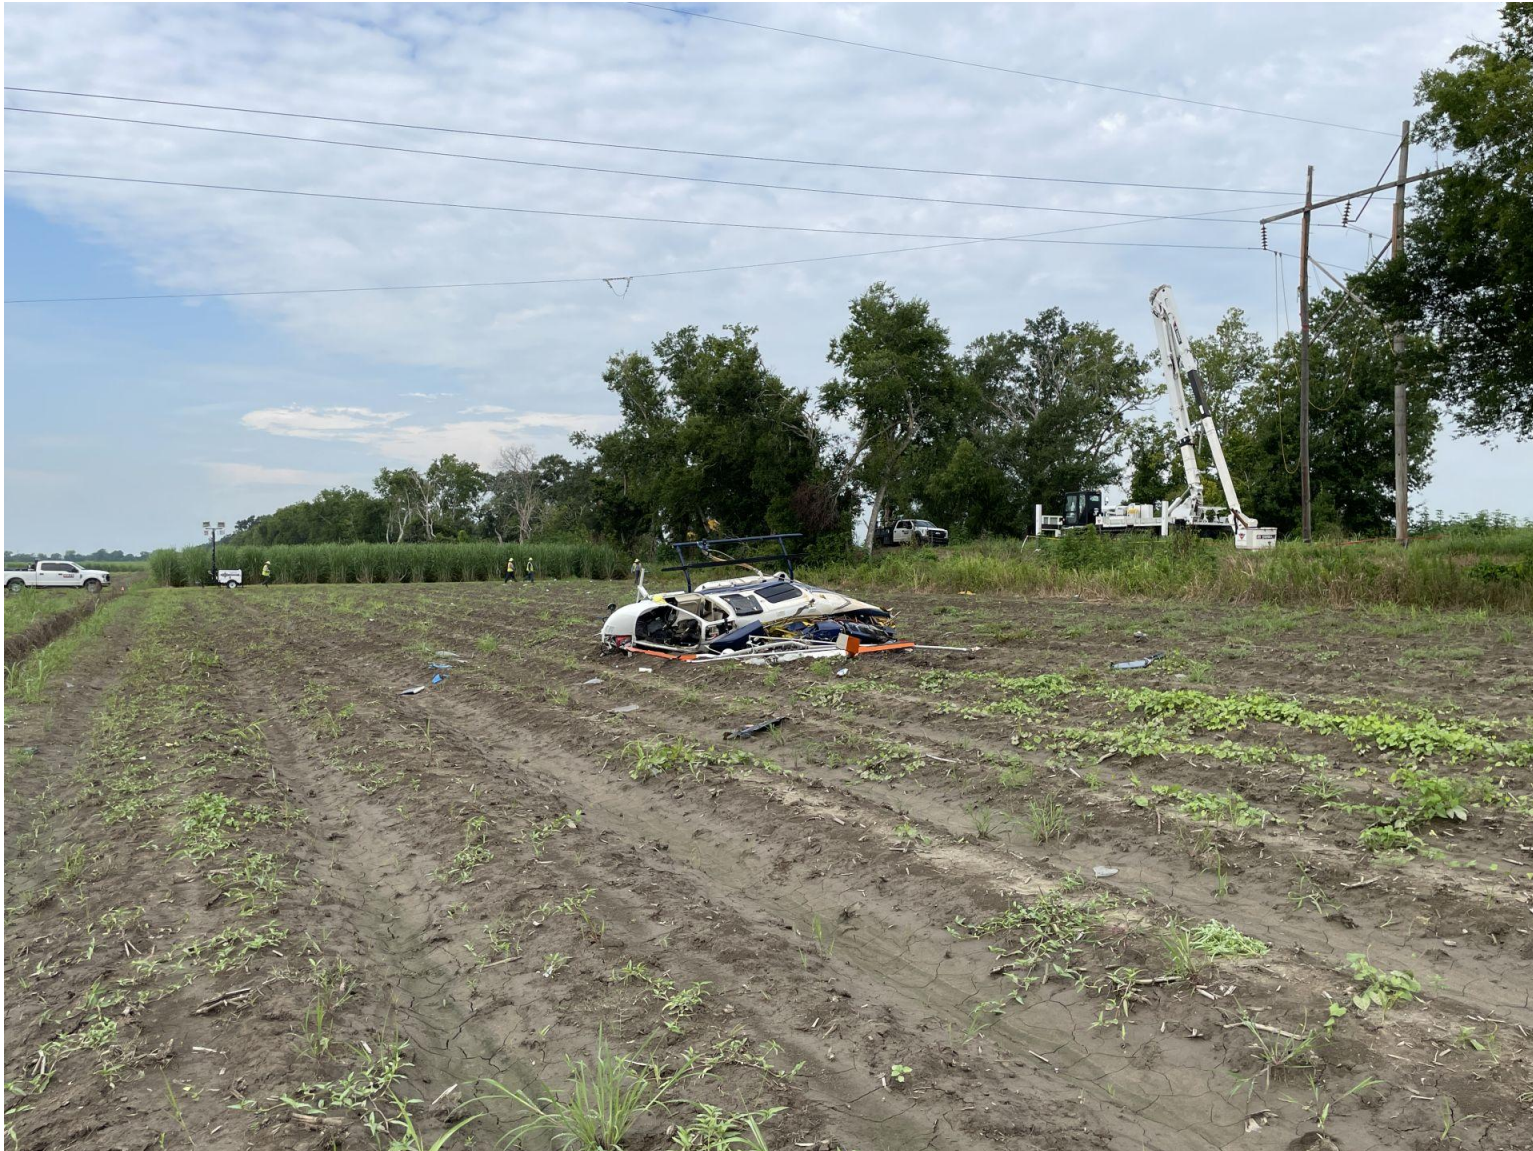
**Photograph 1 - Accident site (NTSB photo)**

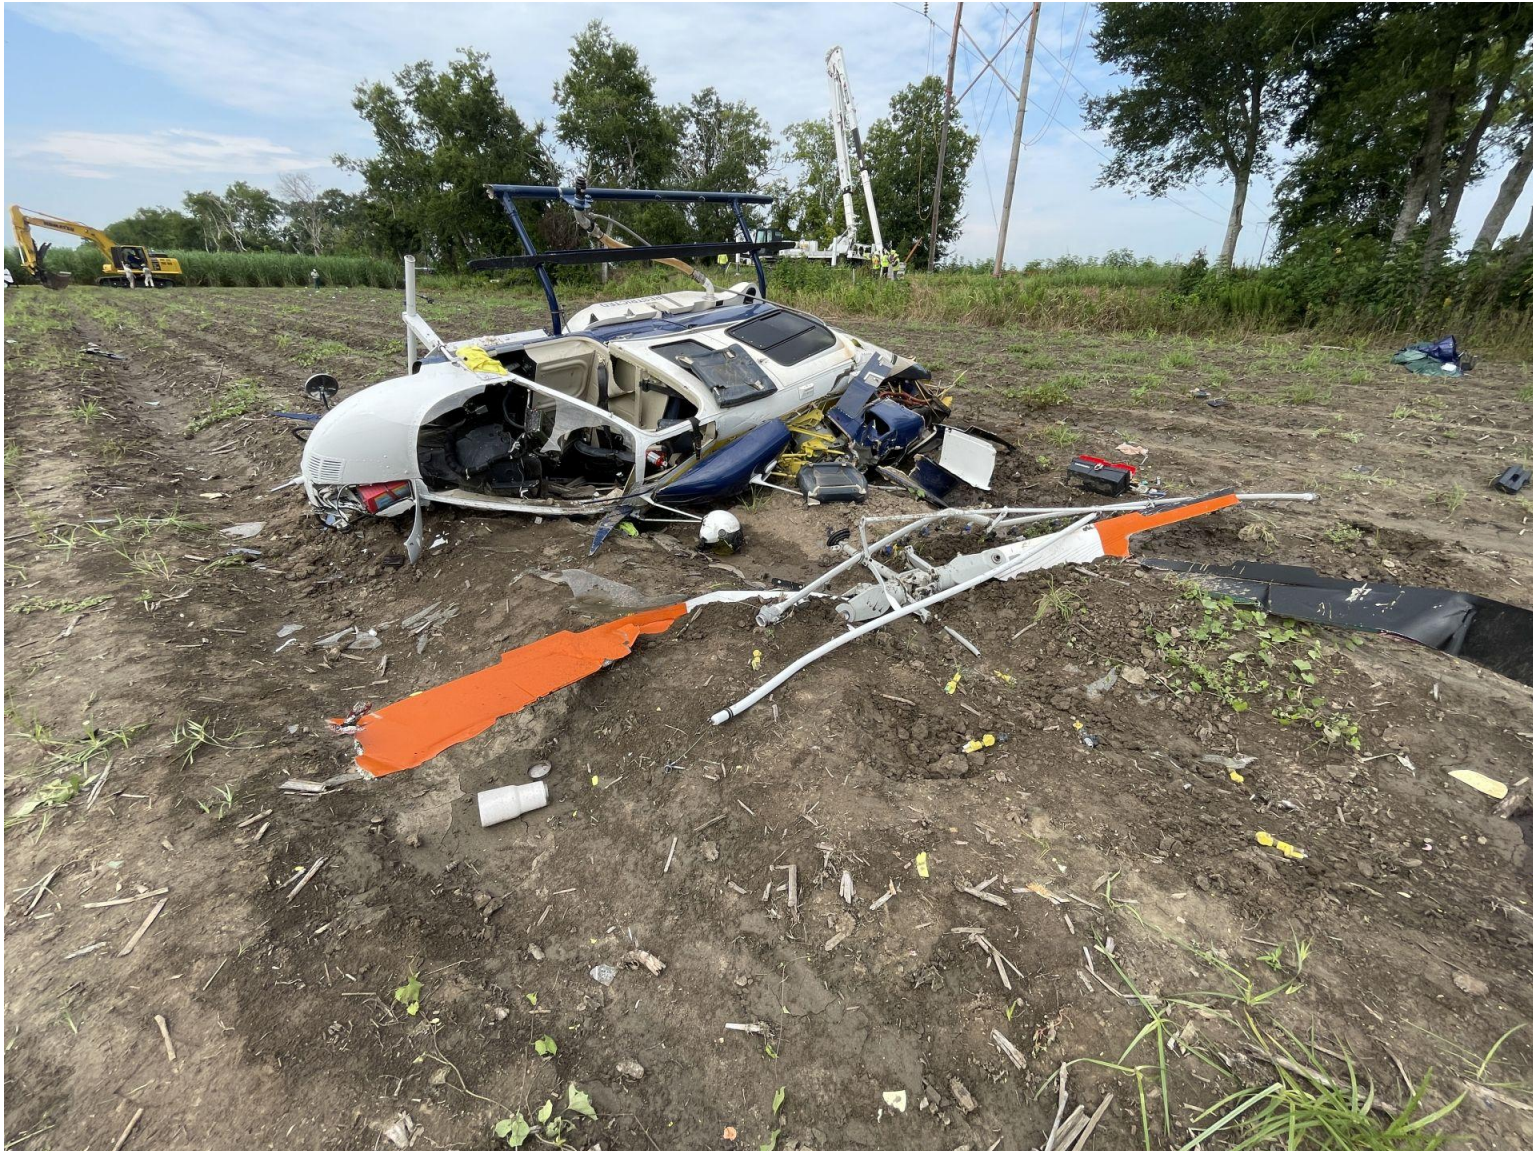
**Photograph 2 - Fuselage / main rotor blades at accident site (NTSB photo)**

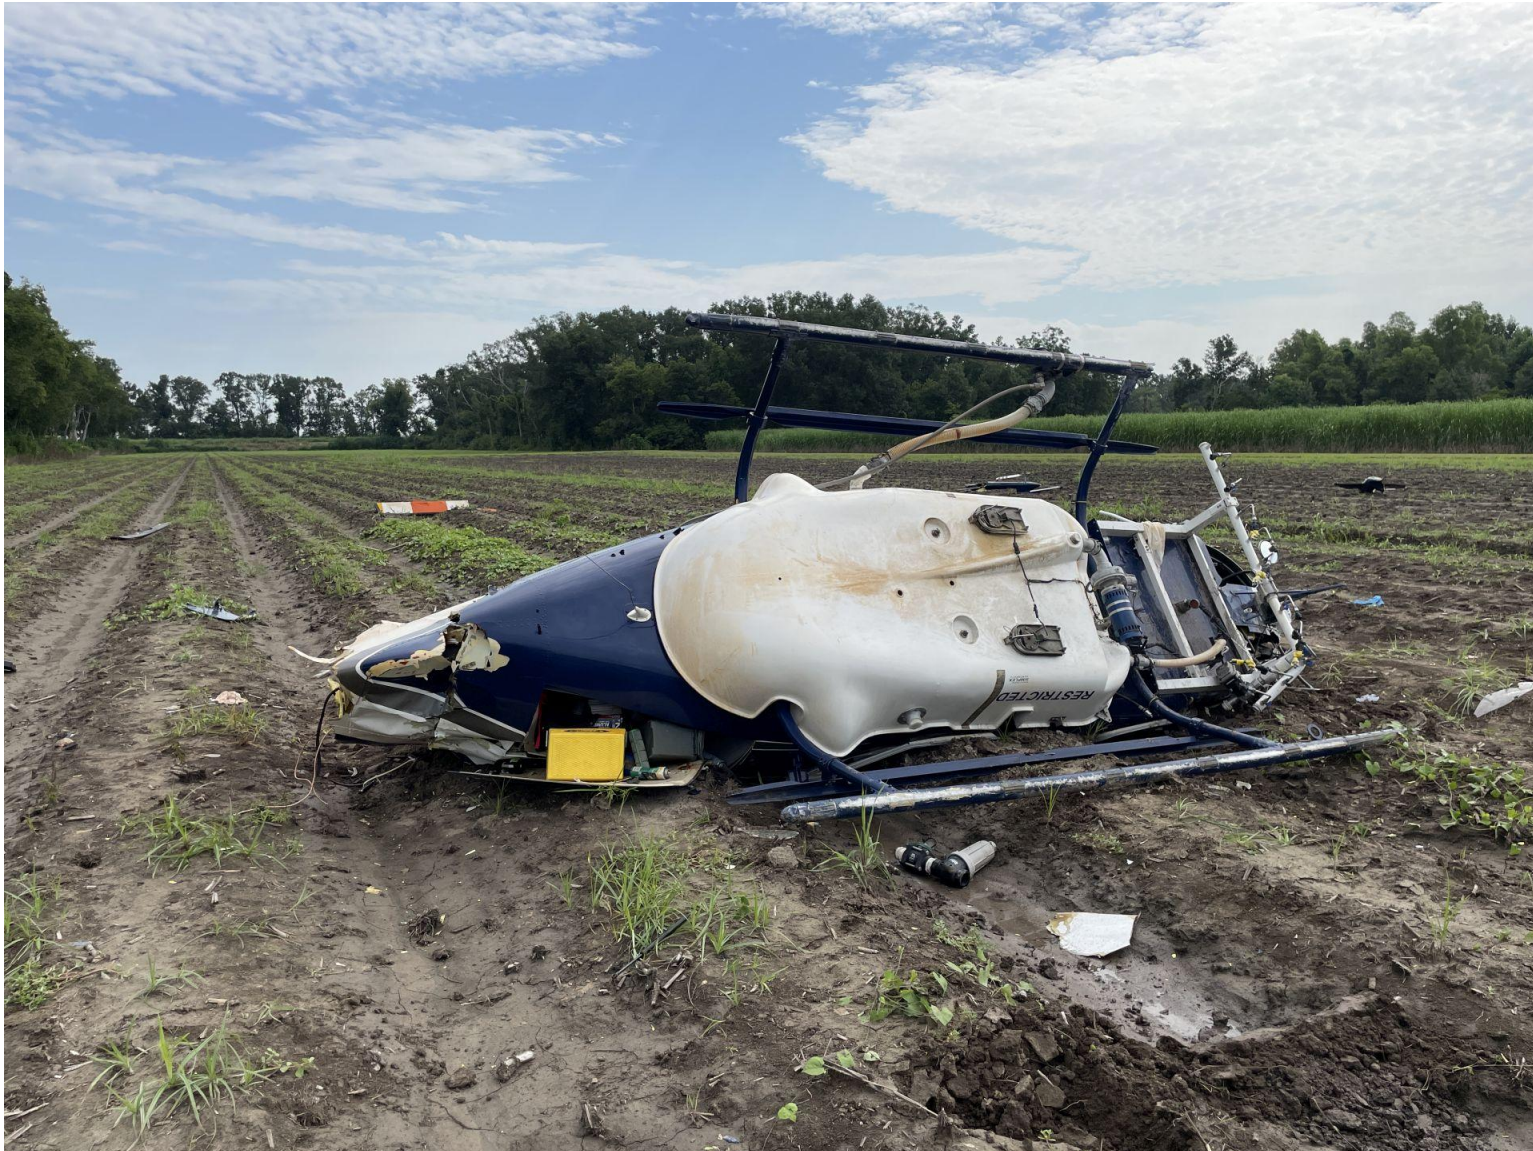
**Photograph 3 - Fuselage at the accident site (NTSB photo)**

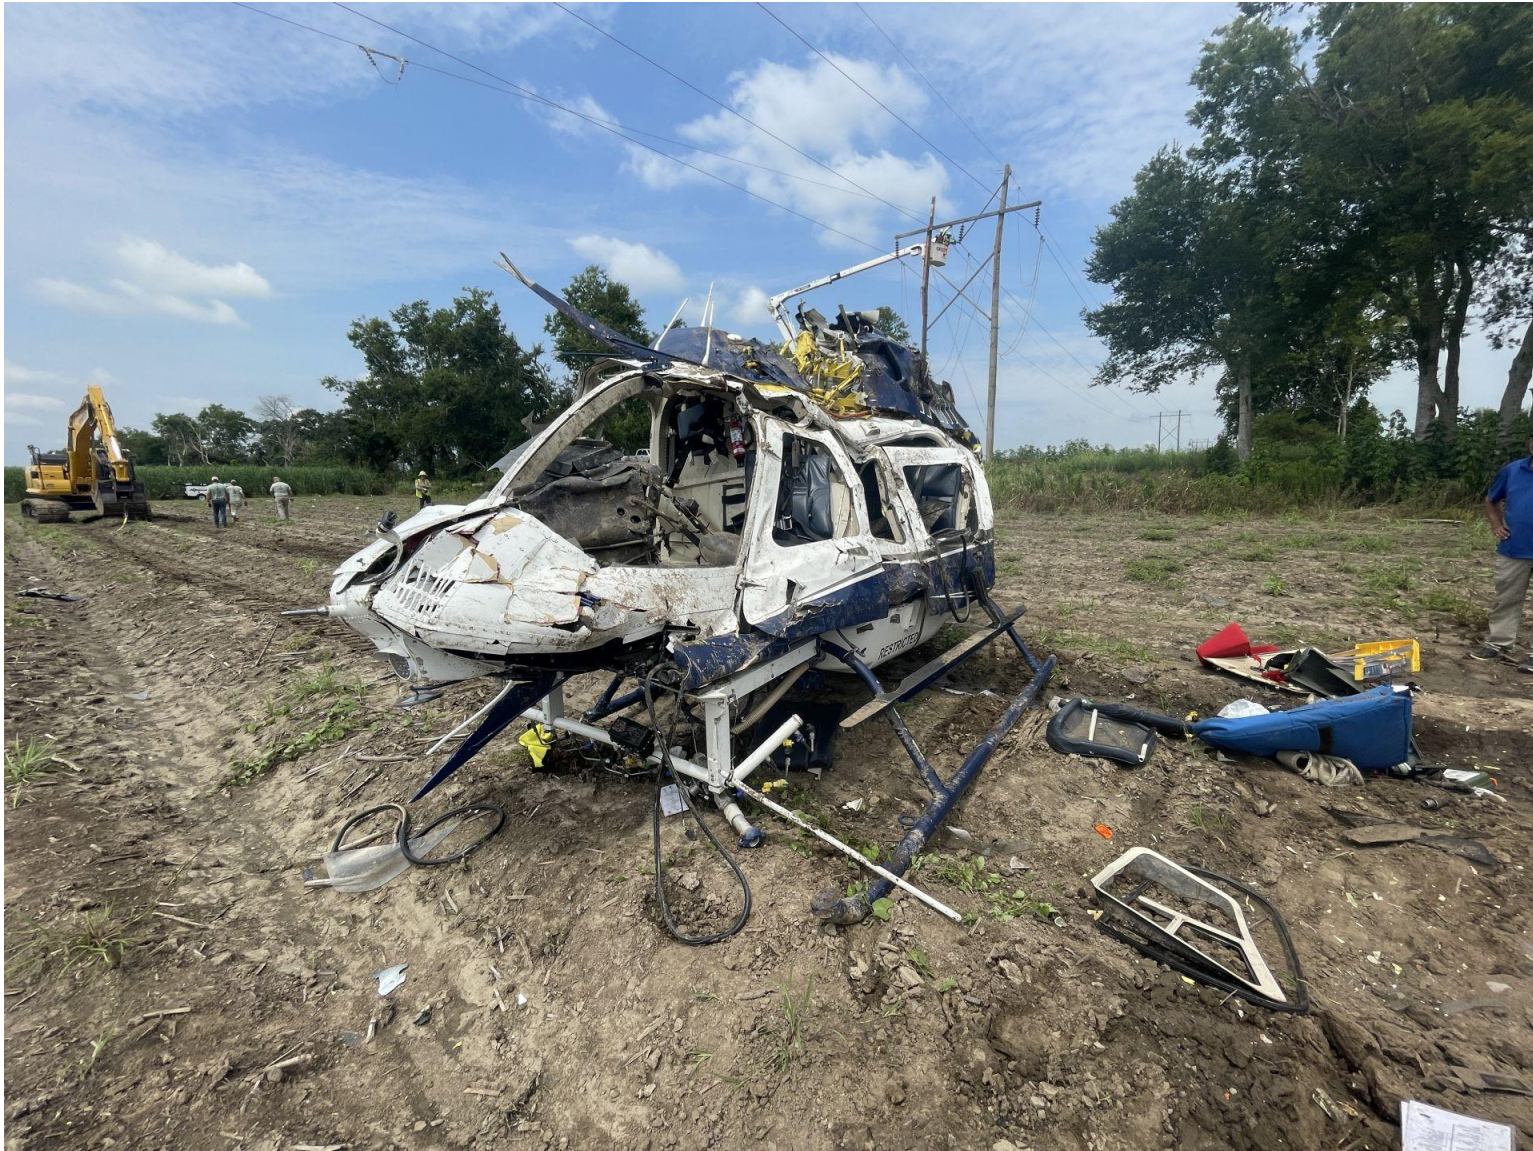
**Photograph 4 - Fuselage at accident site (NTSB photo)**

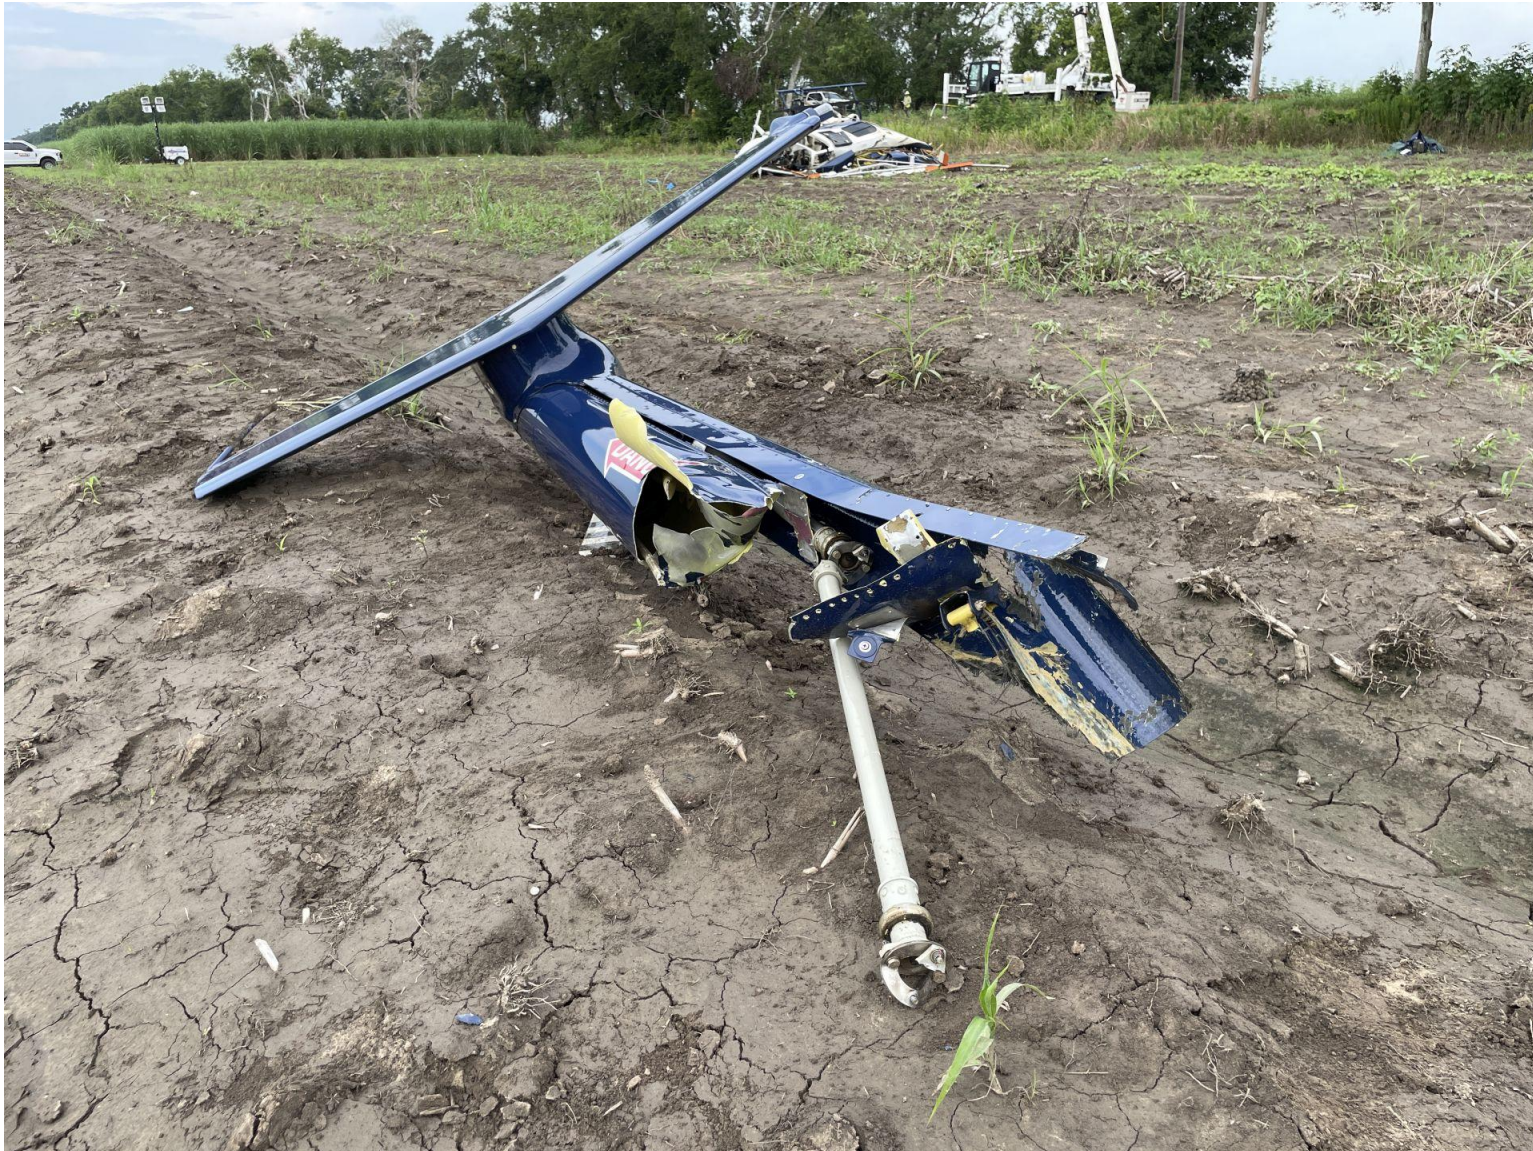
**Photograph 5 - Aft tail boom (NTSB photo)**

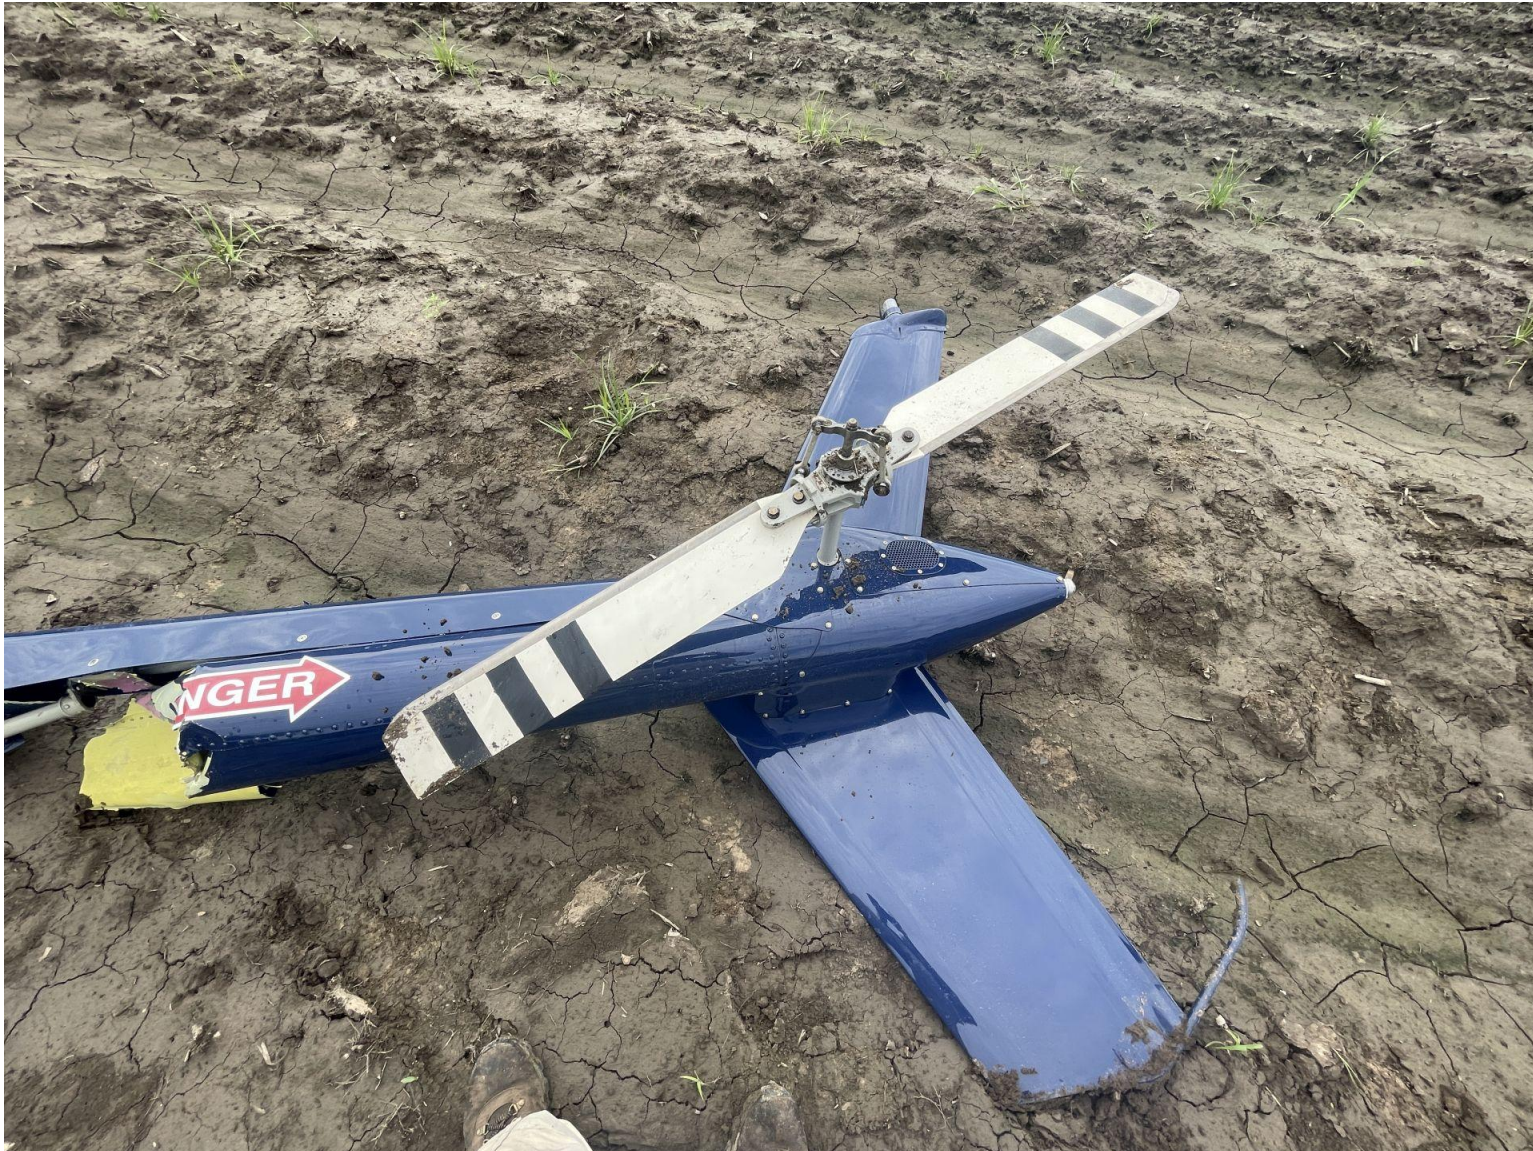
**Photograph 6 - Tail rotor (NTSB photo)**

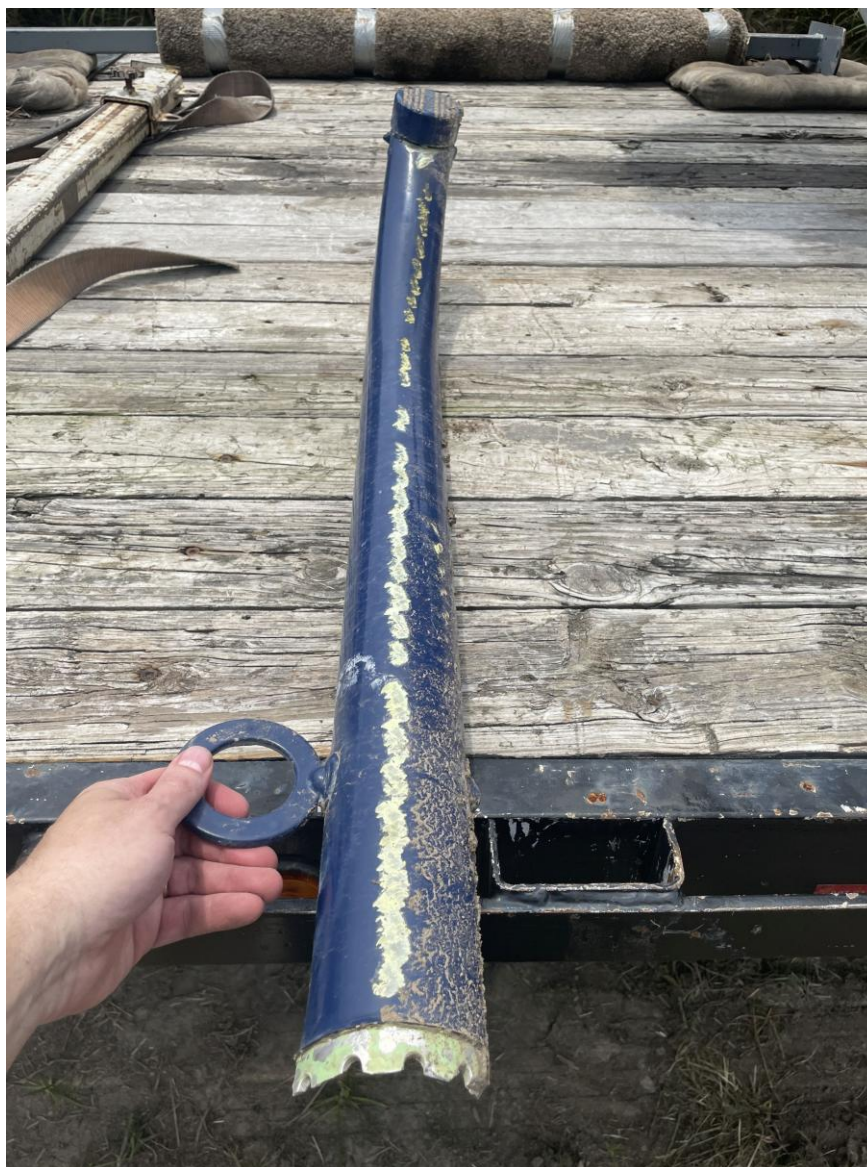
**Photograph 7 - Forward landing skid (NTSB photo)**
