National Transportation Safety Board

Office of Aviation Safety  
Central Region

CEN25LA007

## **INVESTIGATION PHOTOGRAPHS**

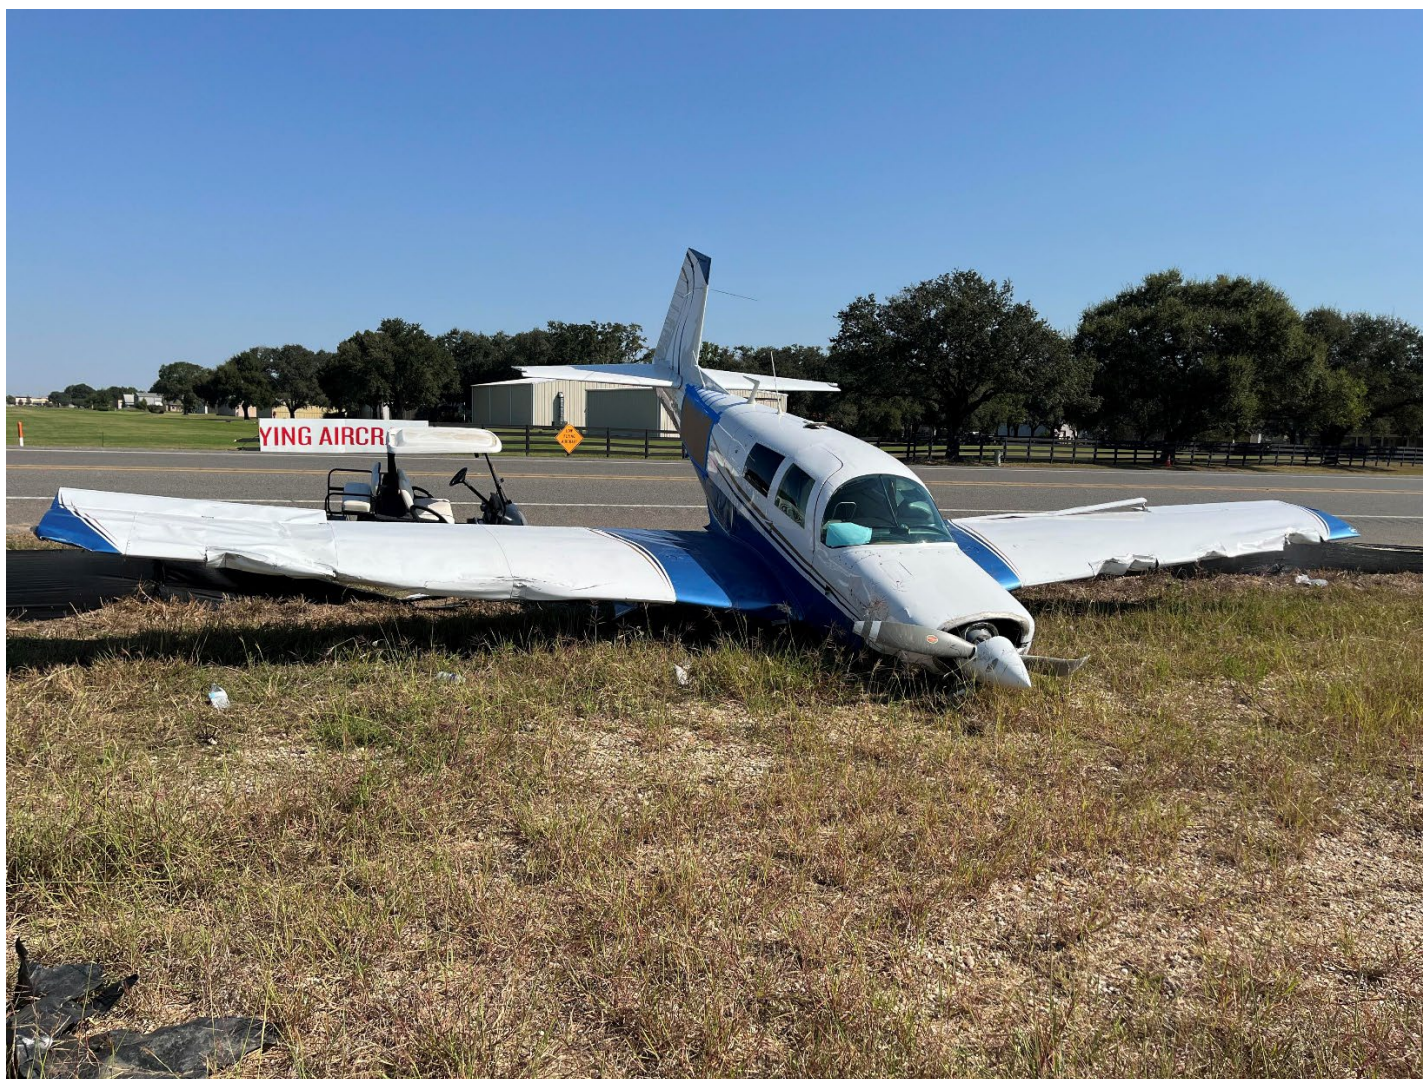
**Photograph 1 - Accident Site (Courtesy of FAA)**

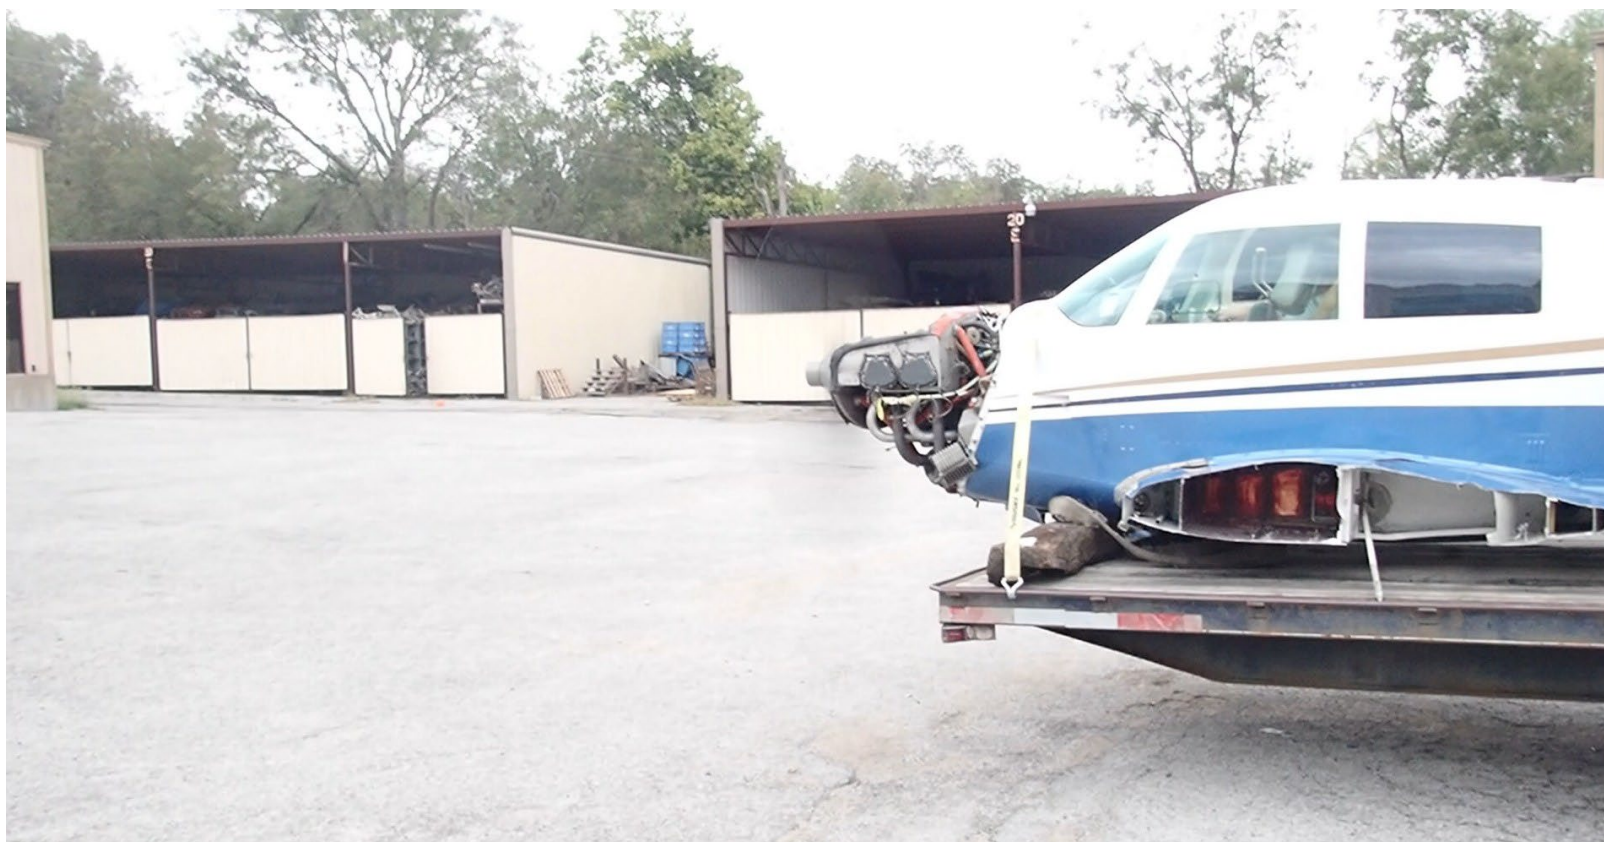
**Photograph 3 - Engine test run in progress**

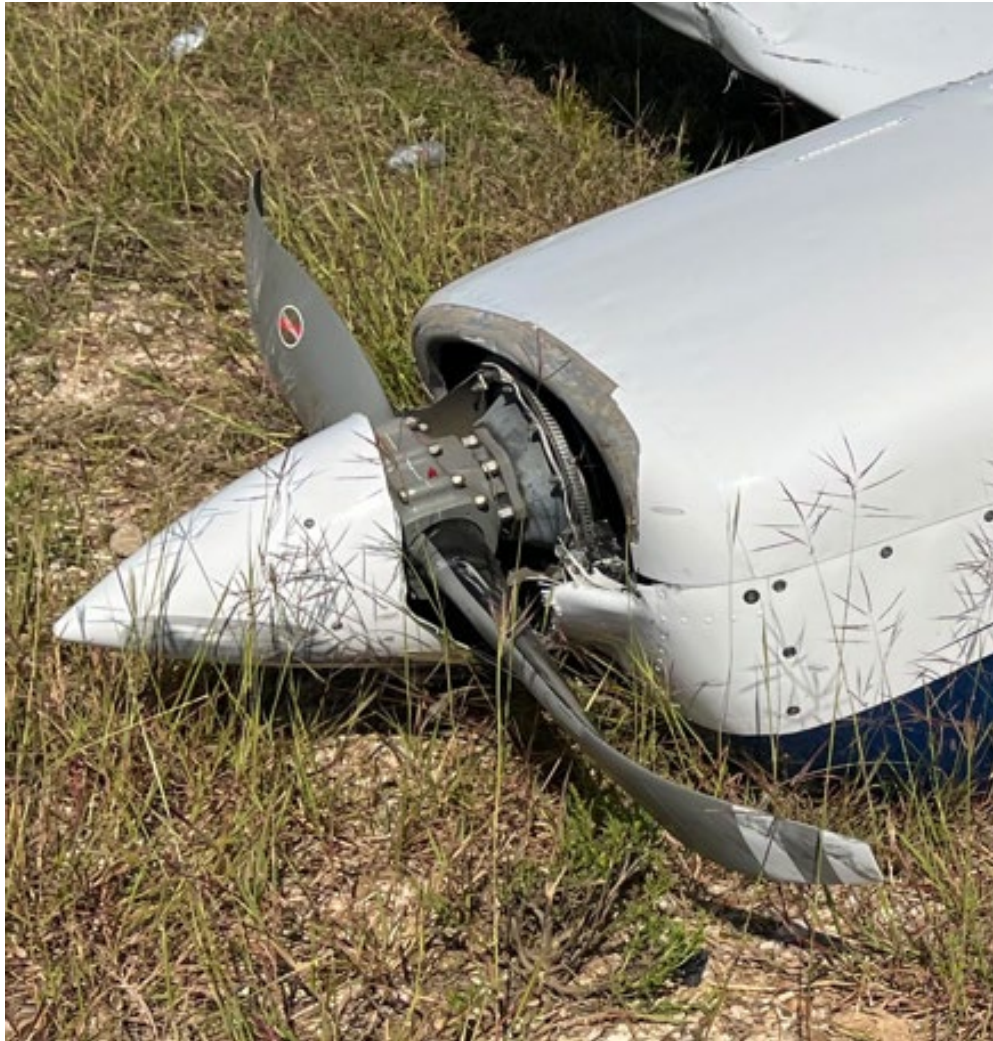
**Photograph 5 - Accident site photo  
Upper & lower cowl fairing damage;  
spinner & spinner mounting bulkhead damage  
(courtesy of FAA)**

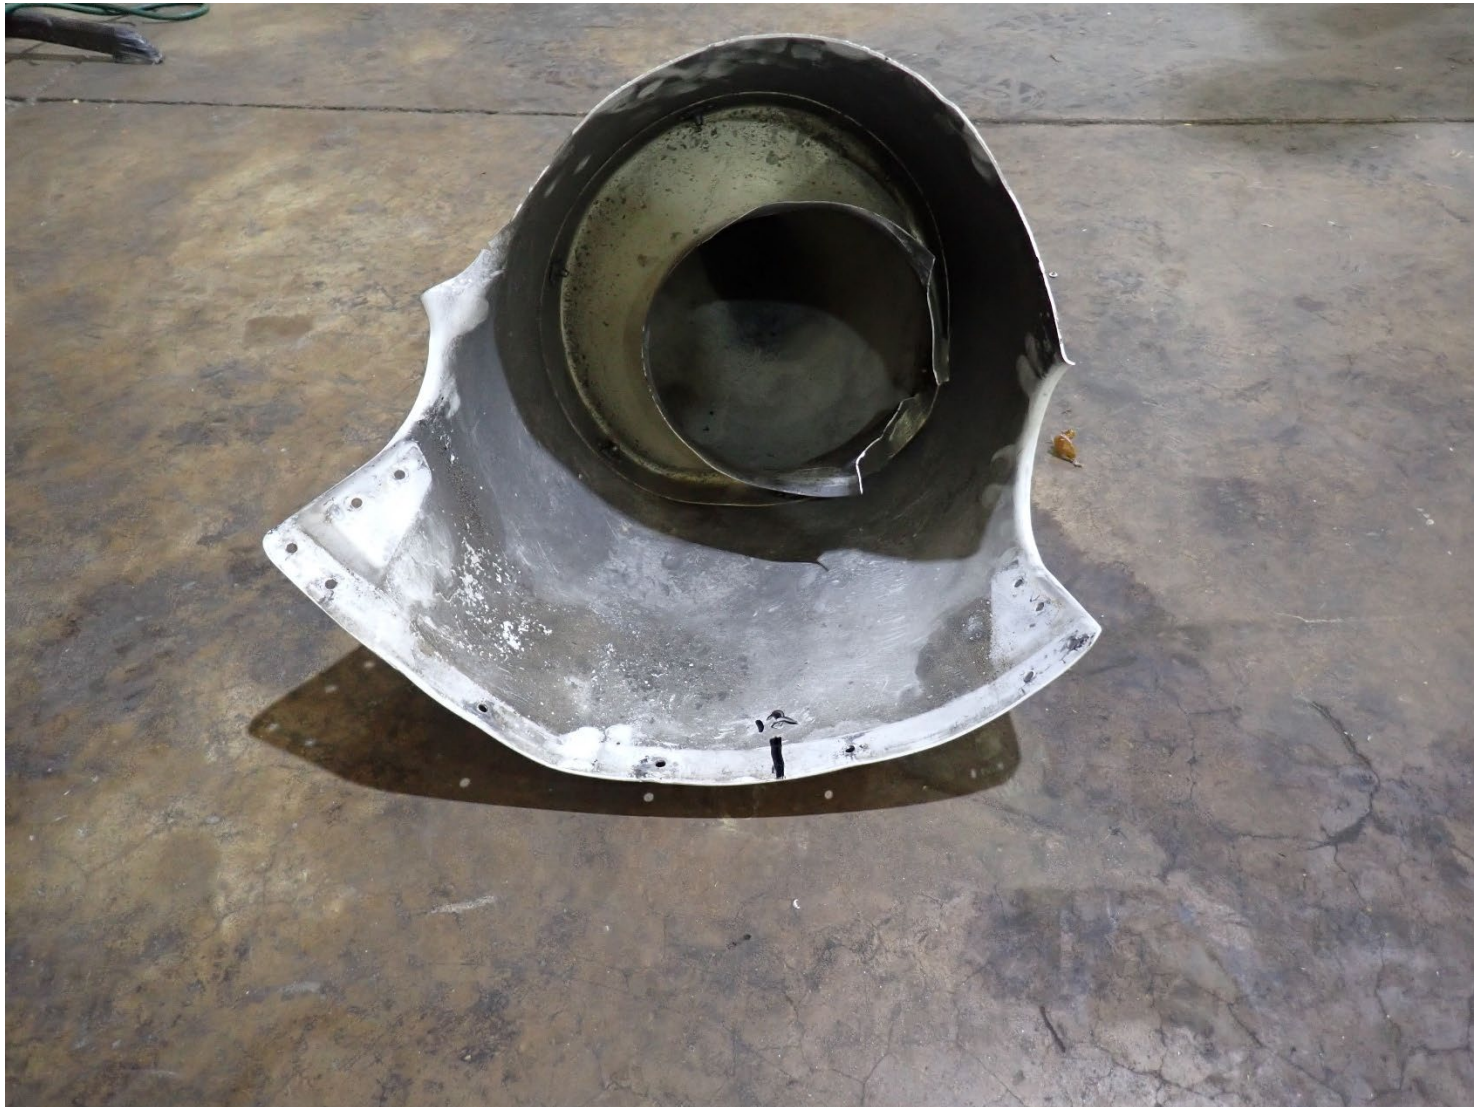
**Photograph 6 - Spinner interior**

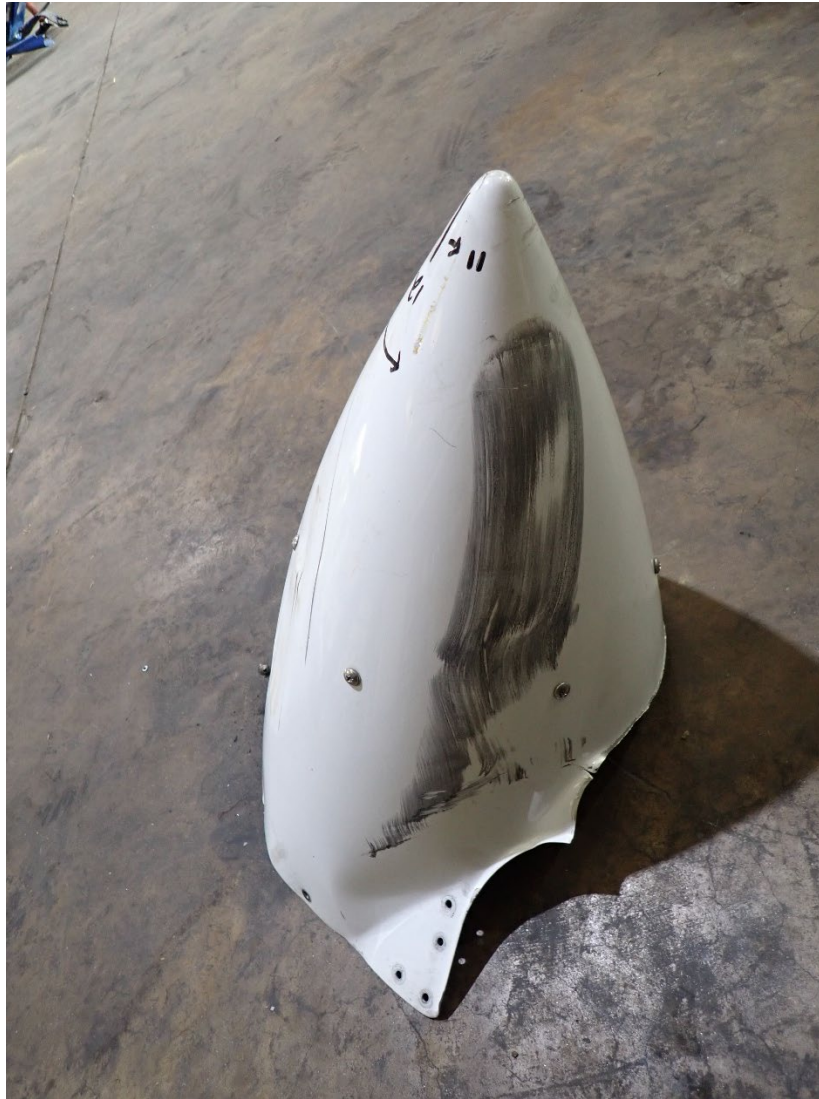
**Photograph 7 - Spinner exterior; paint transfer mark**

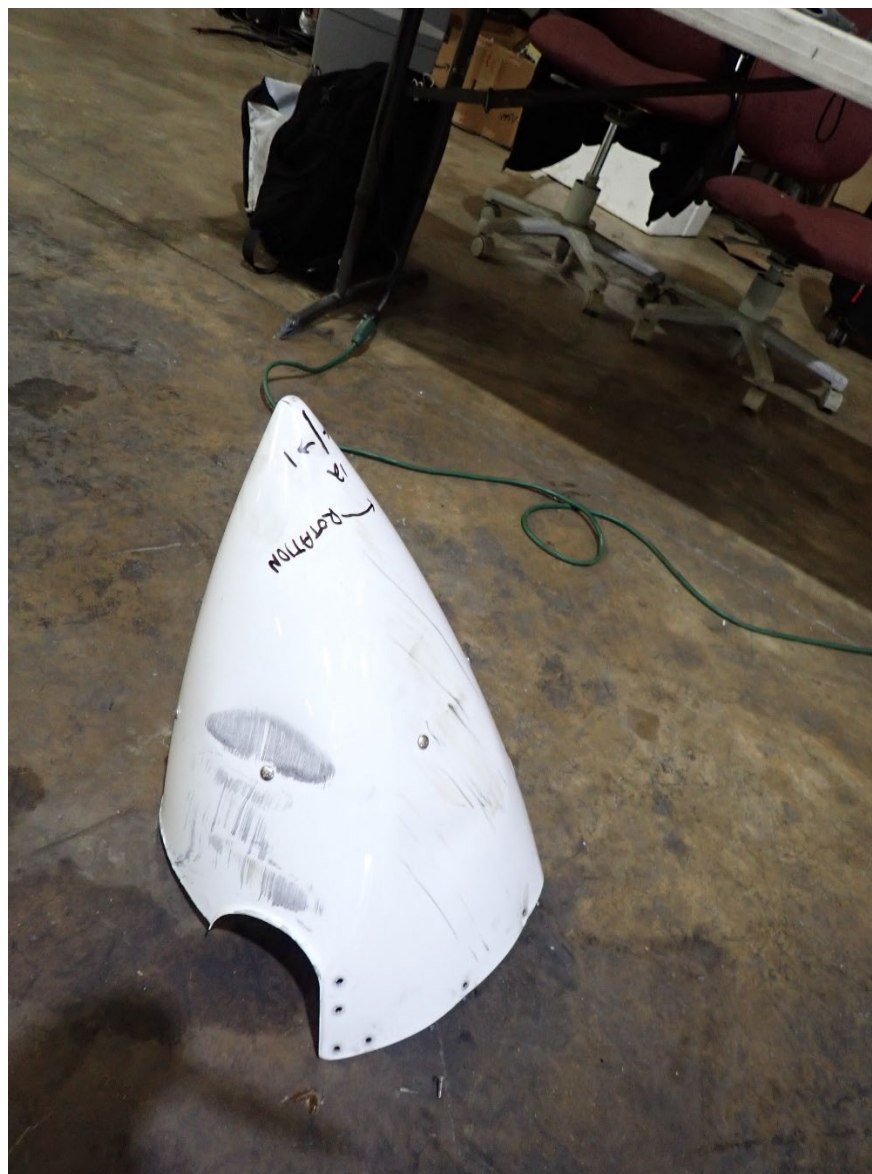
**Photograph 8 - Spinner exterior; paint transfer mark**

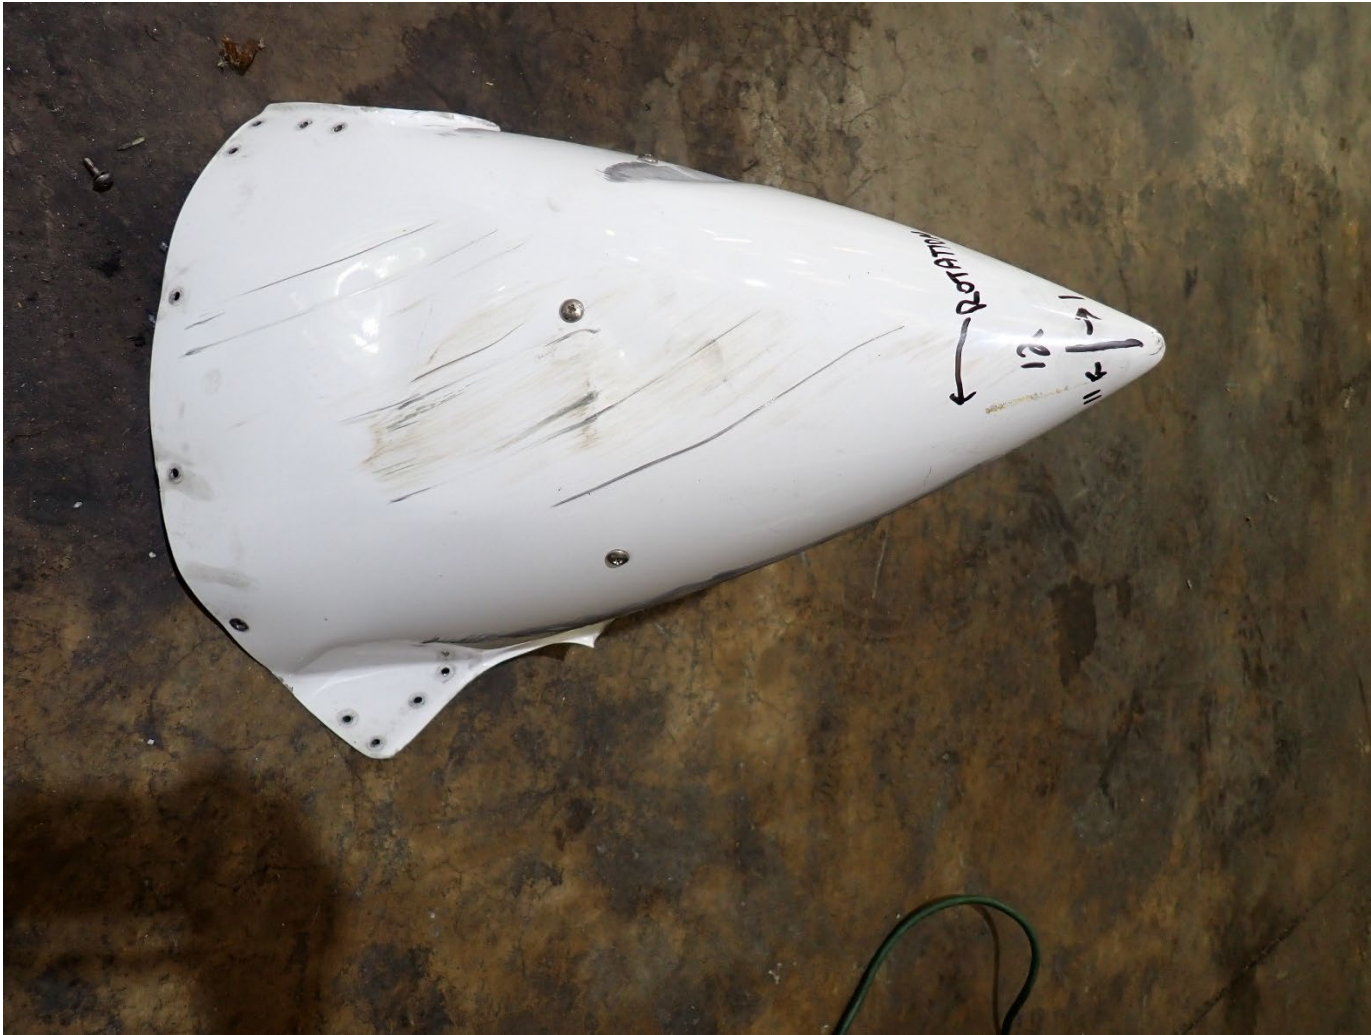
**Photograph 9 - Spinner exterior; scratches**

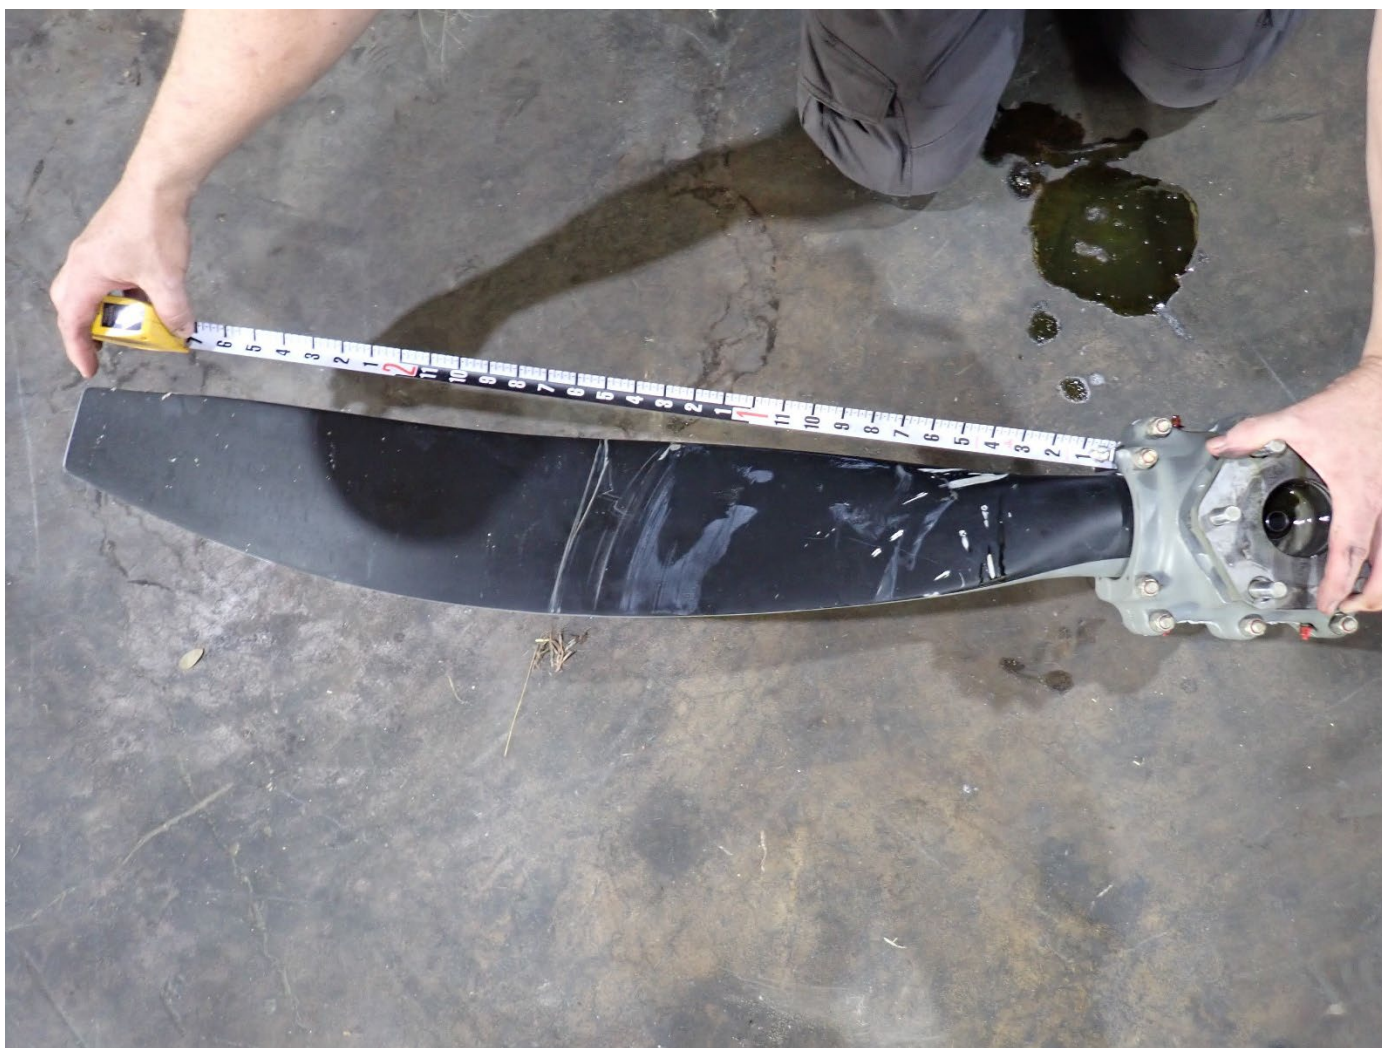
**Photograph 10 - Propeller Blade A - blade face**

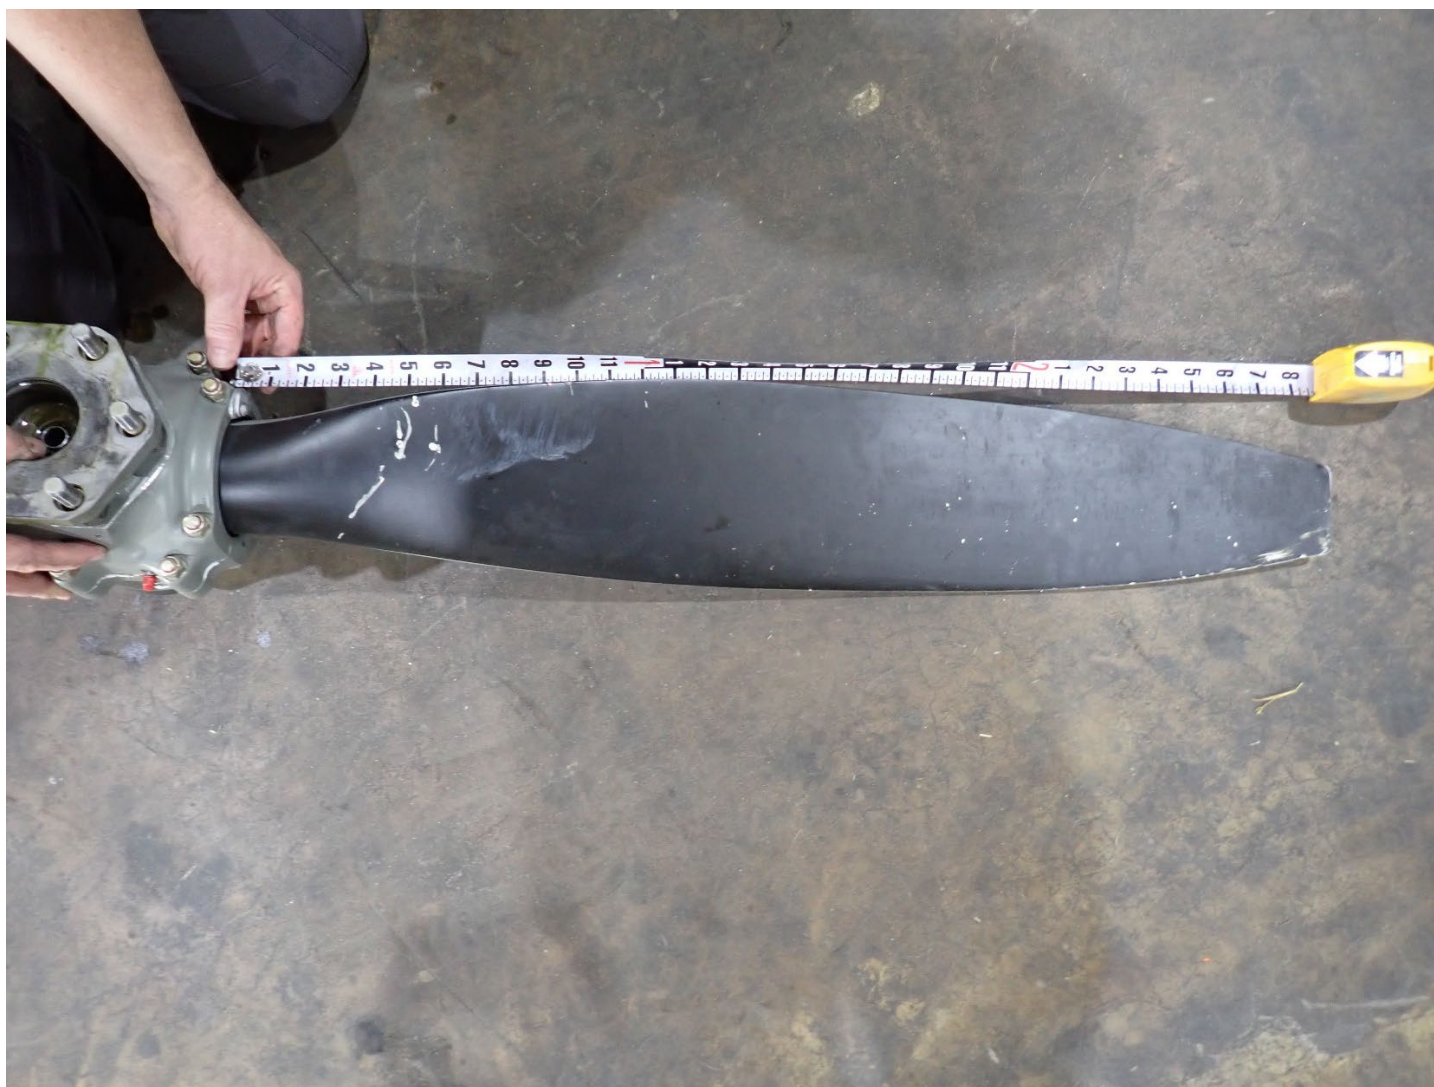
**Photograph 11 - Propeller Blade B - blade face**
