# National Transportation Safety Board

CEN24LA007

## **WRECKAGE EXAM**

Location: Richmond, TX  
Date: October 8, 2024  
Time: 1235 CDT  
1735 UTC  
Airplane: Mooney M20E

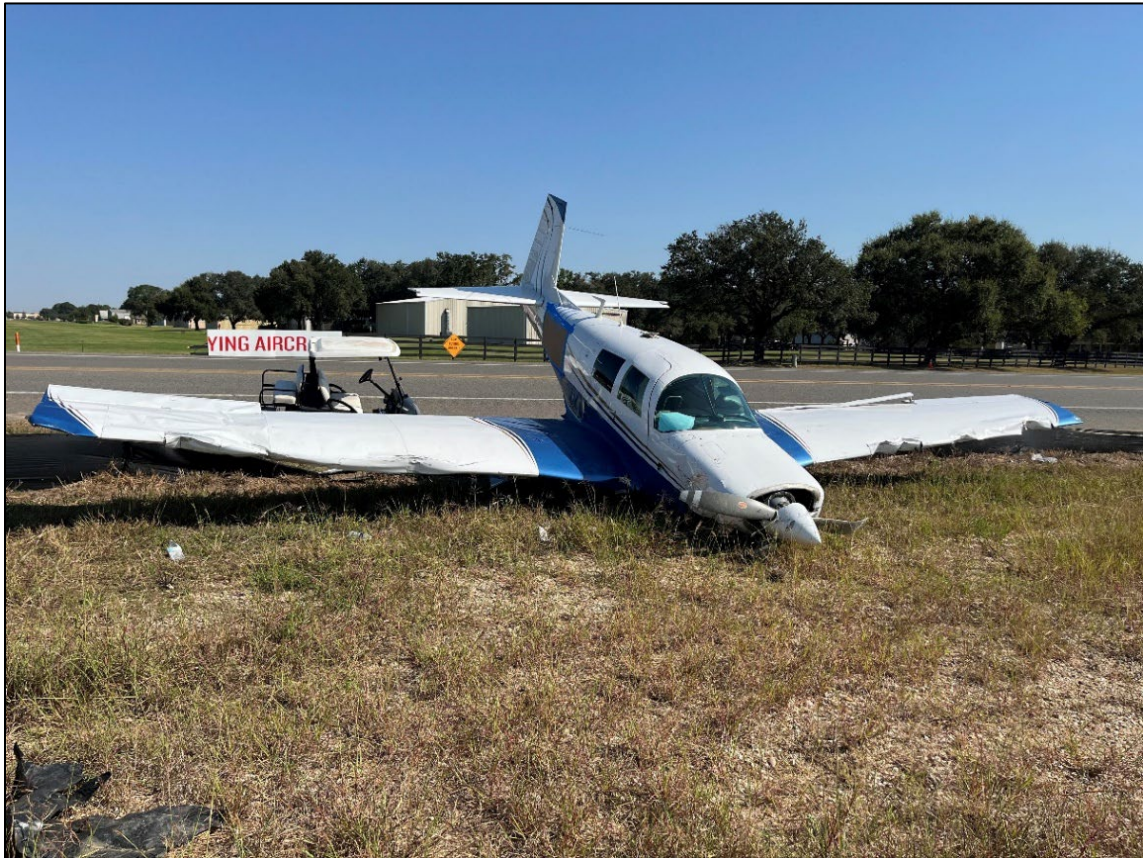
**Figure 1.** Accident site (courtesy of FAA).

The accident airplane overran the end of runway 17 and went through a wood airport perimeter fence that was painted black. The airplane came to rest about 150 feet south of the runway just beyond a road outside the perimeter fence. See Figure 1.

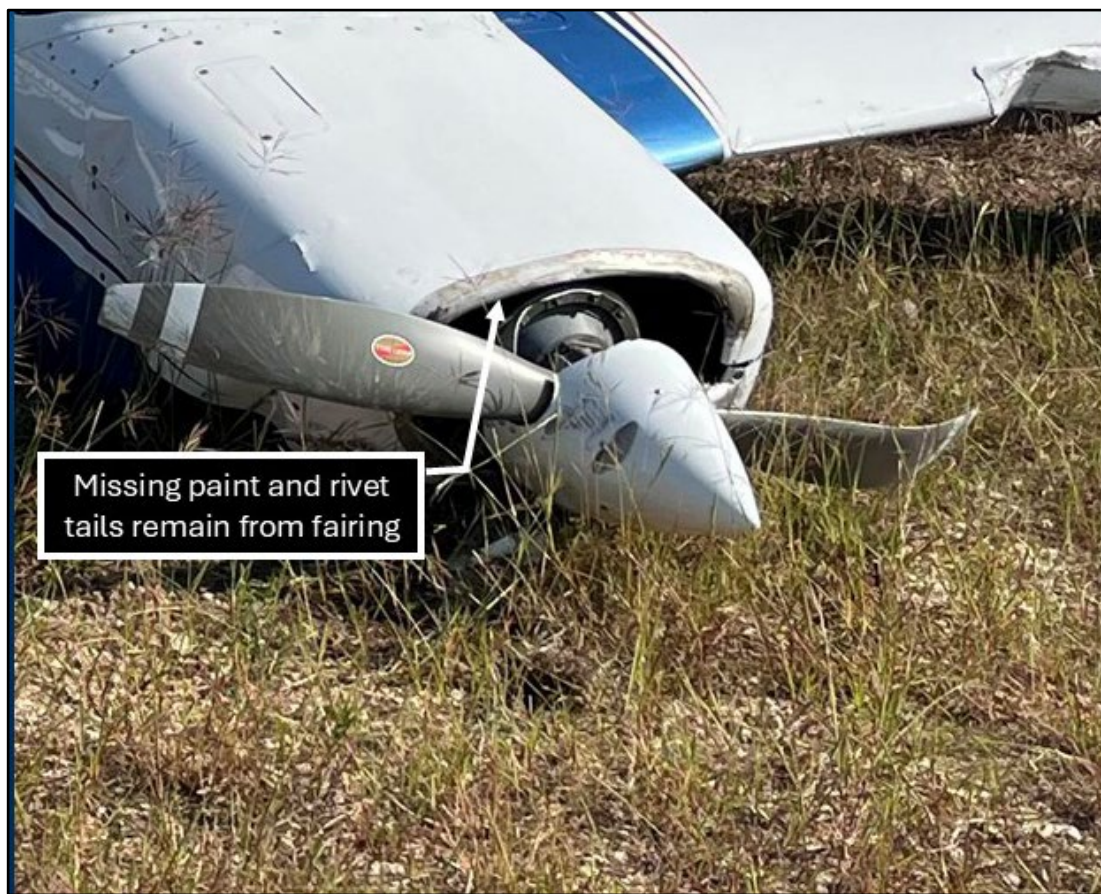
Accident site photos showed the upper cowling forward edge had bare metal and rivet tails indicative of an aftermarket fairing that was no longer present. See Figure 4. None of the missing fairing was recovered from the accident site. Review of the maintenance logs showed a Supplemental Type Certificate (STC) for a "nose bowl modification" (STC SA7589SW) that was installed at the same time as the Lycoming IO-360 engine was installed per its STC in June of 1997.

**Figure 4.** Missing upper cowl fairing (courtesy of FAA).

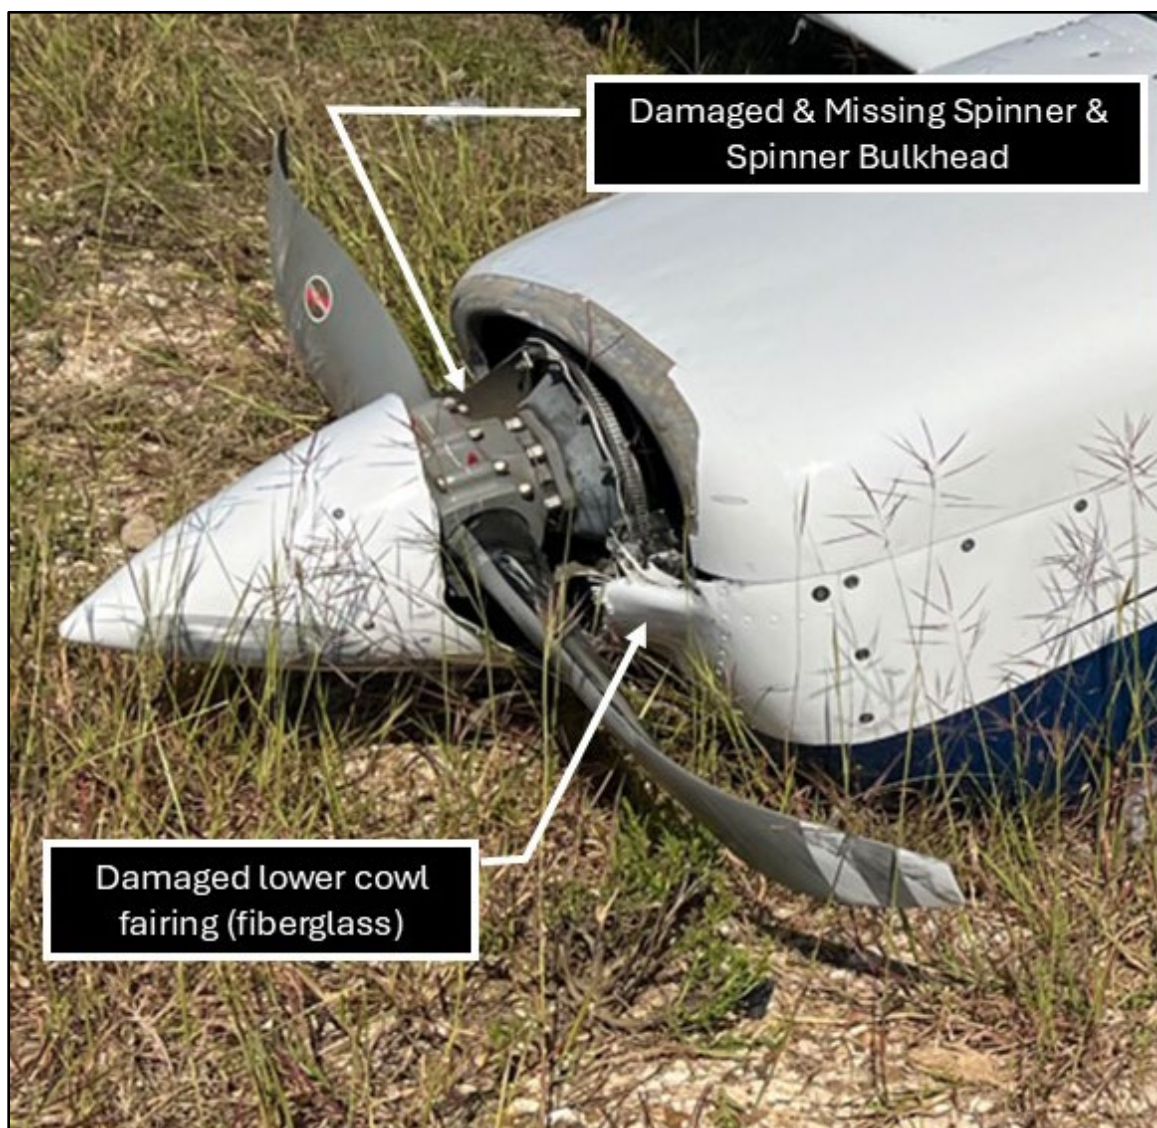
Accident site photos also showed that the lower engine cowl had a damaged aftermarket fiberglass fairing present also. See Figure 5.

**Figure 5.** Damaged lower cowl leading edge.

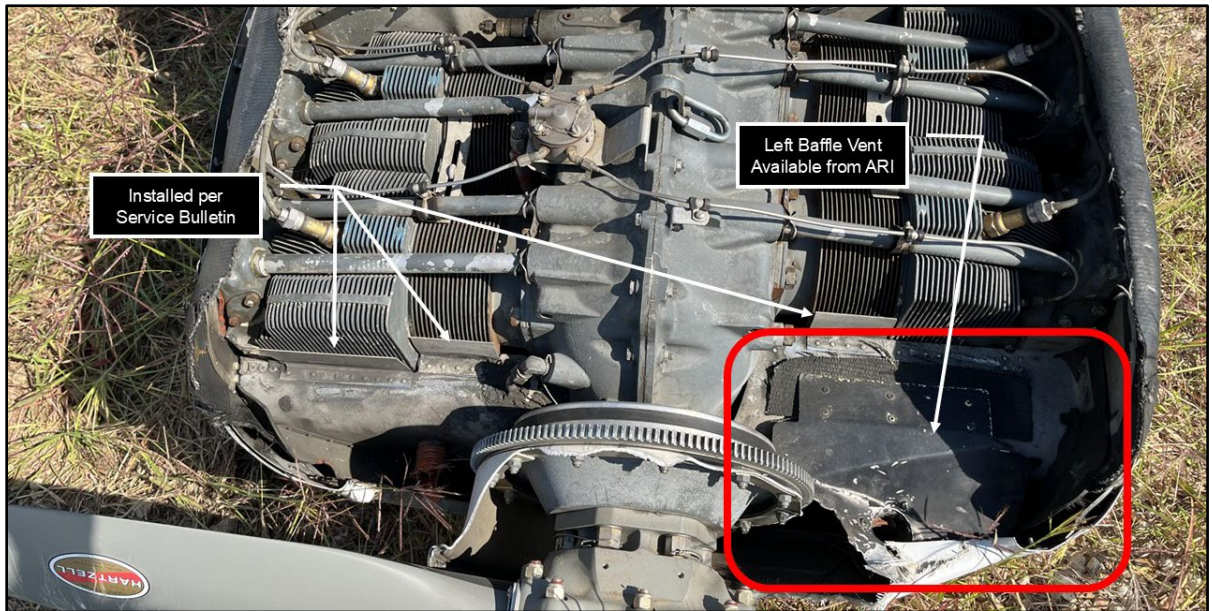
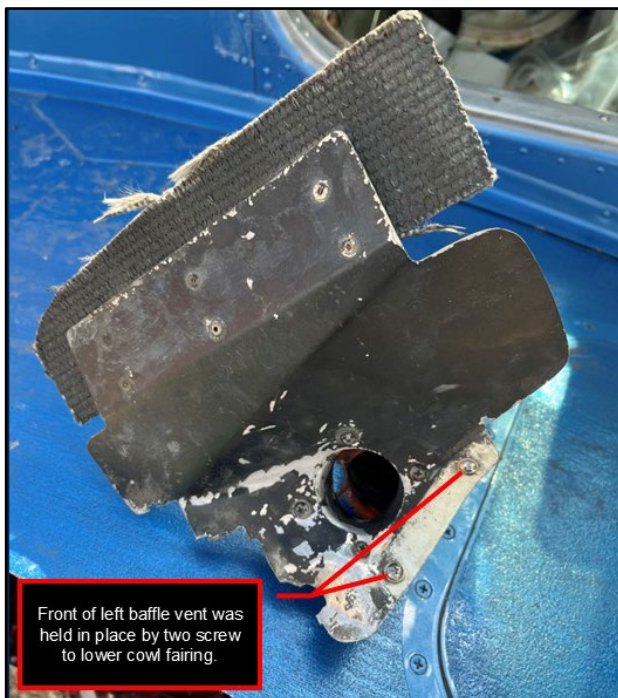
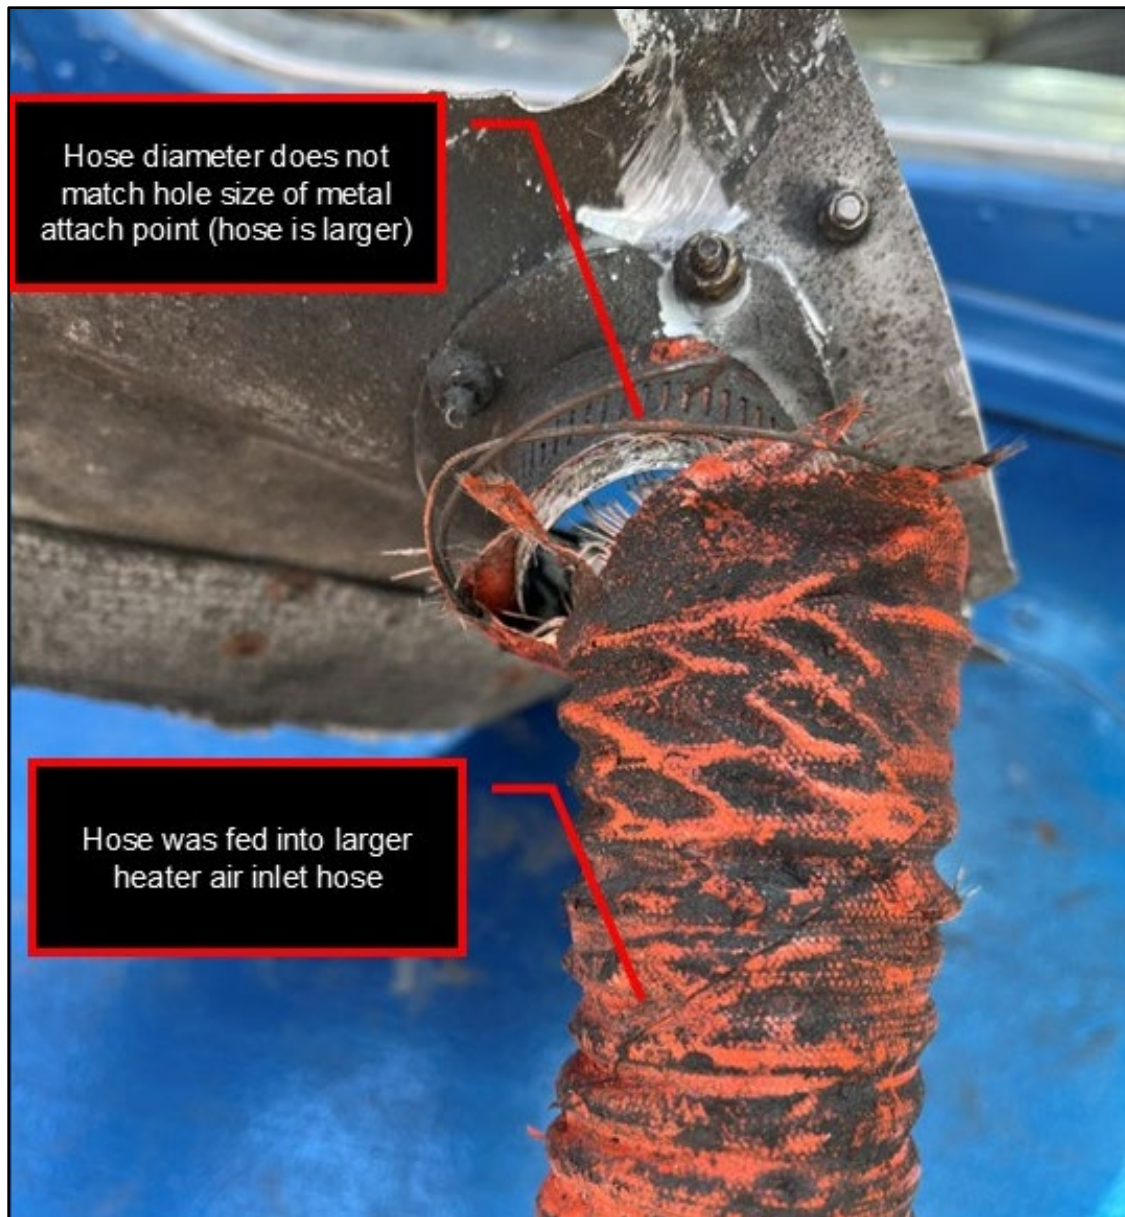
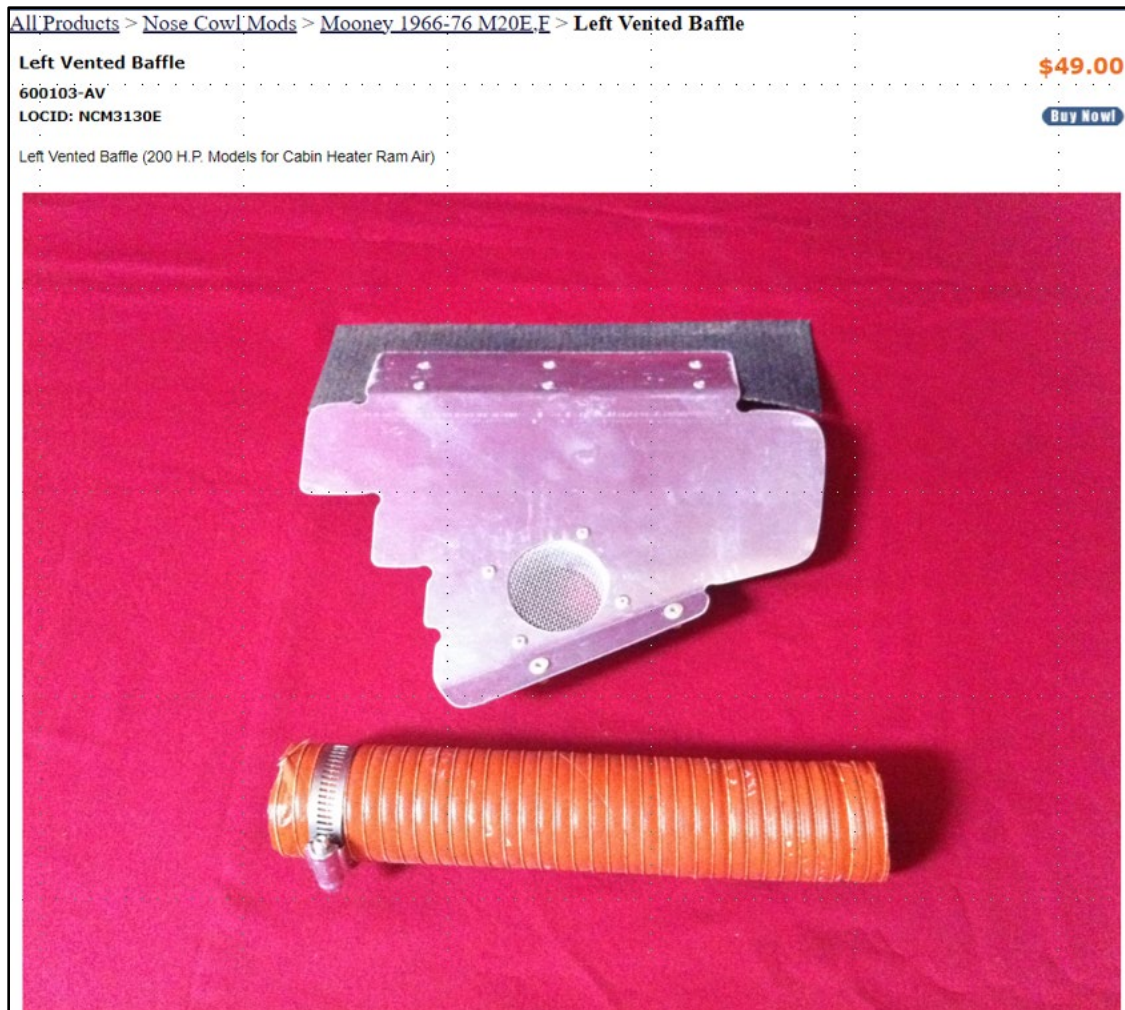
Additionally, the left front corner of the engine compartment had a vented baffle installed that is similar to one sold by Aero Resources Inc. on their website (part number: 600103-AV), however no record of installation was found during the review of the provided maintenance records. See Figures 6-9.

**Figure 6.** Left Vented Baffle (photo courtesy of FAA).

**Figure 7.** Left Vented Baffle top view after removal from airplane.

**Figure 8.** Left Vented Baffle bottom view after removal from airplane.

**Figure 9.** Left Vented Baffle, part number 600103-AV, Air Resources Inc. website.

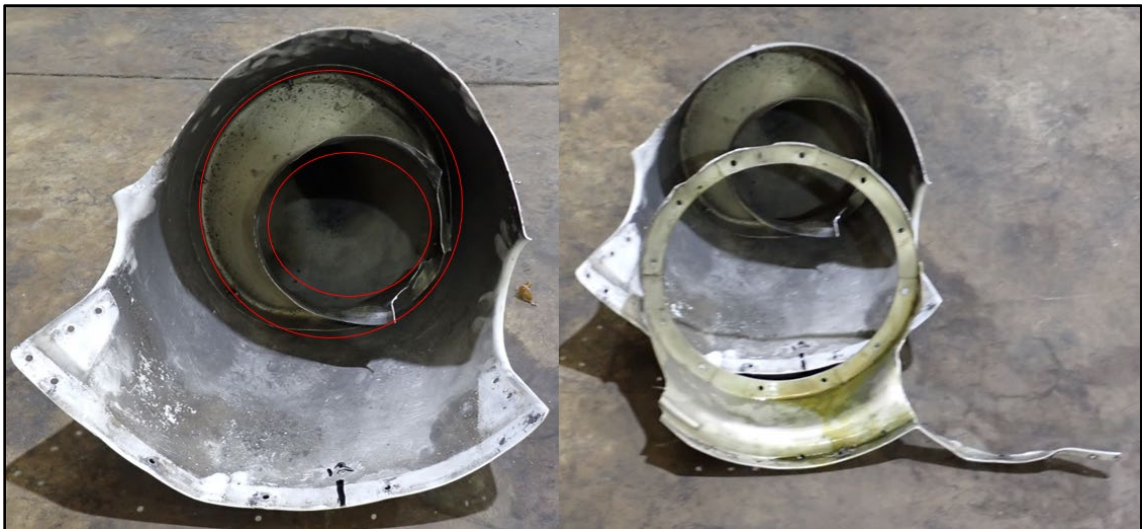
During the airframe examination a portion of the spinner was noted to be missing and not present in the recovered wreckage. The damaged spinner was removed from the spinner bulkhead. On the inside of the spinner, the bulkhead that fits over the piston dome on the propeller hub was offset from its normal position to one side and showed rotational damage consistent with having occurred while engine power was present. See Figure 12.

**Figure 12.** Left photo diagram shows rotational damage to interior bulkhead of the spinner. Photo on right shows the remaining portions of the spinner and spinner bulkhead.<sup>1</sup>

A portion of the spinner bulkhead was missing and not present in the recovered wreckage. The exterior of the remaining spinner bulkhead on the airplane had missing paint and scratches in the metal present around its circumference consistent with chafing or hard contact while rotating. See Figures 12-13.

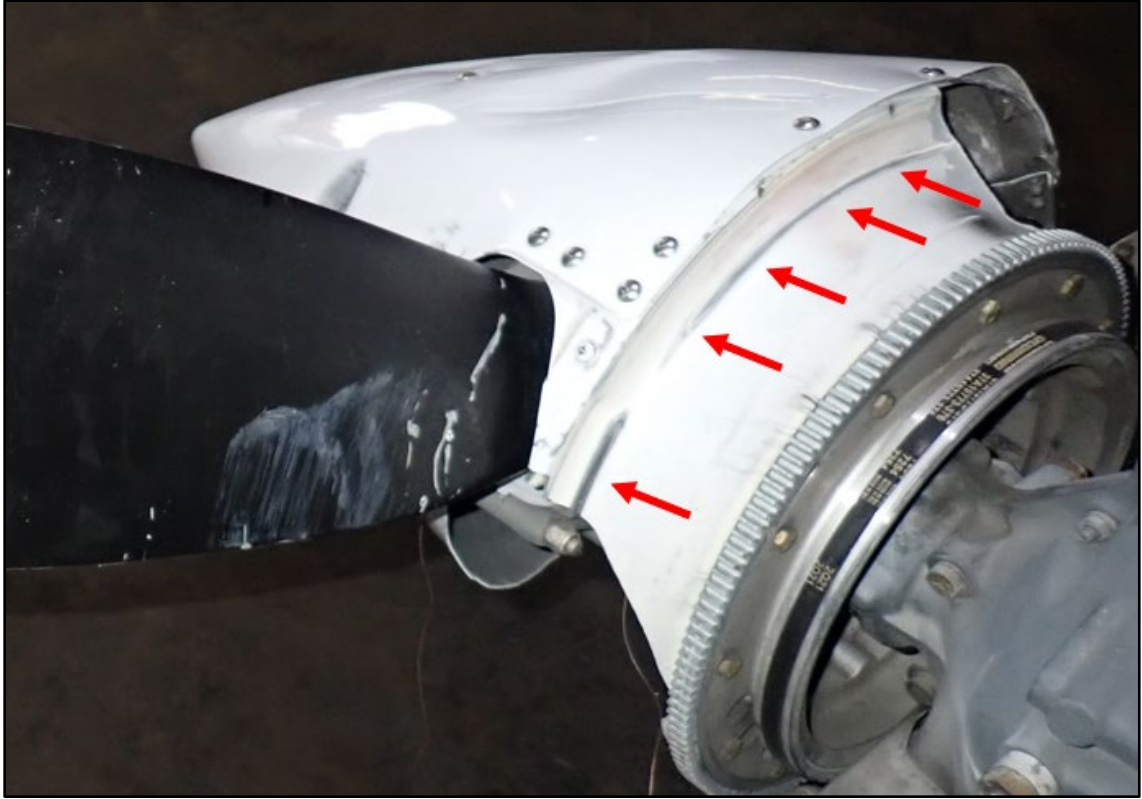
**Figure 13.** Contact marks on the remaining portion of the spinner bulkhead.

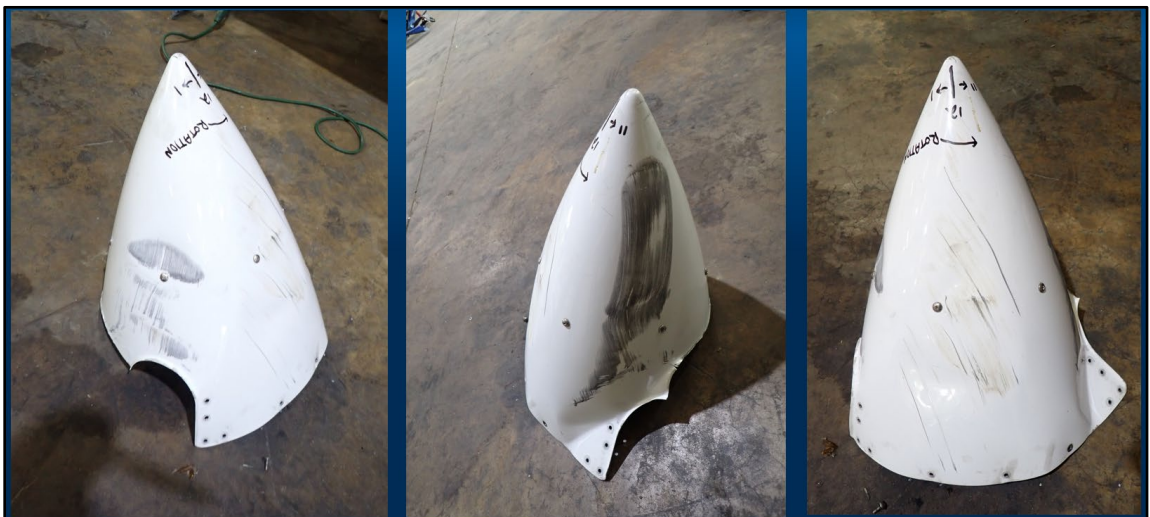
The exterior of the spinner had two black paint transfer marks that were similar to the color of the fence the airplane went through. The two black marks were horizontal down the longitudinal axis of the spinner. Additionally, the spinner had an area of scratches that penetrated the paint and scratched the metal that were at a 30-45 degree angle. See Figure 14.

**Figure 14.** Spinner exterior.

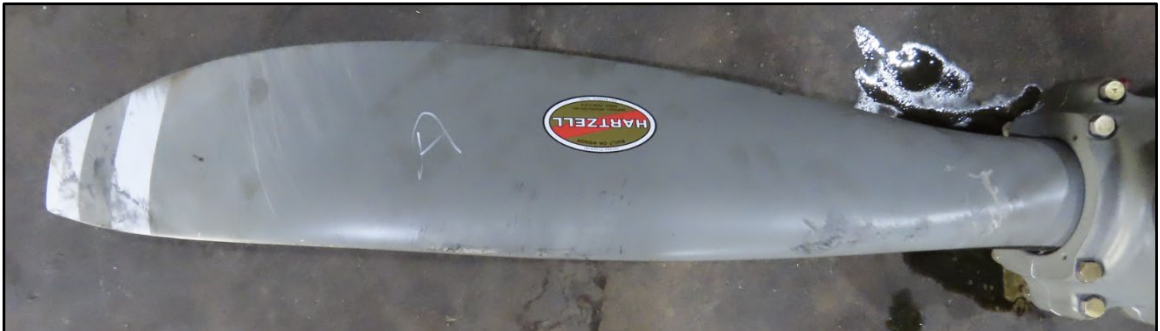
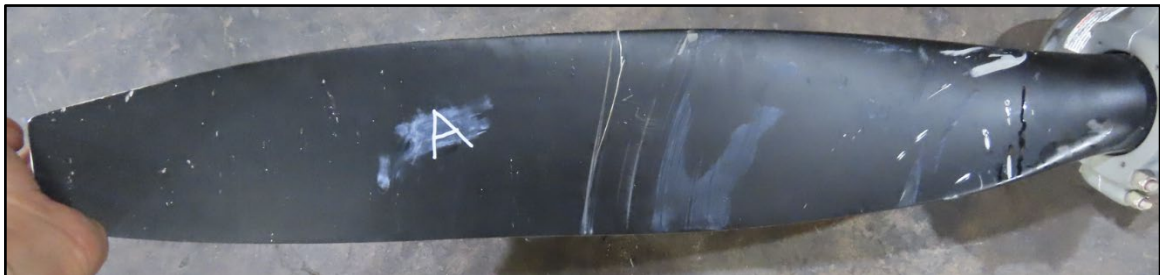
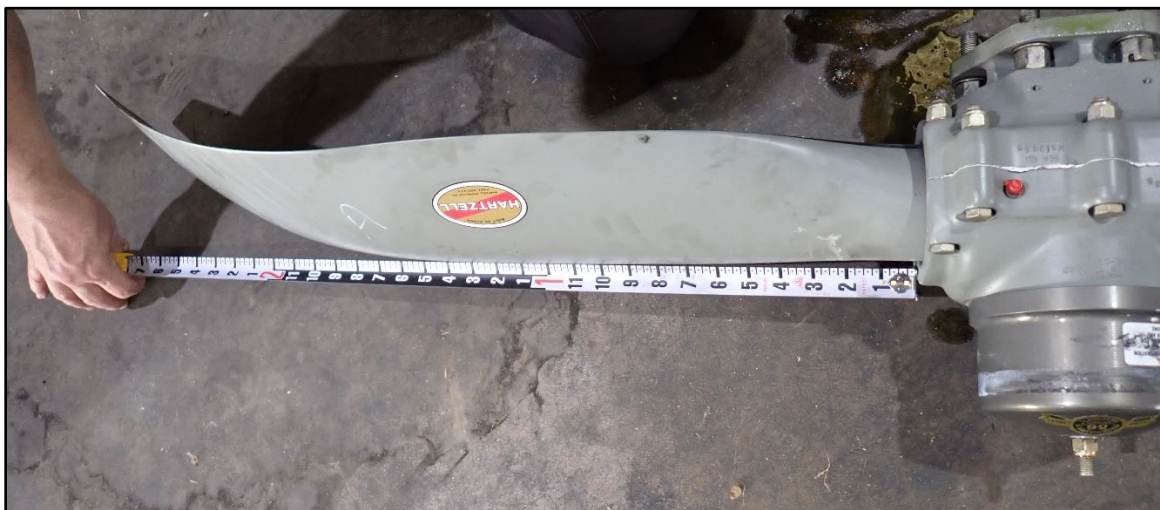
The blade back on Blade A (cambered side) showed paint transfer consistent with the color of the wood fence the plane went through and other paint marring. The blade face on Blade A had scratches, gouges, and white paint transfers near the blade root and paint transfer was also present mid-span. Blade A was bent aft near the outboard end. See Figures 15-17.

**Figure 15.** Blade A - blade back.

**Figure 16.** Blade A - blade face.

**Figure 17.** Blade A bent aft near outboard end of blade.

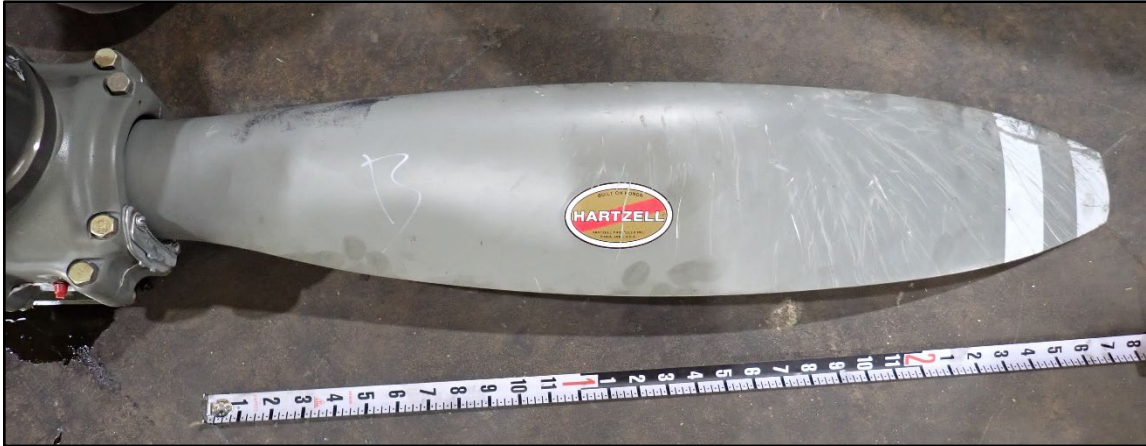
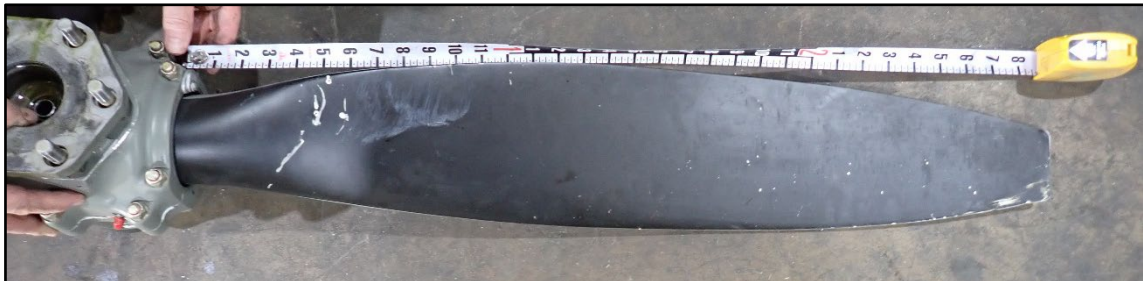
The blade back of Blade B (cambered side) had paint marring present. Blade B's blade face had had paint transfer, scratches, gouges near the blade root. Blade B was bent aft at its mid-span. See Figures 18-19.

**Figure 18.** Blade B - blade back.

**Figure 19.** Blade B - blade face. Blade is bent aft at mid-span.
