CEN25LA015

## INVESTIGATION PHOTOGRAPHS

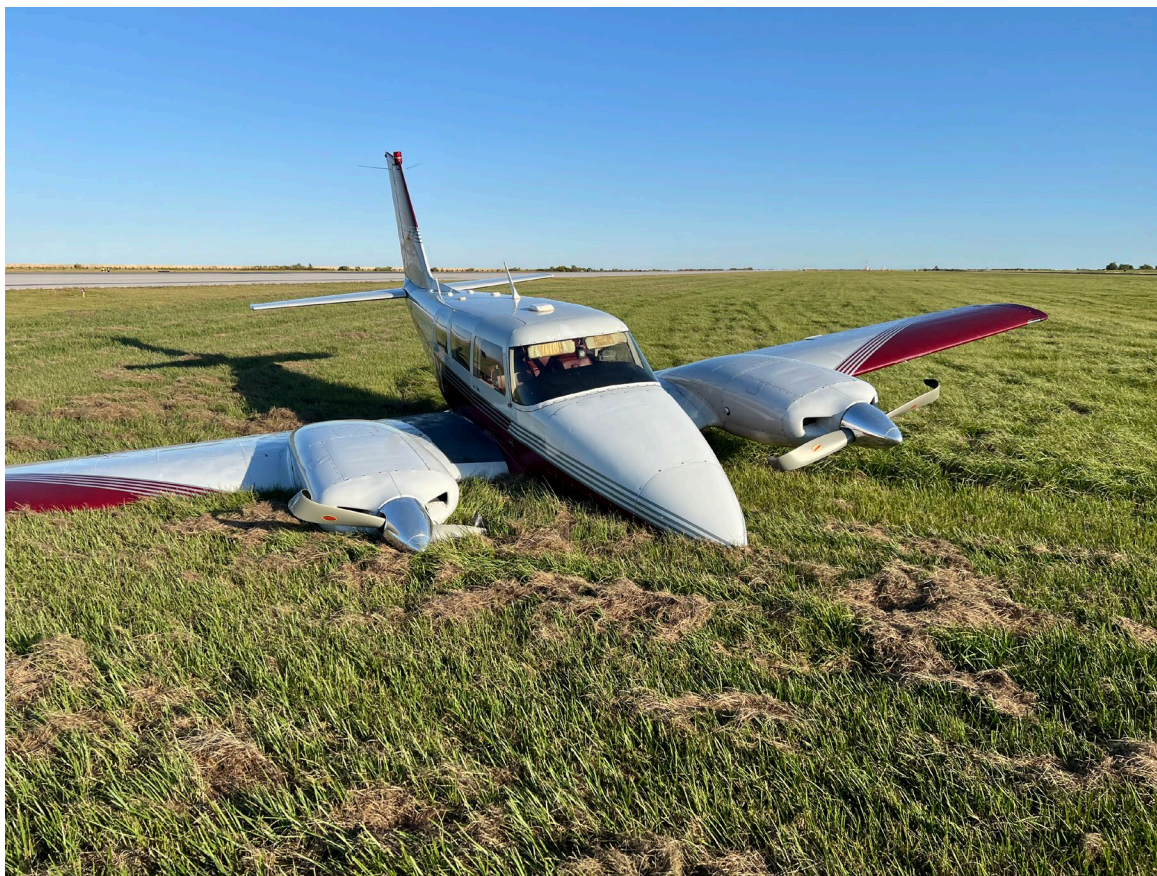
Photograph 1 – Accident site (Courtesy of accident pilot)

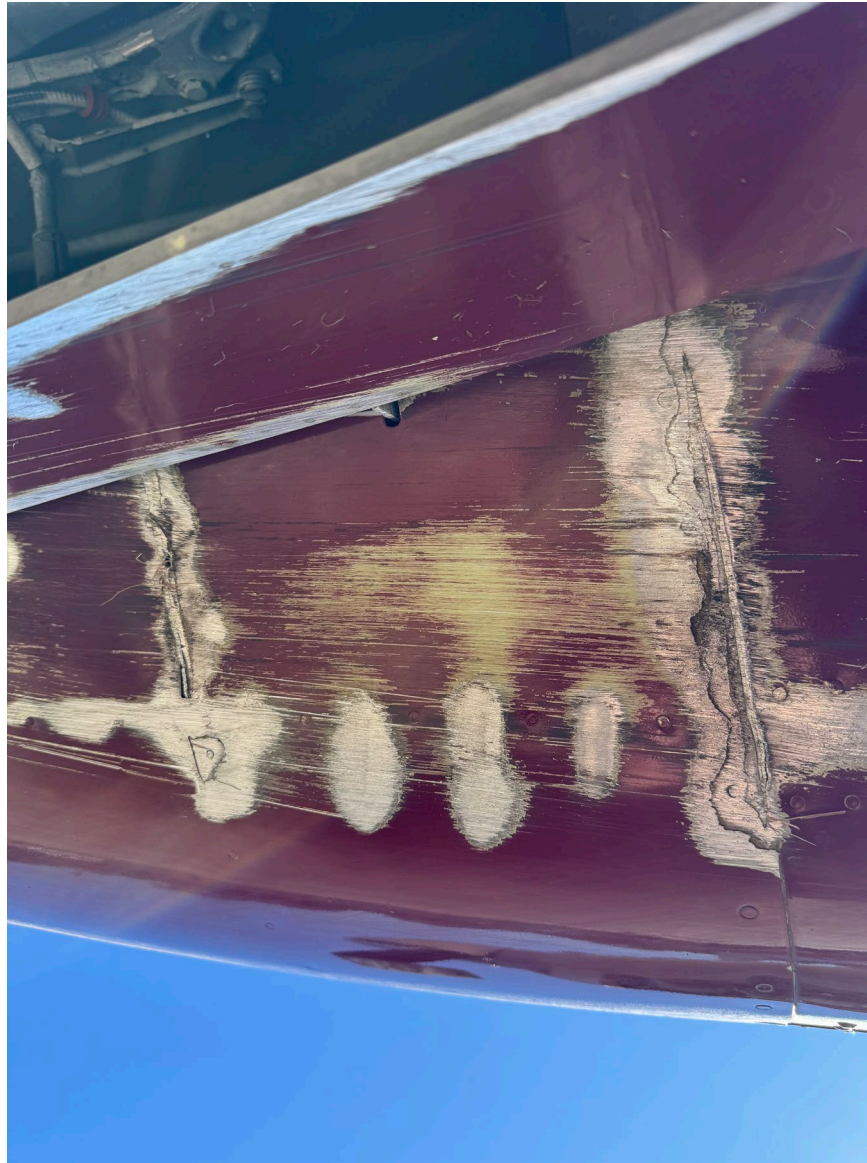
Photograph 2 –Fuselage damage (Courtesy of accident pilot)

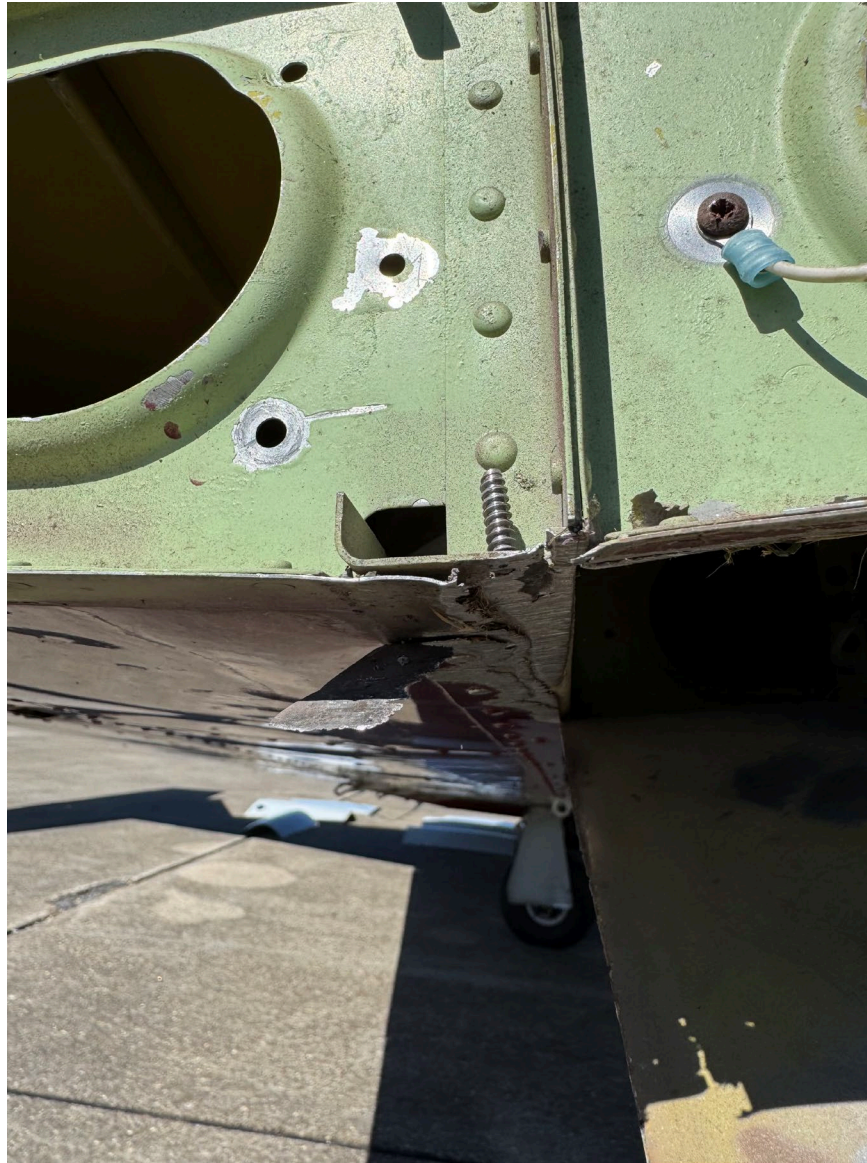
Photograph 3 – Spar damage (Courtesy of accident pilot)
