# National Transportation Safety Board

CEN25LA018

## INVESTIGATION SUMMARY

Location: Van, Texas  
Date: October 17, 2024  
Time: 0946 Central daylight time  
Airplane: N81481, Piper PA-32R-301

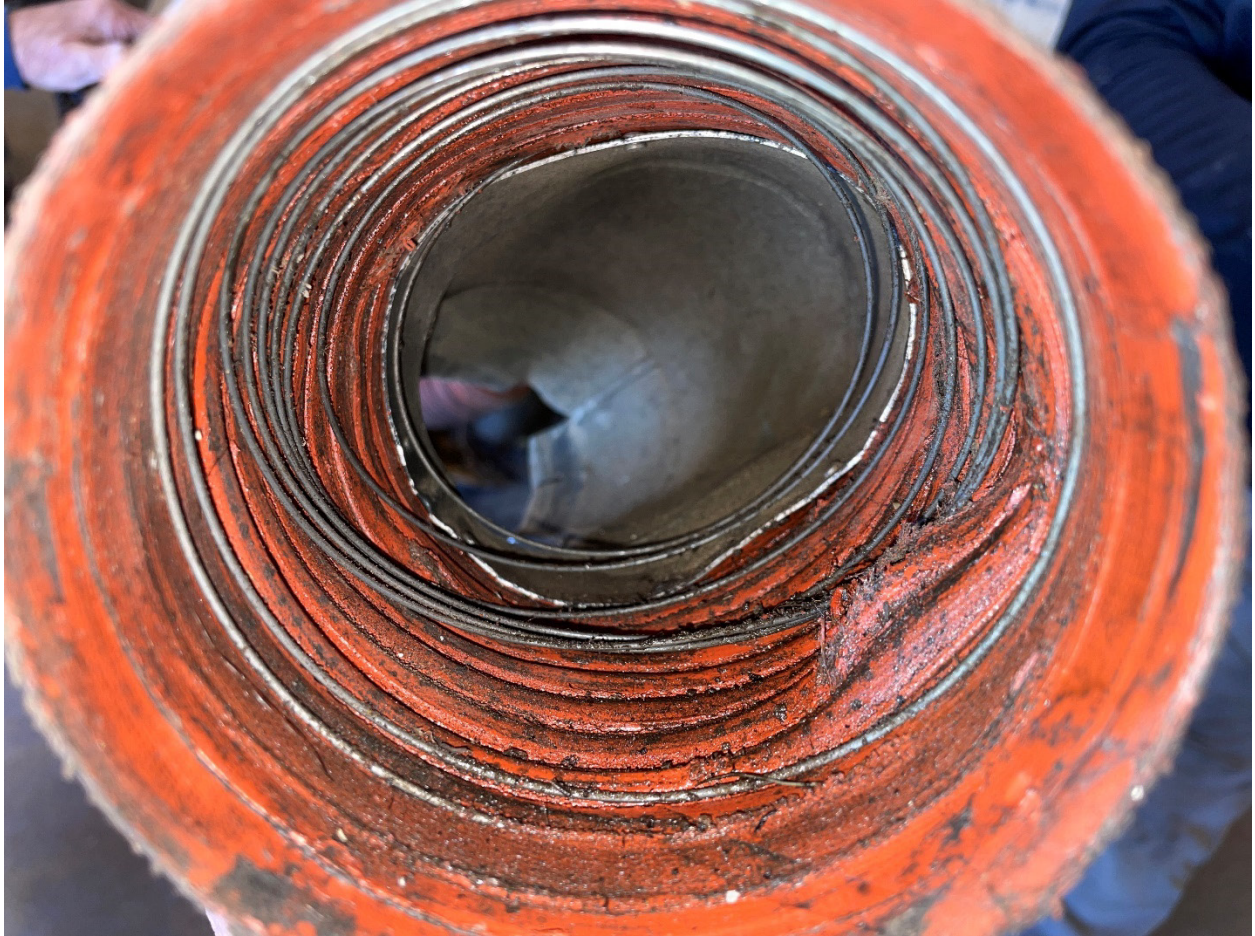
A second airframe examination was completed at the same time as the engine test run on March 20, 2025. The team revisited the condition of the airbox, bracket filter, air plenum and hose connections leading up to the fuel servo. The hose from the airbox to the 90° servo inlet adapter was an orange scat duct (figure 1-2). It did not have any part numbers or identifying markings. The scat duct had several tears on the outside that were covered with an orange sealant. The sealant was ripped and torn but appeared to have been previously covering tears in the scat duct. The metal wire on the inside of the scat duct was loose and had been rubbing/chafing on the inside of the airbox. The oily substance from the bracket air filter was covering the inside of the scat duct. There was complete oil coverage on the inside of the scat duct, indicative of the wire not being in place for an extended period of time, which allowed the oil to cover the surface completely. The scat duct was able to collapse easily when light hand pressure was applied to the outside of the scat duct. The internal wiring shifted easily and allowed the scat duct to collapse. There was no evidence of impact damage to the scat duct or the internal wiring.

The orange scat duct was the incorrect part and should have been a double wall, flexible air duct p/n 99849-08, alternate p/n 565-458.

Figure 1. Inside view of the failed scat duct.

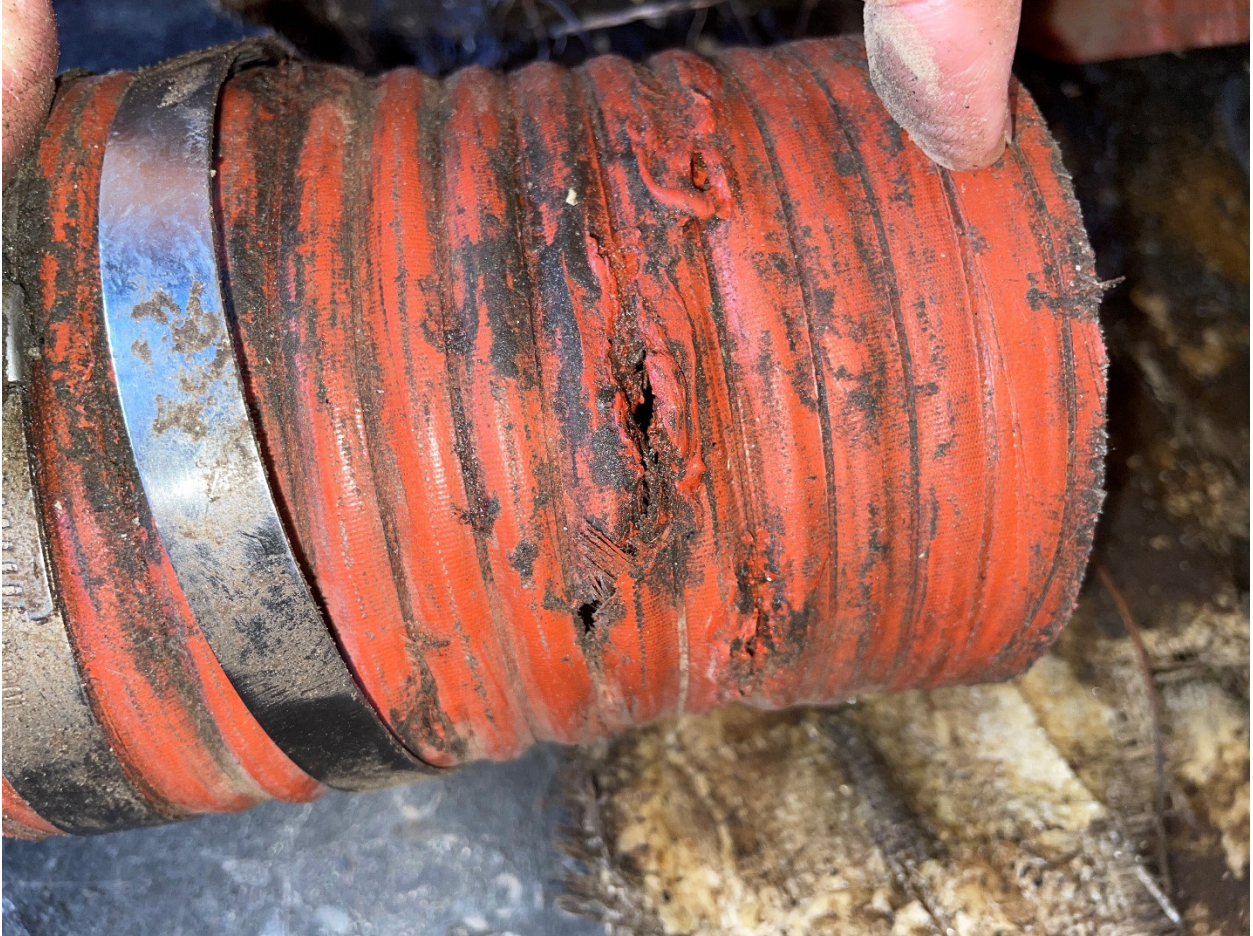
Figure 2. Outside view of the failed scot duct with several holes and orange silicone on and near the holes.

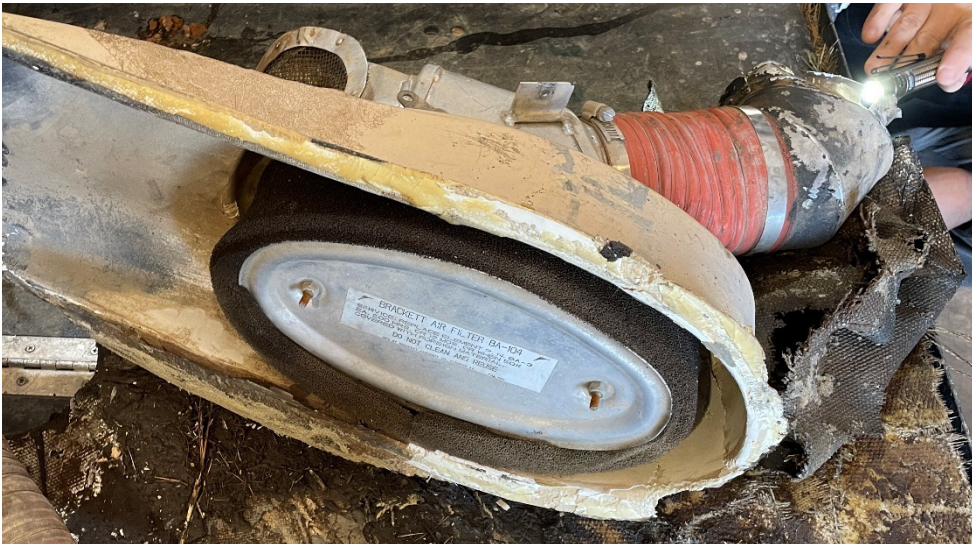
Figure 3. Air scoop, air filter, airbox, and failed scot duct at the postaccident exam.

Annual inspection: 3/25/2024 at 3,962.3 hrs tach. During this inspection the lower cowl induction air scoop was rebonded to the engine cowling. The failed scat duct would have been removed and reinstalled to the airbox during this work (figure 3-4).

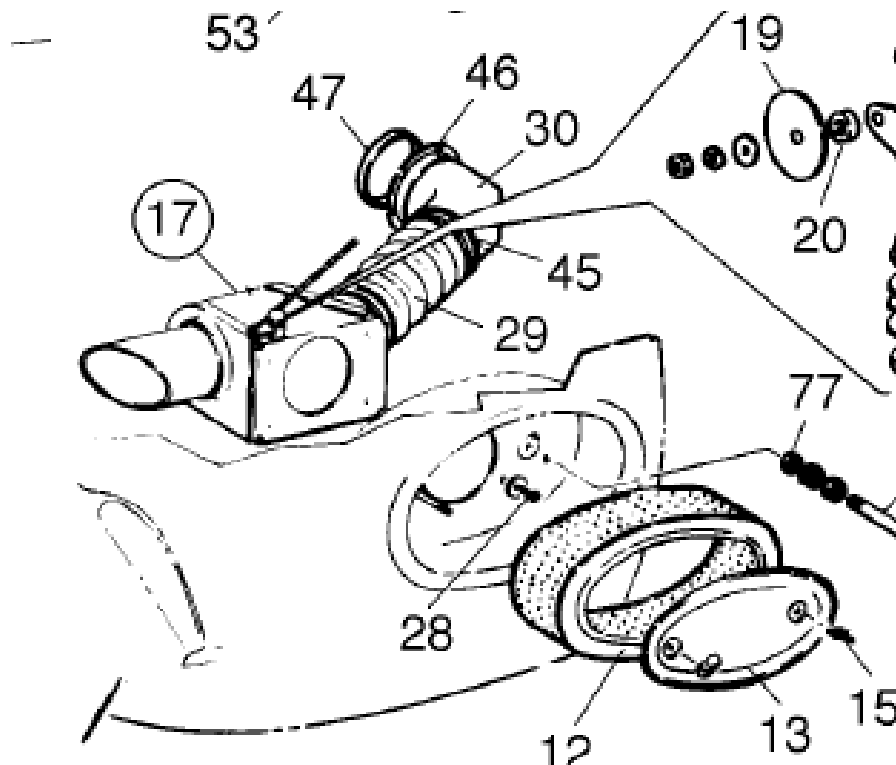
Figure 4. Piper PA-32R parts catalog showing p/n 99849-08 flexible air duct (No. 29).

If an air inlet hose is observed exhibiting any of the conditions listed above or is not an approved Piper part, then replace the hose with an approved Piper part before the next flight. Refer to the appropriate Piper Parts Catalog for approved part number information.
