CEN25LA018

## INVESTIGATION PHOTOGRAPHS

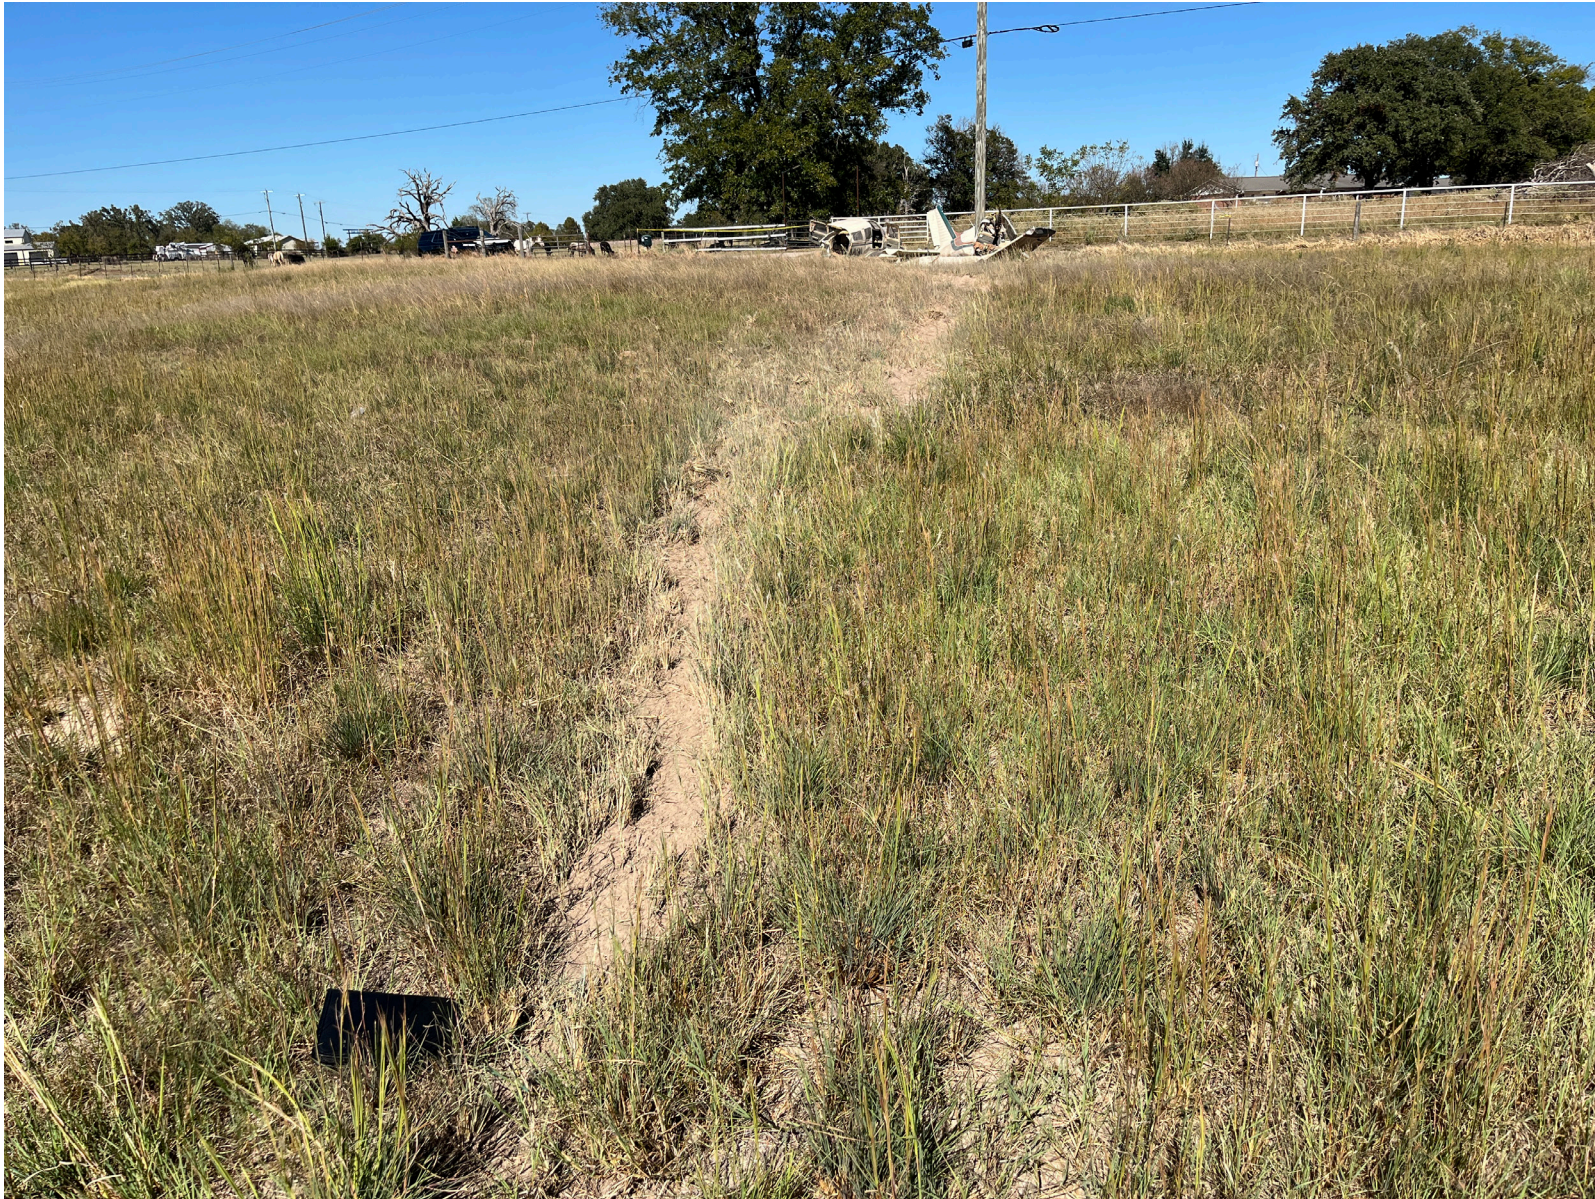
**Photograph 1 - Accident site (Courtesy of FAA)**

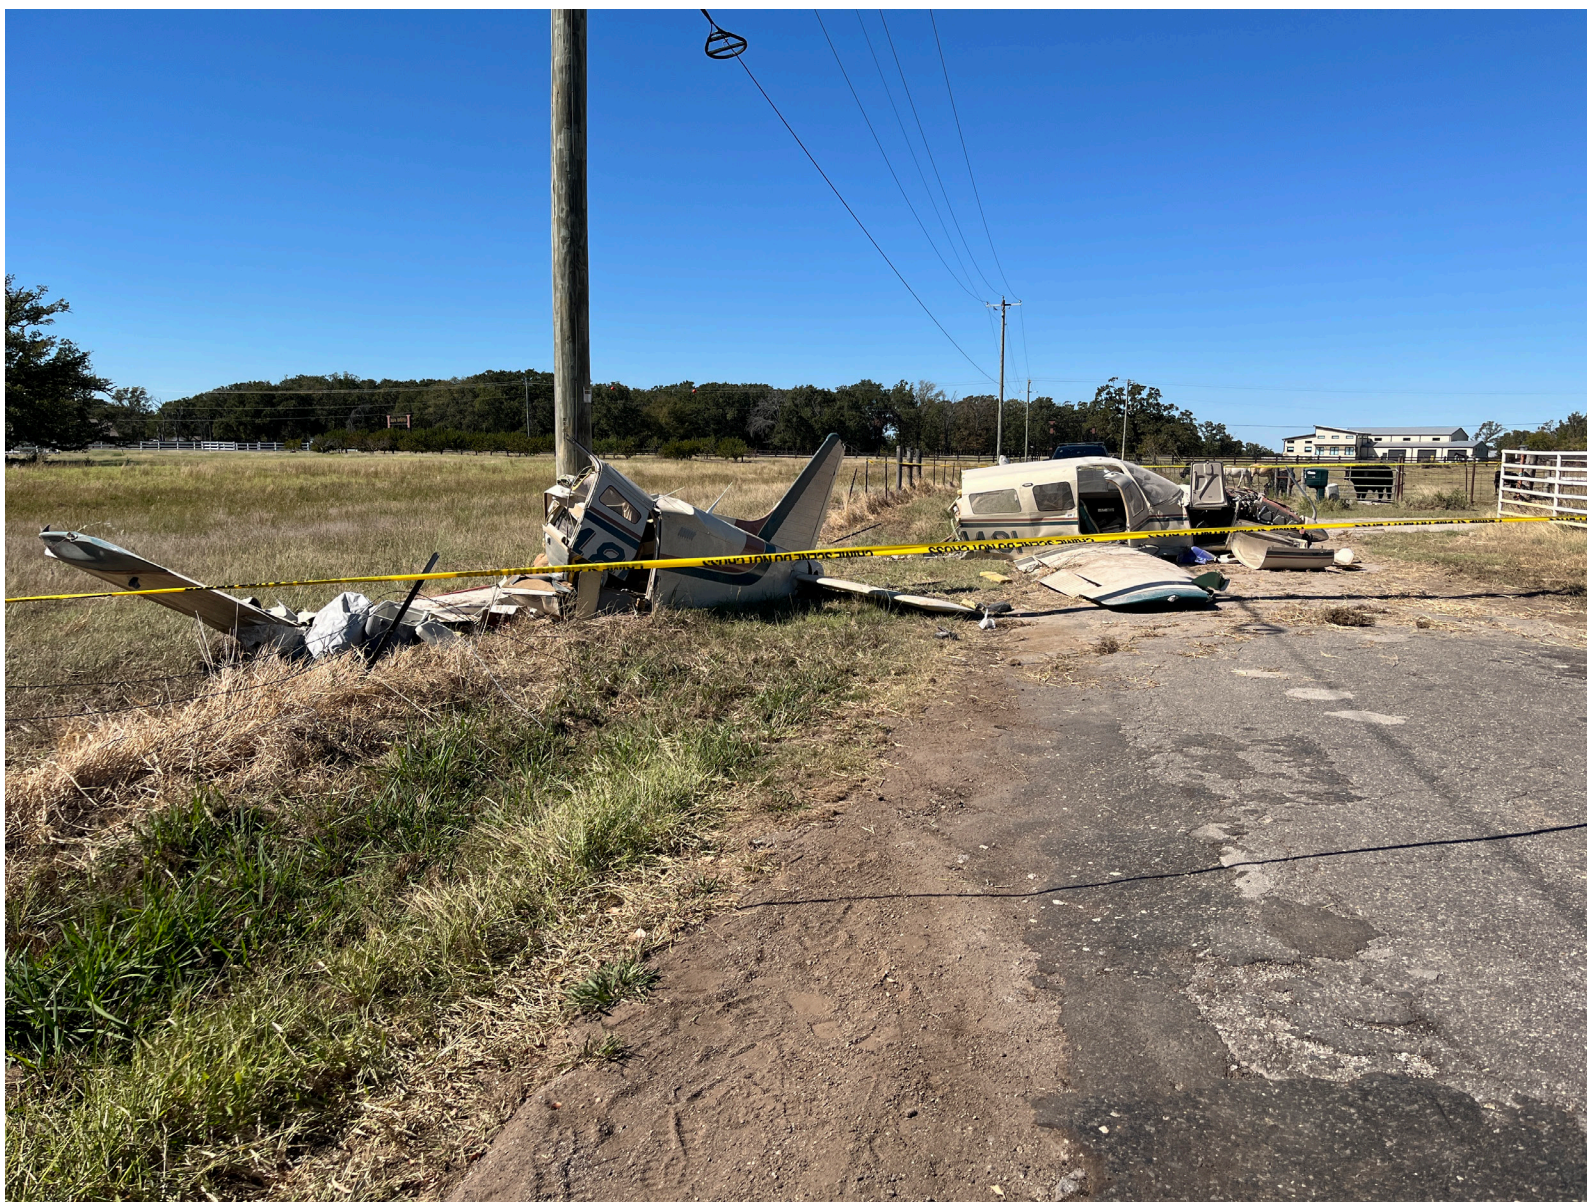
**Photograph 2 - Accident site (Courtesy of FAA)**

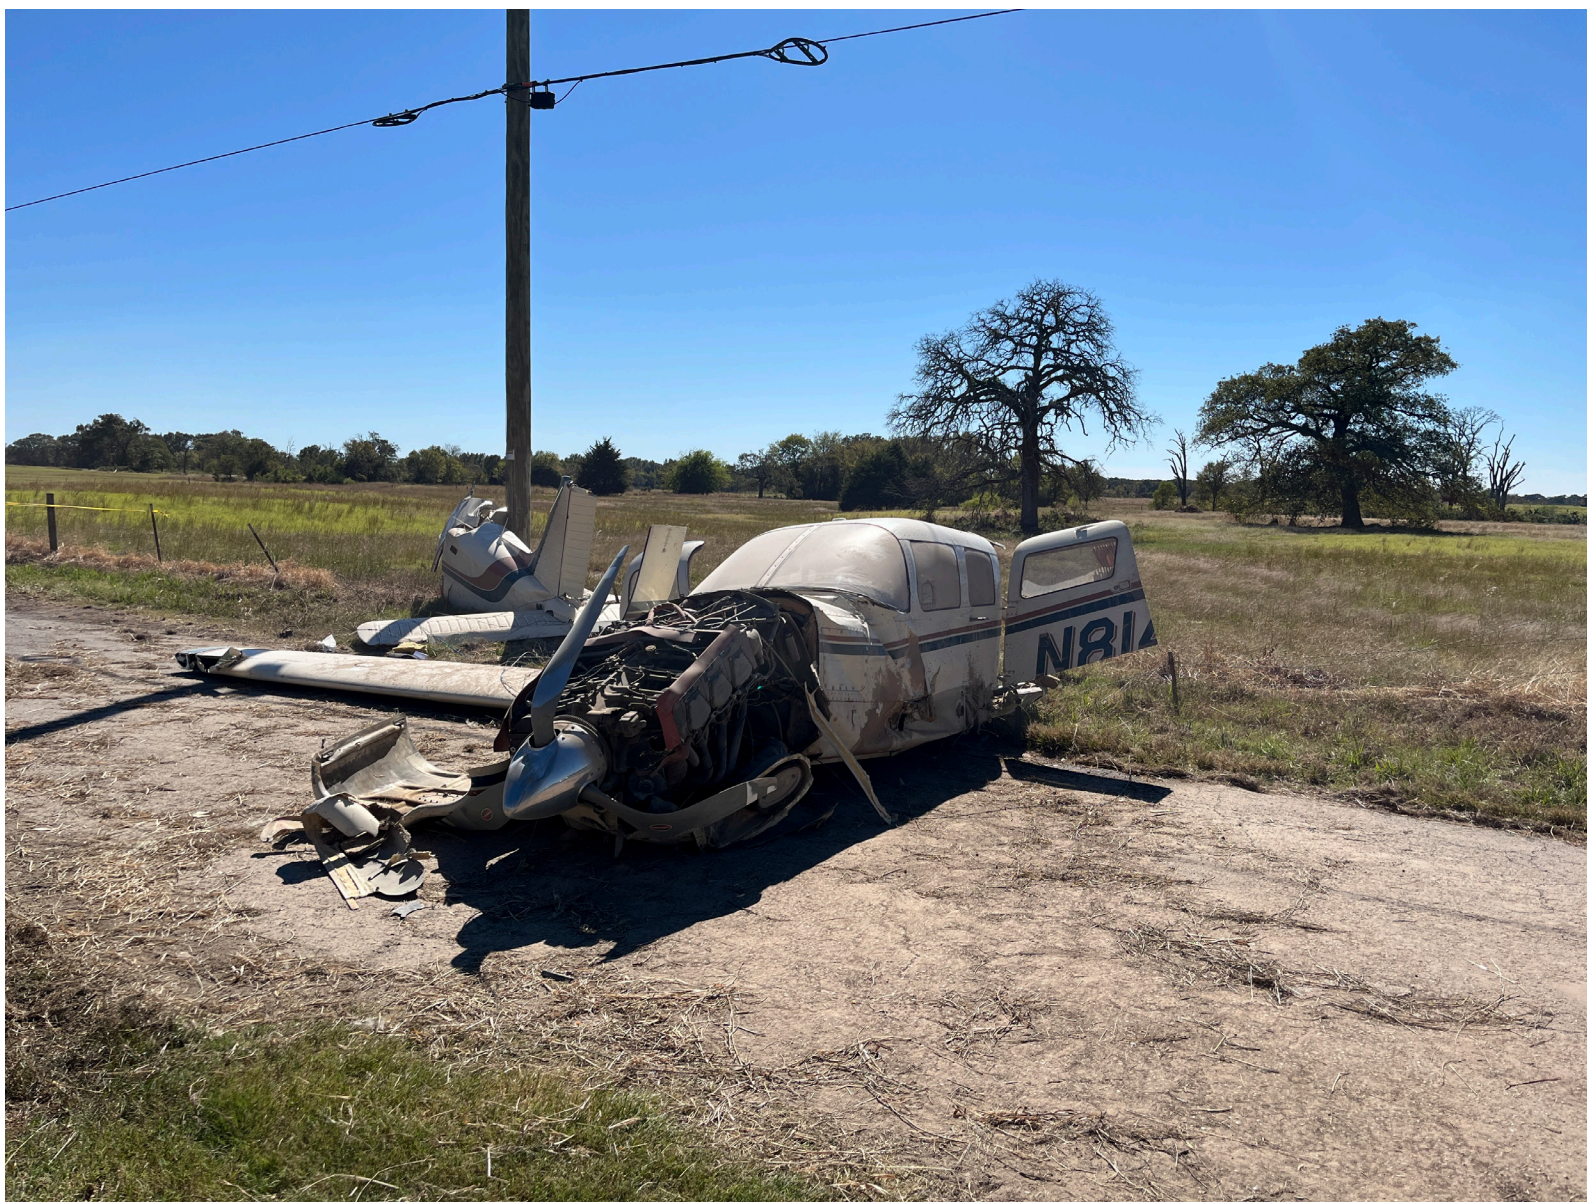
**Photograph 3 - Accident site (Courtesy of FAA)**

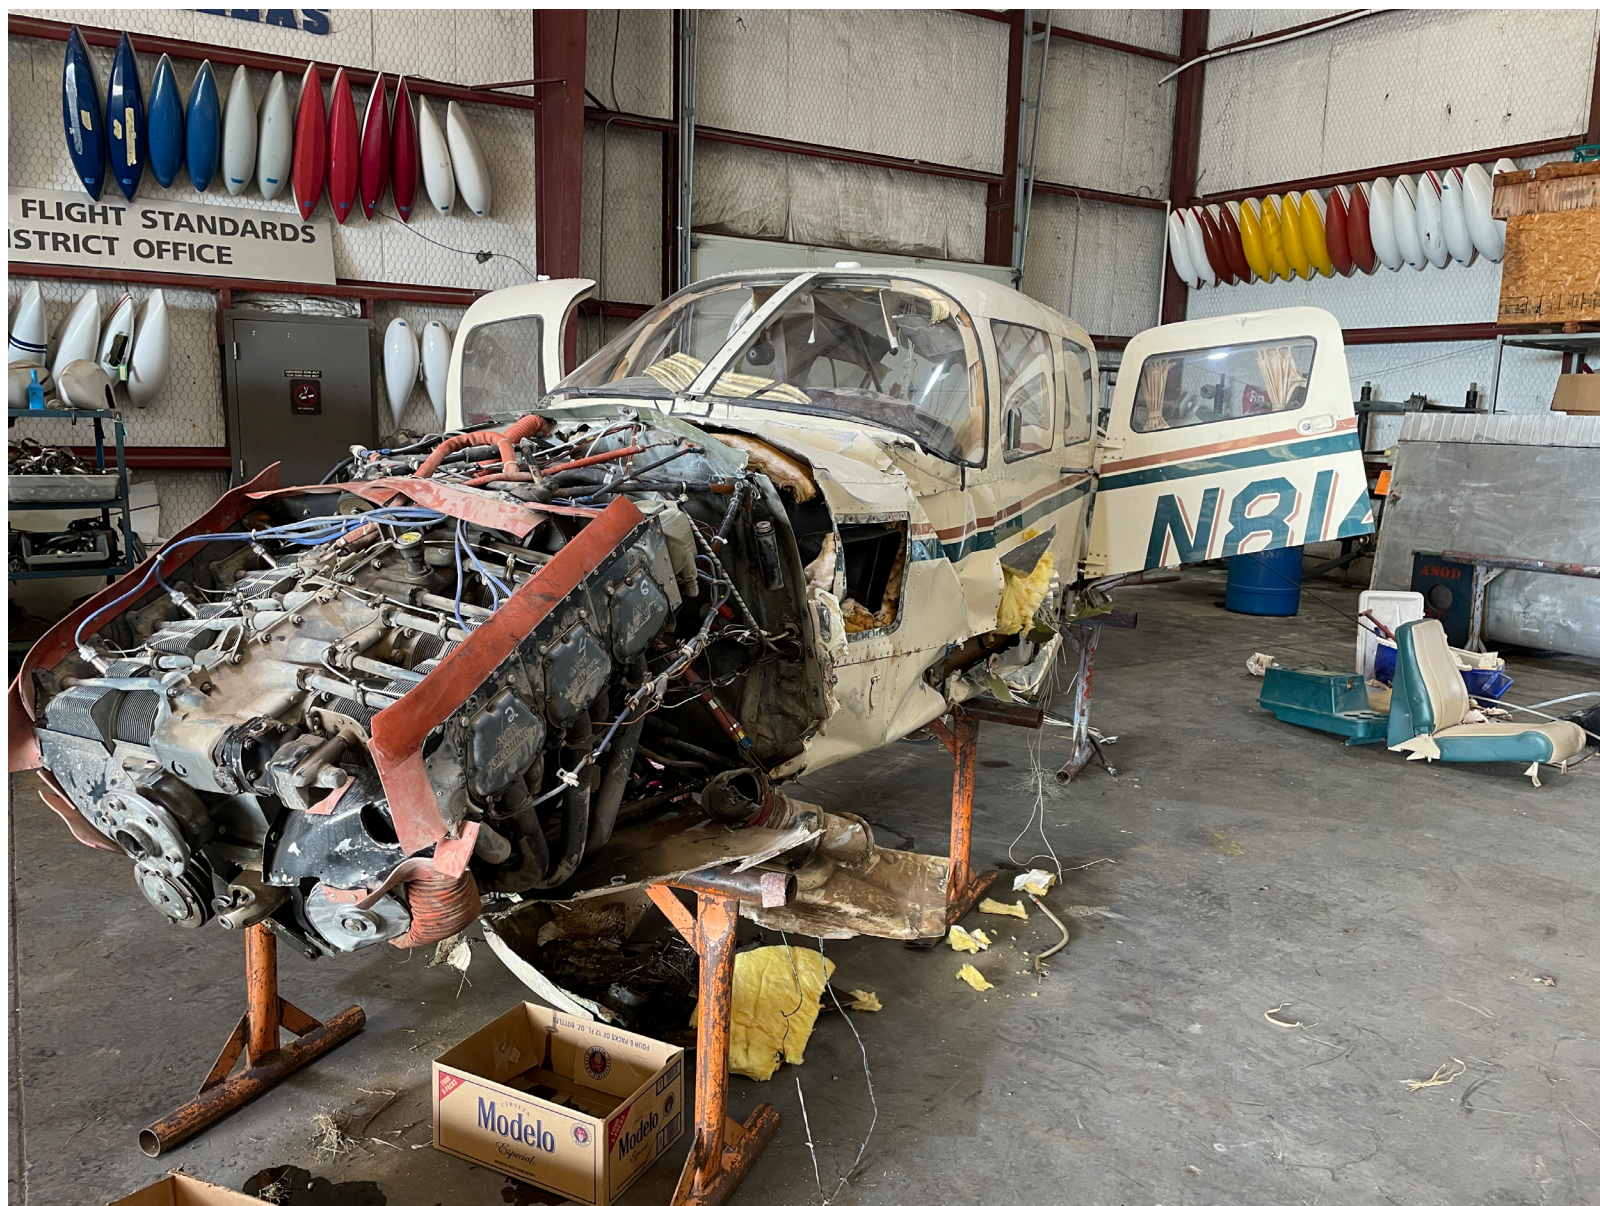
**Photograph 4 - Airplane during examination (Courtesy of NTSB)**

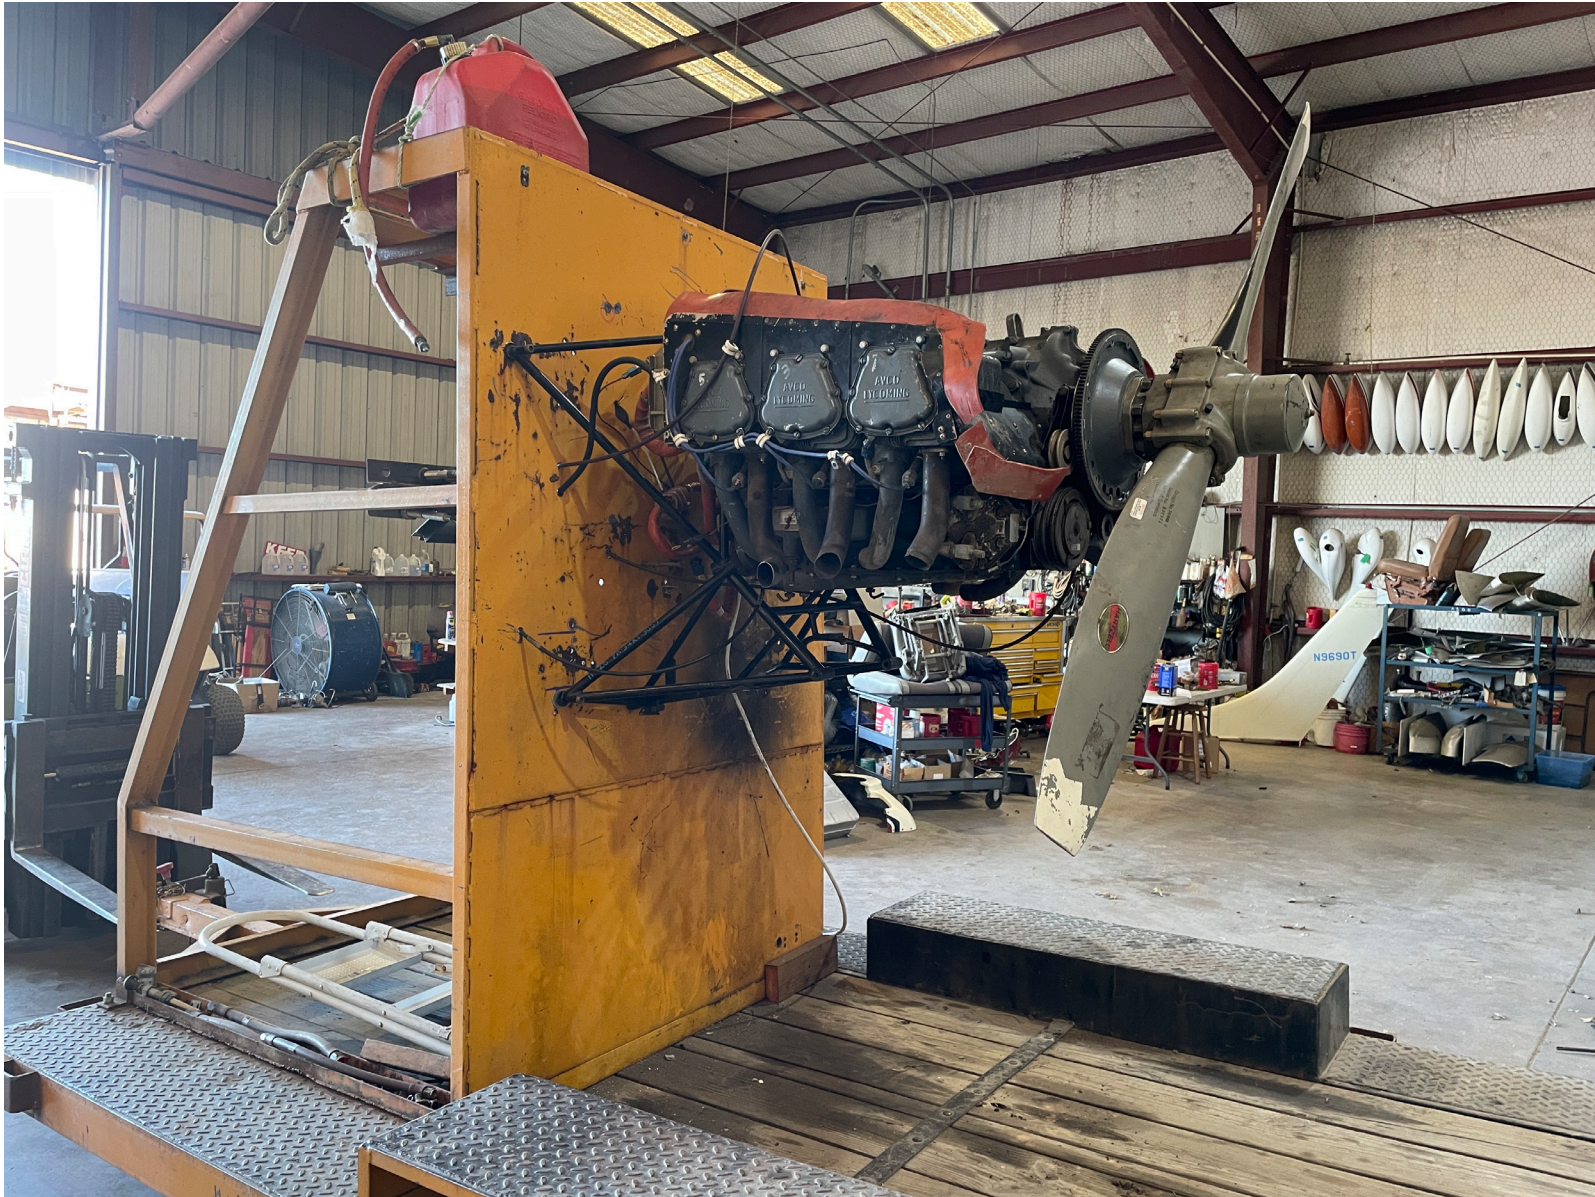
**Photograph 5 - Engine on test rig (Courtesy of NTSB)**

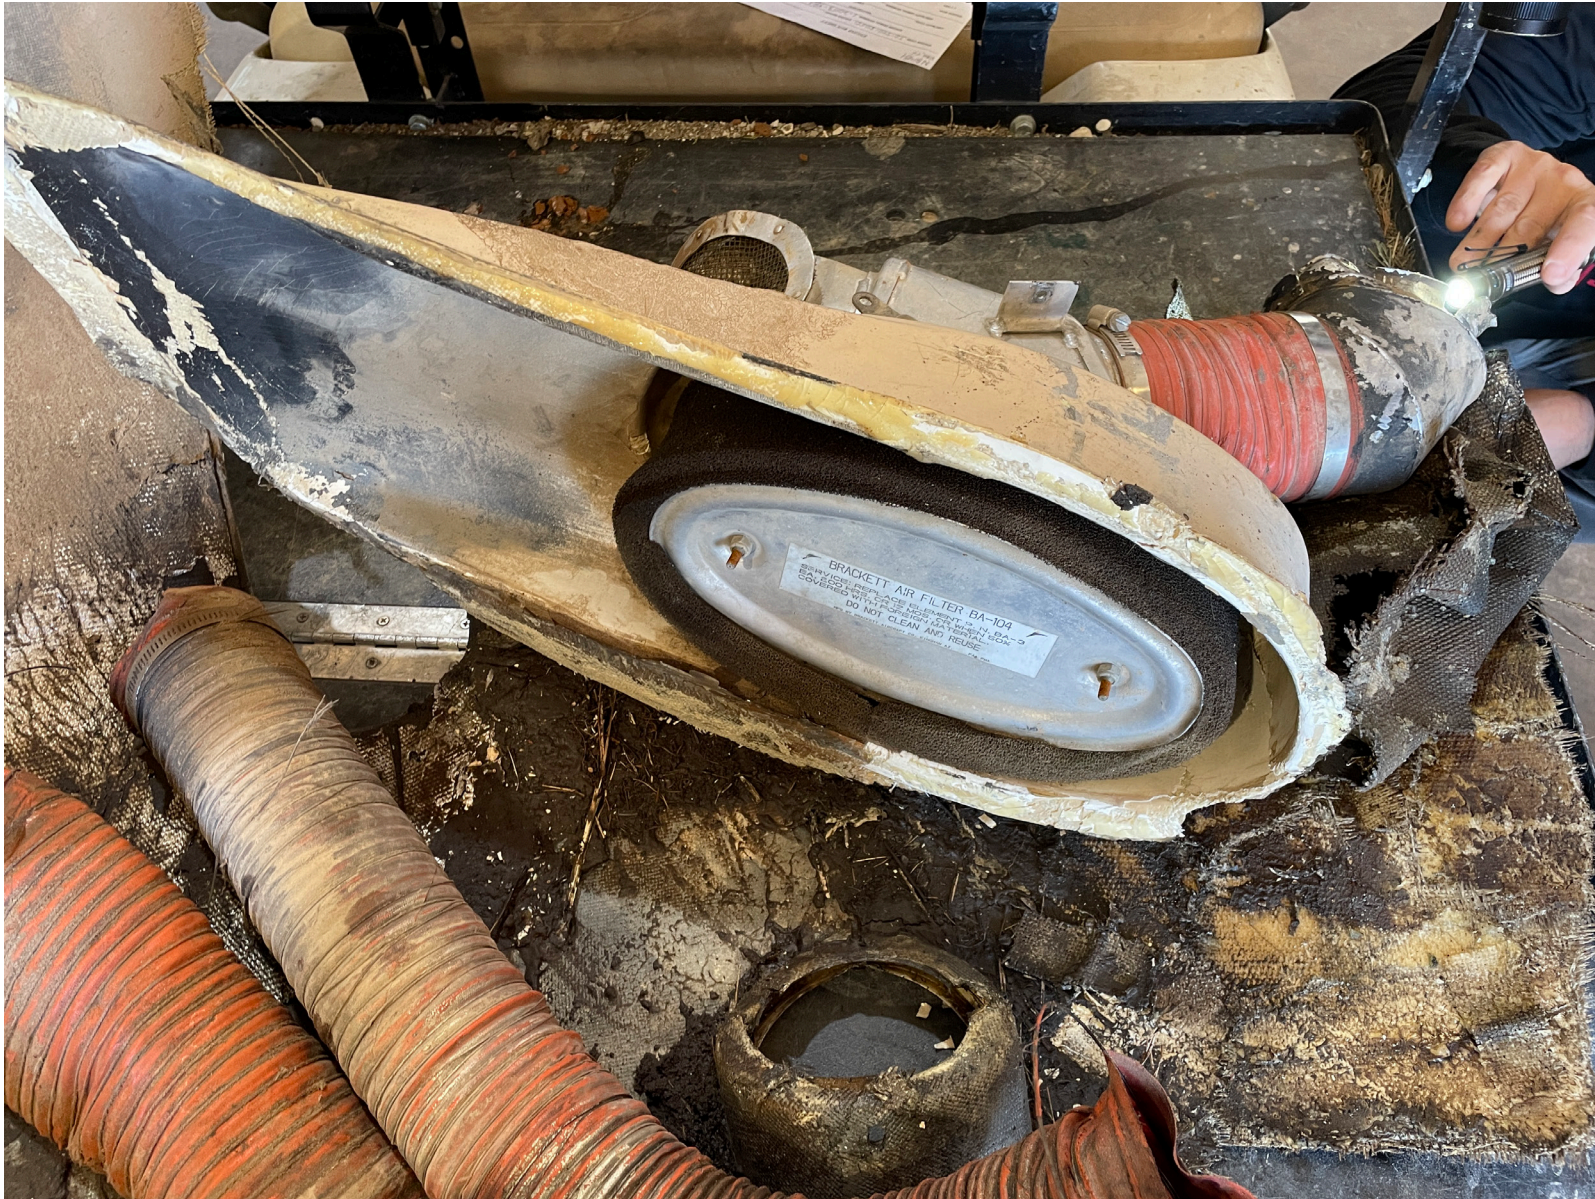
**Photograph 6 - Air filter, air box, scat duct (Courtesy of NTSB)**

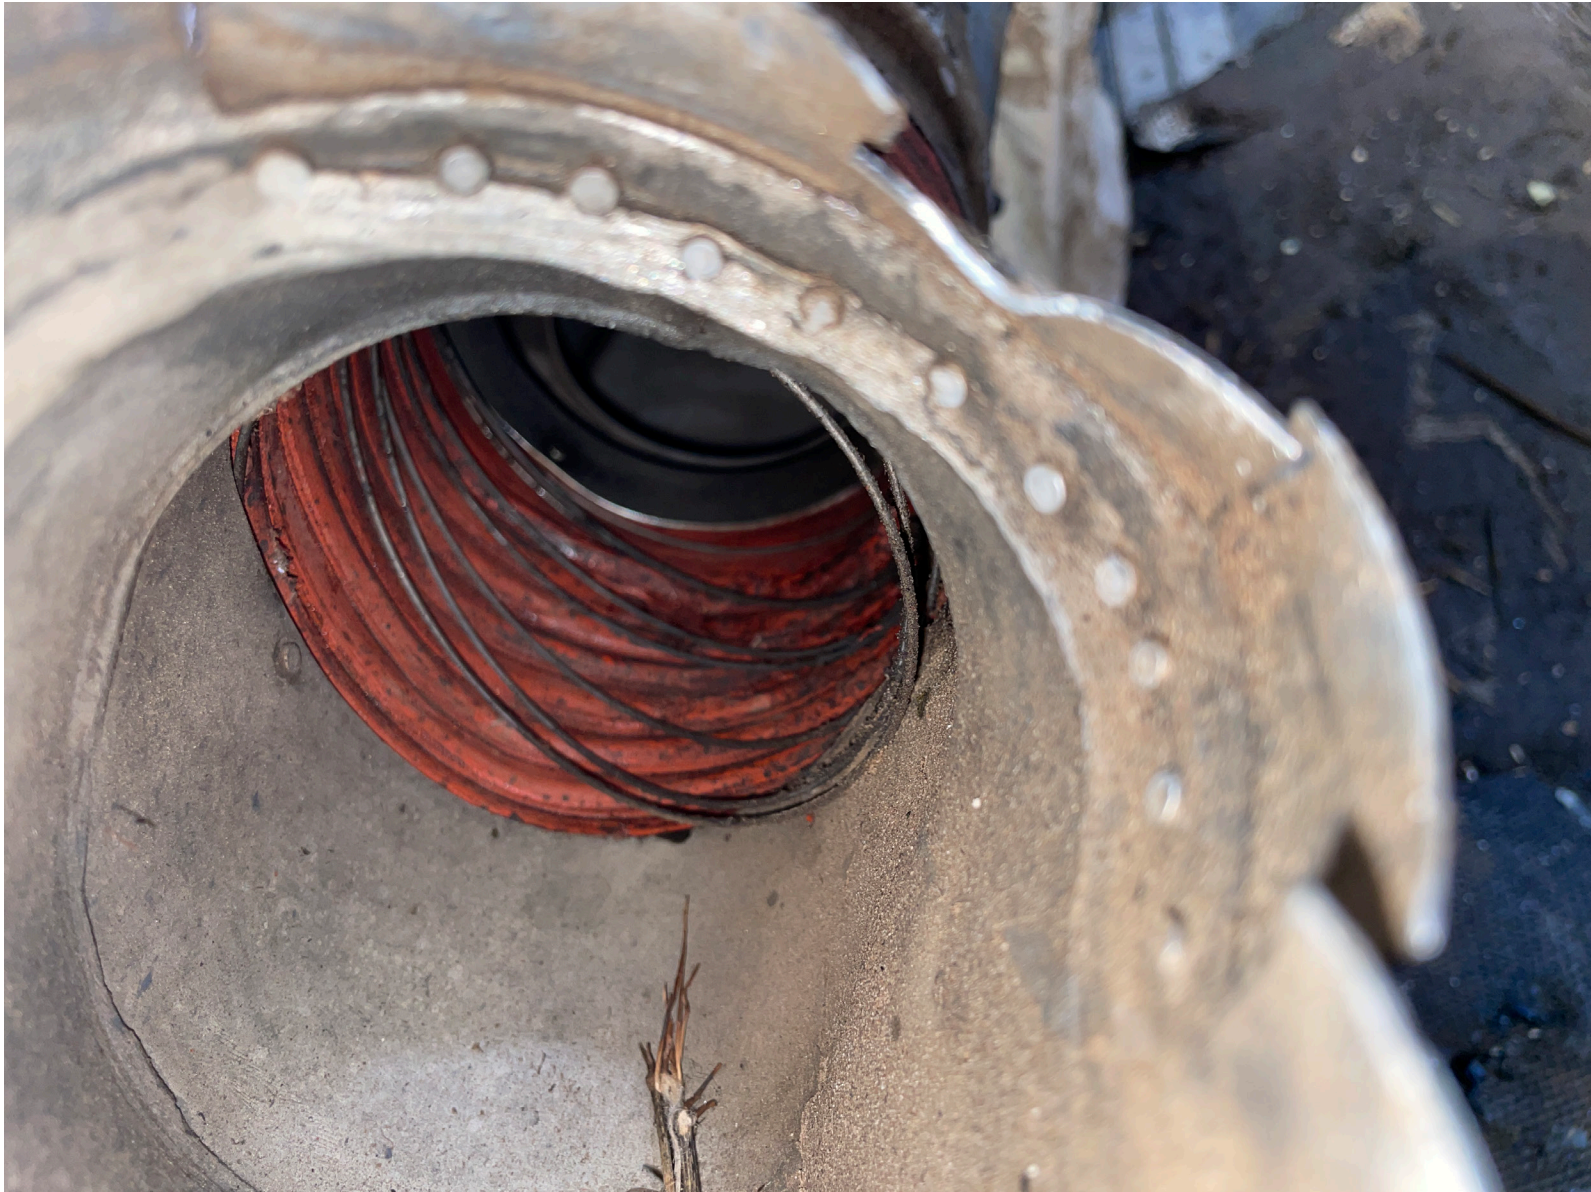
**Photograph 7 - Collapsed and degraded scat duct (Courtesy of NTSB)**

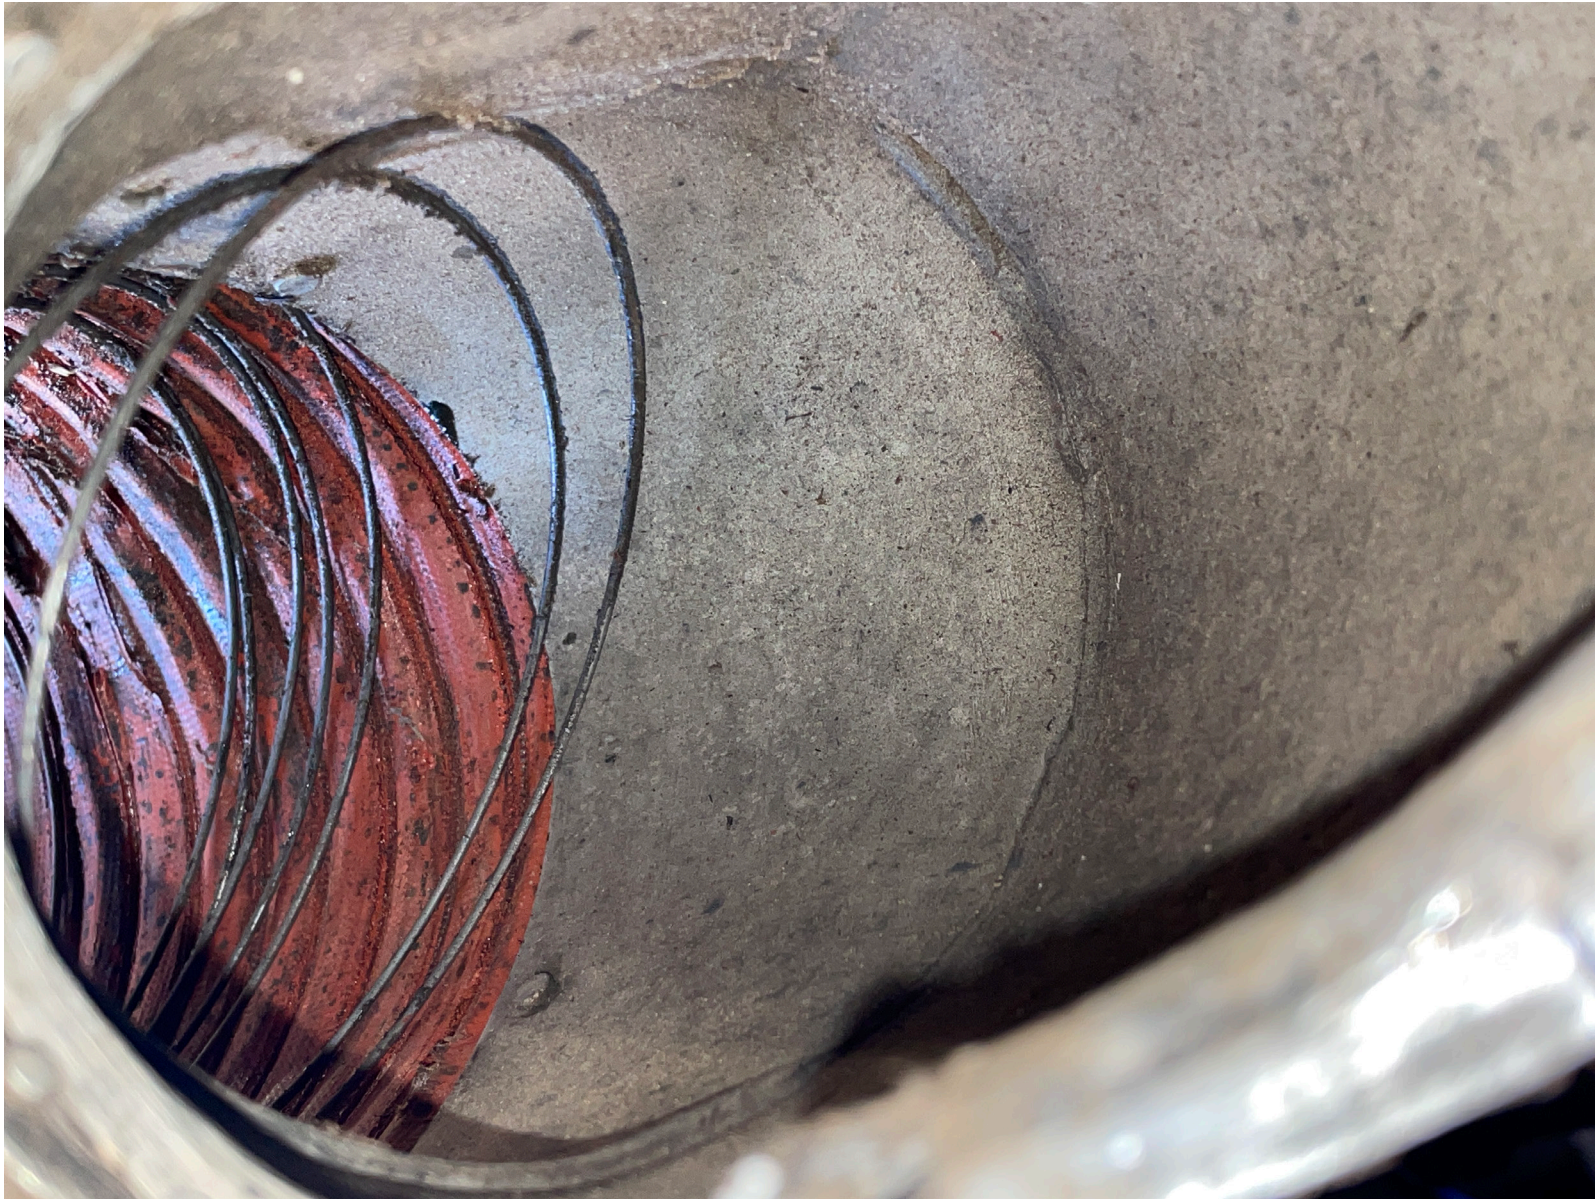
**Photograph 8 - Collapsed and degraded scat duct (Courtesy of NTSB)**

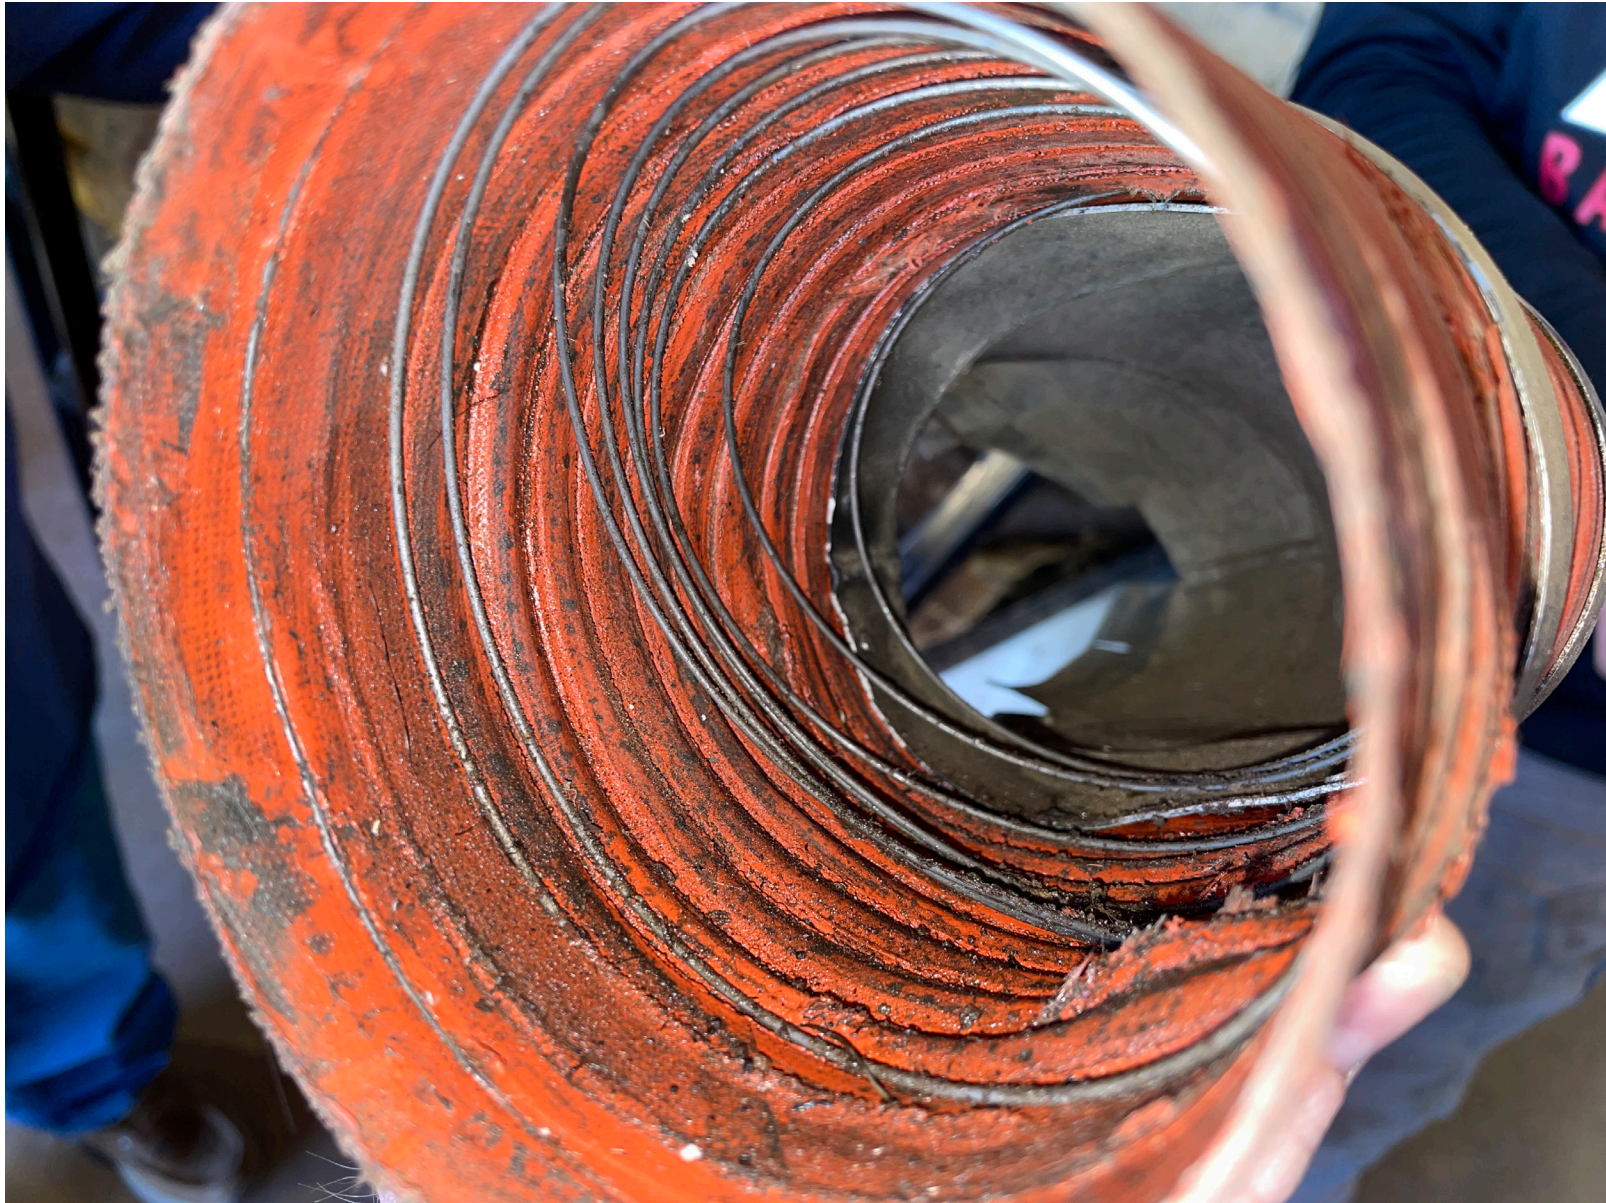
**Photograph 9 - Collapsed and degraded scat duct (Courtesy of NTSB)**

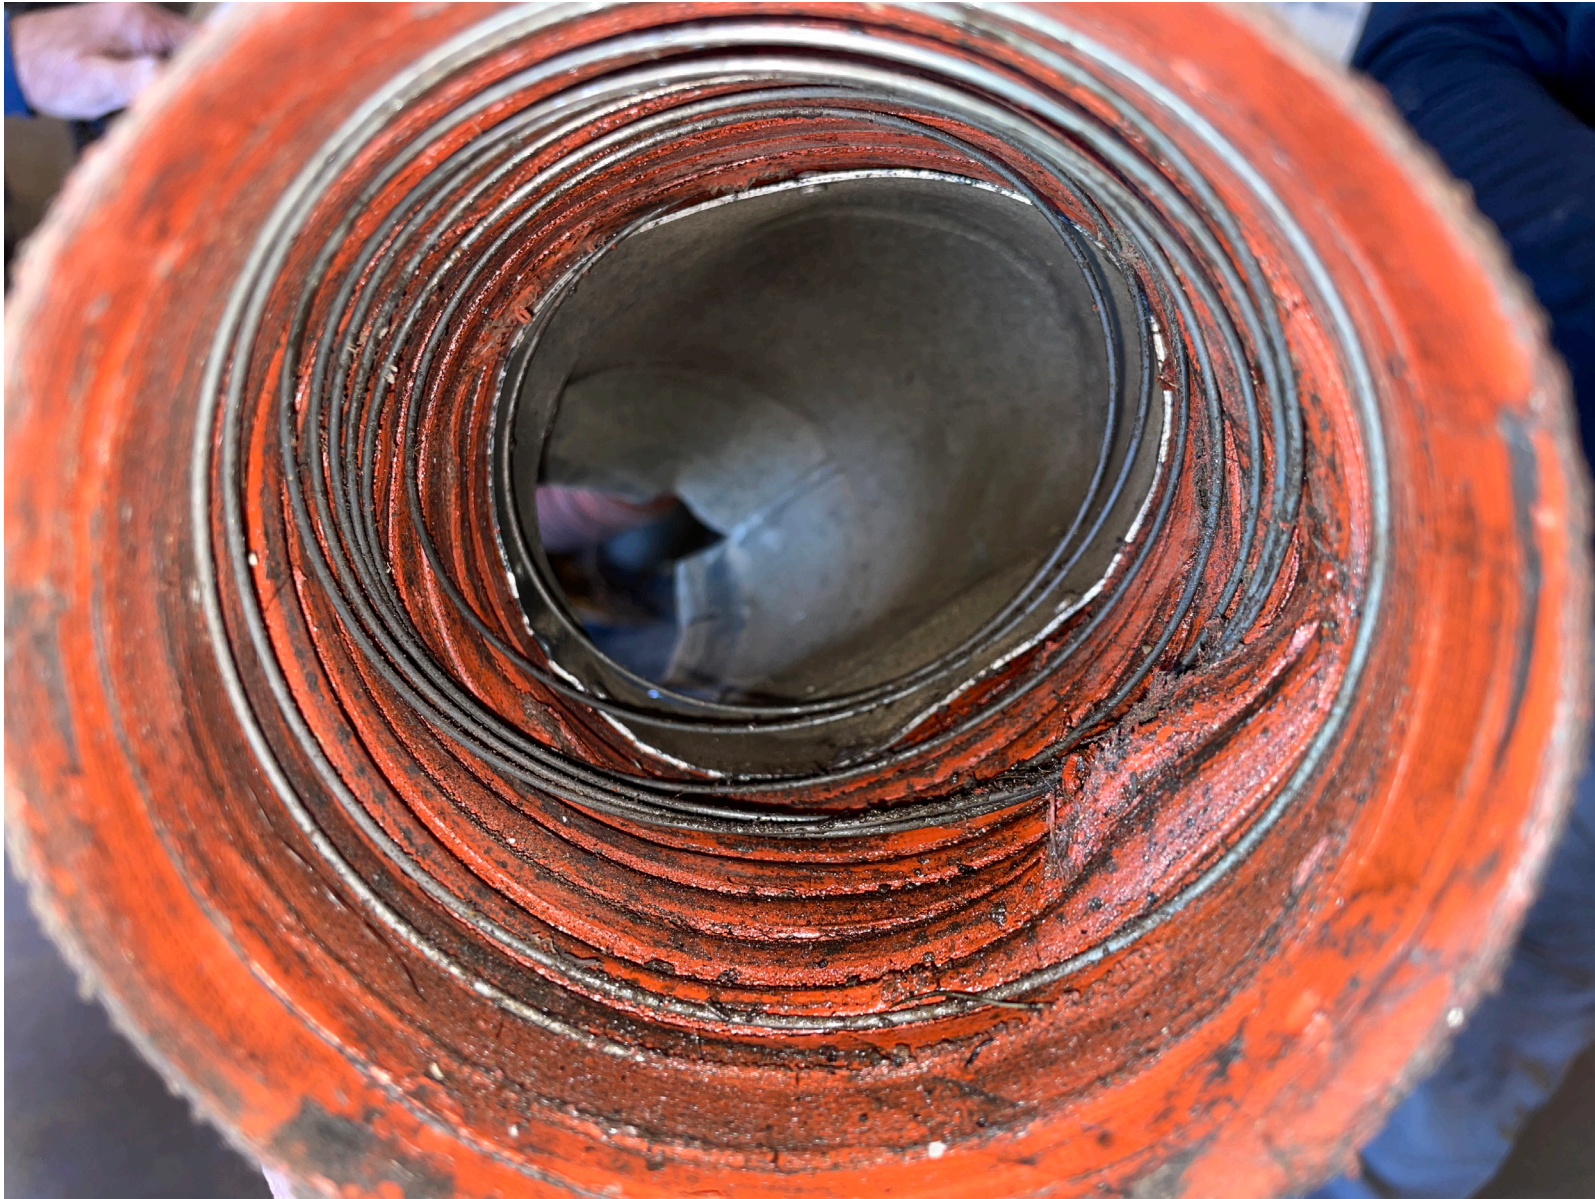
**Photograph 10 - Collapsed and degraded scat duct (Courtesy of NTSB)**

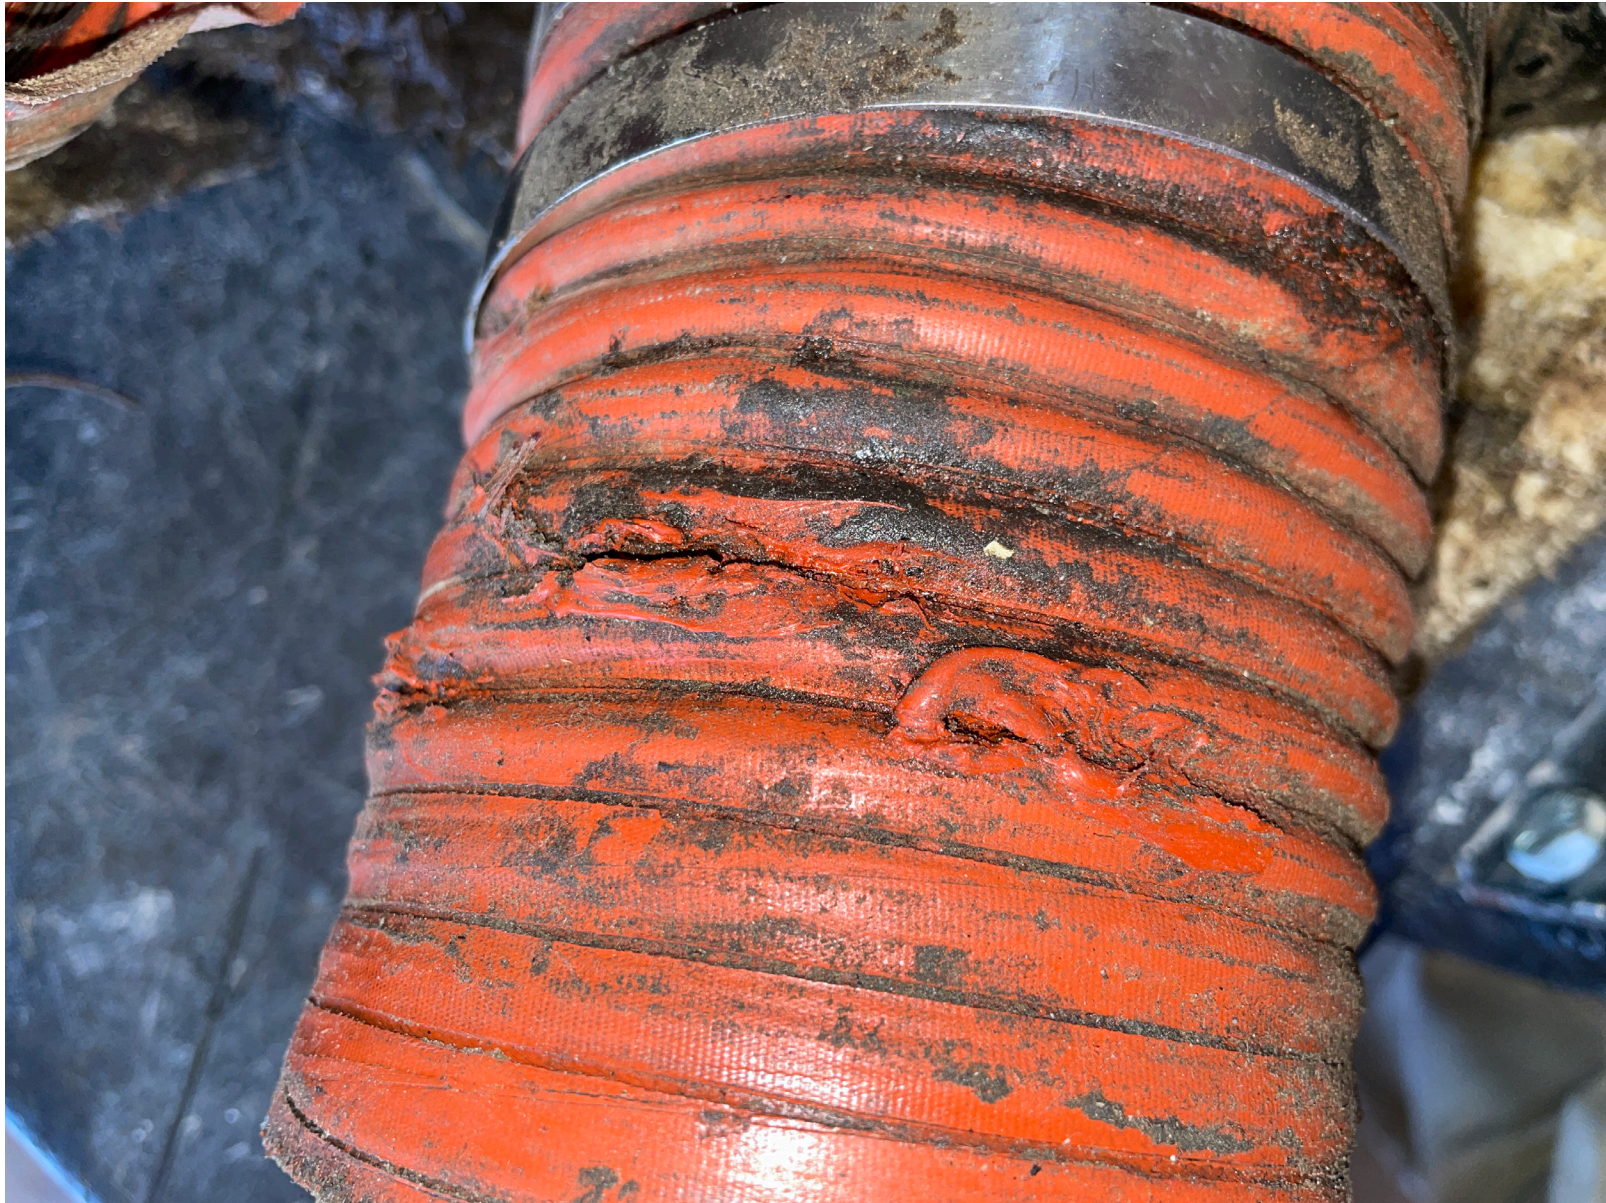
**Photograph 11 - Scat duct holes and repairs (Courtesy of NTSB)**

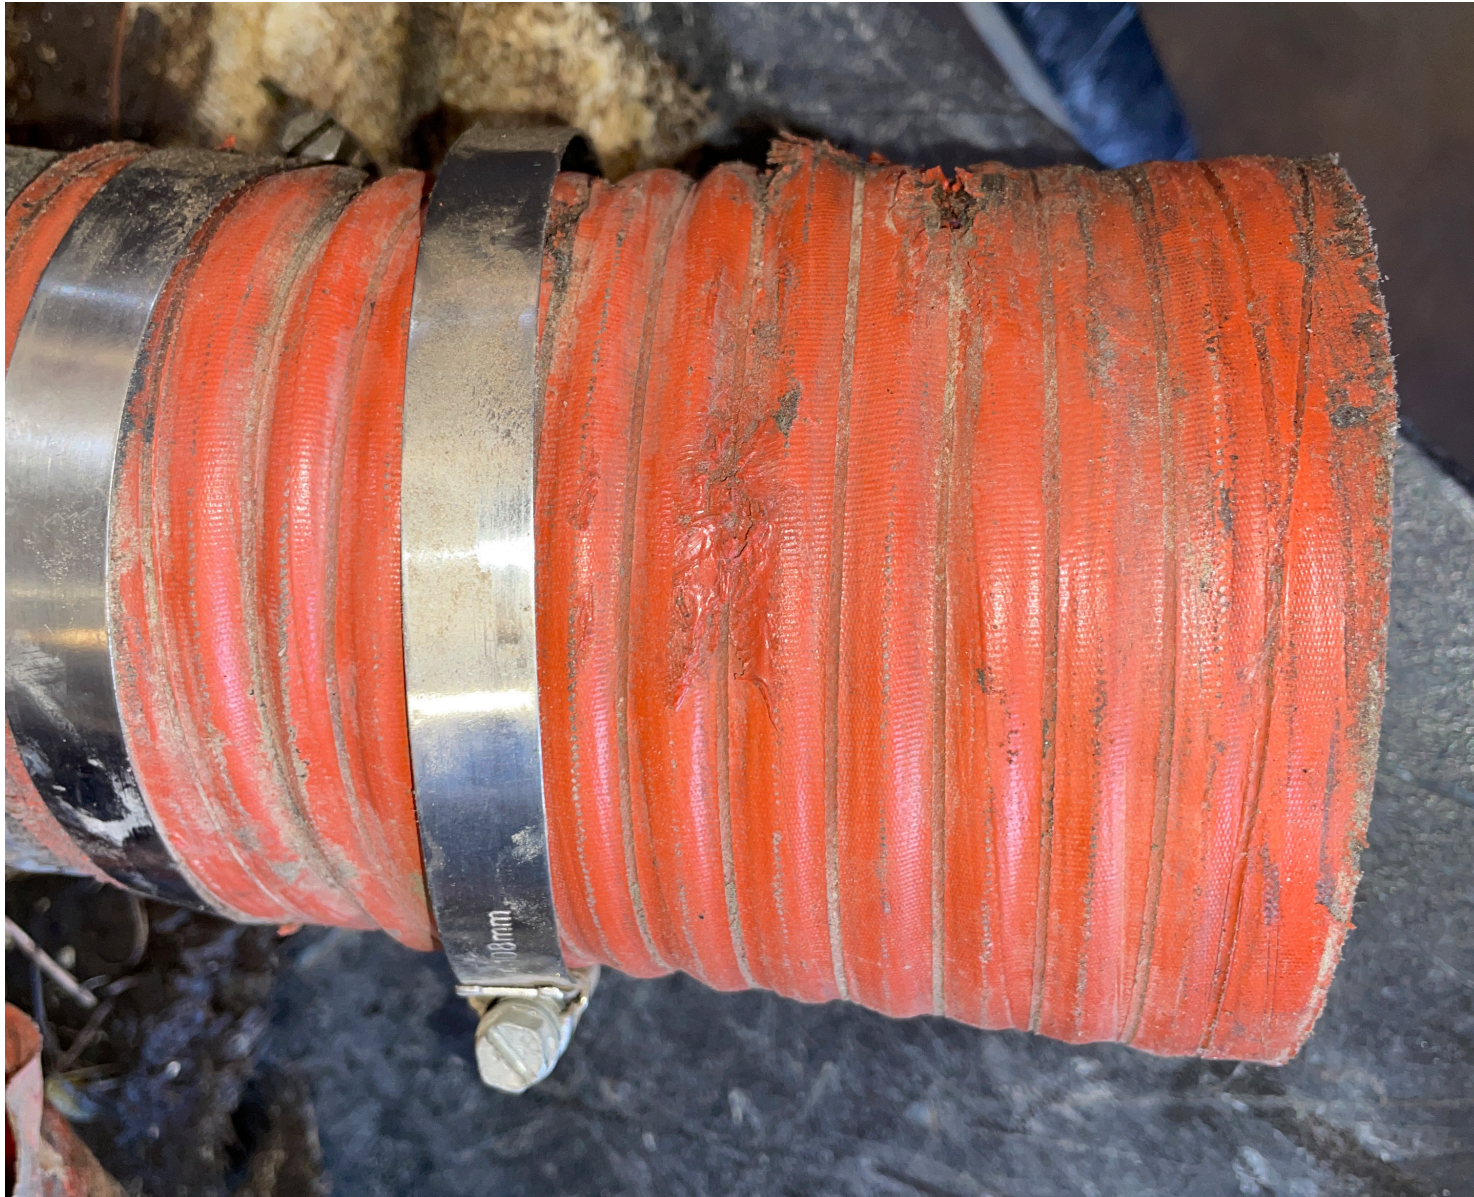
**Photograph 12 - Scat duct holes and repairs (Courtesy of NTSB)**
