CEN25LA018

## INVESTIGATION PHOTOGRAPHS

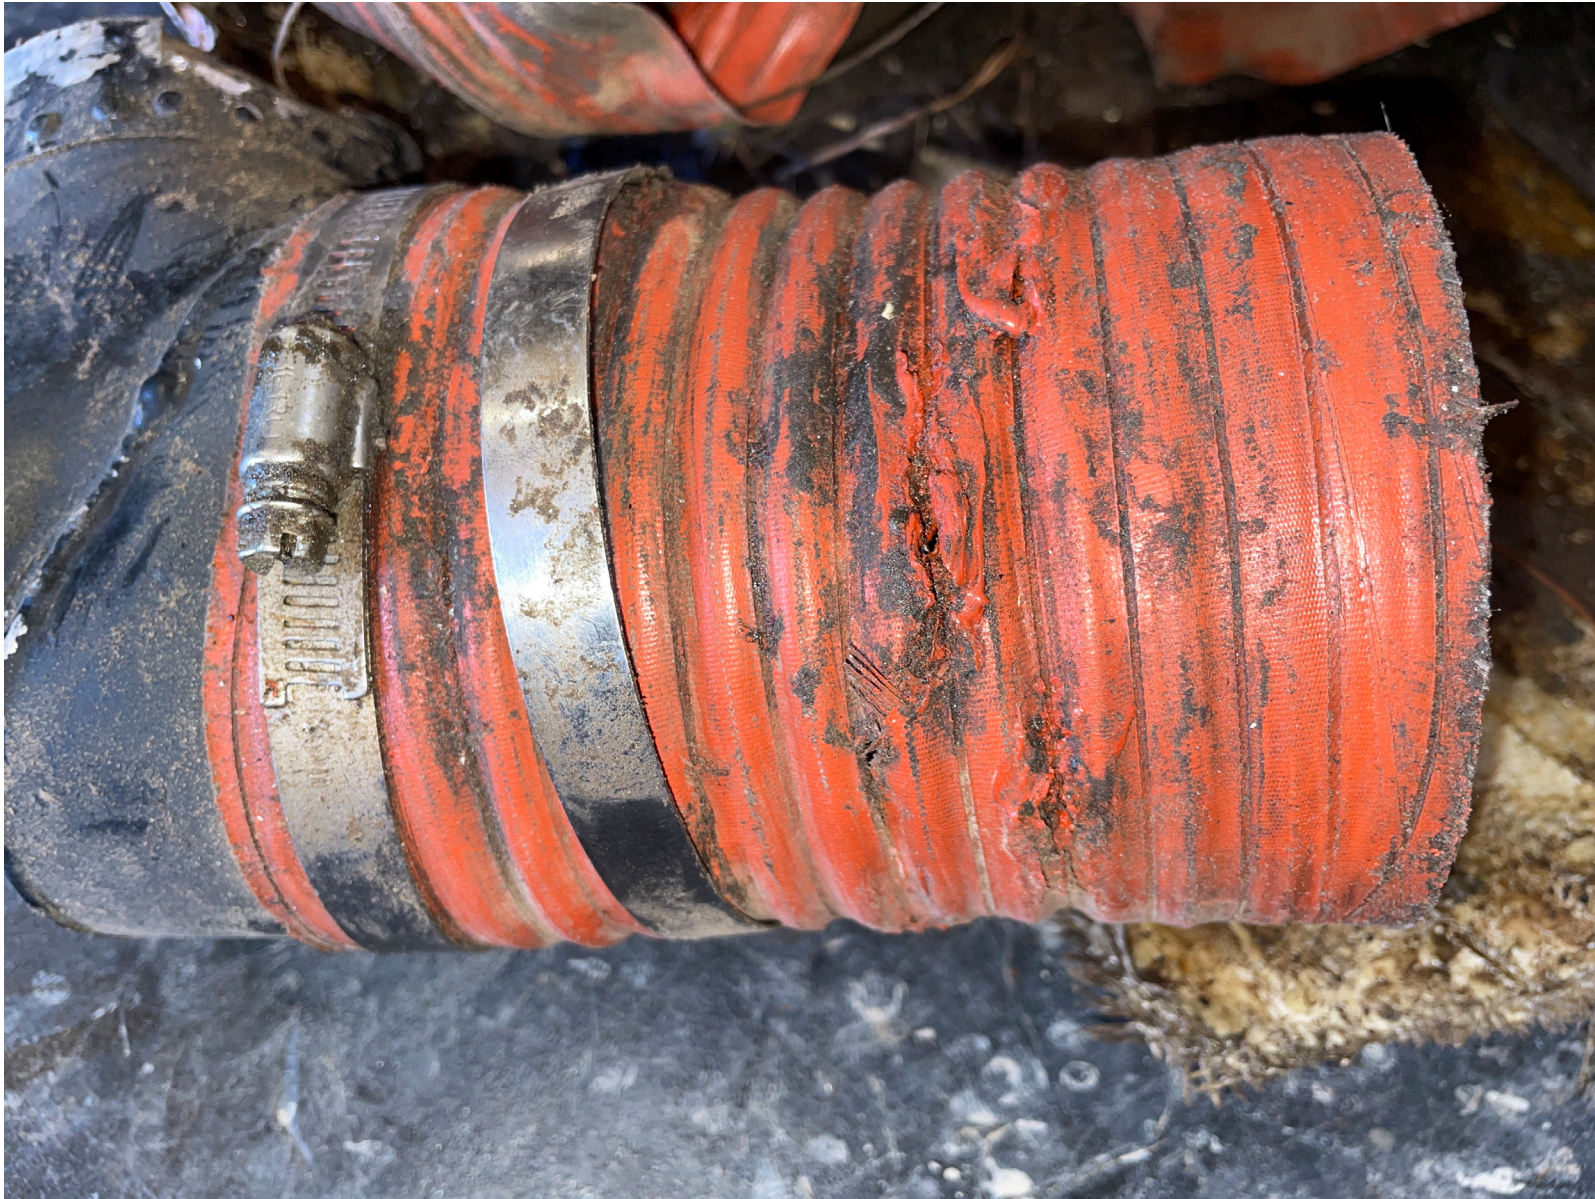
**Photograph 13 - Scat duct holes and repairs (Courtesy of NTSB)**
