Mitchell Gallo  
Senior Aerospace Engineer  
Aviation Safety - Central Region

**Dates:** November 7 and November 15, 2024

**Subject:** CEN25LA035 Record of Examinations

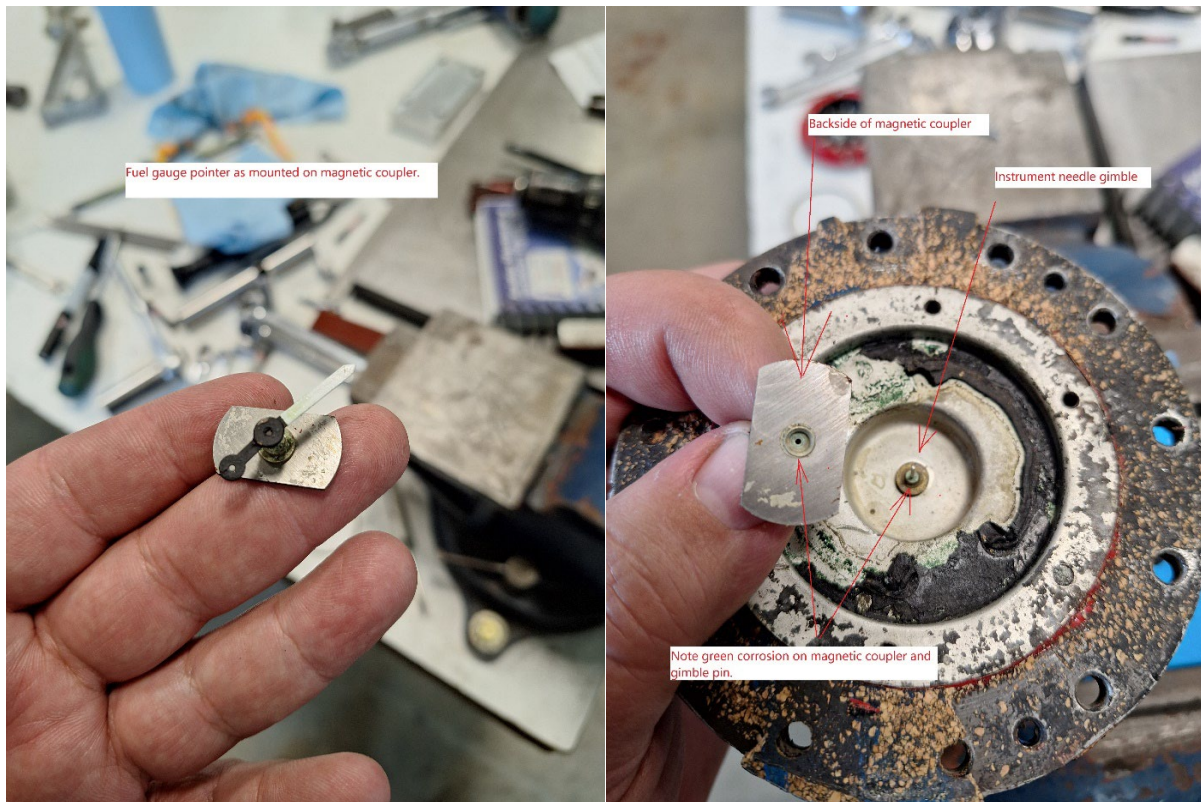
While testing the fuel quantity gauges for accuracy, it was noted that the left fuel gauge indication was stuck at 3 gallons when fuel was introduced, and remained at 3 gallons as the fuel quantity was altered. The right fuel quantity indicator was accurate throughout its range. No fuel leaks were noted to the left and right fuel tanks. The tank venting and fuel selector valve functions were normal.

The left and right wing fuel gauges were removed by a mechanic who provided photos of a green colored corrosion on the left fuel gauge components shown in Figure 1.

Figure 1 - The left wing fuel gauge pointer (left) and the underside of the fuel gauge (right)
