# National Transportation Safety Board

Office of Research and Engineering

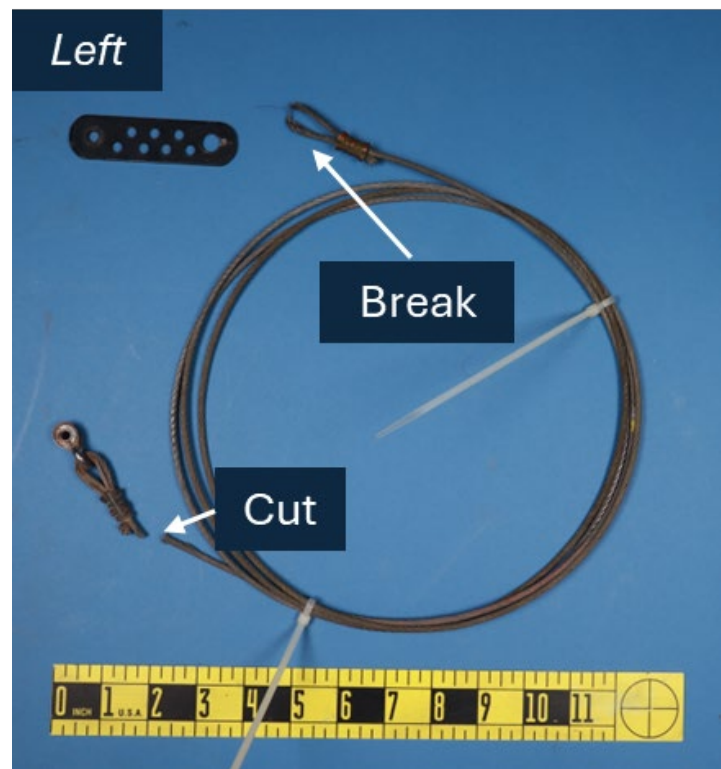
**Figure 2.** The fractured left rudder cable. The cable was cut during recovery.

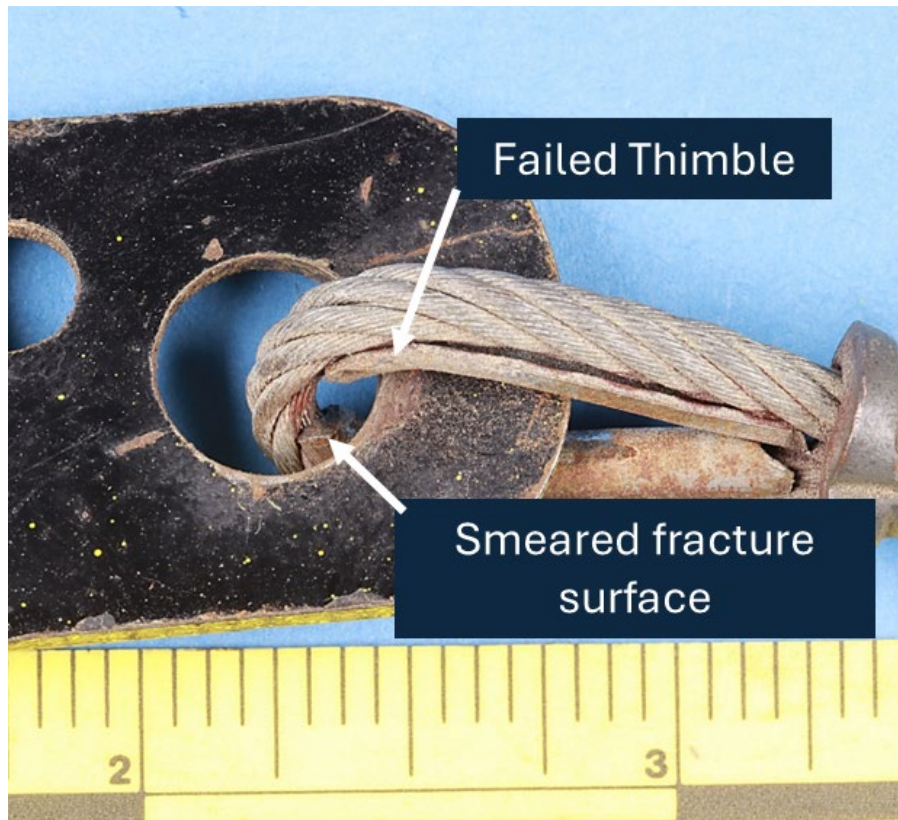
**Figure 3.** Close-up image of the right rudder cable showing the broken thimble in the loop attaching the cable to the linkage.

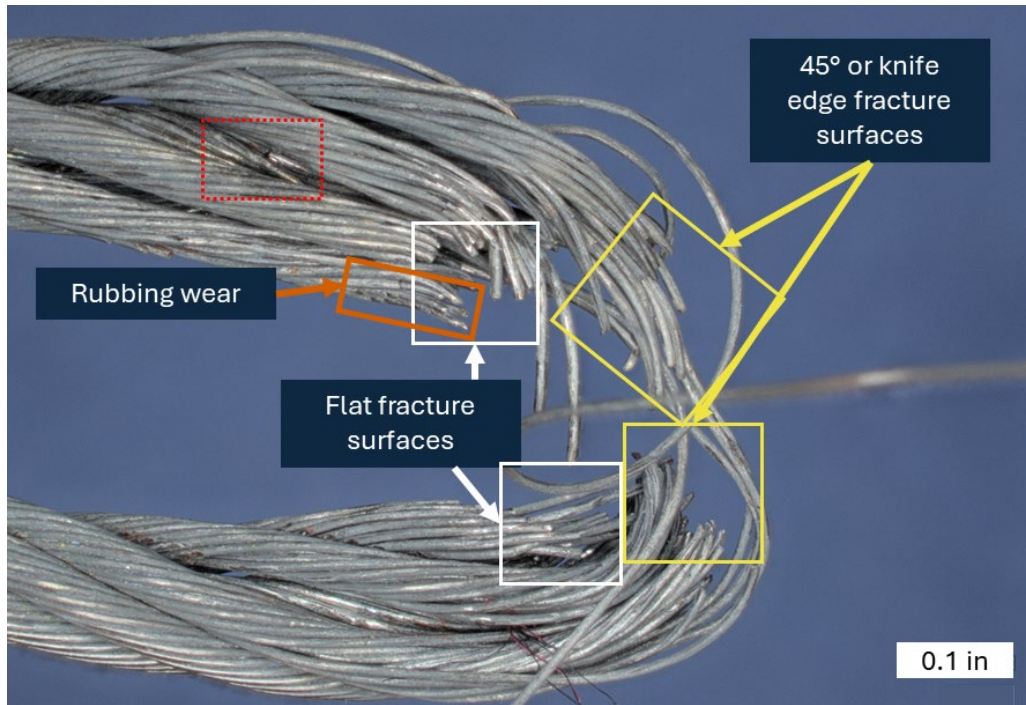
**Figure 4.** Fractured end of the cable loop from the left rudder cable. The area outlined in the red dashed line is highlighted in Figure 6.

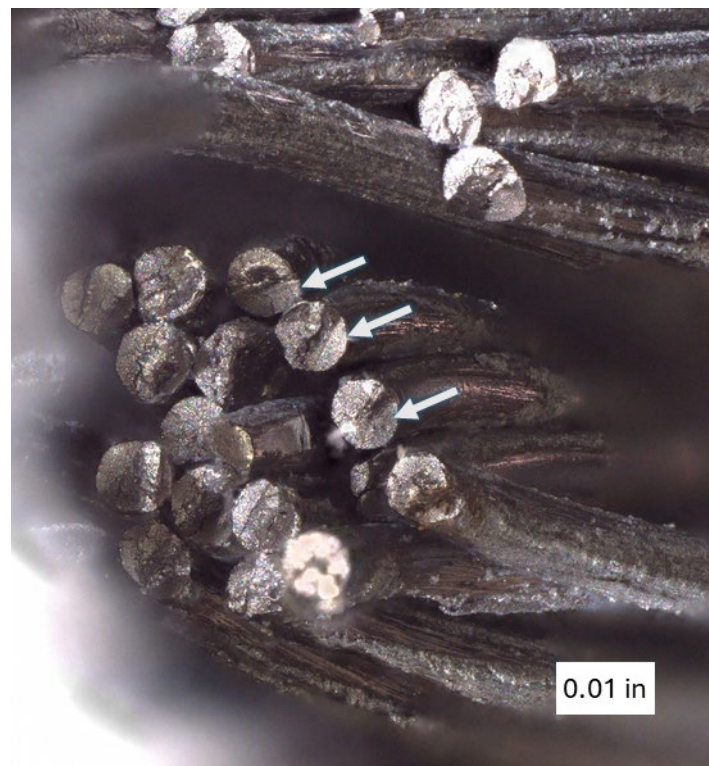
**Figure 5.** Magnified view of a fractured cable bundle. White arrows point to thumbnail-shaped regions on several strands.

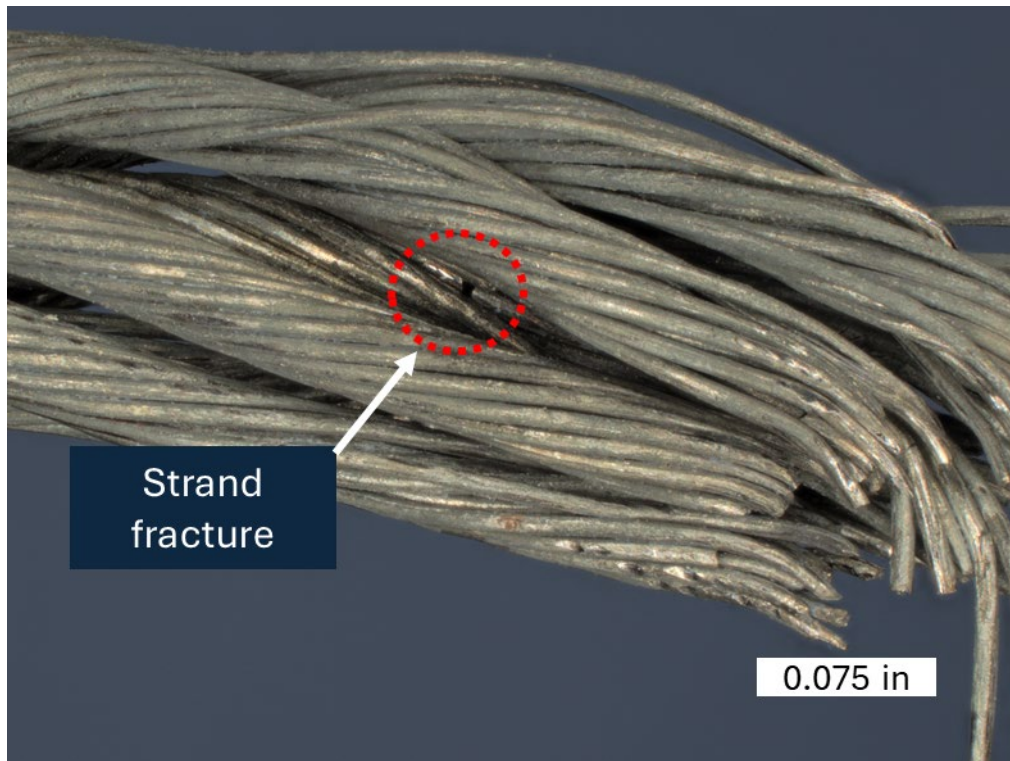
**Figure 6.** Fractured wire in a strand away from the cable failure.

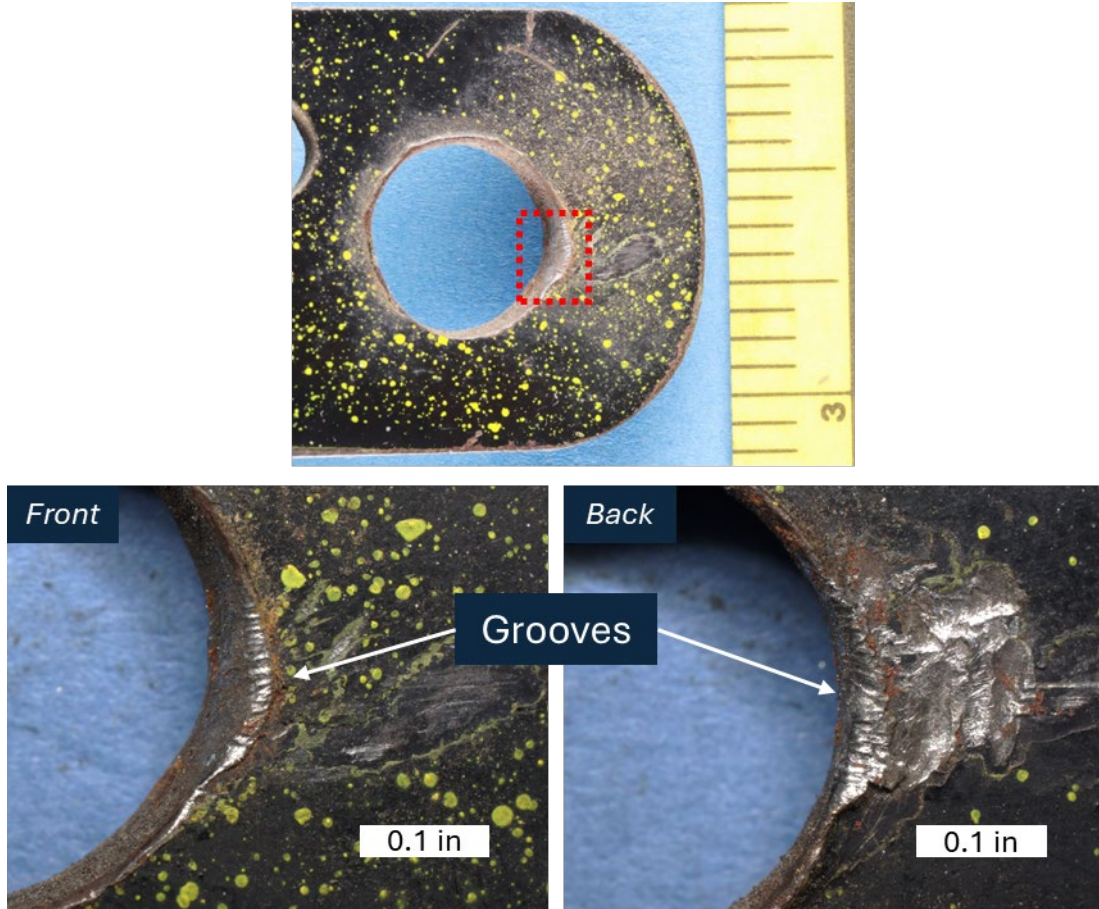
**Figure 7.** (Top) Left linkage. The red square shows the location of surface damage at the corner of the through hole where the cable would have been attached. (Bottom Left) Magnified view of the damage, which resembles grooves on the front side of the linkage. (Bottom Right) Magnified view of the grooves on the back of the linkage.
