CEN25LA050

## INVESTIGATION PHOTOGRAPHS

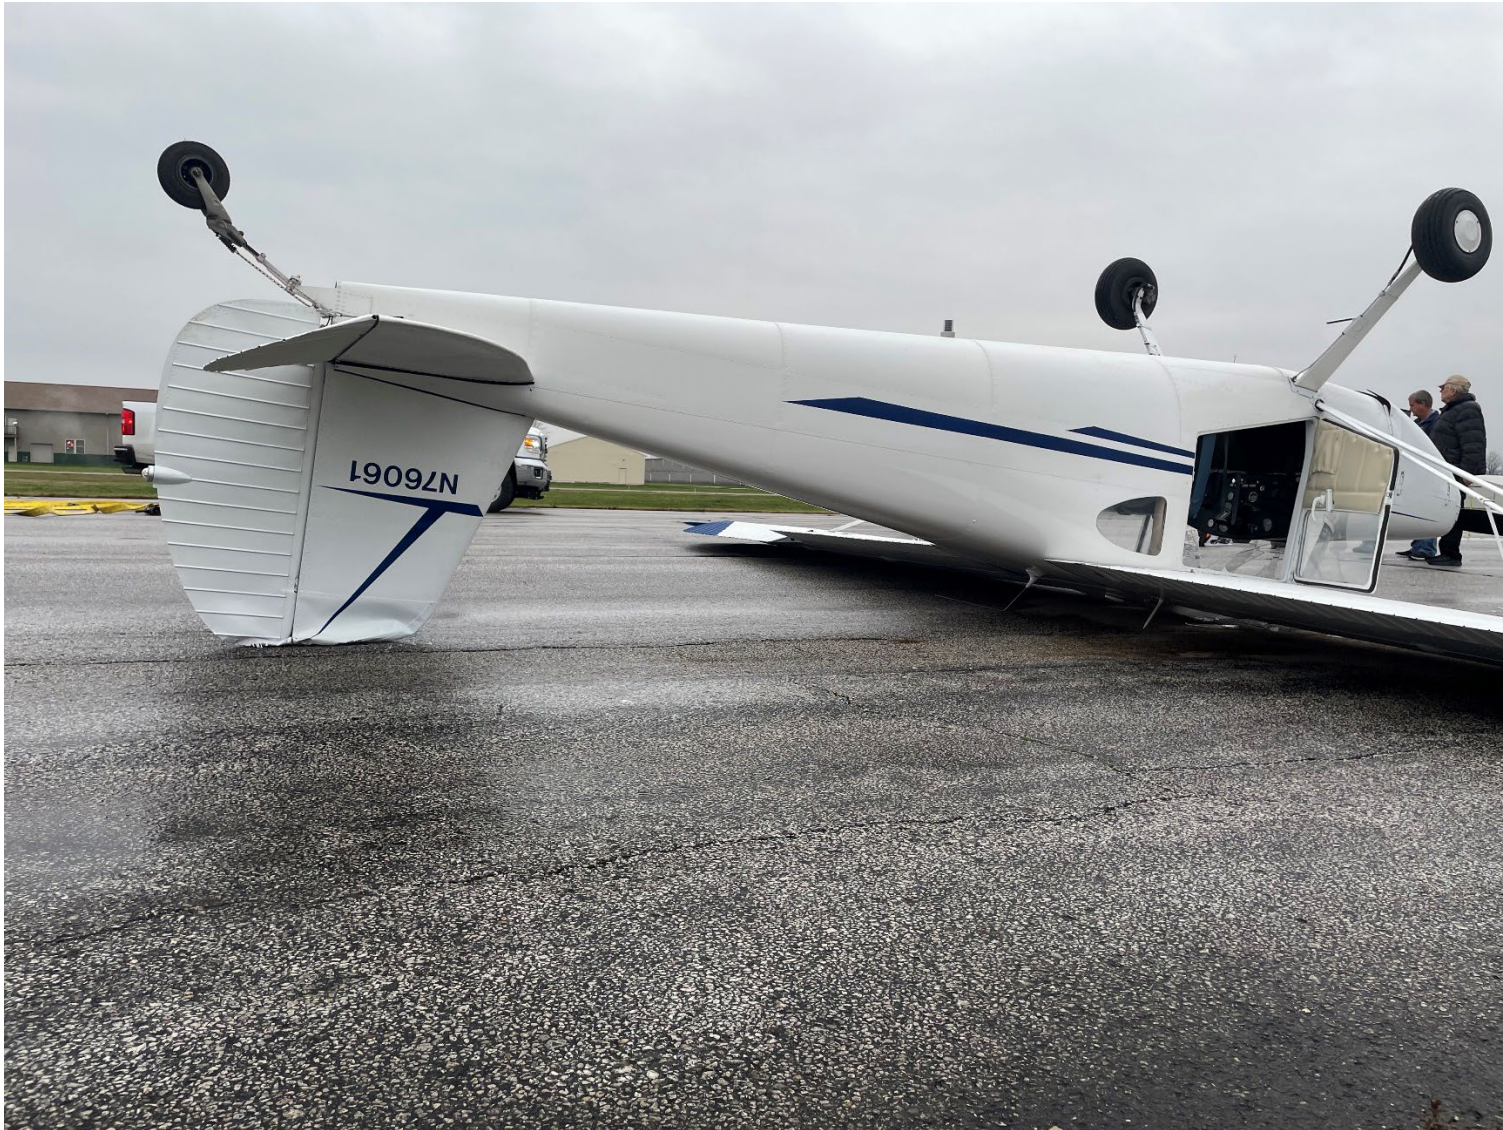
**Photograph 1 - Accident Site (Courtesy of Airport Manager)**

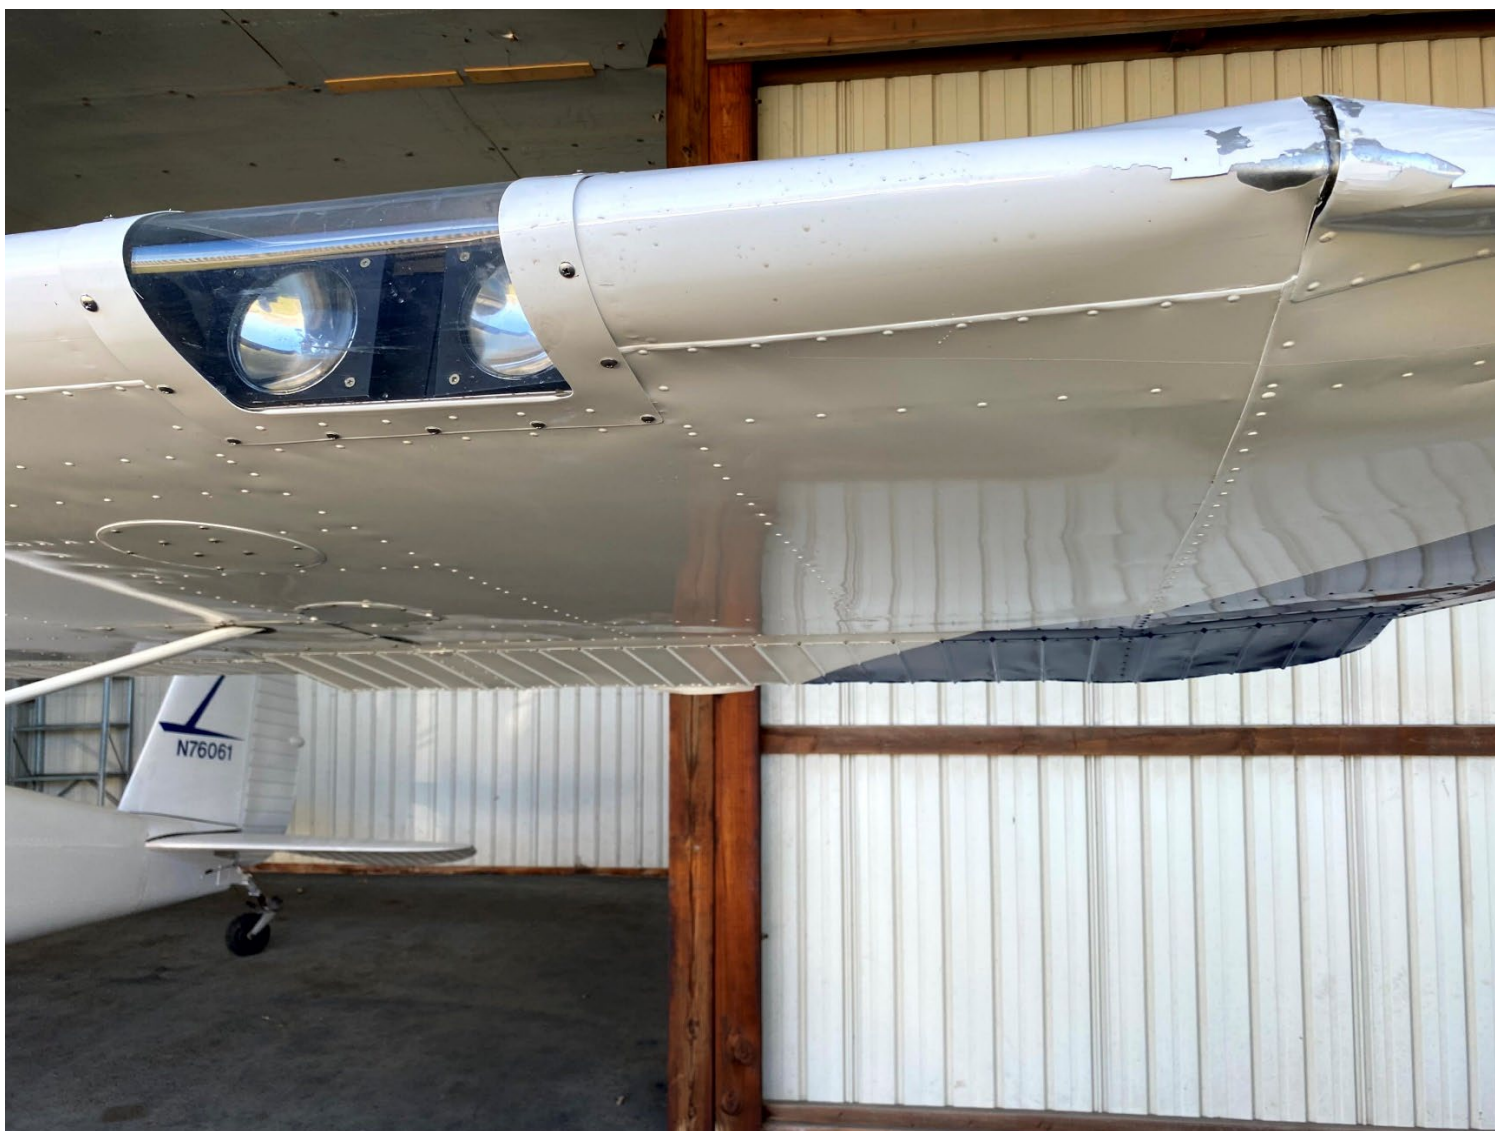
**Photograph 2 - Left Wing Damage (Courtesy of Federal Aviation Administration)**
