CEN25LA053

## INVESTIGATION PHOTOGRAPHS

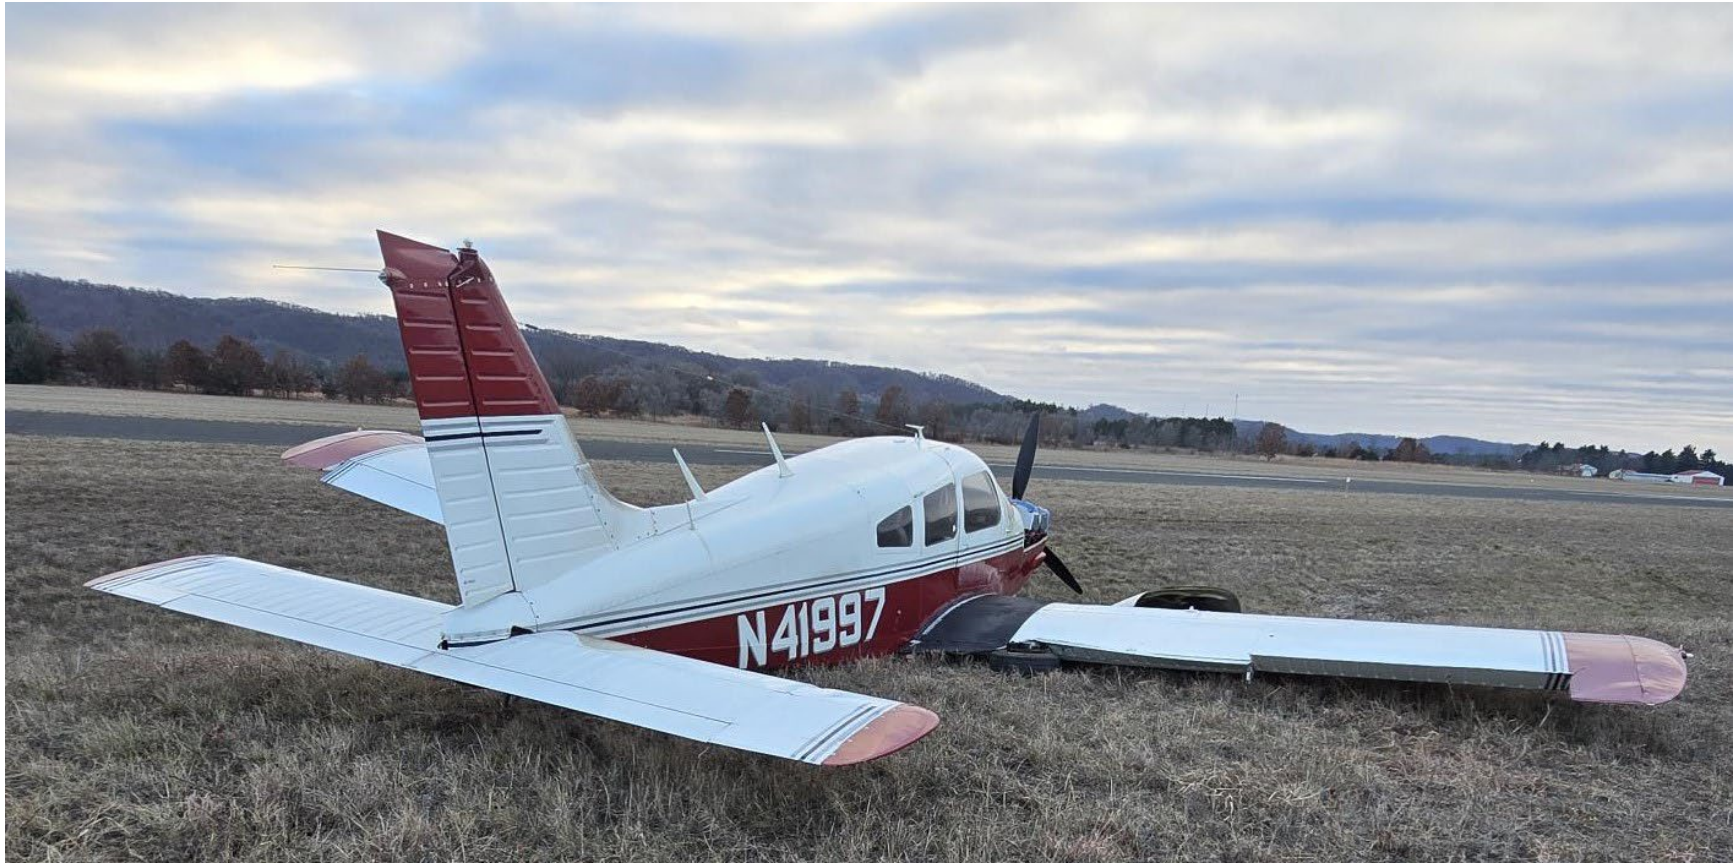
**Photograph 1 - Accident Airplane (Source: Federal Aviation Administration)**

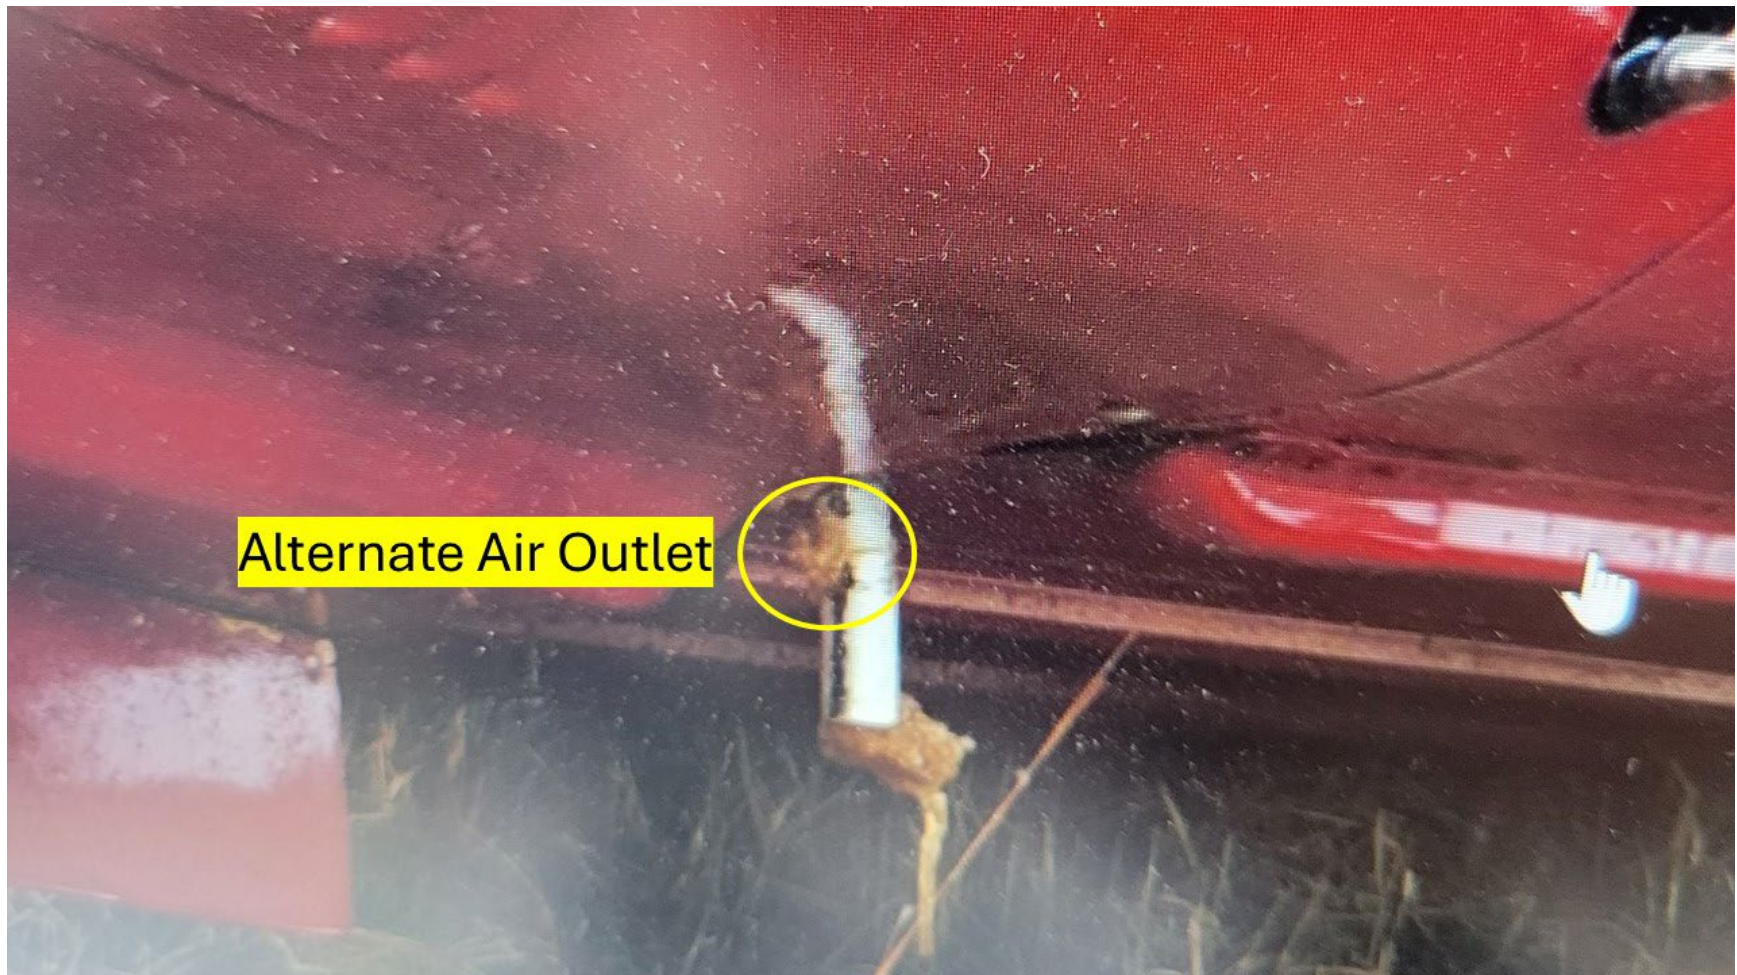
**Photograph 2 - Ice obstructed engine oil breather tube and alternate air outlet (Source: Recovery Company)**

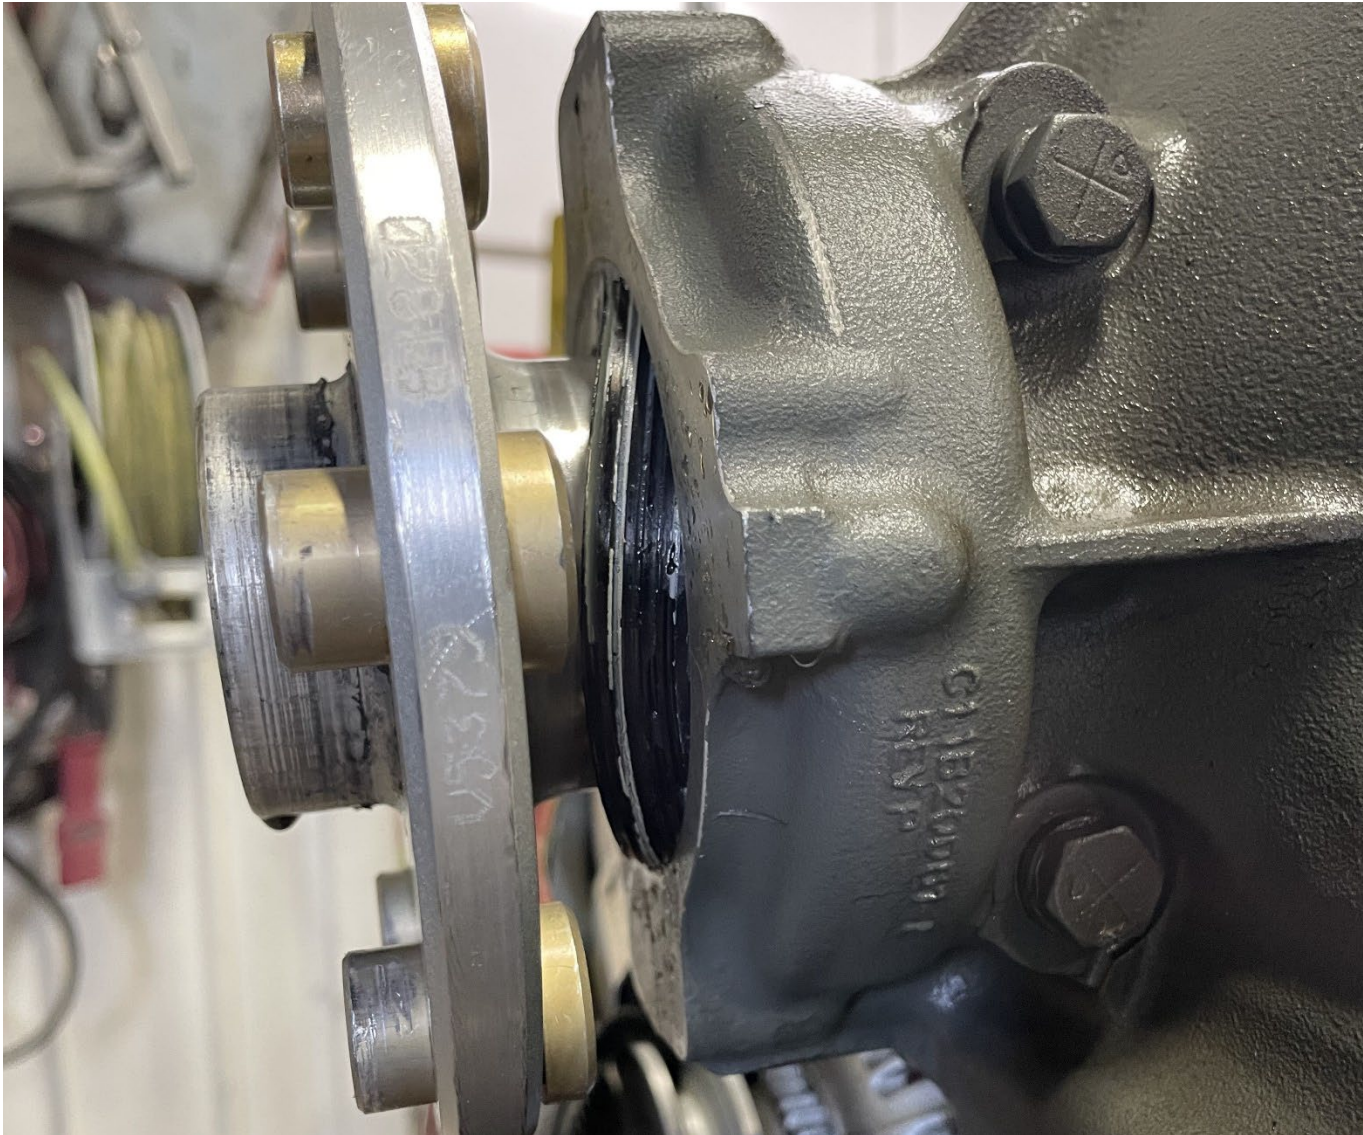
**Photograph 3 - Extruded crankshaft oil seal**

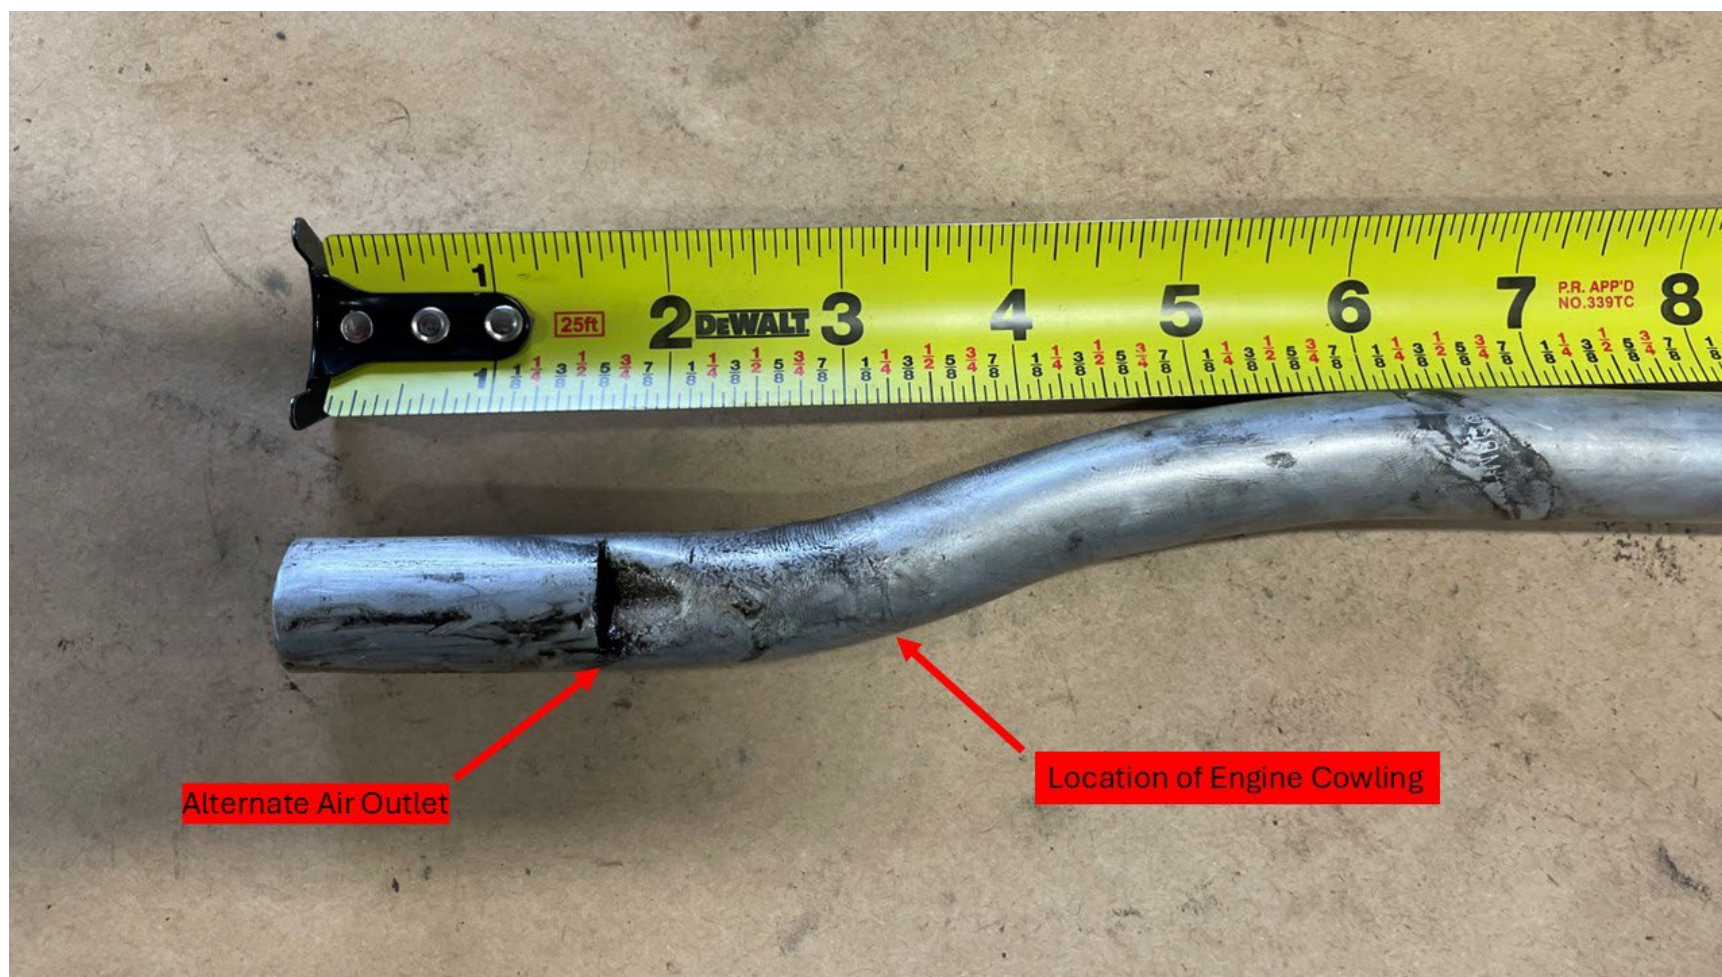
**Photograph 4 - Engine oil breather tube with alternate air outlet and location of engine cowling**
