# National Transportation Safety Board

CEN25LA053

## AIRCRAFT EXAMINATION SUMMARY

Location: Boscobel, WI  
Date: 12/01/2024  
Time: 18:21 CST  
Aircraft: Piper PA-28R-200; N41997

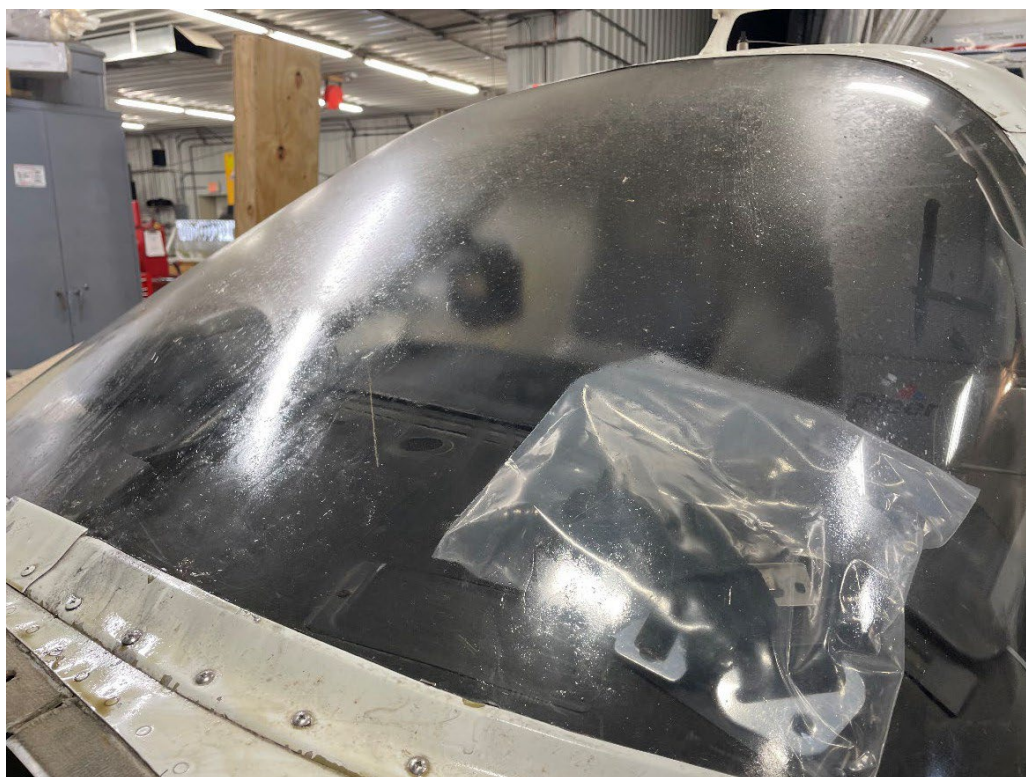
- Oil residue covered forward windscreen, right side of fuselage and vertical stabilizer (horizontal stabilator removed during recovery and washed – pre-recovery photographs showed oil residue on horizontal stabilator).

2. Oil residue noted on forward windscreen.

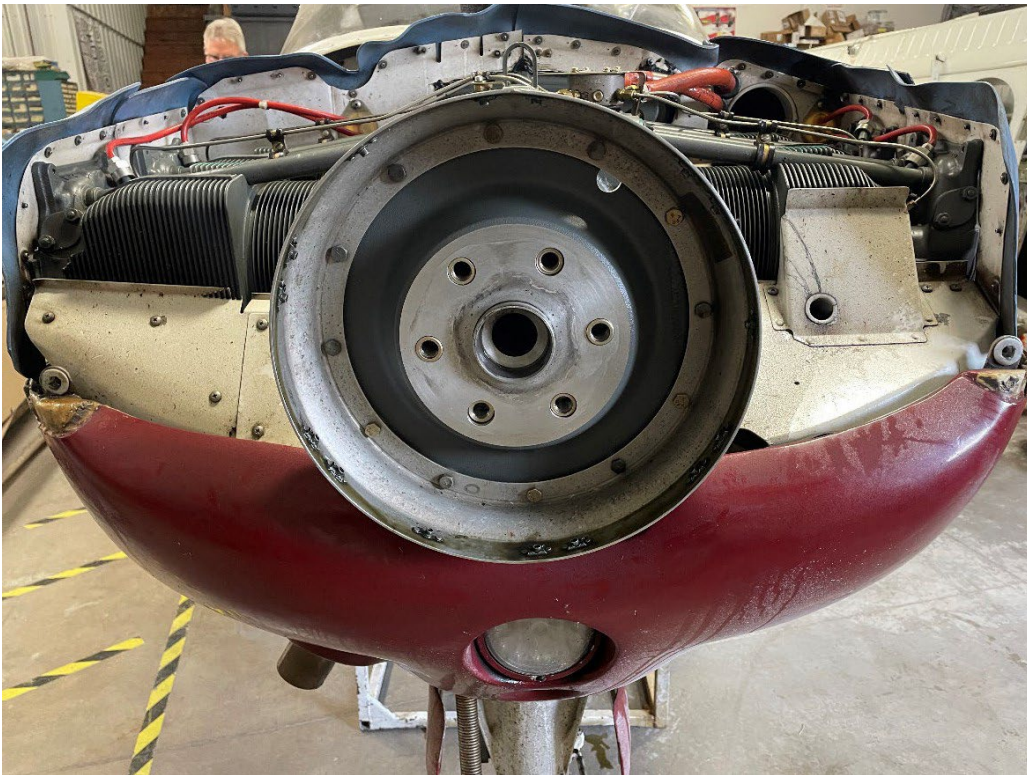
4. Propeller removed.

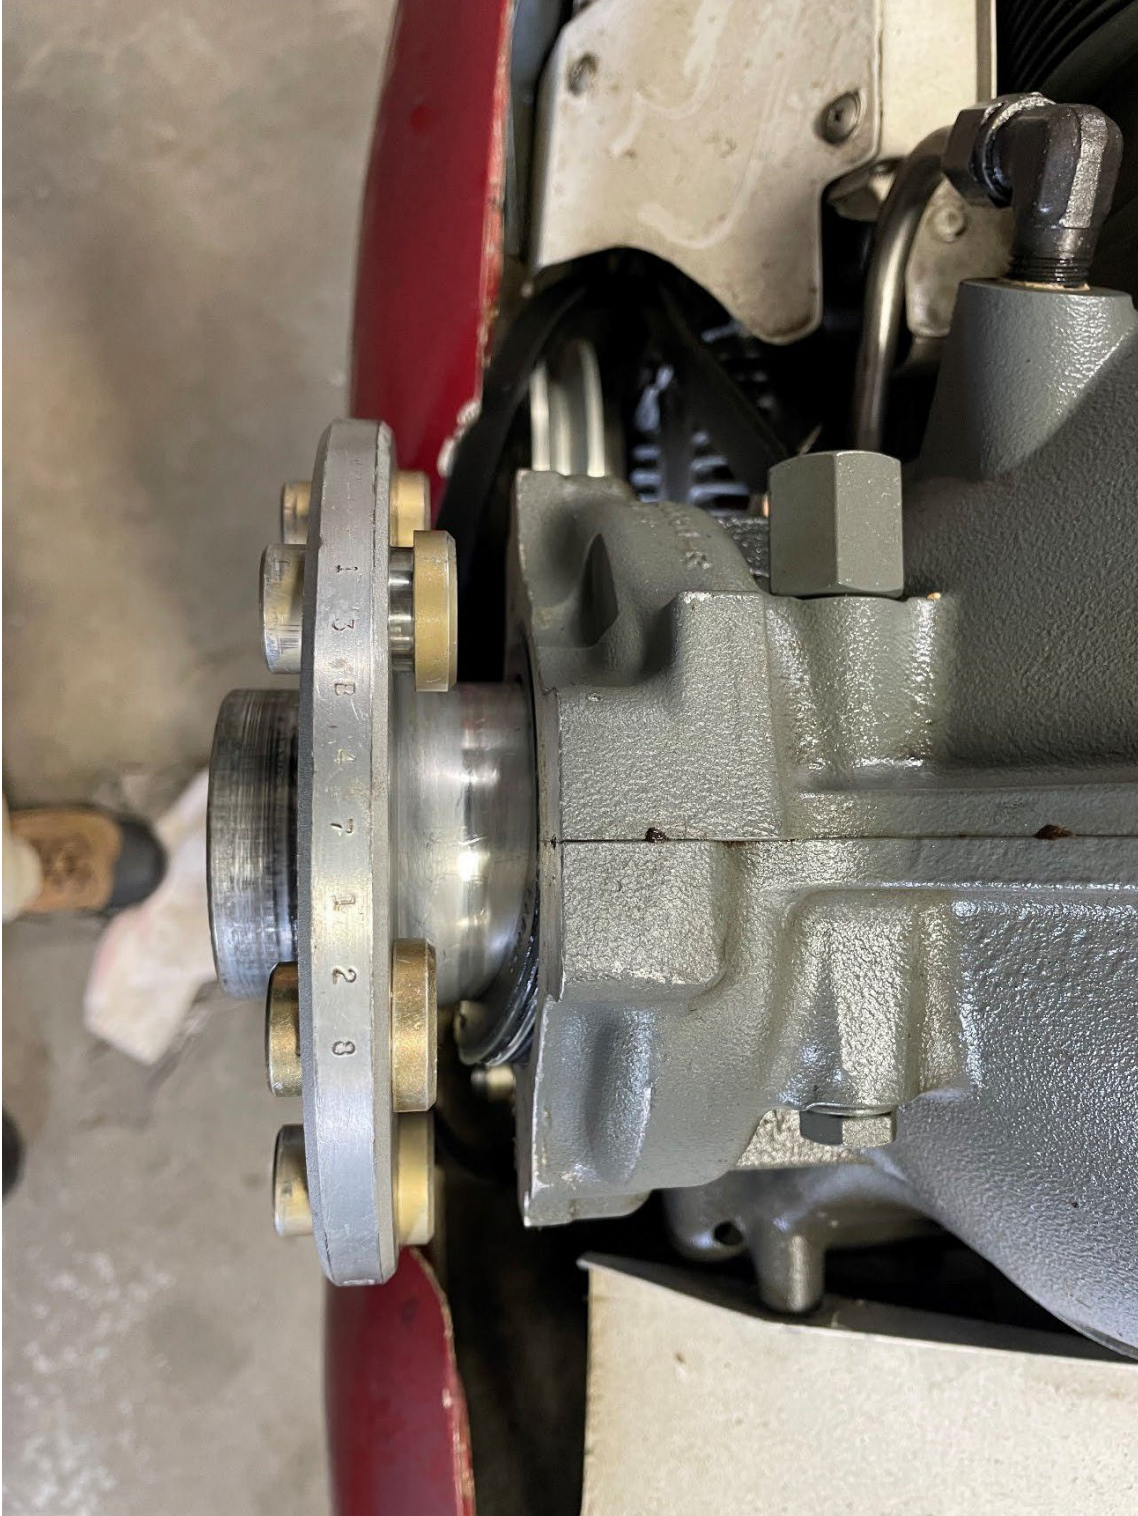
- Oil dipstick measured 3 quarts of oil contained within the engine.
- Engine/airframe oil breather clear of obstructions.
- Propeller and ring gear support removed, nose seal protruding from crankcase.

5. Nose seal protruding from crankcase.

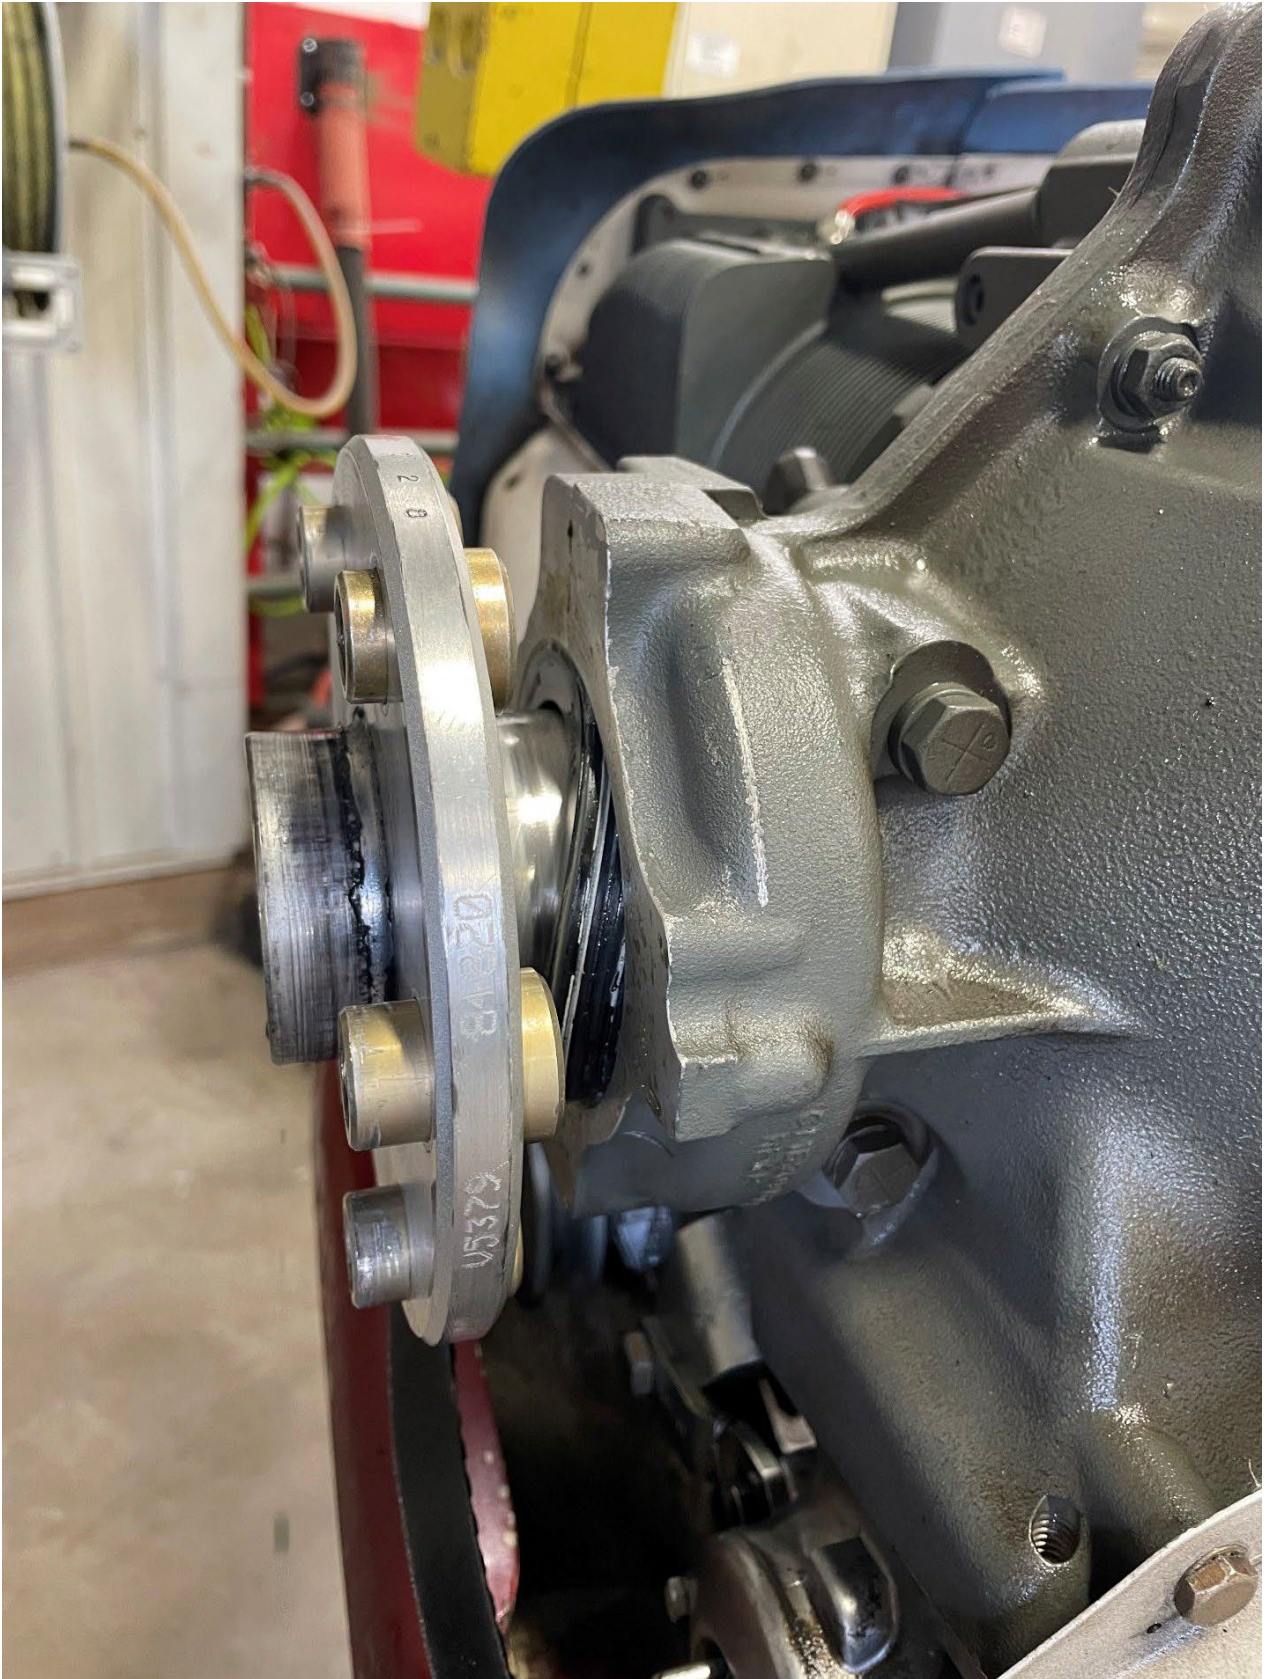
6. Nose seal protruding from crankcase.

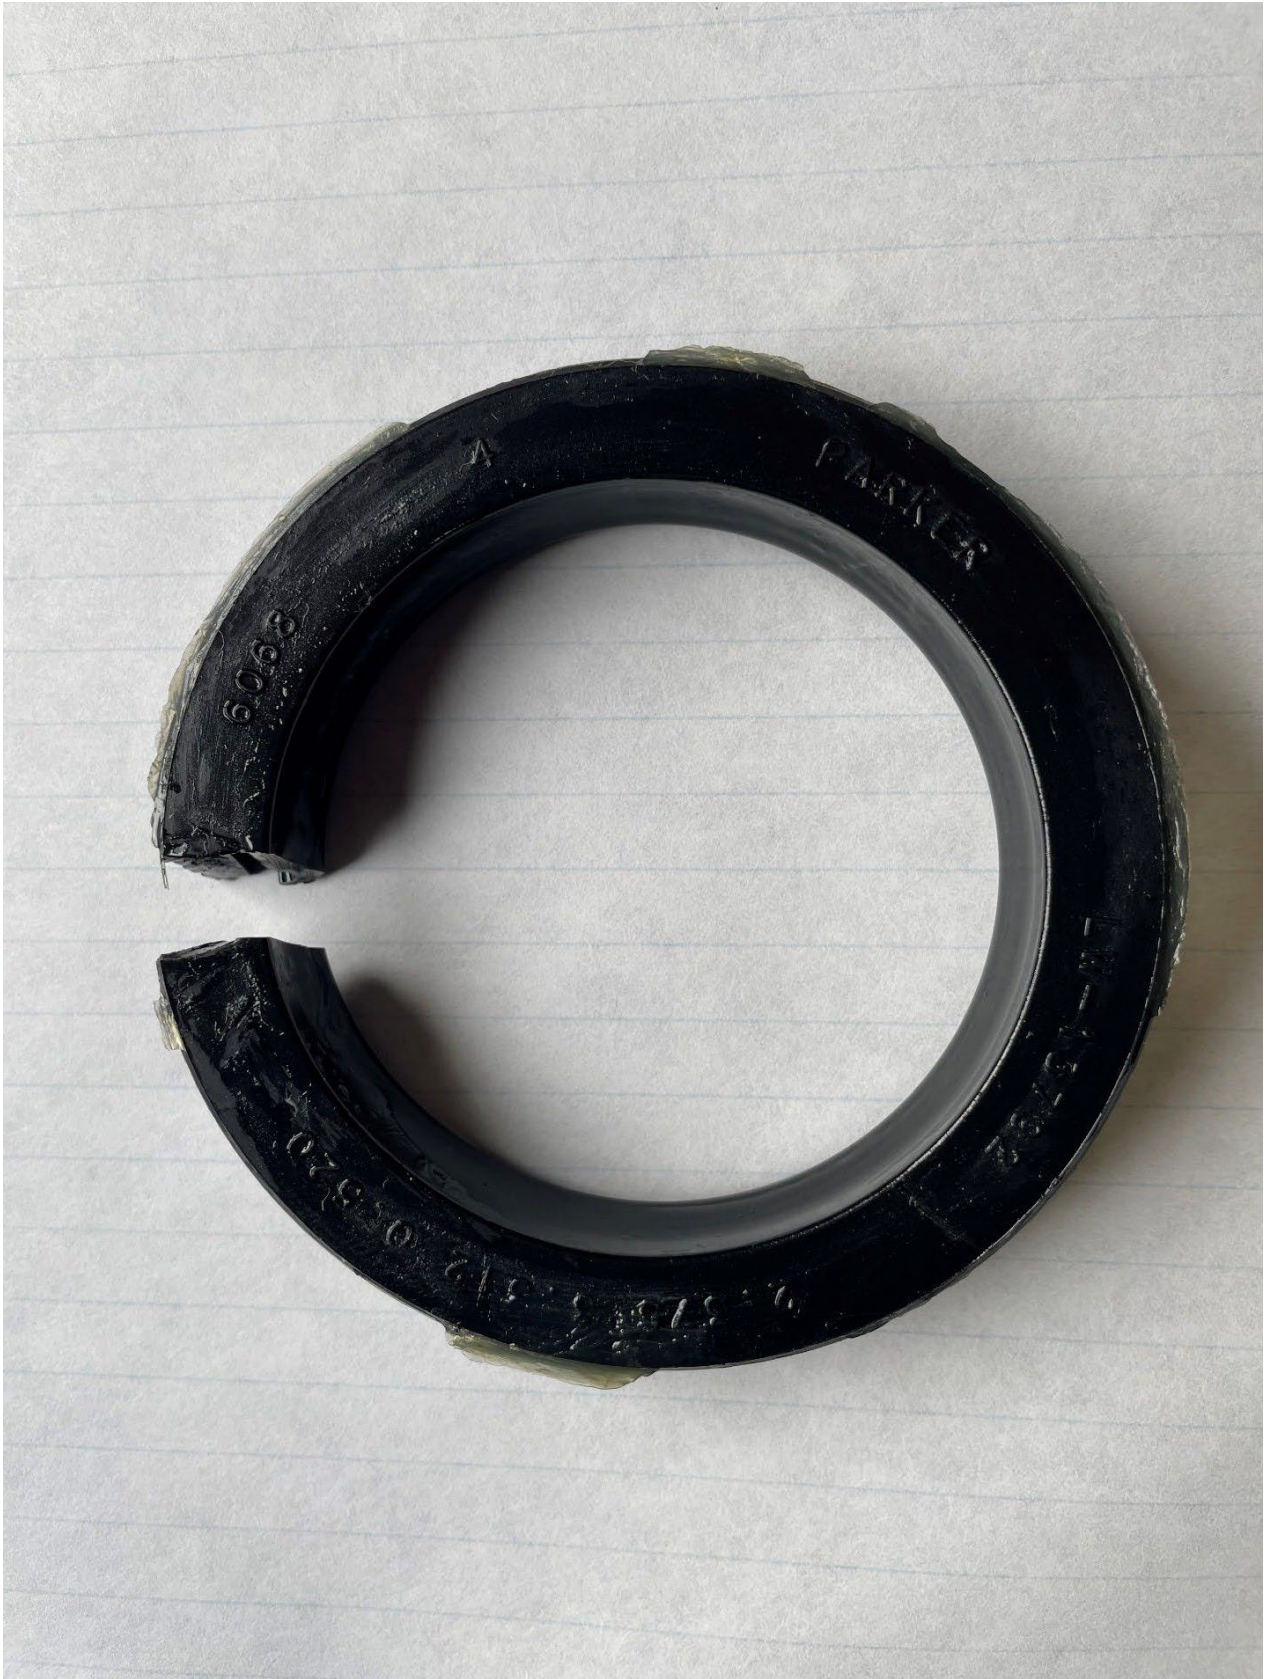
- Nose seal removed by cutting seal to facilitate removal around crankshaft.
- Top spark plugs removed; no issues noted.
- All four cylinders borescoped; no issues noted.

7. Nose seal removed from engine - front face.

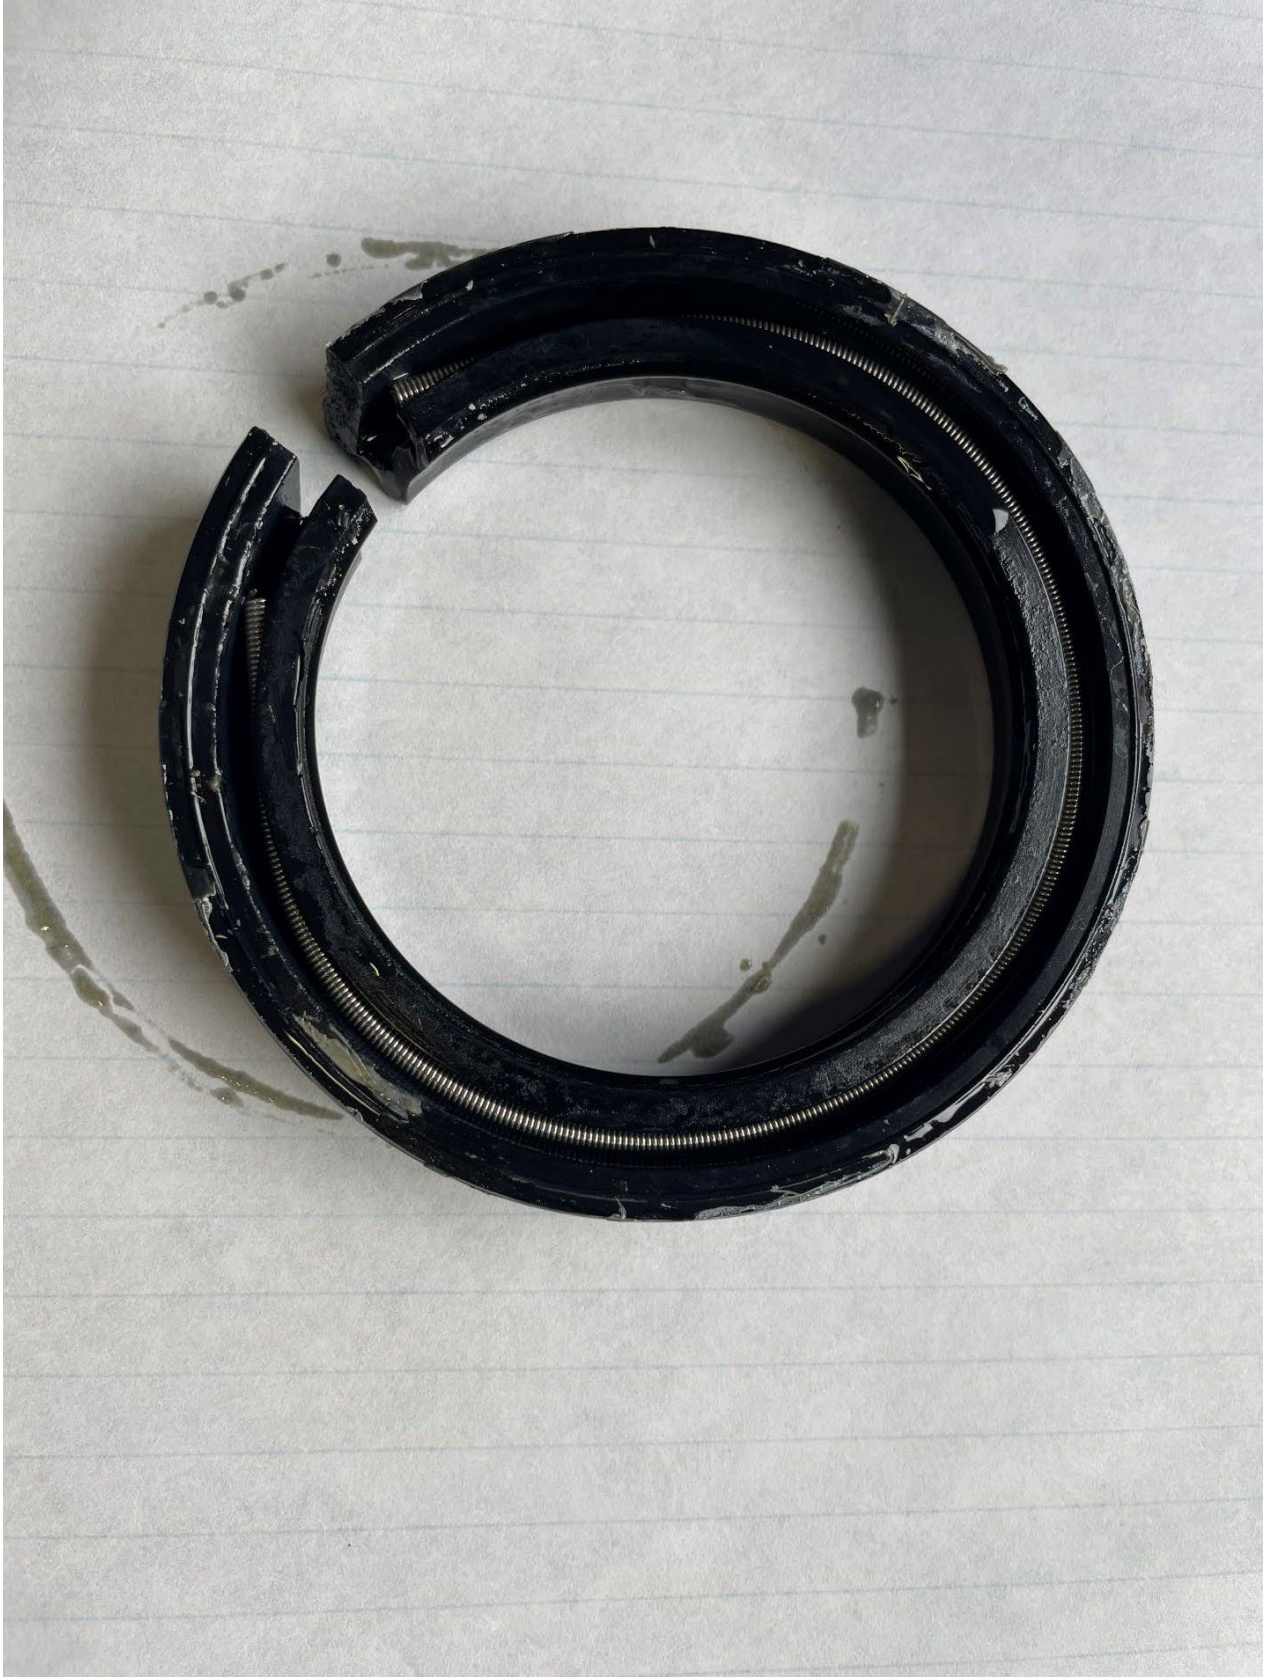
8. Nose seal removed from engine - rear face.

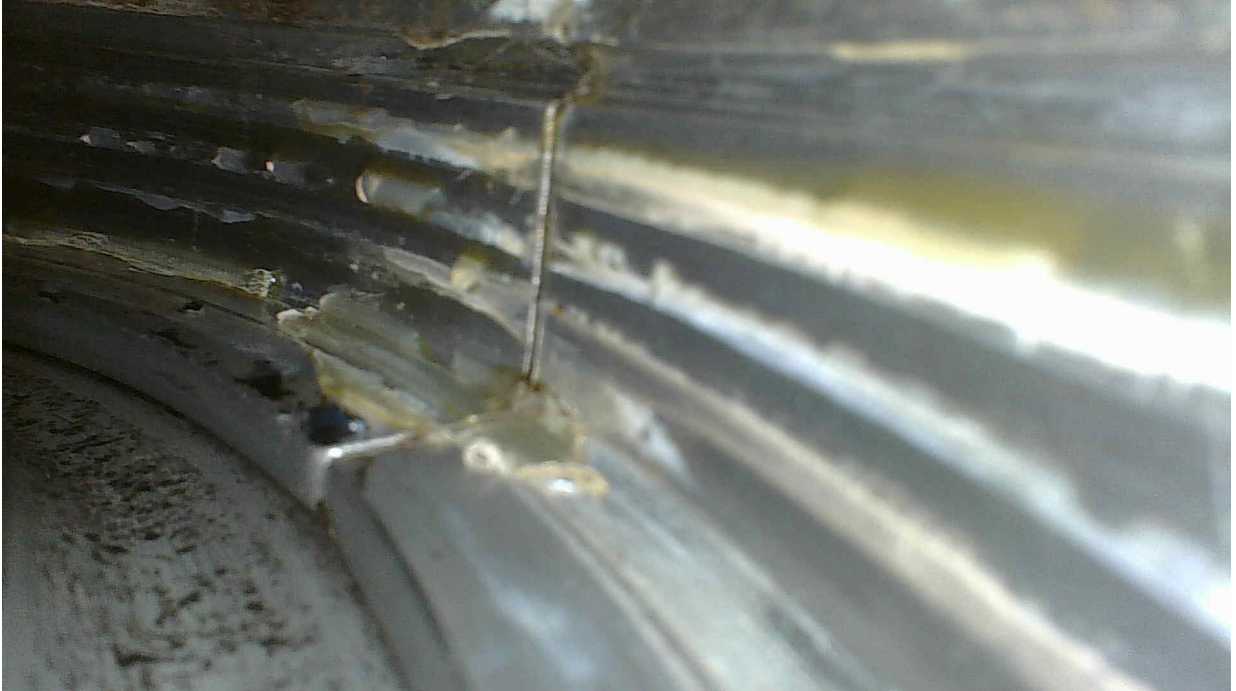
9. Crankshaft bore at upper case halves (photo taken with a borescope).

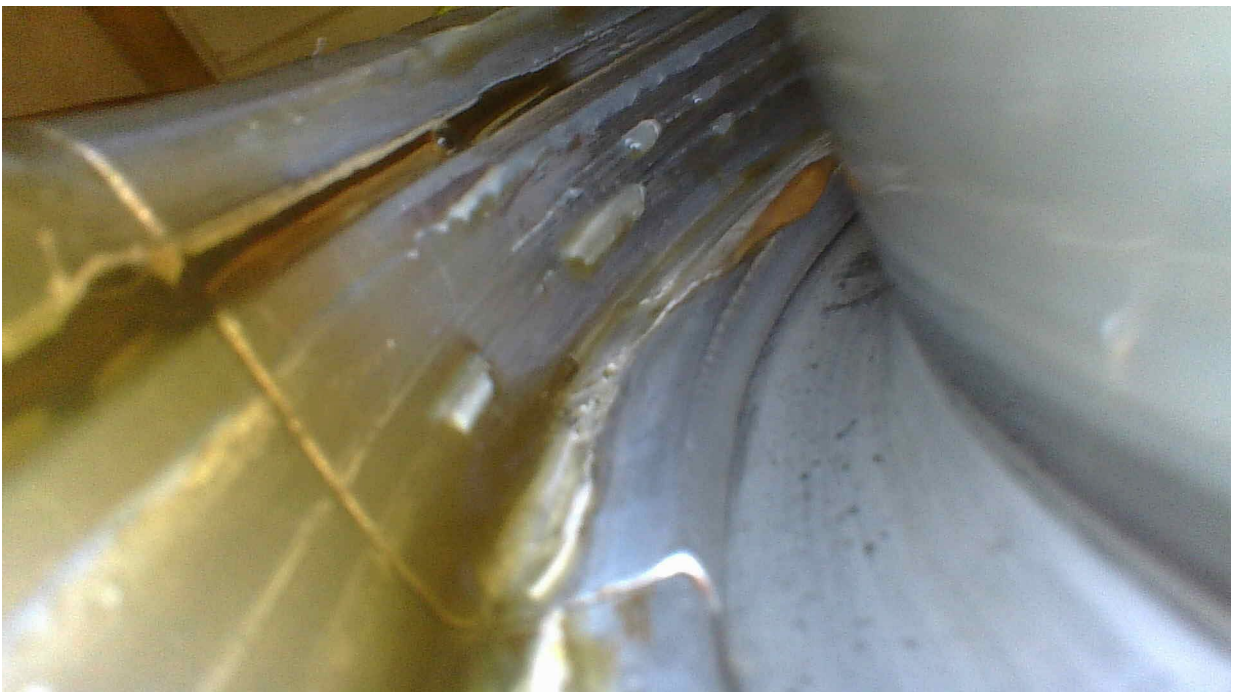
10. Crankshaft bore at lower case halves (photo taken with a borescope).

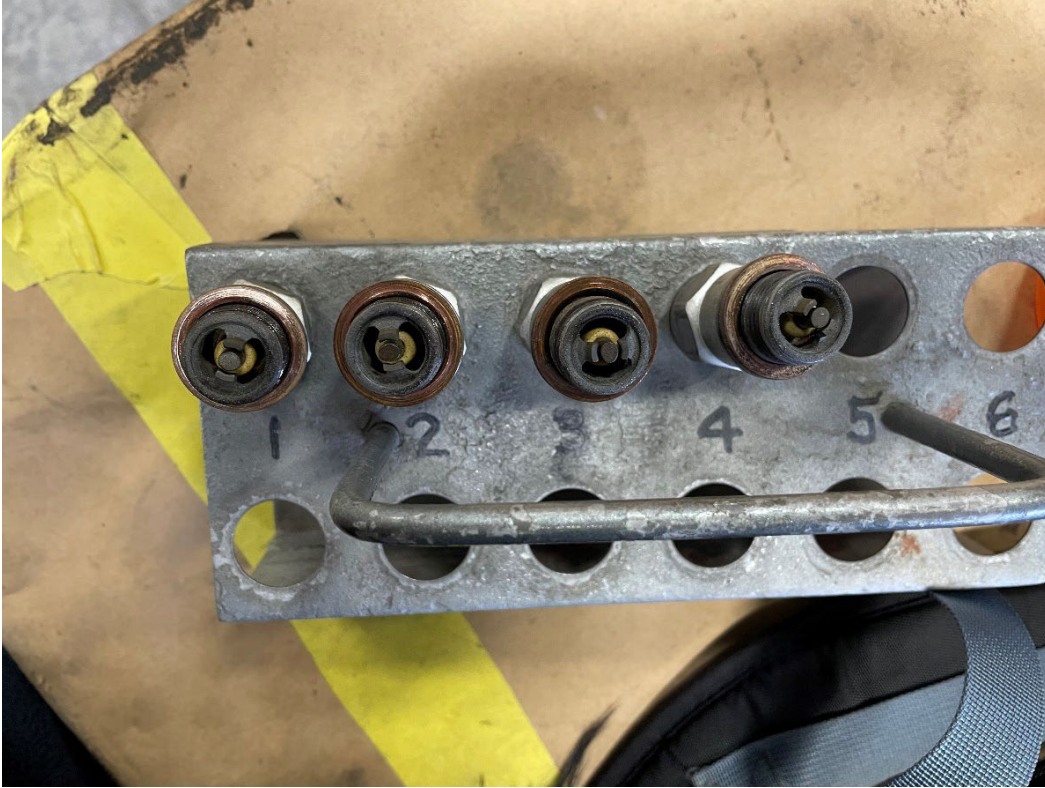
11. Engine top sparks plugs.

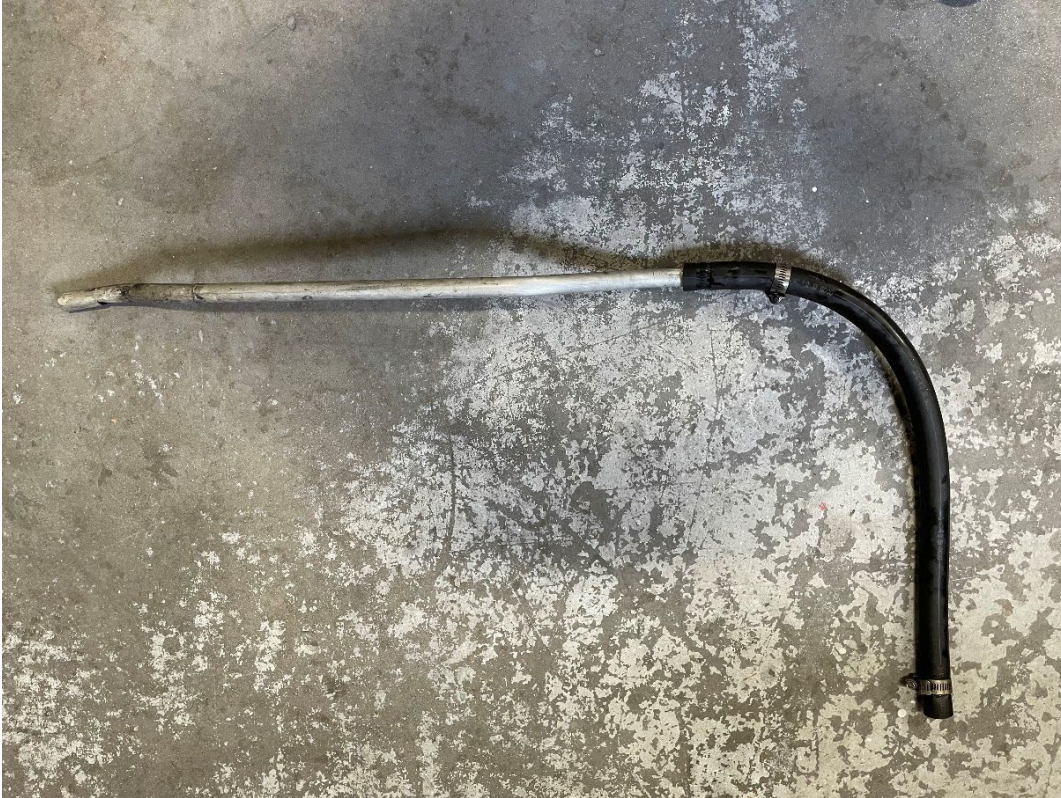
13. Aircraft oil breather tube, as removed.

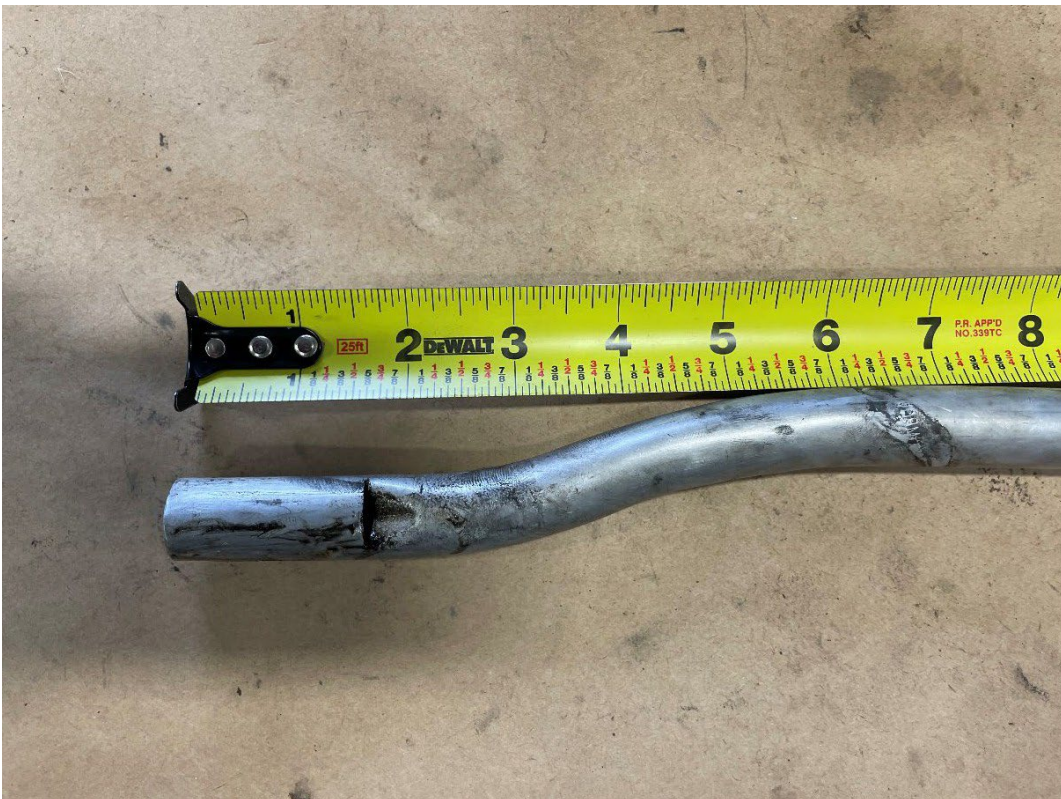
- Engine/airframe breather tube removed. Secondary breather hole located about 1.5” from the bottom/end of the aluminum tube.

14. Bottom/end of breather tube with secondary hole.
