# National Transportation Safety Board

CEN25LA054

## **RECORD OF CONVERSATION**

On December 13, 2024, at 1500 central standard time, NTSB Investigator Fox, FAA Inspector Horacek, and Lycoming Air Safety Investigator Harsanyi discussed the wreckage examination of American Aviation AA-1B airplane, N6242L, that was involved in a forced landing accident that occurred on December 1, 2024, shortly after takeoff from runway 34 at Brenham Municipal Airport (11R), Brenham, Texas:

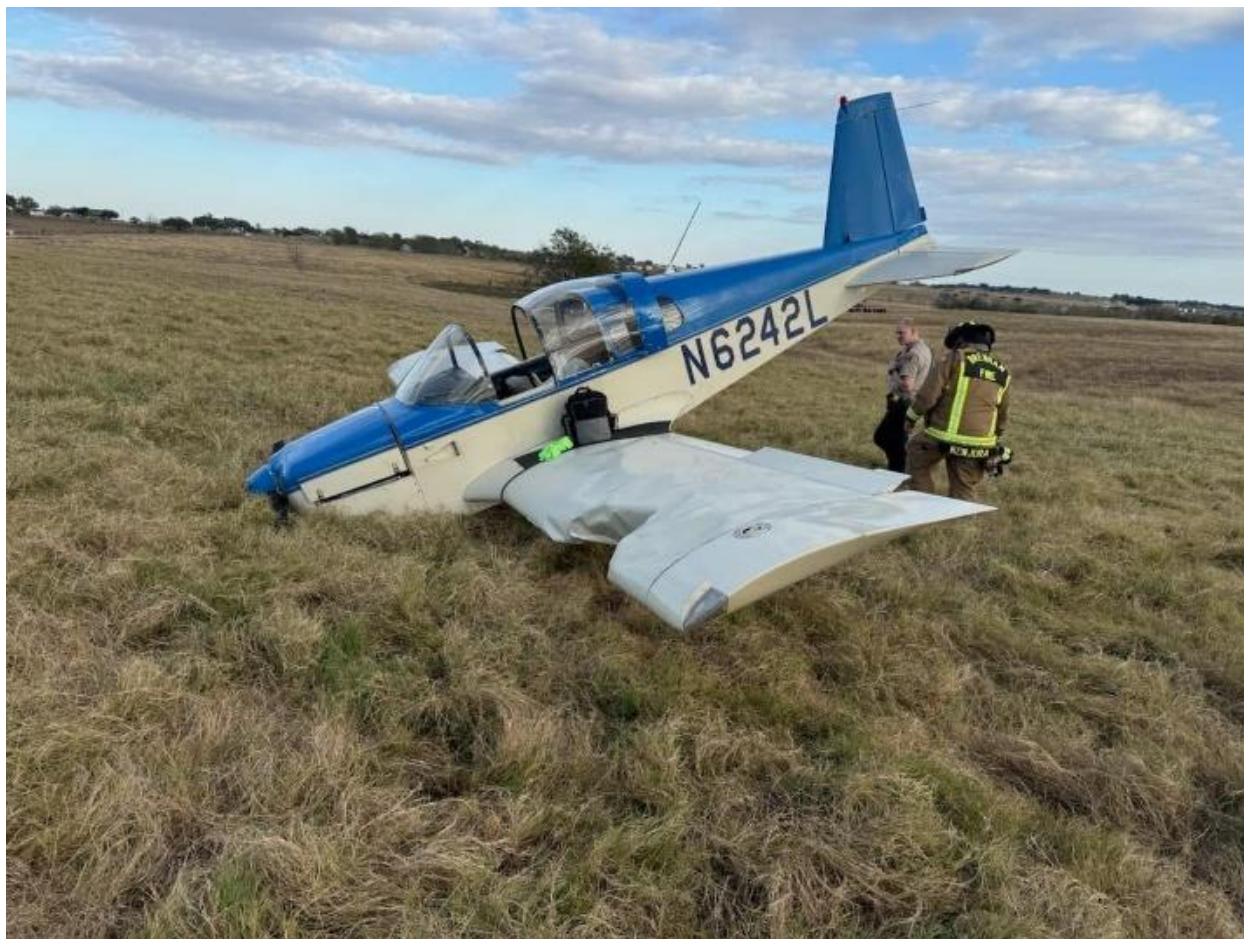
Inspector Horacek stated that the airplane's left wing leading edge was substantially damaged during the forced landing, as shown in figure 1. The left wing exhibited a large semicircular impact likely due to a collision with the separated nose gear and/or with an anthill in the grass field, as shown in figure 2. However, the leading-edge damage did not exhibit evidence of tire rubber transfer or scratching, nor did it contain anything resembling dirt/sand.

**Figure 1.** Airplane at accident site. (Photo courtesy of Brenham Fire Department)

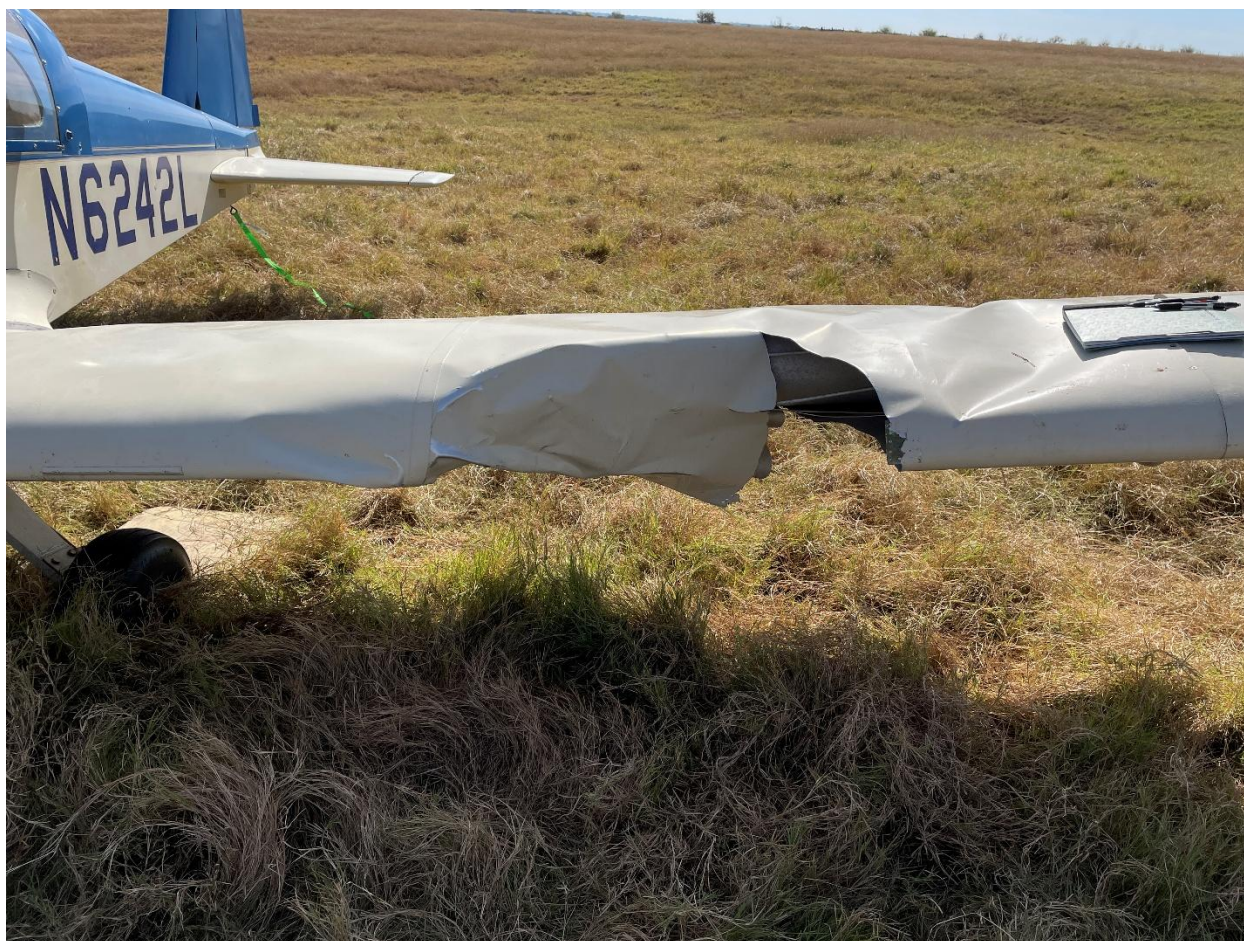
**Figure 2.** Left wing damage. (Photo courtesy of FAA)

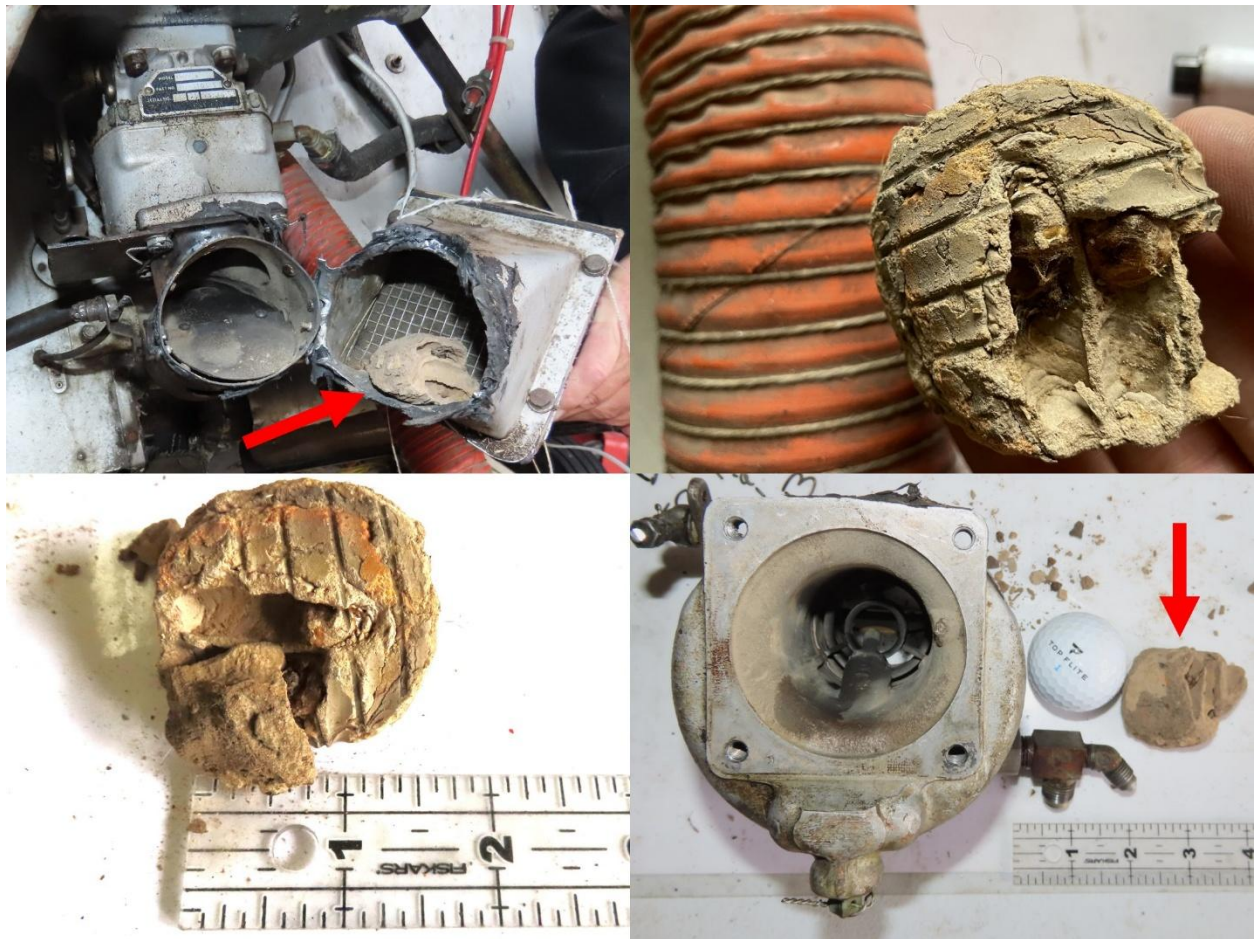
Mr. Harsanyi stated that his examination of the engine did not reveal any evidence of a mechanical failure that would prevent normal operation. Visual examination of the engine's exterior revealed that all four engine cylinders had evidence of mud dauber nests within their respective cooling fins. Additionally, a roughly 1.5-inch diameter mud dauber nest was found in the airbox between the air filter and the throat of the carburetor, as shown in figure 3. Additionally, dirt with the same color as the mud dauber nest was observed within the carburetor throat and on the clean side of the air filter. The recovered mud dauber nest exhibited impressions consistent with the spacing of the wire coil that supported the flexible ducting associated with the

carburetor heat system. The flexible ducting also contained various-sized fragments of mud dauber nest debris.

**Figure 3.** Mud dauber nest found in the airbox between the air filter and the throat of the carburetor. Red arrows point to the mud dauber nest. (Photos courtesy of Lycoming Engines and edited by NTSB)
