CEN25LA058

## INVESTIGATION PHOTOGRAPHS

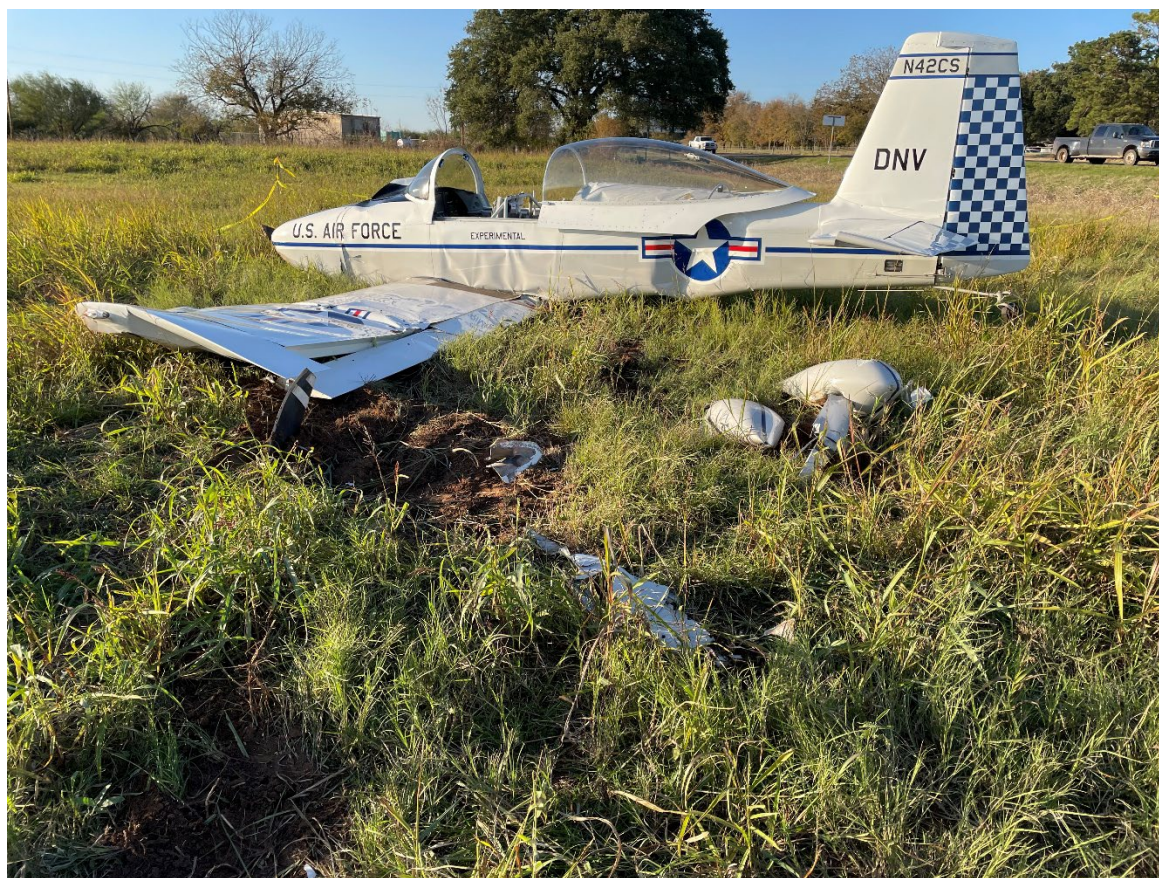
**Photograph 1 - Damage to Airplane (Courtesy of FAA)**

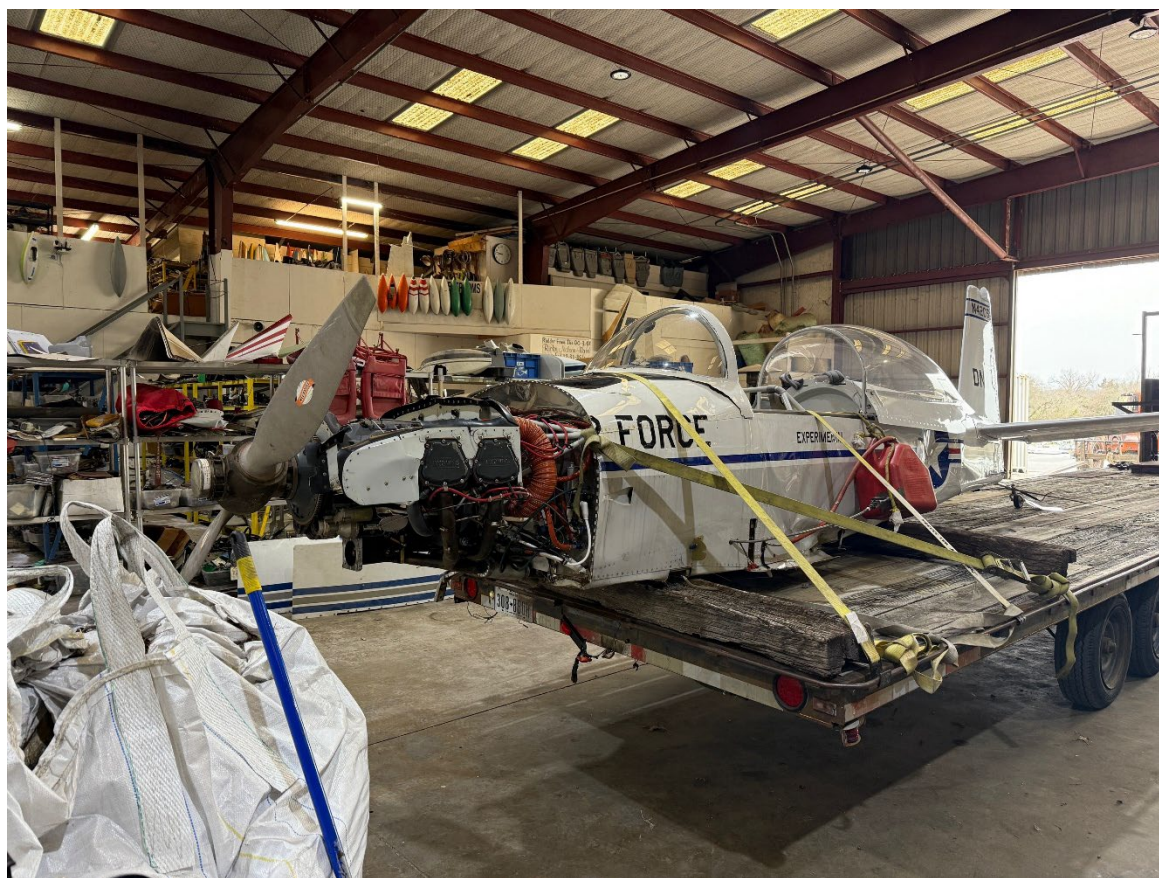
**Photograph 2 - Airplane Prior to Engine Run**
