# National Transportation Safety Board

CEN25LA058

## **ENGINE RUN**

Location: Smithville, Texas  
Date: December 10, 2024  
Time: 1130 Local  
1735 UTC  
Airplane: Vans RV8

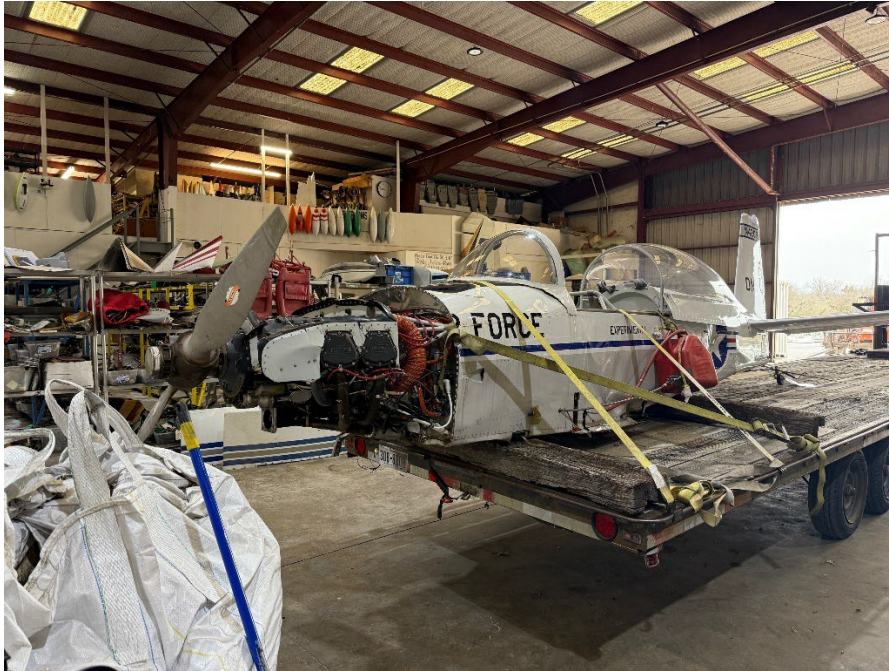
**Figure 1 Airplane Being Setup for Engine Run**

The airplane's engine and propeller were in a condition which allowed for an engine run to be conducted on the airframe. The wings had been removed so fuel was provided via a fuel canister and was connected directly to the fuel system. The airplane was moved outside and prepared for the engine run.

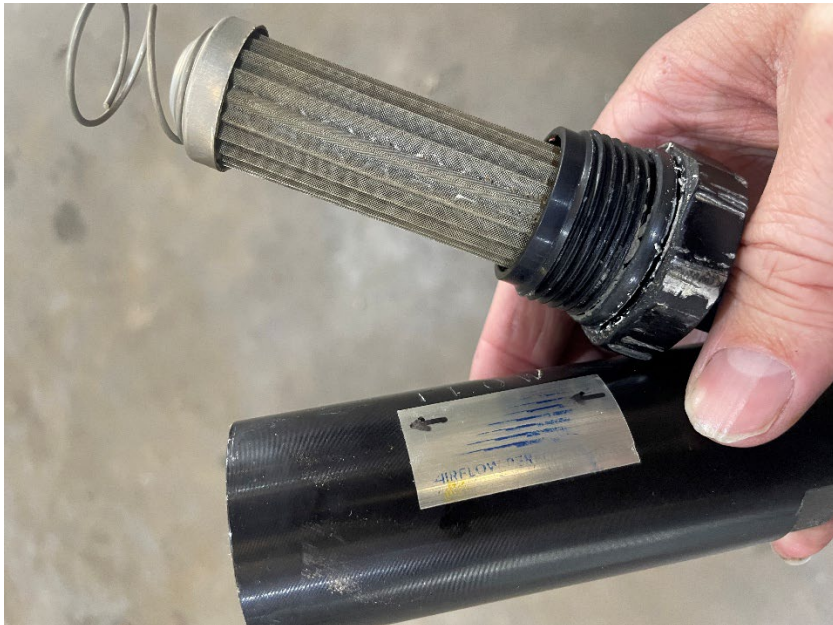
**Figure 2 Fuel Filter**

The engine was primed and started. The engine ran without hesitation and produced rated power. During the engine run, it was noted that the ignition switch did not appear to operate properly, and the engine continued to operate although the switch was moved to the "off" position. The engine run was completed. The fuel filter which was found free of debris.

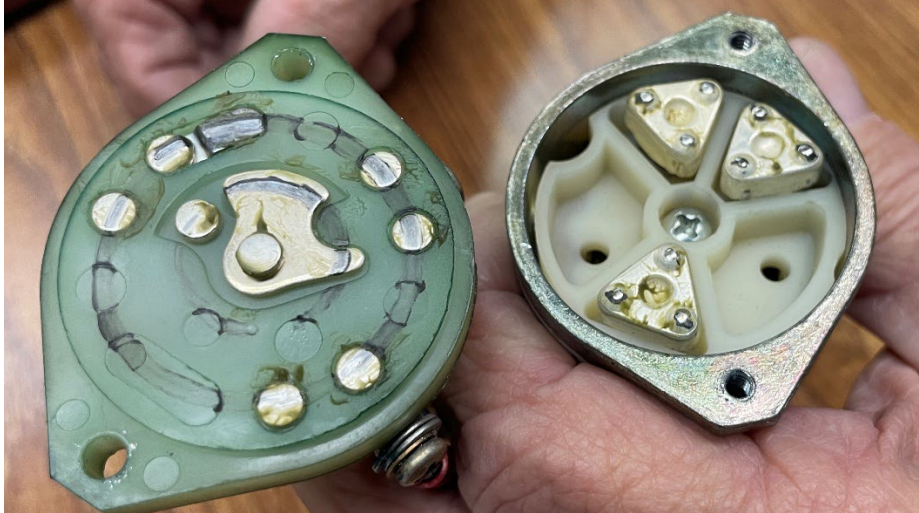
**Figure 3 Ignition Switch**

The ignition switch was removed from the airplane and examined. Using an ohmmeter switch continuity was checked. The switch connection ground intermittently and appeared to be in a condition which would have allowed continued operation of the magnetos. Disassembly of the switch did not find any anomalies. The ignition switch did not appear to contribute to the accident.
