National Transportation Safety Board

CEN25LA071

## INVESTIGATION PHOTOGRAPHS

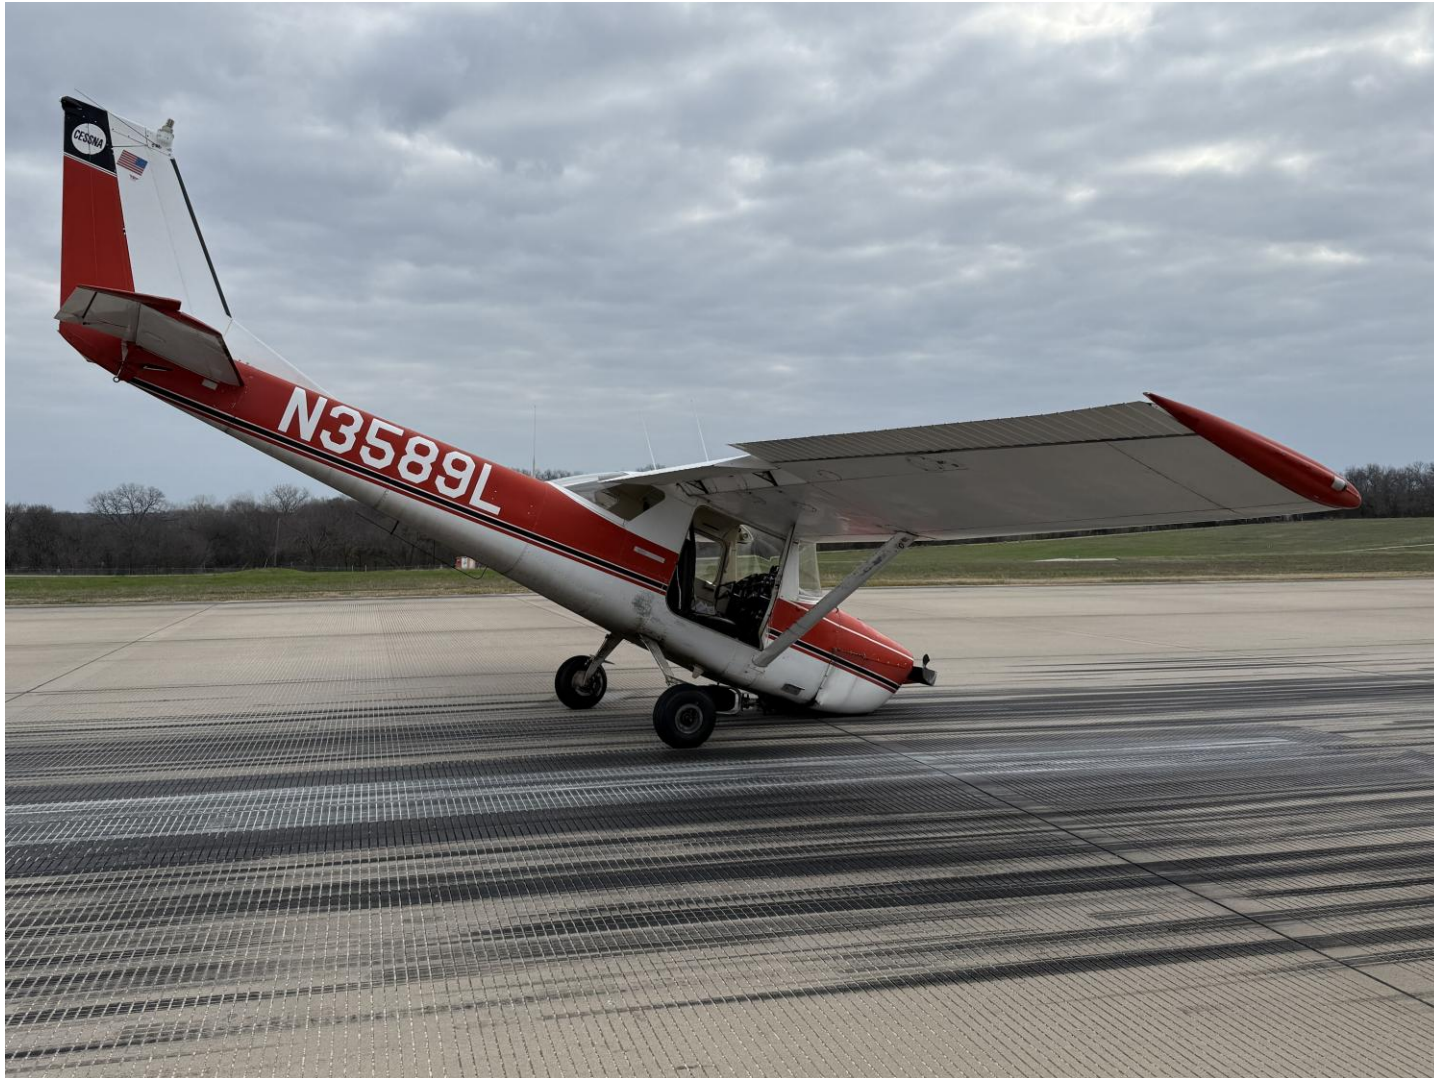
**Photograph 1 - Airplane at Accident Site, Right Side  
(Courtesy of McKinney National Airport Management)**

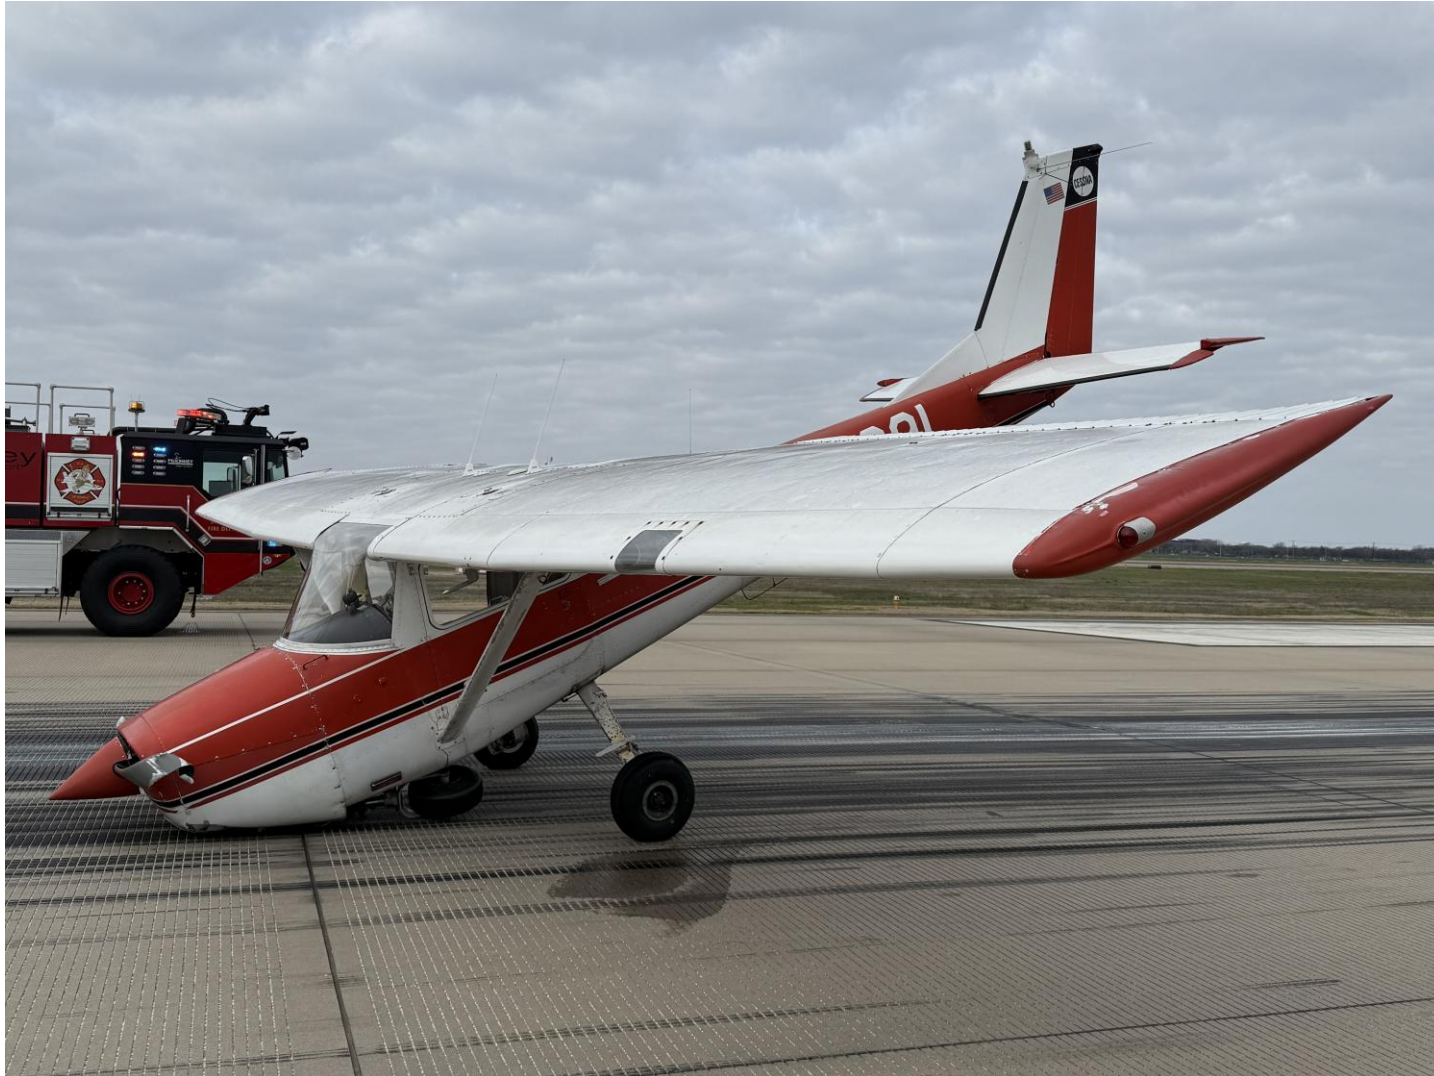
**Photograph 2 - Airplane at Accident Site, Left Side  
(Courtesy of McKinney National Airport Management)**

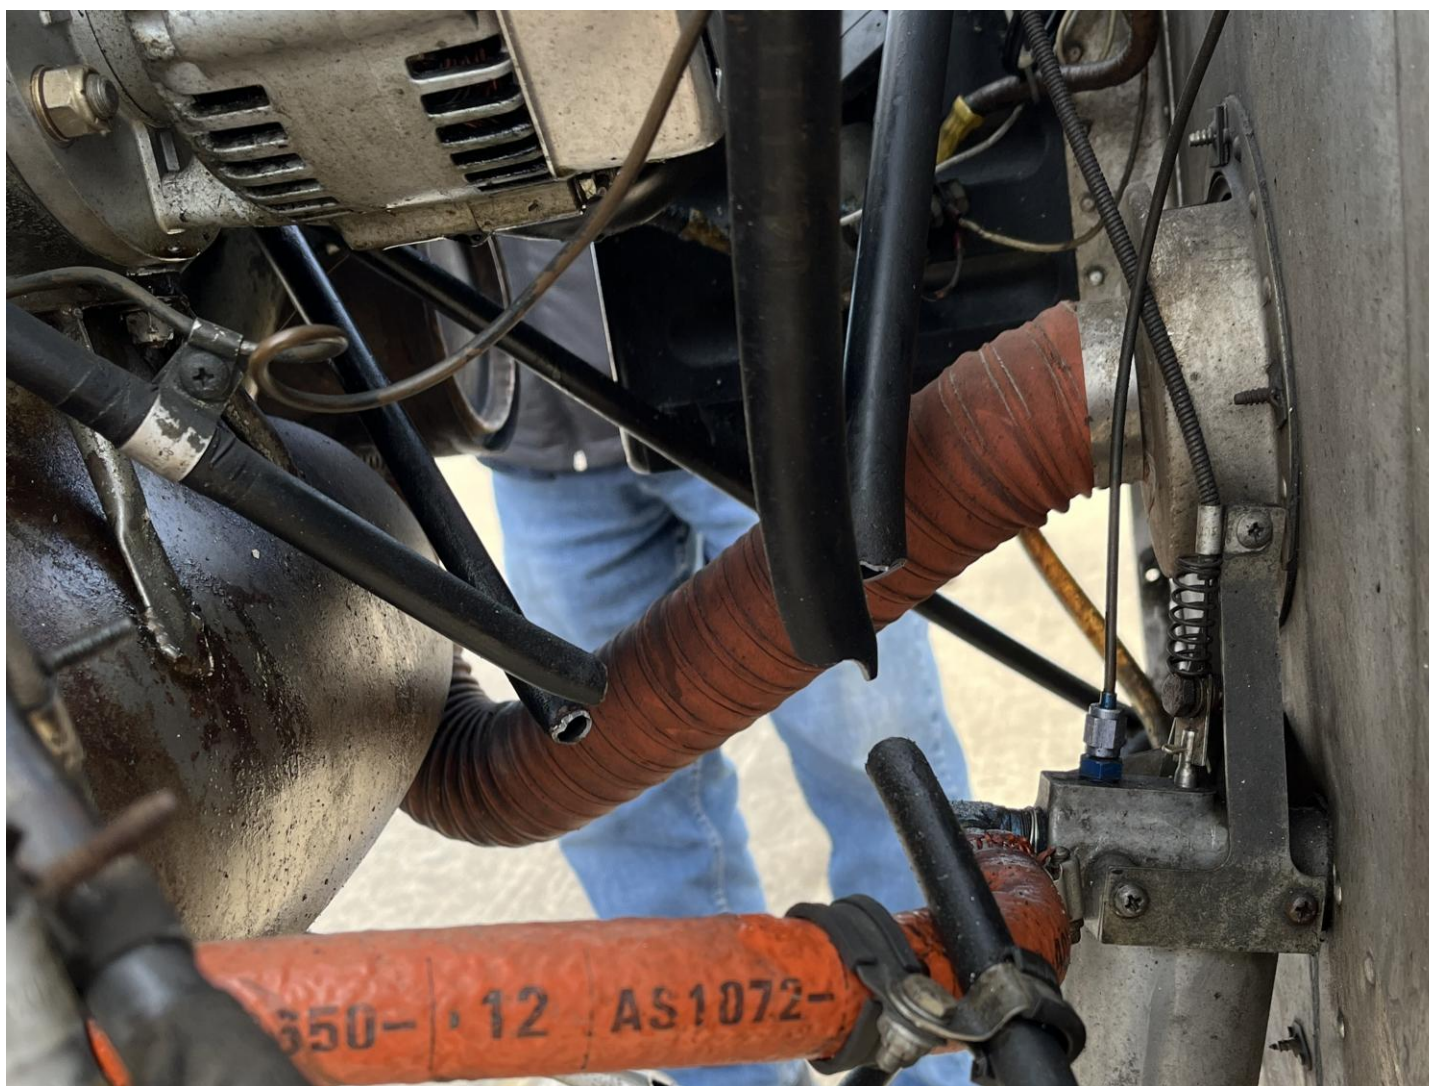
**Photograph 3 - Engine Mount Tubes  
(Courtesy of FAA)**
