# National Transportation Safety Board

CEN25LA081

## EXAMINATION SUMMARY

Location: Bentonville, Arkansas  
Date: January 16, 2025  
Time: 1530 central standard time  
Airplane: N6799P, Piper PA-24-250

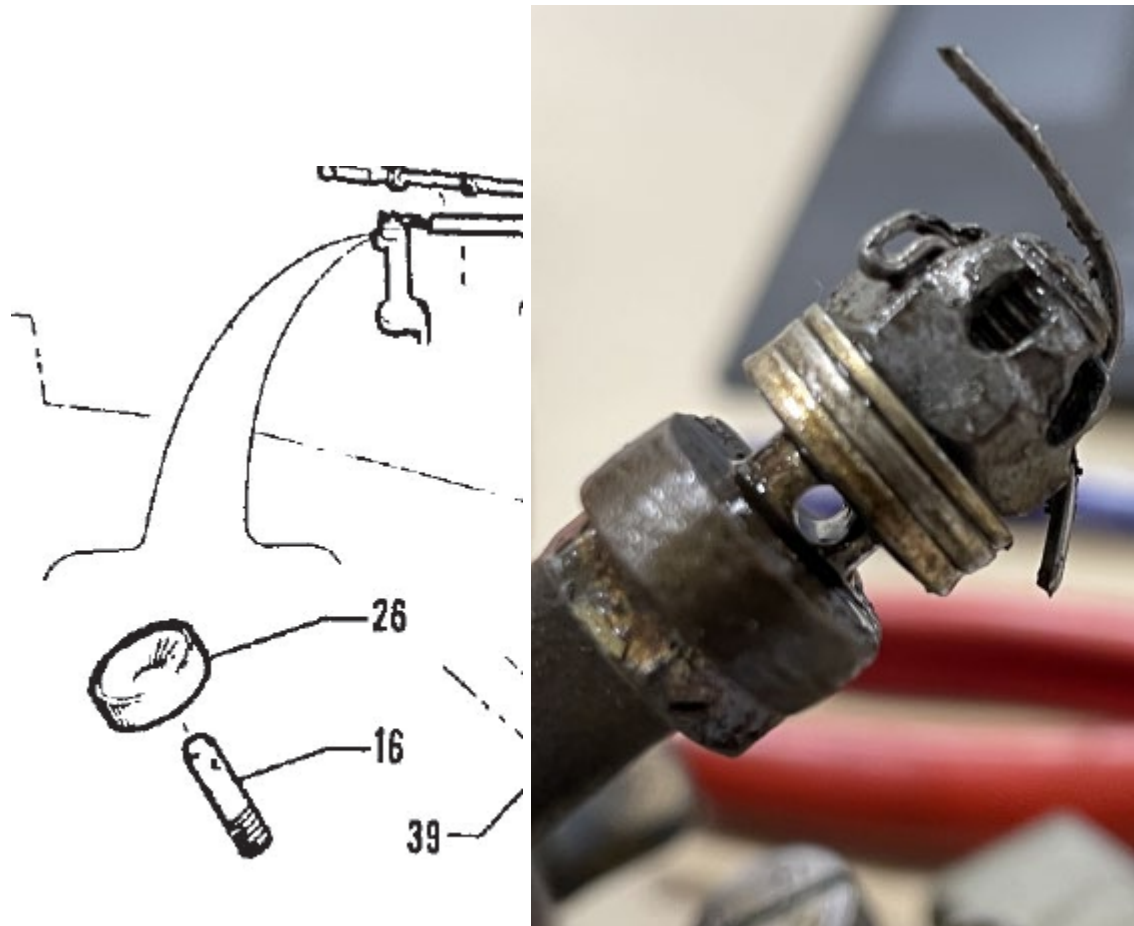
As first viewed, the carburetor was impact separated from its mounting point on the engine's induction plenum and was resting on the lower engine cowling. The mixture lever was halfway between full rich and idle cut-off. The mixture control cable was not attached to the mixture lever. The hardware on the mixture control arm remained installed but was not the correct hardware. The mixture cable moved as expected when the cockpit control was manipulated.

Figure 2. Mixture arm hardware to secure mixture cable.
