CEN25LA083

## INVESTIGATION PHOTOGRAPHS

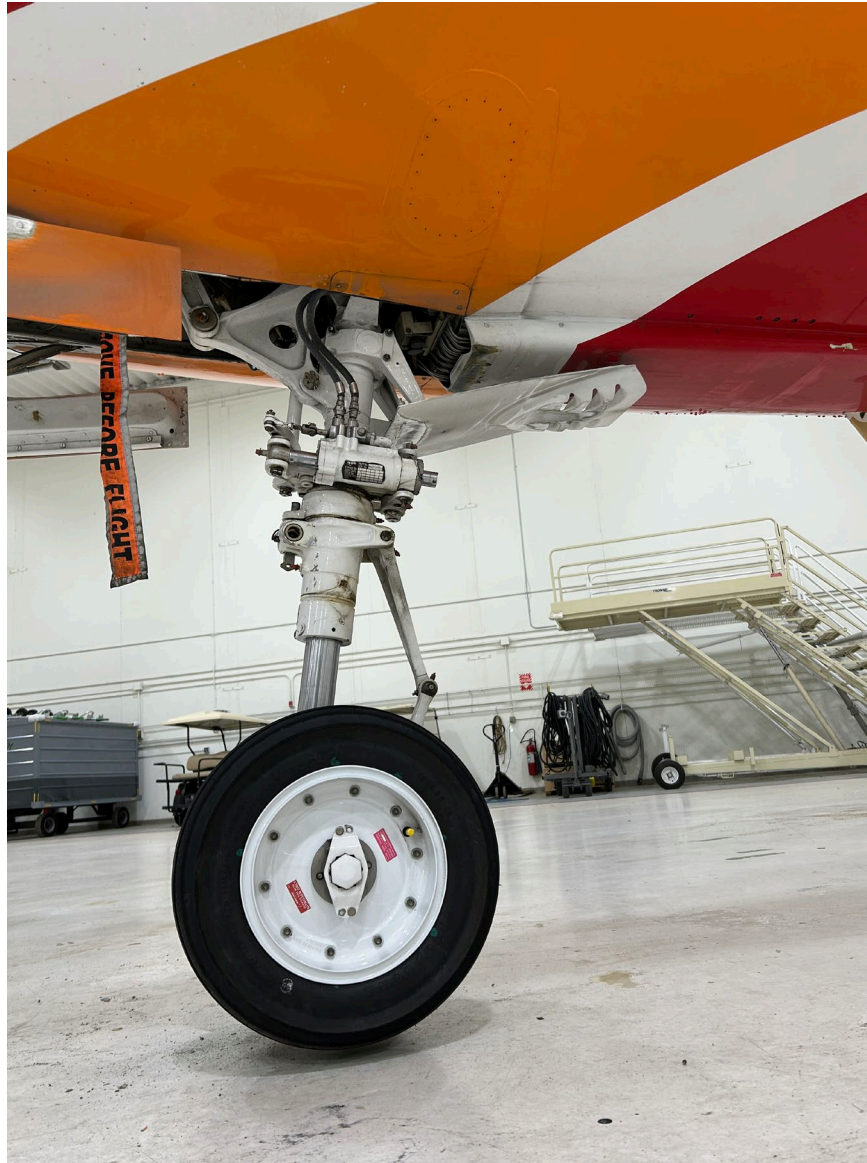
**Photograph 1 - Nose Landing Gear Fully Extended and Locked Down (Courtesy of FAA)**

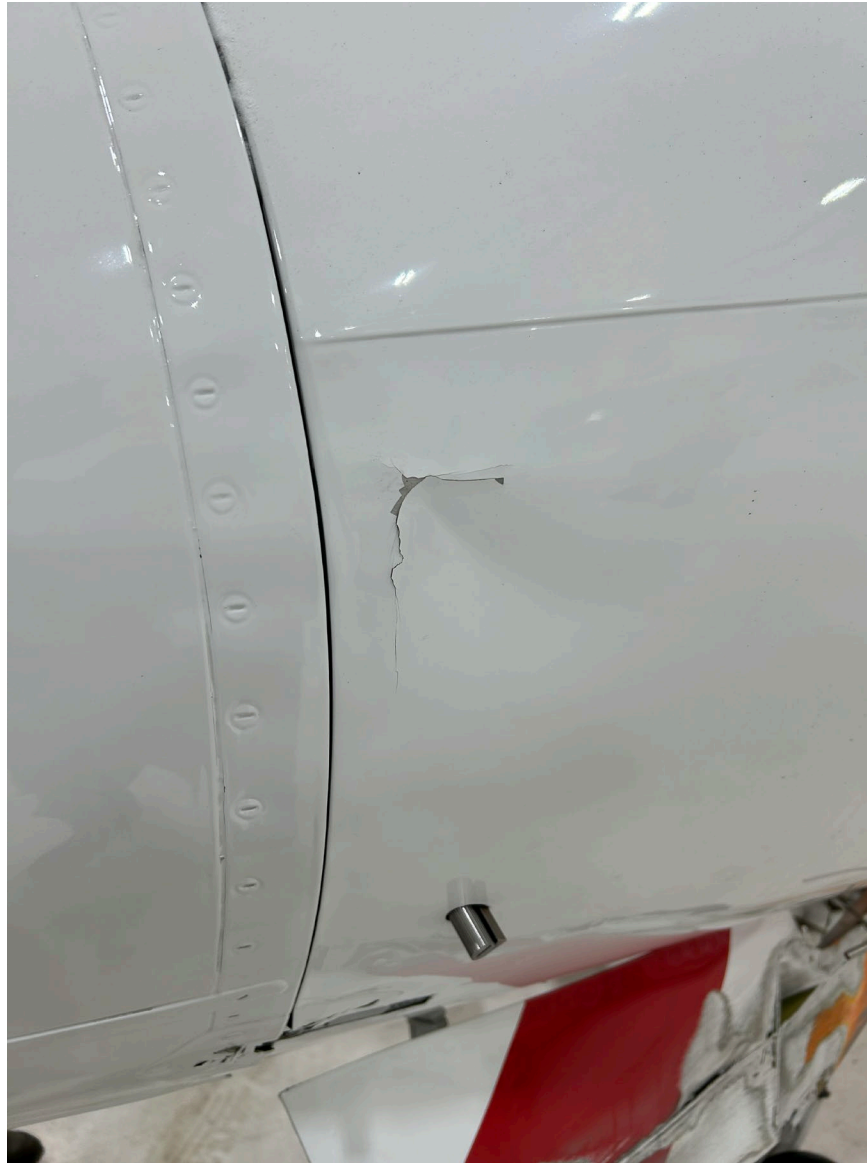
**Photograph 2 - Substantial Damage to Fuselage (Courtesy of FAA)**
