National Transportation Safety Board

CEN25LA095

## INVESTIGATION PHOTOGRAPHS

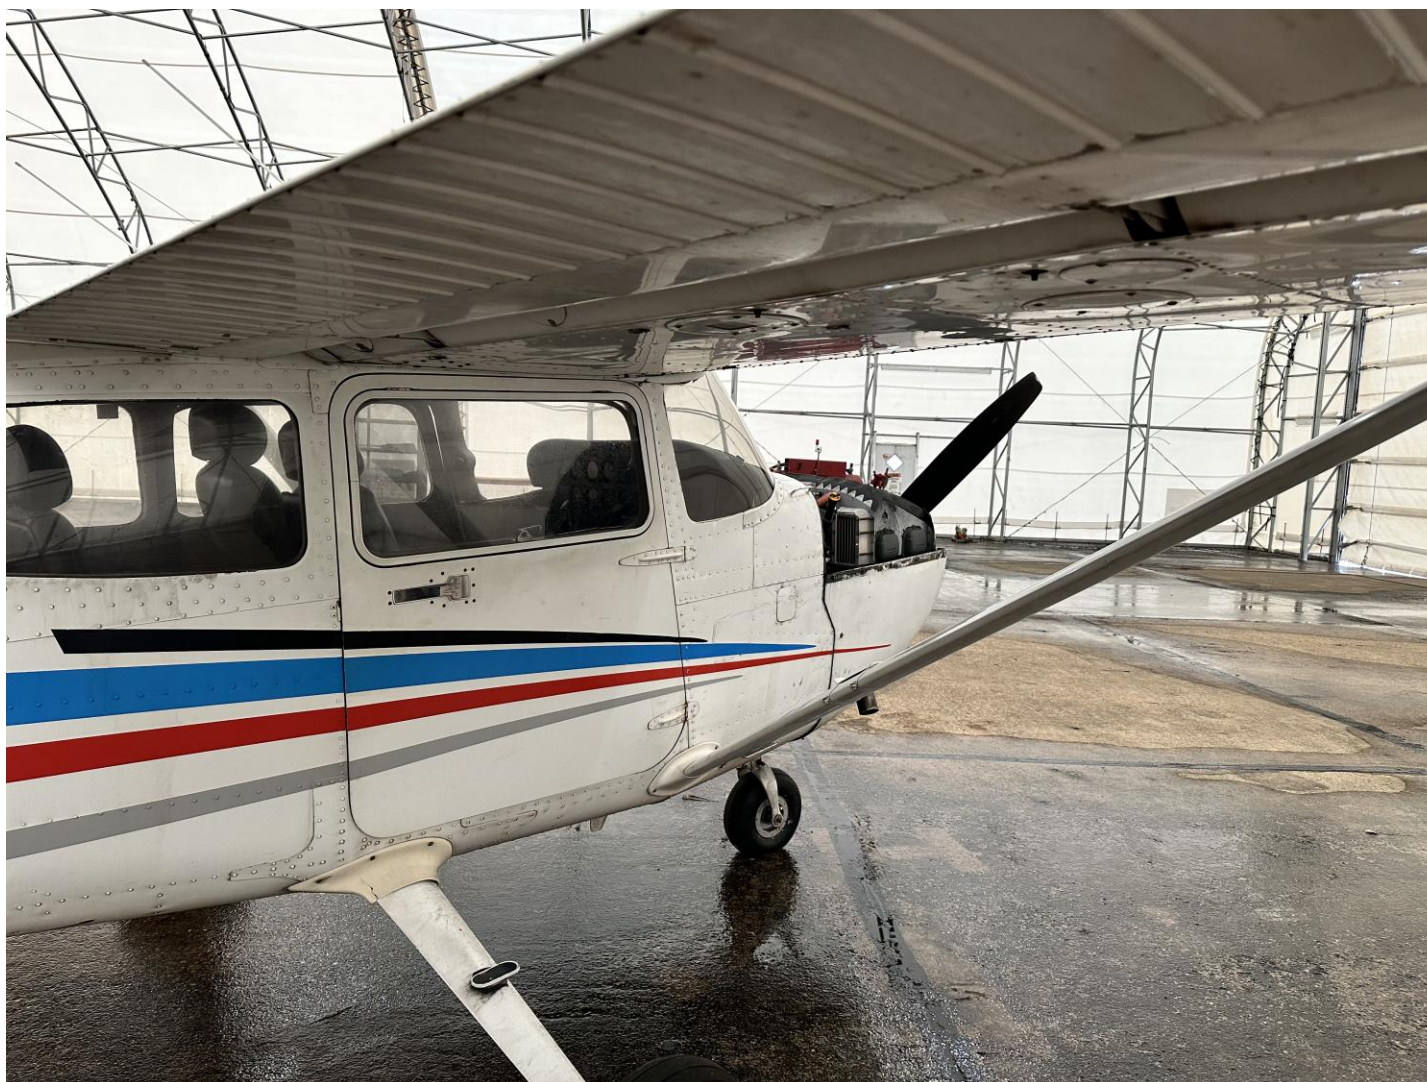
**Photograph 1 - Airplane During Postaccident Examination (Courtesy of FAA)**

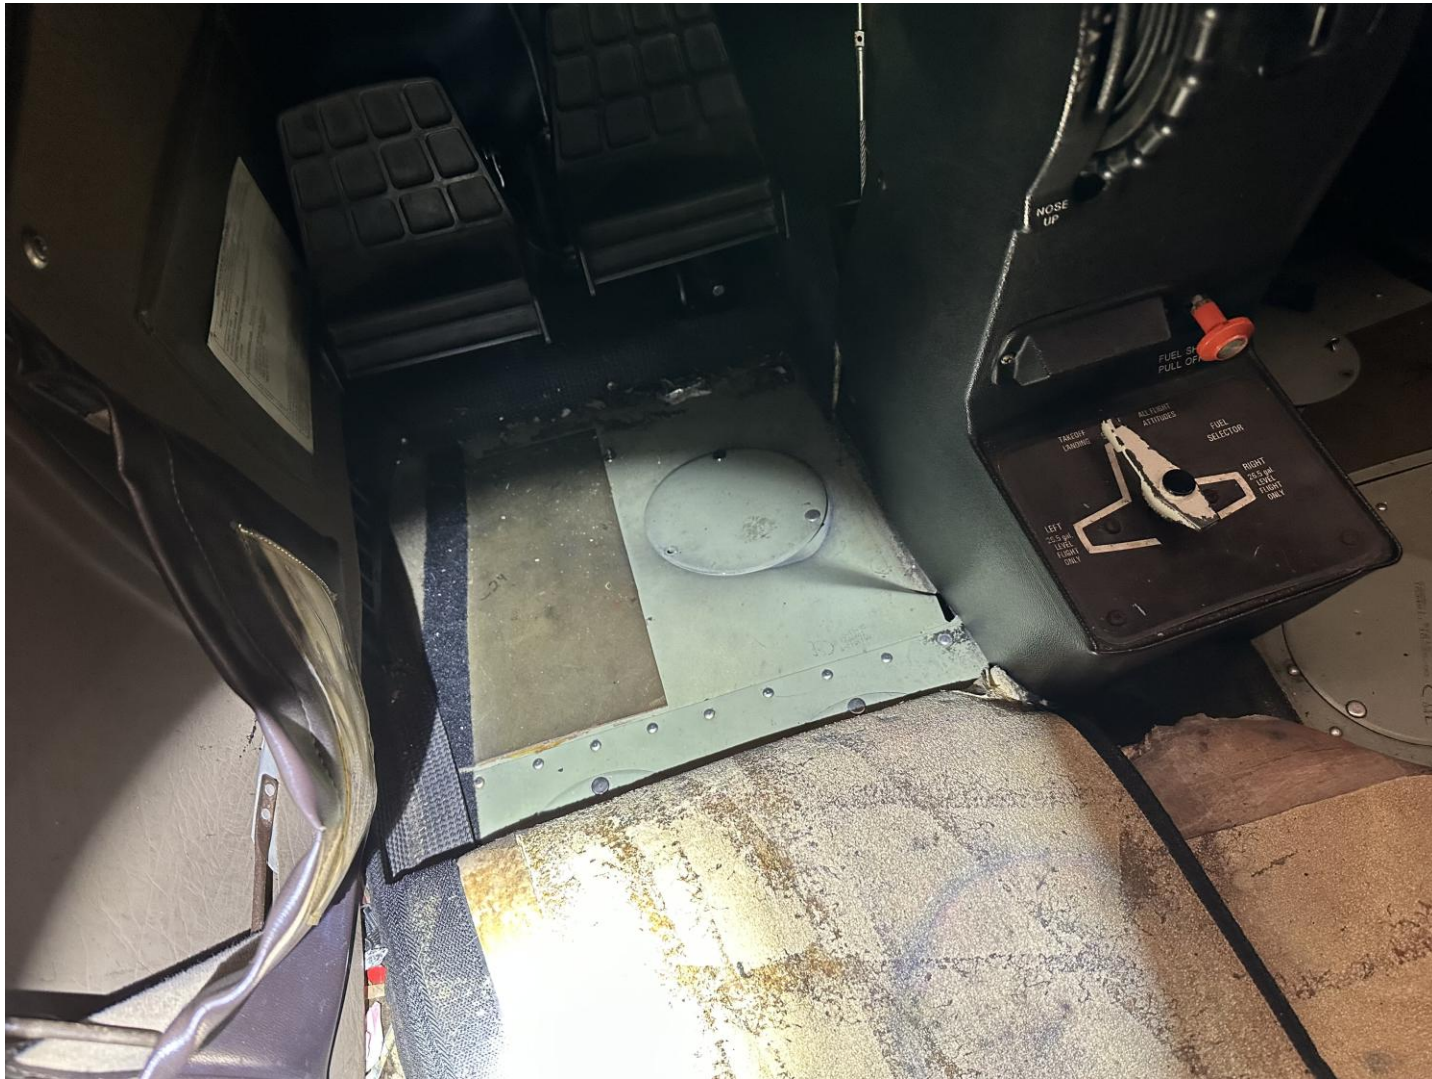
**Photograph 2 - Lower Airframe Damage, Left Pilot Position (Courtesy of FAA)**

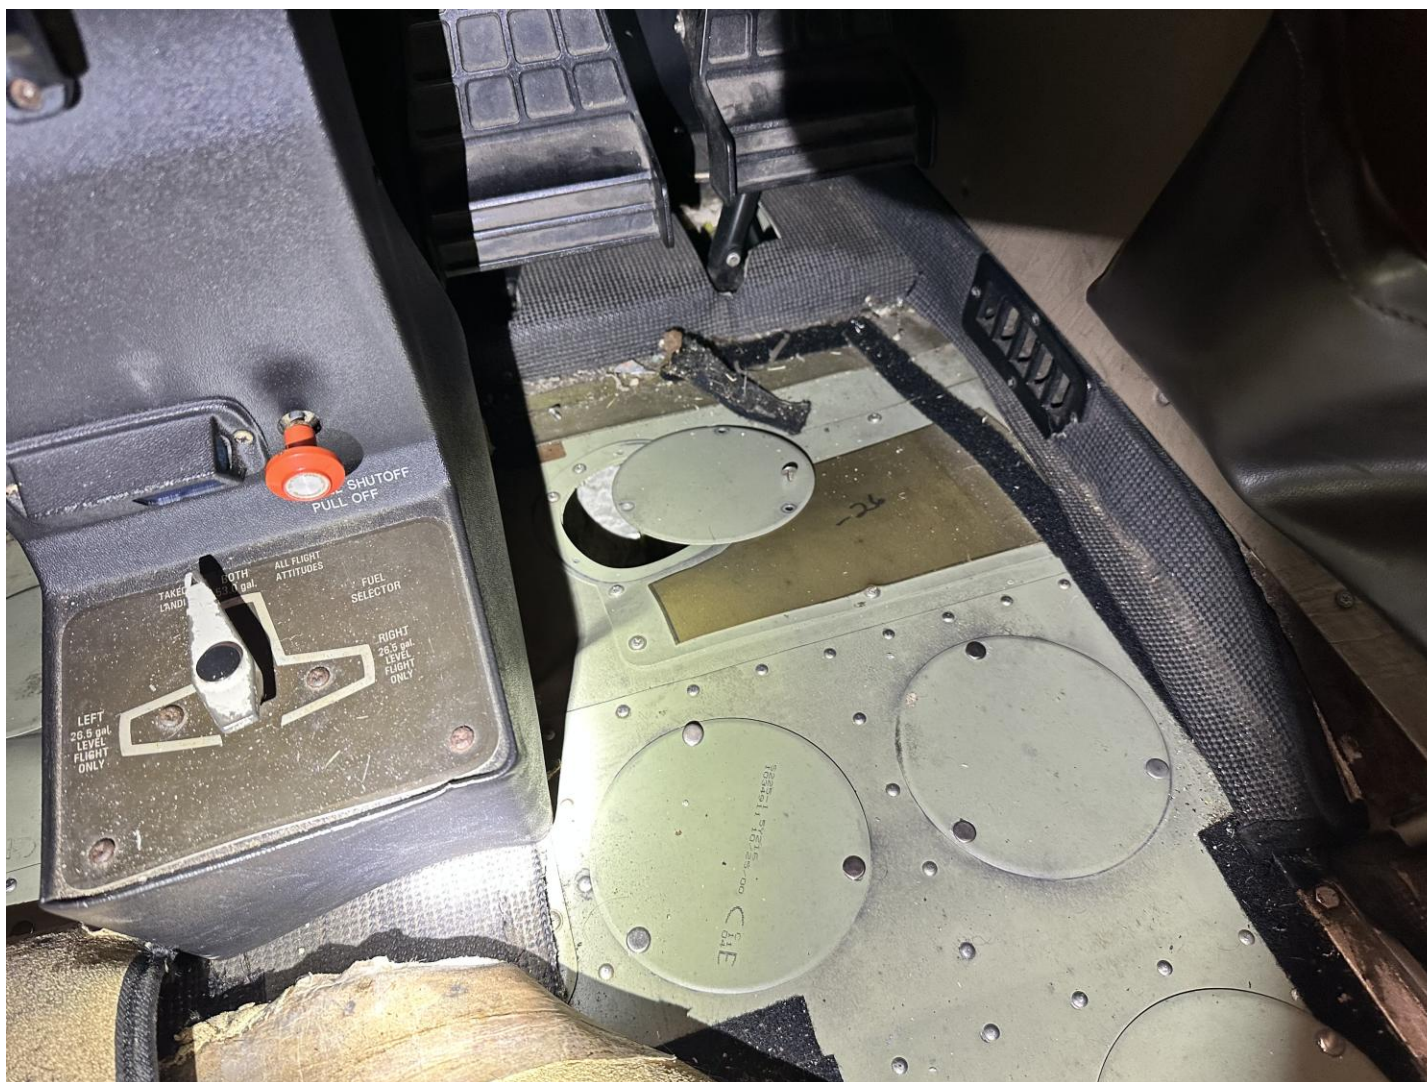
**Photograph 3 - Lower Airframe Damage, Right Pilot Position (Courtesy of FAA)**
