CEN25LA100

## INVESTIGATION PHOTOGRAPHS

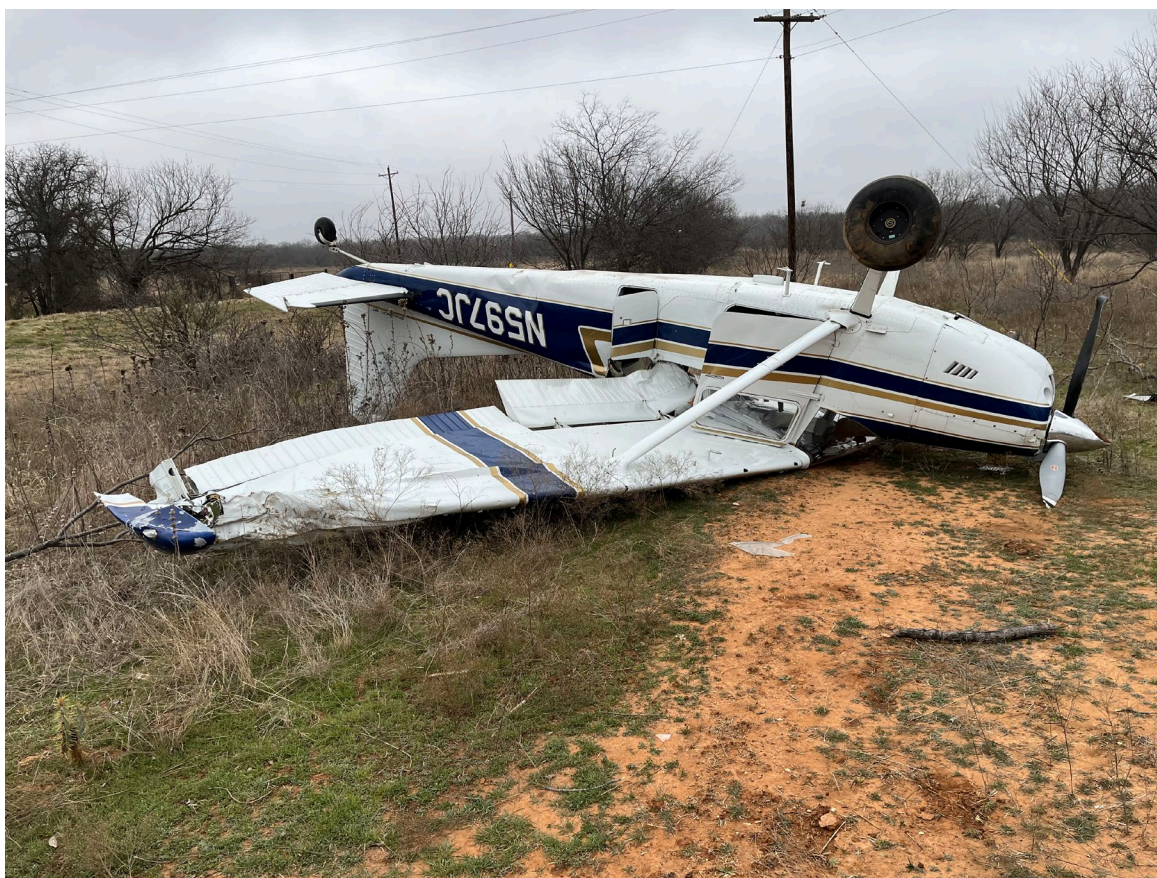
**Photograph 1 - Accident Overview (Courtesy of FAA)**

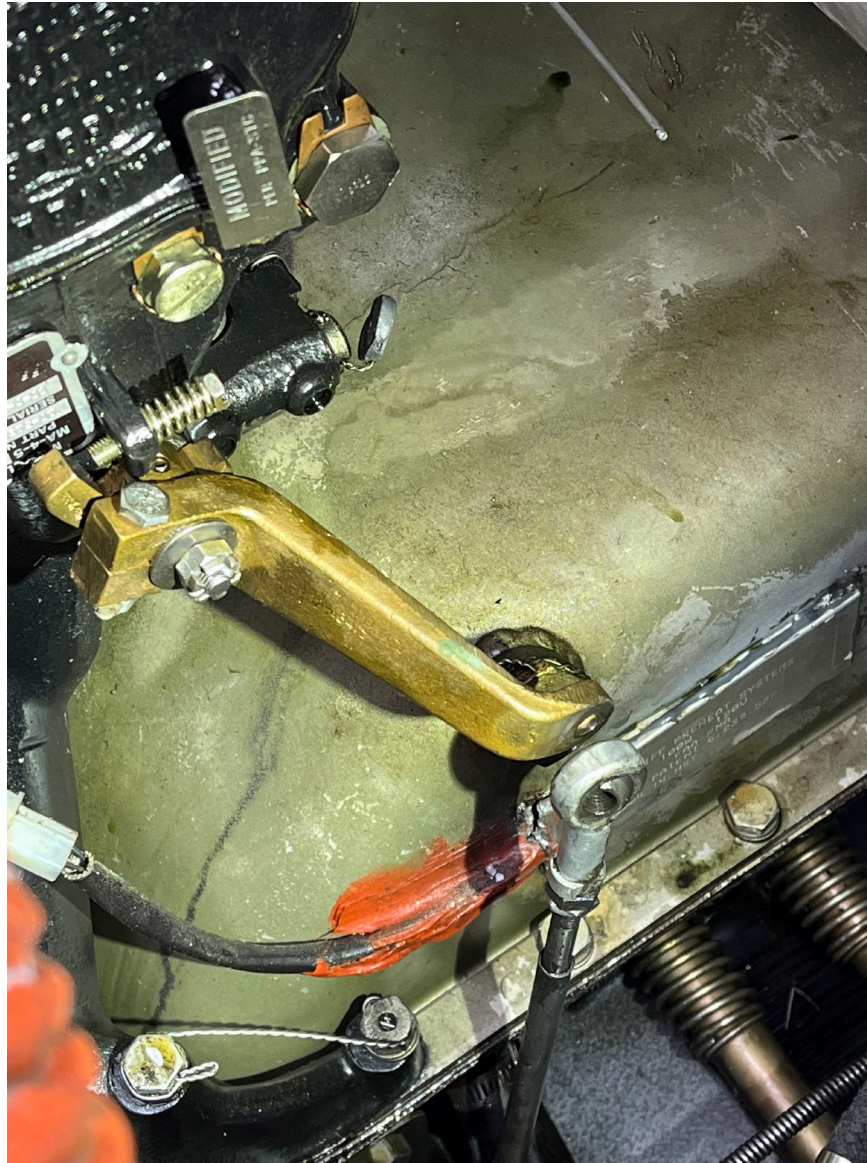
**Photograph 2 - Throttle Arm and Cable End (Courtesy of FAA)**
