CEN25LA109

## INVESTIGATION PHOTOGRAPHS

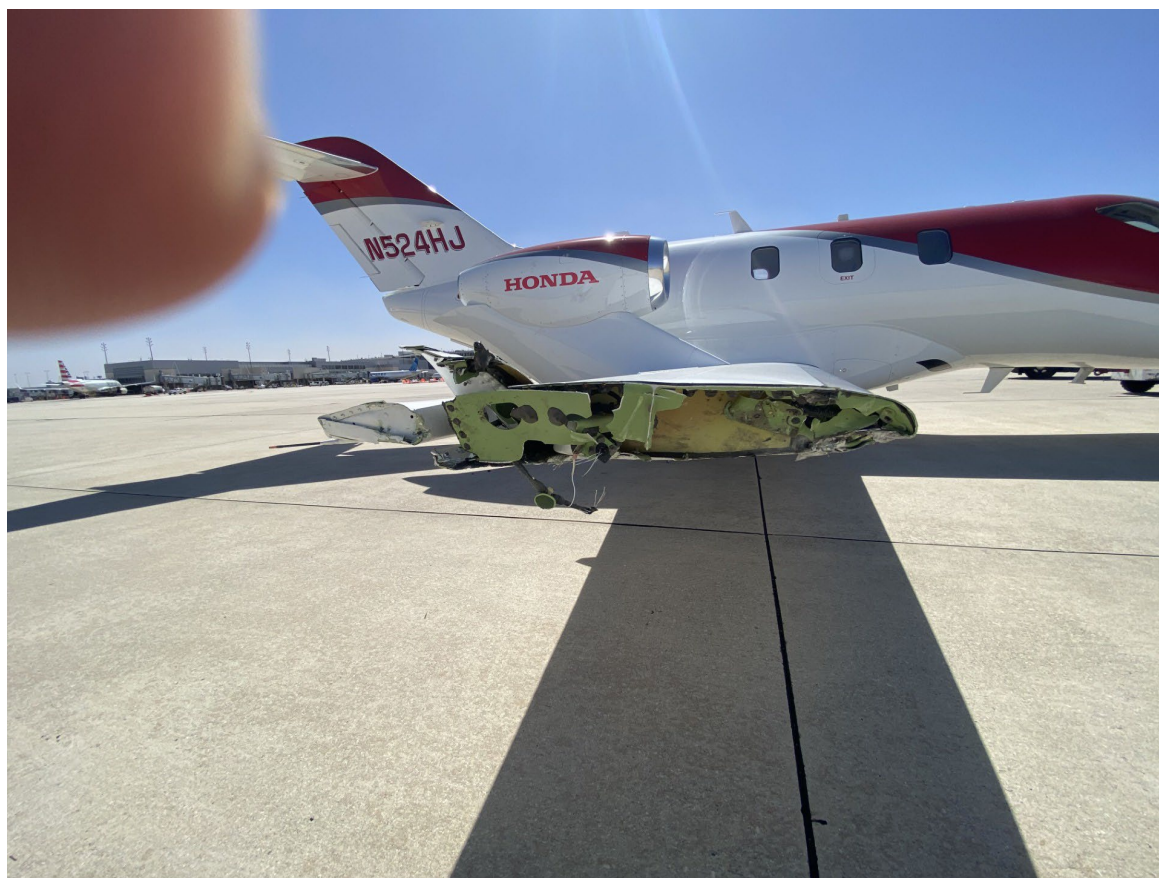
**Photograph 1 - Right wing damage (Courtesy of FAA)**
