# National Transportation Safety Board

Office of Research and Engineering

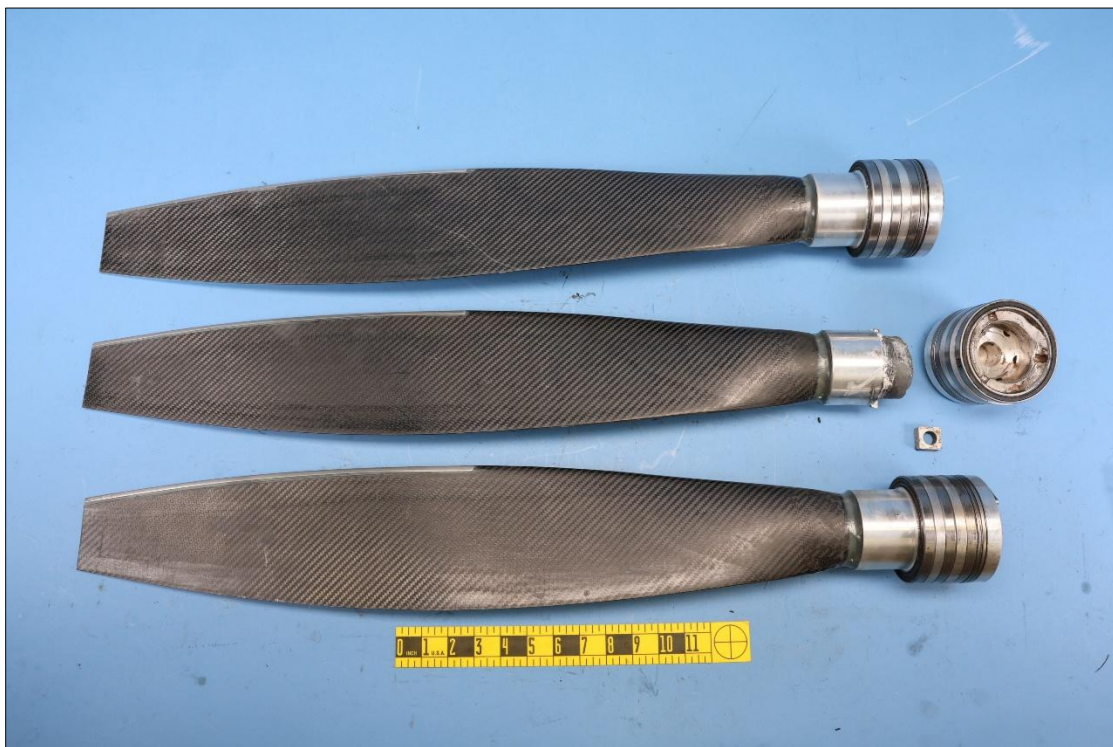
**Figure 2.** As-received photos of the three propeller blade assemblies. Blade 2 can be seen in the center with a fractured blade root at the point of the cartridge bearings.

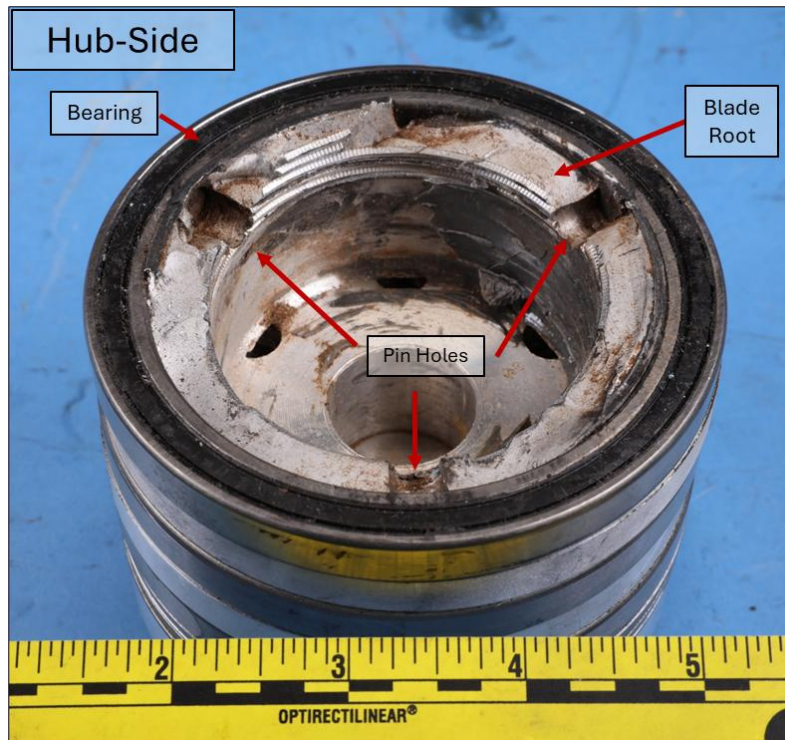
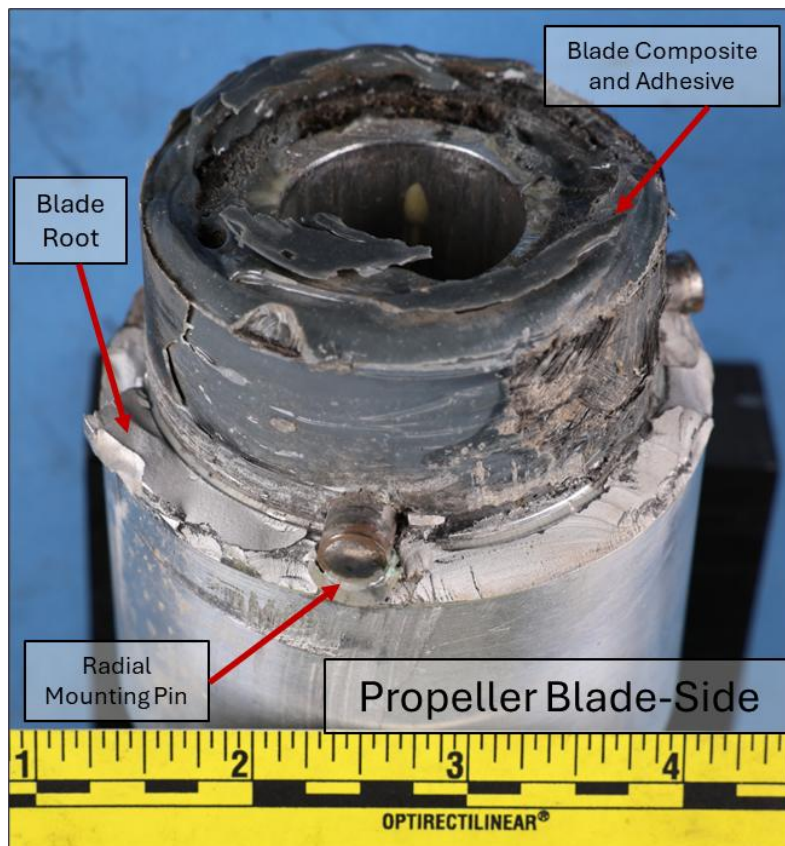
**Figure 3.** As-received photos of the Blade 2 blade root fracture sections.

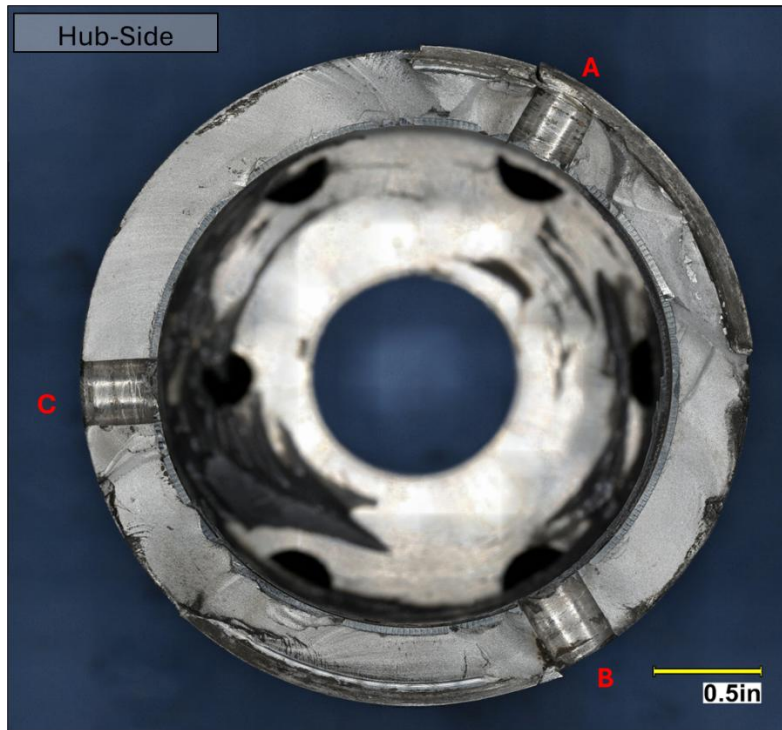
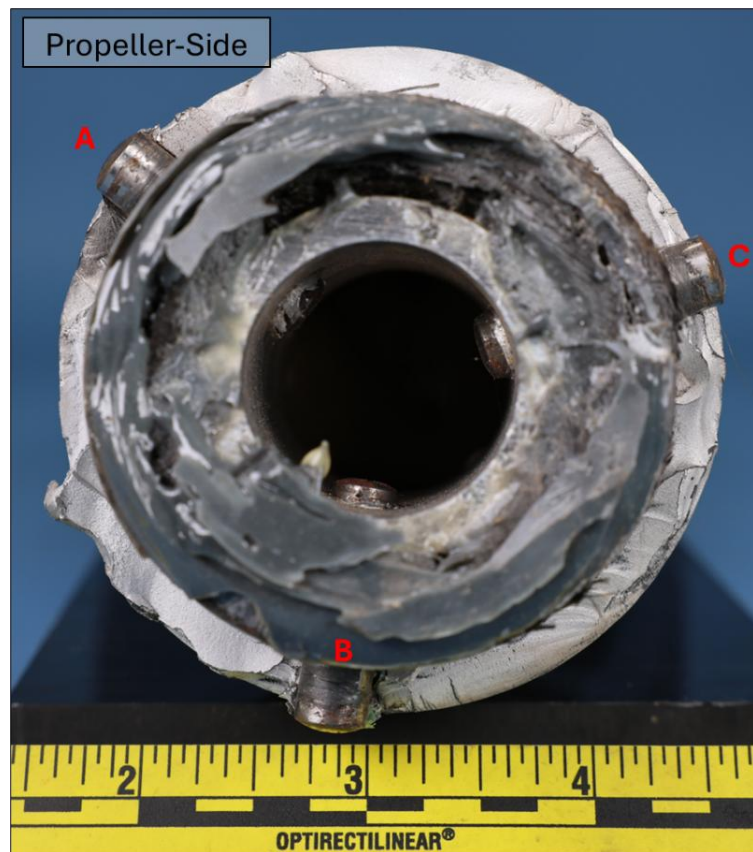
**Figure 4.** Digital Microscopic image (top) and photograph of the Blade 2 blade root fracture surfaces.

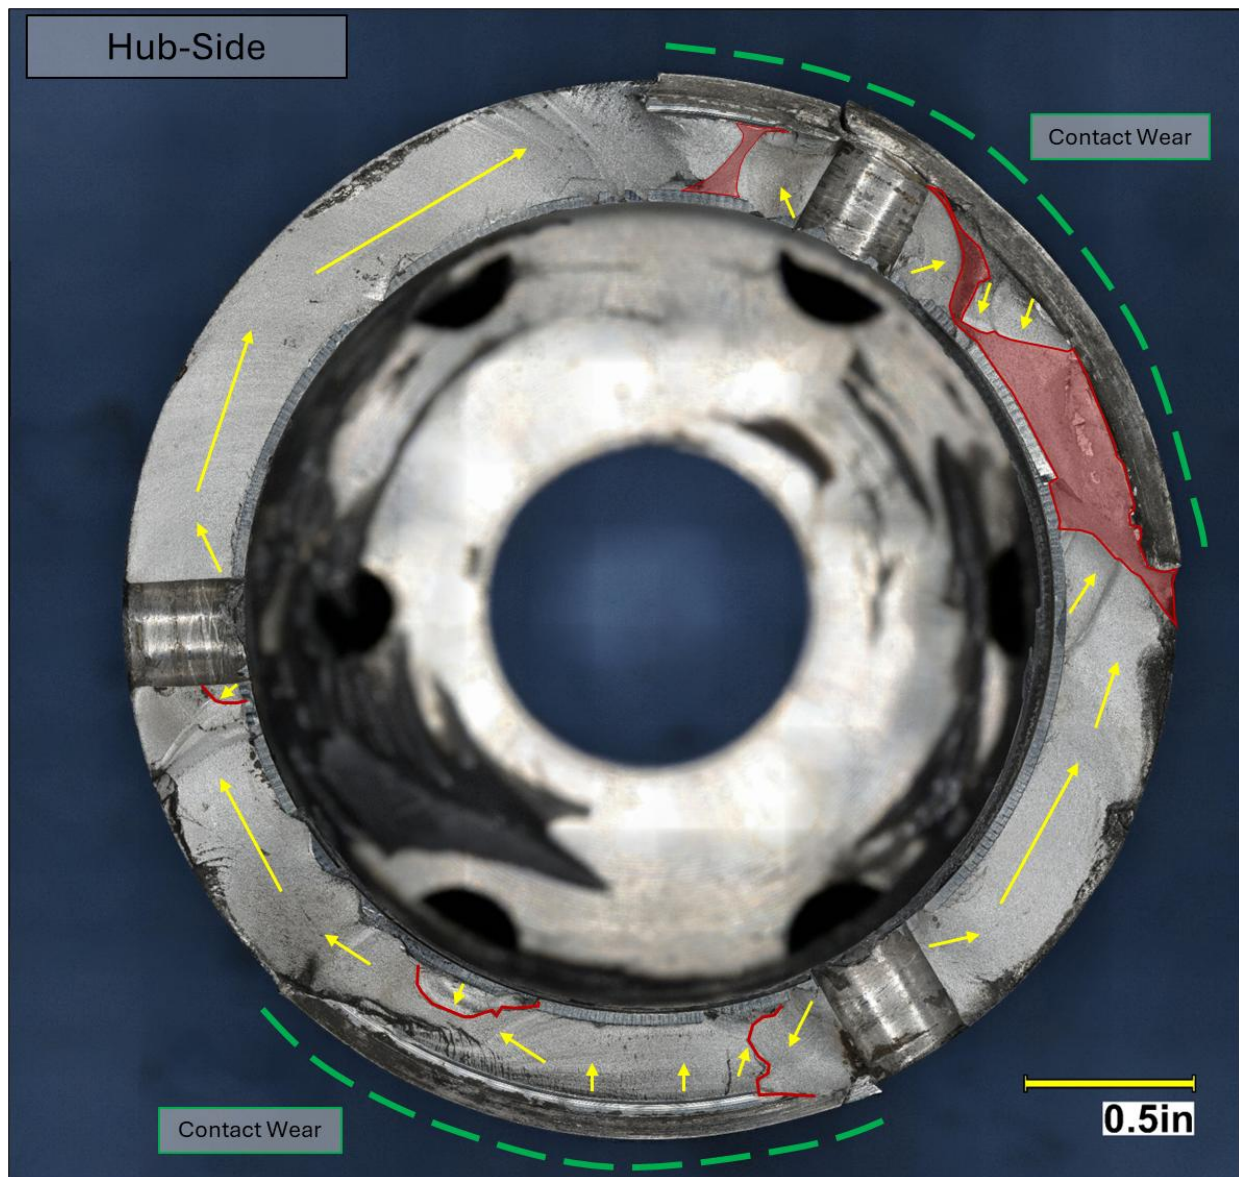
**Figure 5.** Annotated digital microscope image of the Blade 2 blade root fracture surface. Yellow arrows designate the fracture propagation direction and various additional fracture initiations. Red denotes fracture boundaries and regions of overstress. Green highlights regions where the fillet radius was still present and exhibiting aggressive contact wear.

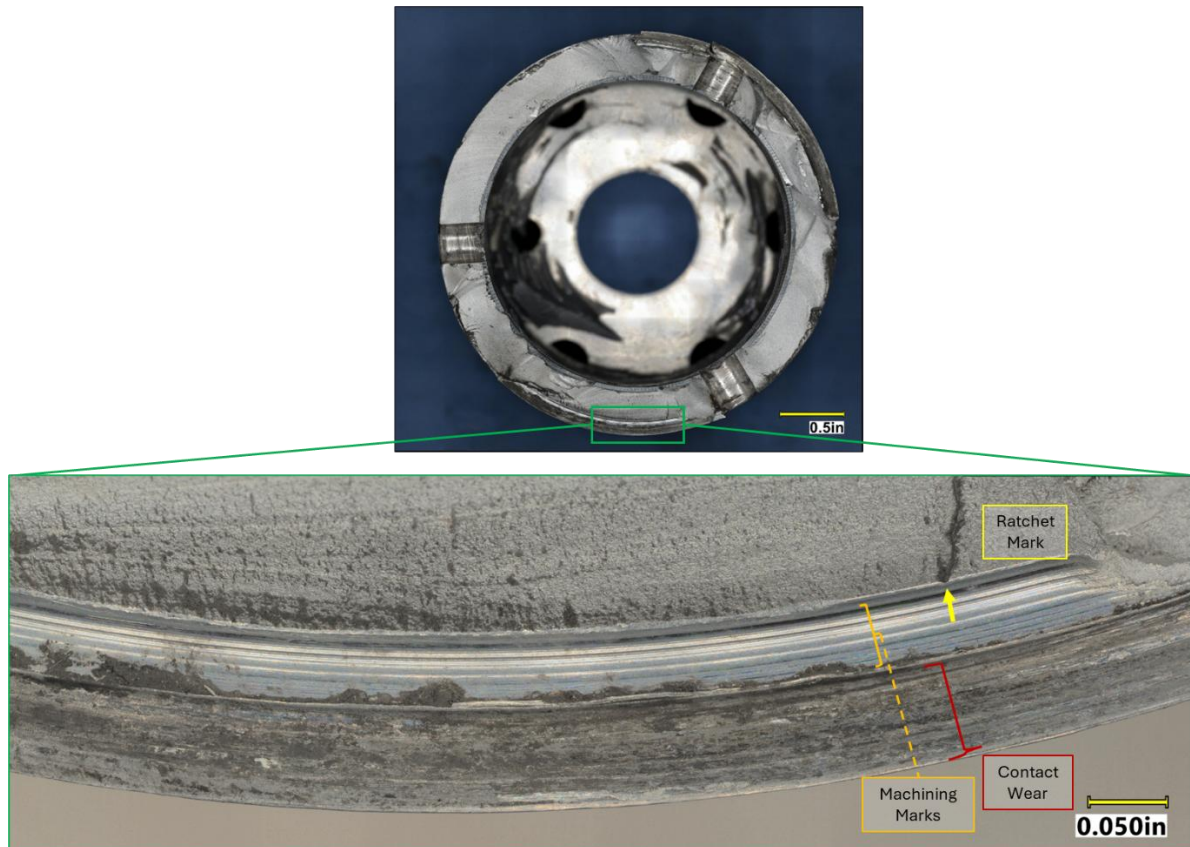
**Figure 6.** Digital microscopic images highlighting the contact wear adjacent to the fracture initiation point. Red denotes the contact wear exhibiting loss of material. Coarse machine marks were observed circumferentially around the blade root.

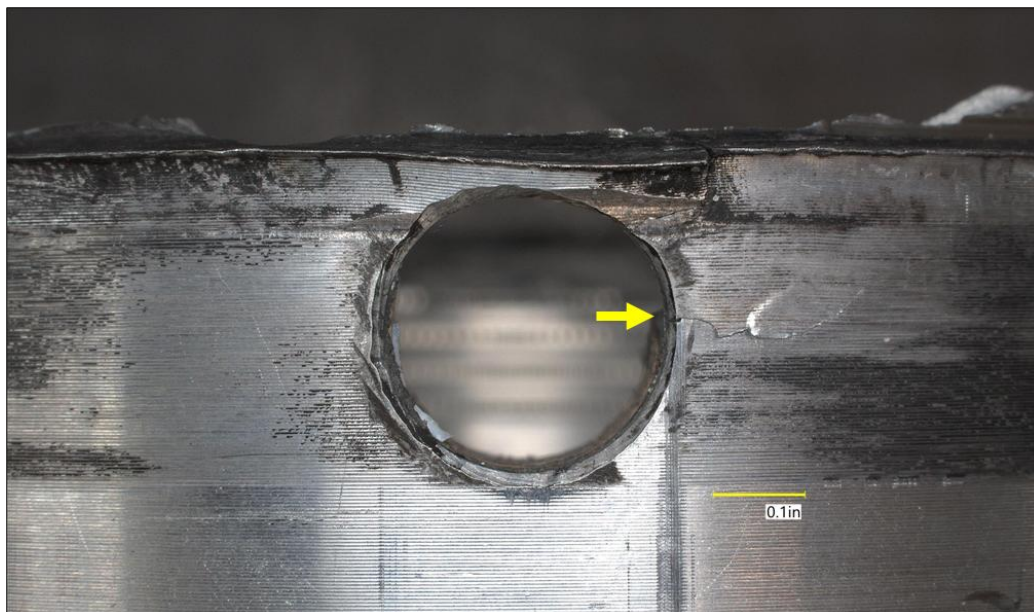
**Figure 7.** Digital microscopic image of a radial pin hole with bearing removed, exhibiting a crack emanating from the corner.

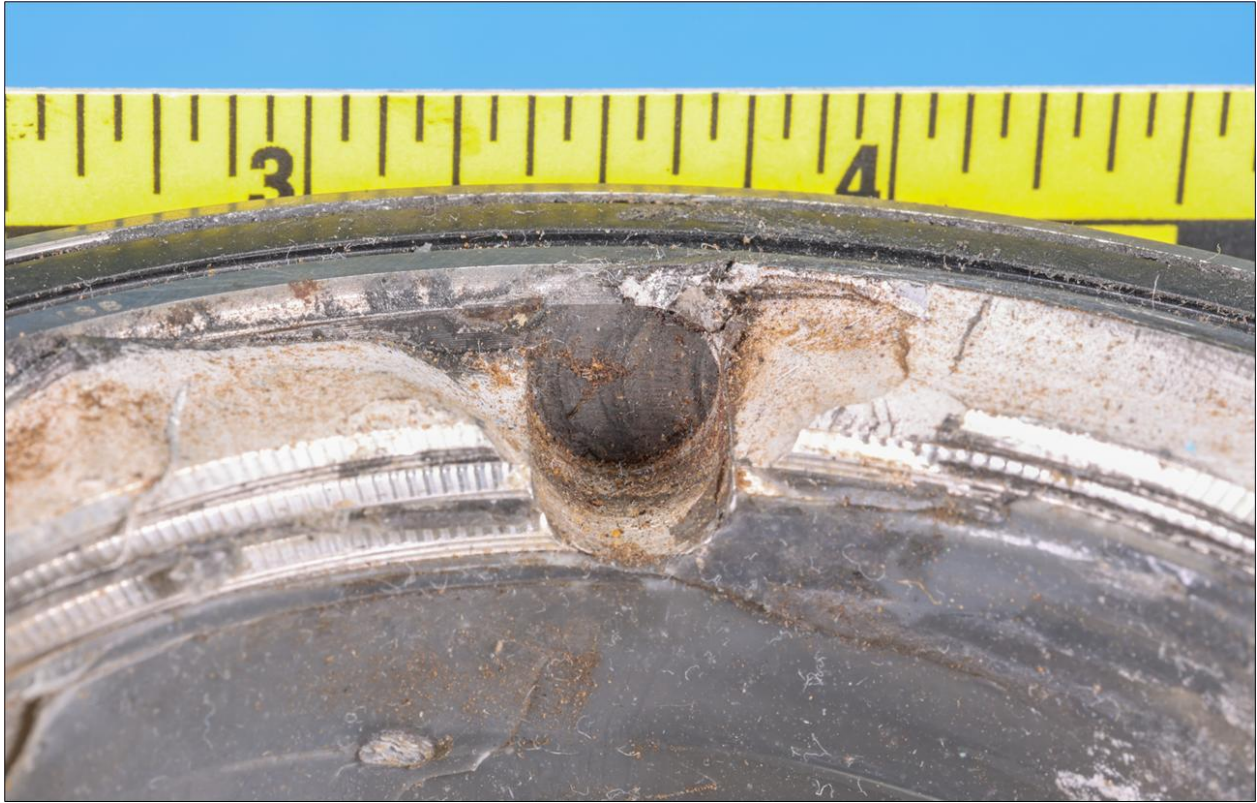
**Figure 8.** Witness marks indicating the cartridge bearing inner ring migrated during operation or failure.

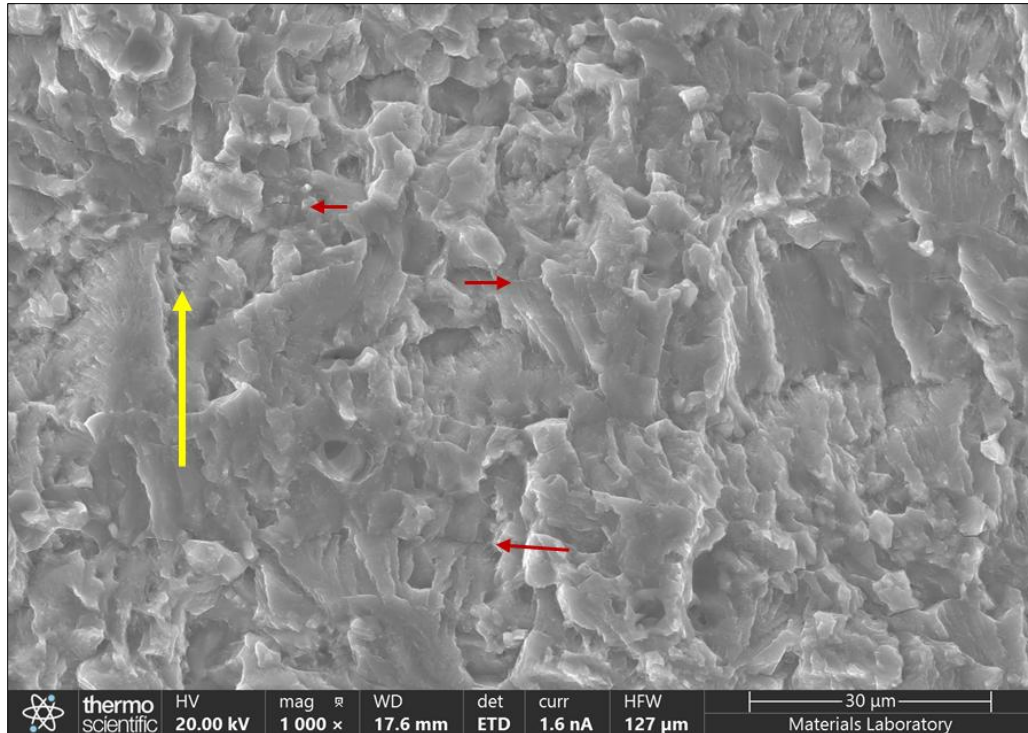
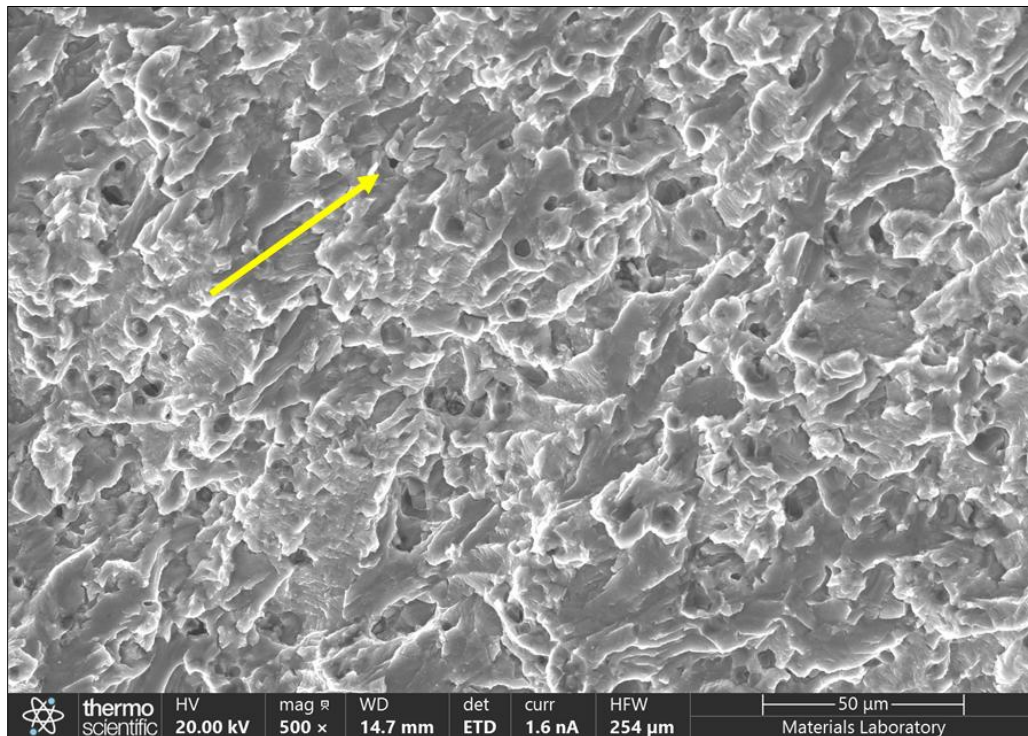
**Figure 9.** Scanning electron microscopic images of the blade root fracture surface exhibiting a feathery fracture progression and numerous tear ridges, consistent with high cycle fatigue in aluminum. Red arrows identify fine secondary cracking perpendicular to the propagation direction (yellow arrows).

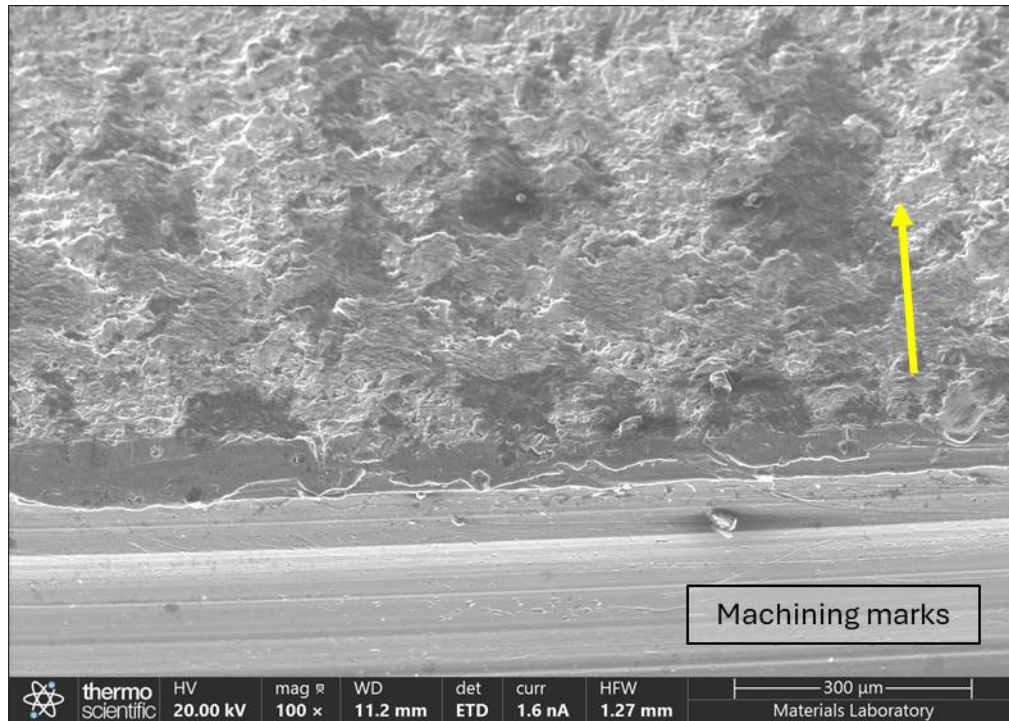
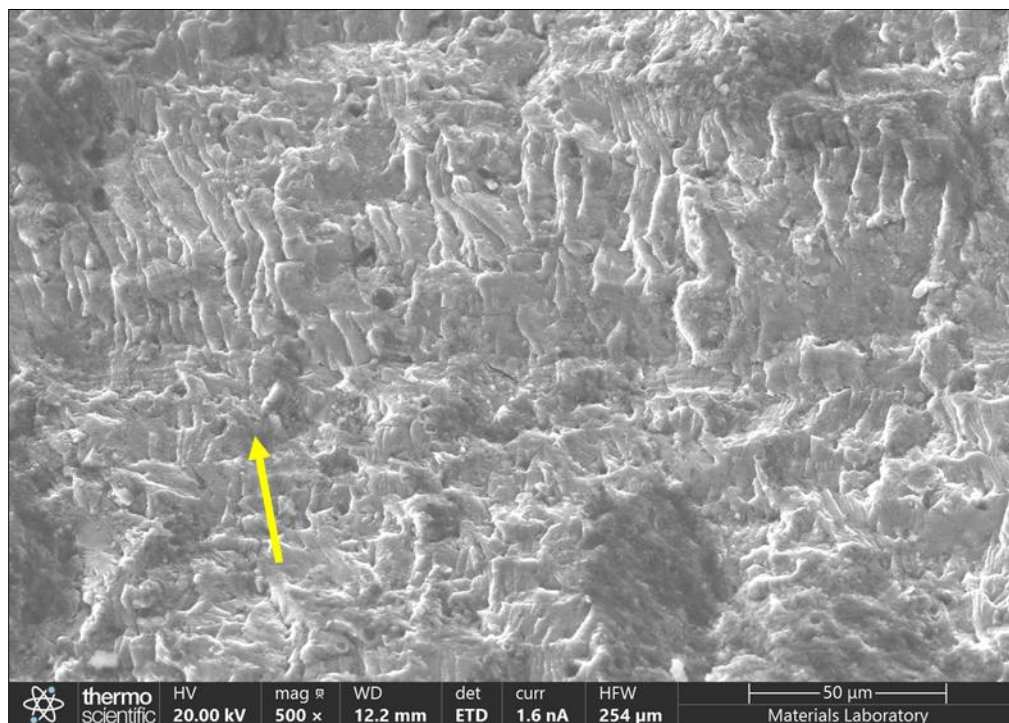
**Figure 10.** SEM images at the origin of the primary fracture. The crack appears to emanate from a single machining mark spanning the width of the region. Some of the origin sustained fracture rub. The direction of crack growth is indicated by yellow arrows.

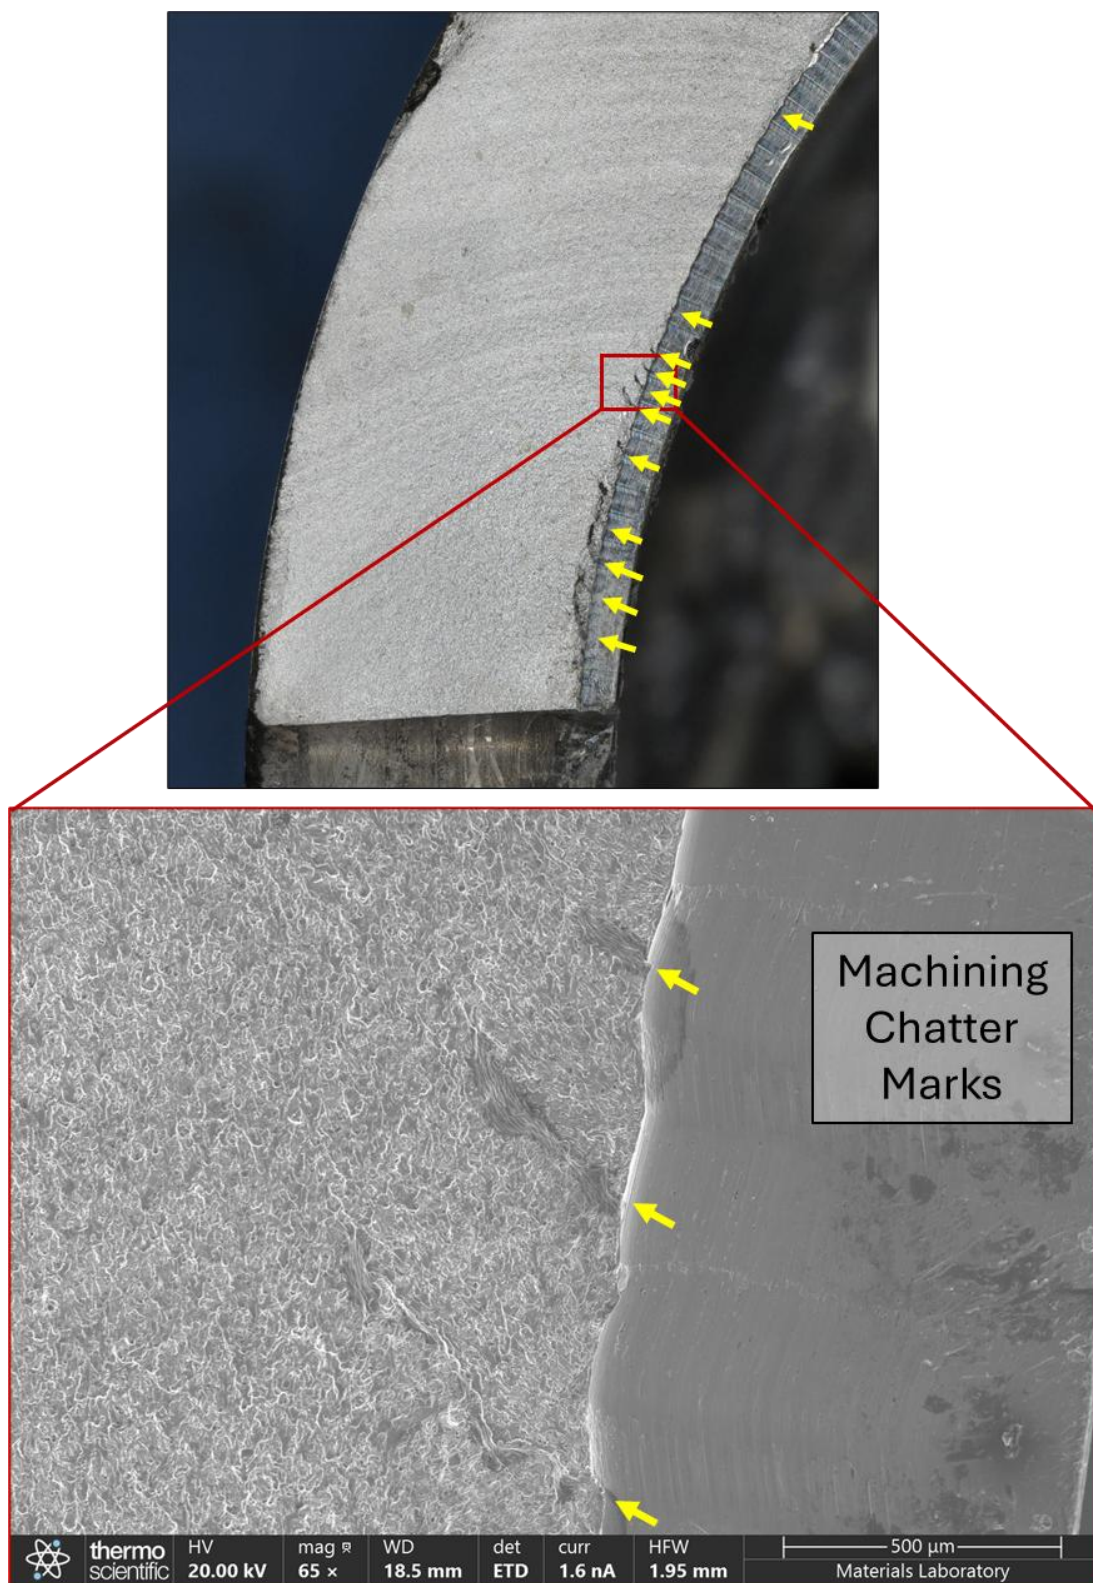
**Figure 11.** Ratchet marks observed mid-progression of the fracture. Scanning electron microscope images show they appear to emanate from chatter marks observed on the internal threads of the blade root. Yellow arrows indicate observed ratchet marks.

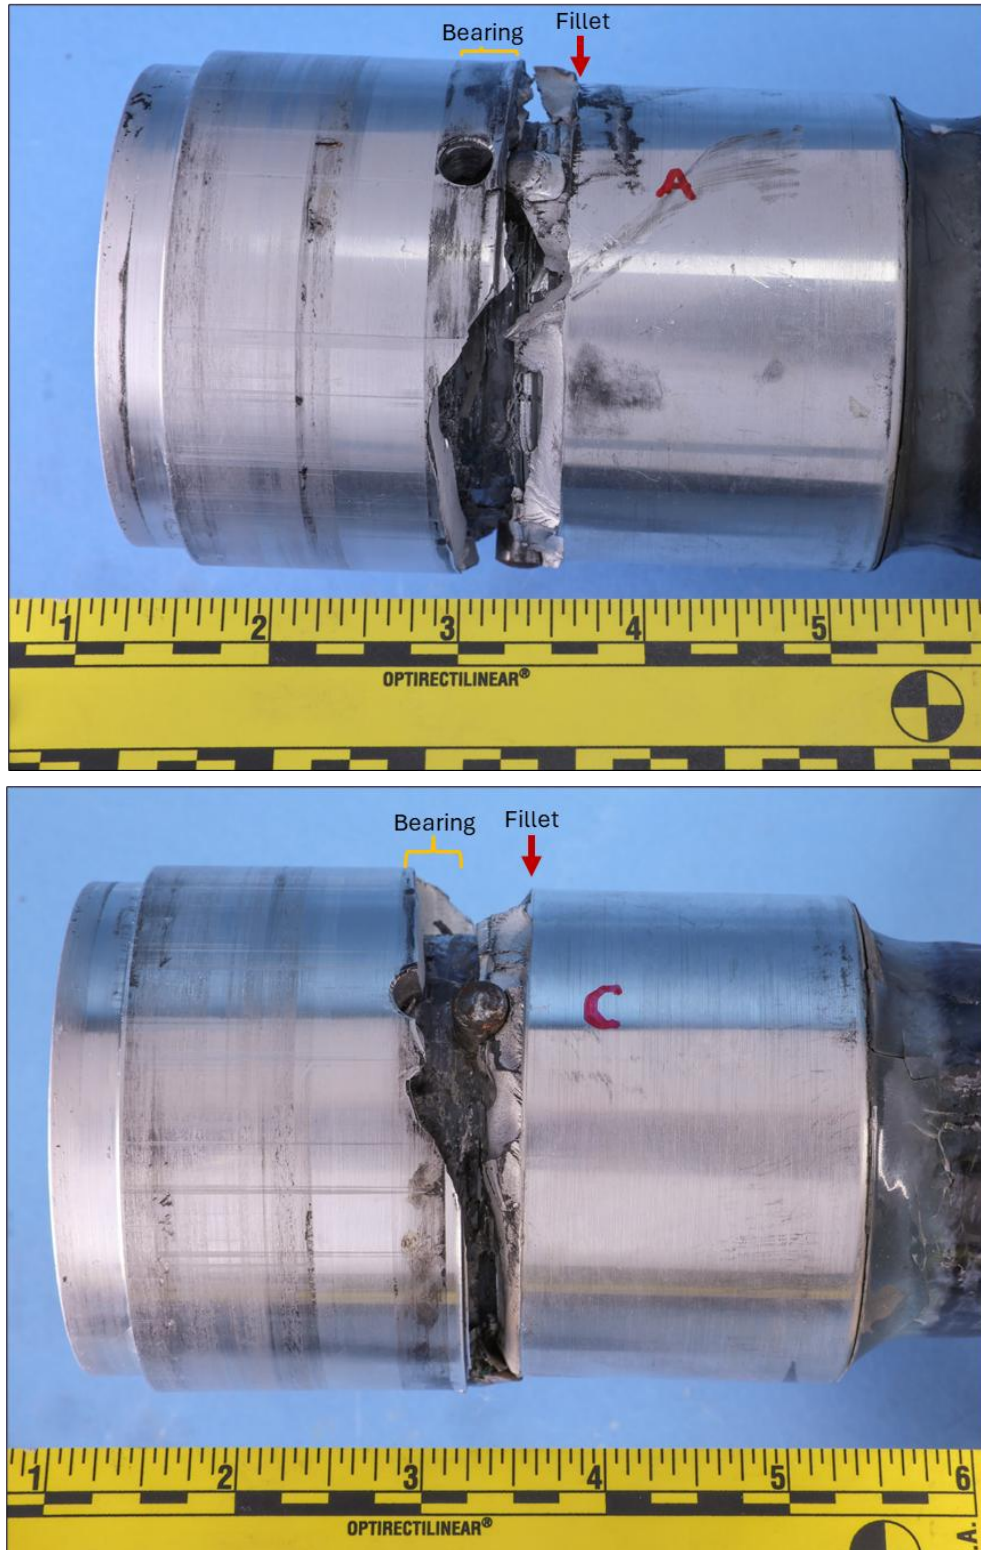
**Figure 12.** Assembled images of the Blade 2 blade root comparing fracture surface profiles, exhibiting missing sections along the cartridge bearing interface. A gap is present between the fitment to prevent the opposing fracture surfaces from contact and damage.

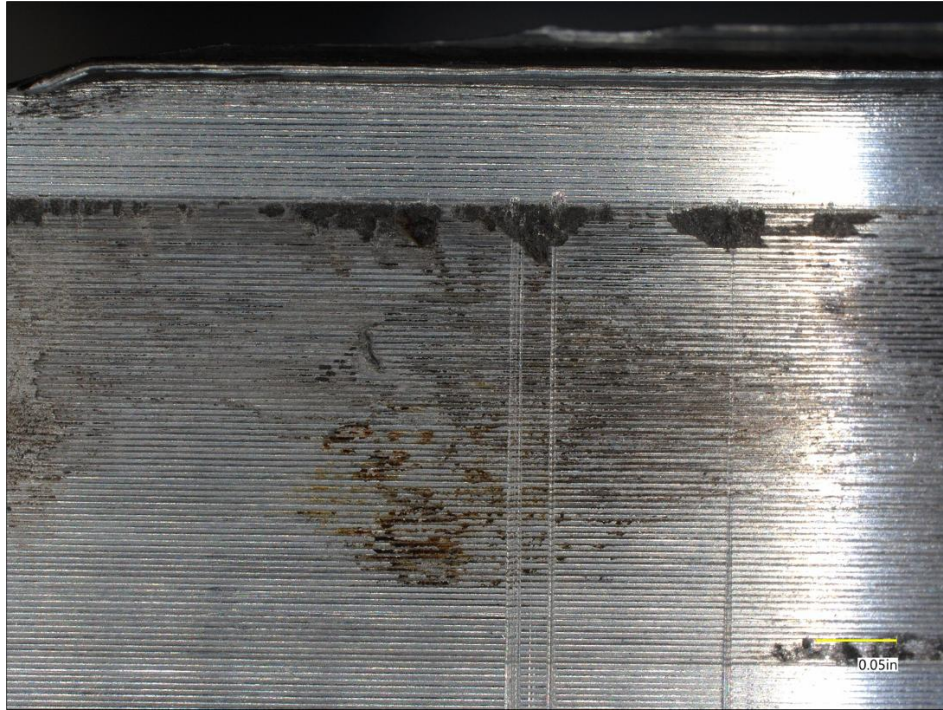
**Figure 13.** Digital microscopic image of the fretting corrosion and galling observed on the blade root underneath the top cartridge bearing. Vertical scratches observed are associated with lab disassembly and removal of the bearings.

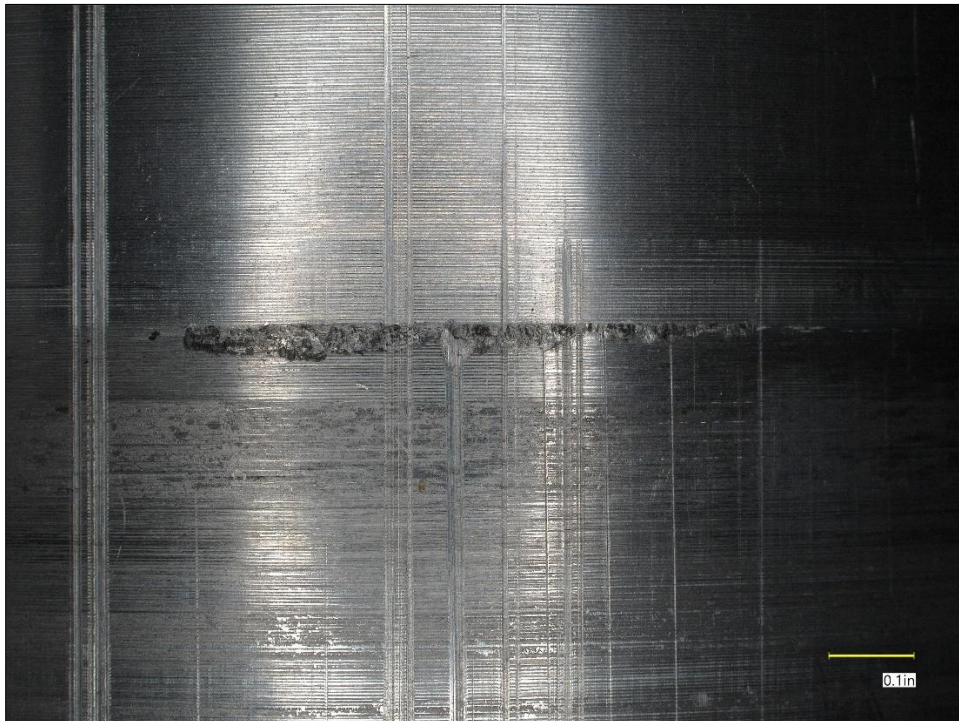
**Figure 14.** Digital microscopic image of the fretting corrosion and galling observed on the blade root underneath the middle cartridge bearing. Vertical scratches observed are associated with lab disassembly and removal of the bearings.

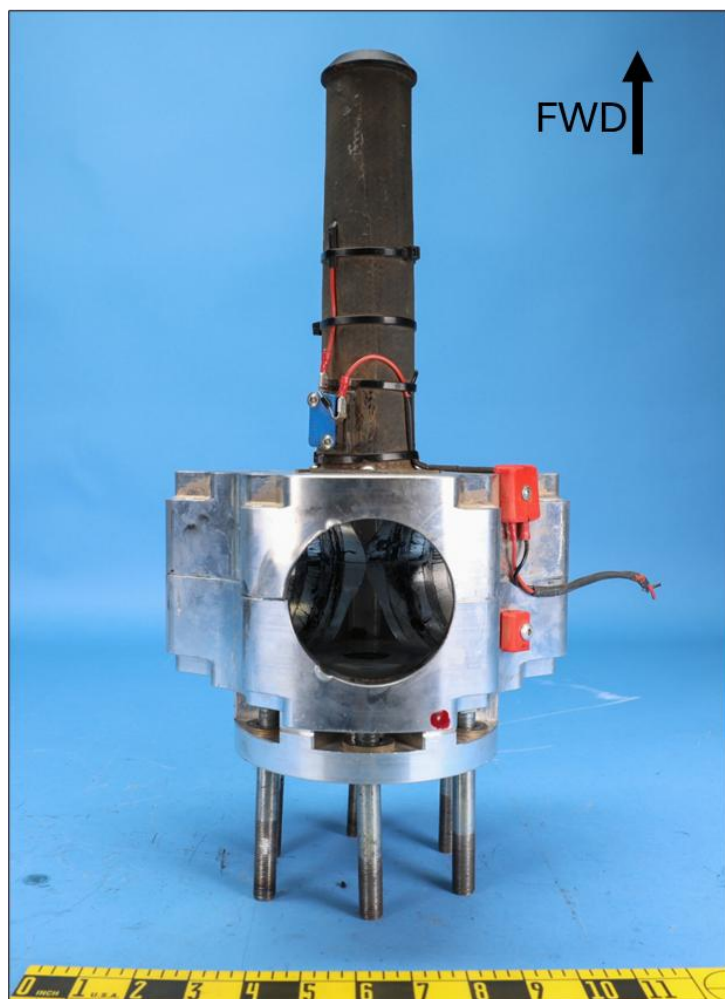
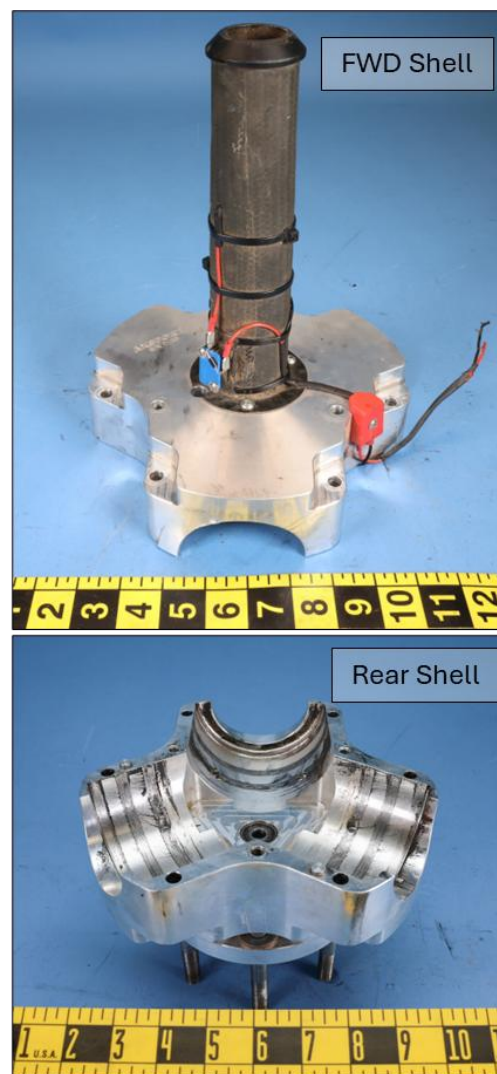
**Figure 15.** As-received photos of the hub assembly, both assembled (left) and separated into both half components (right).

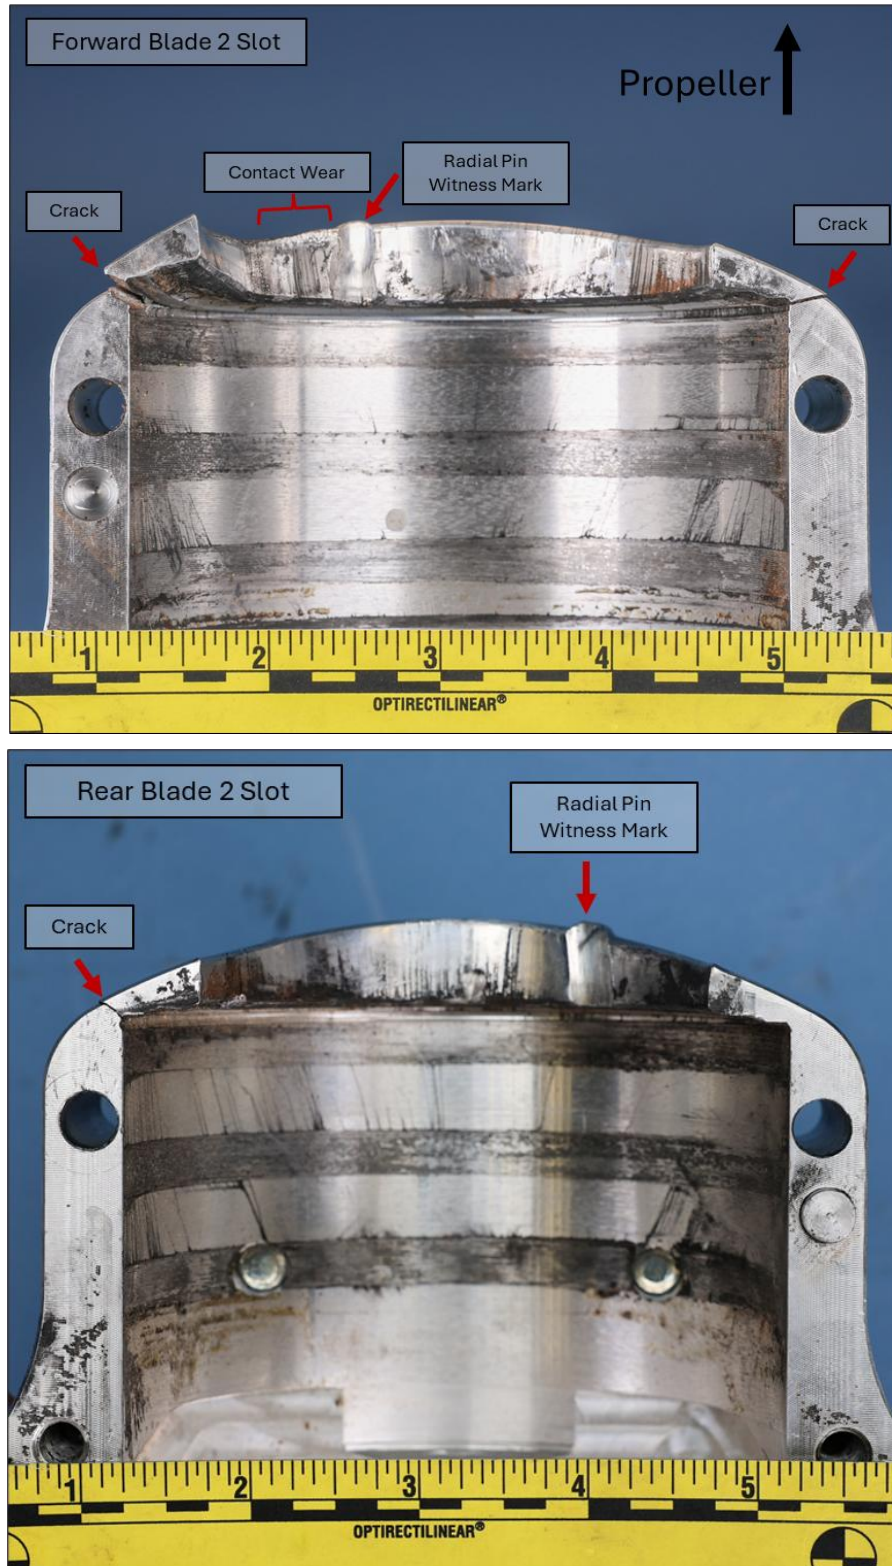
**Figure 16.** Annotated images of both shell halves of the Blade 2 slot., identifying cracks, contact wear, and radial pin witness marks that assisted in locating the final blade orientation.

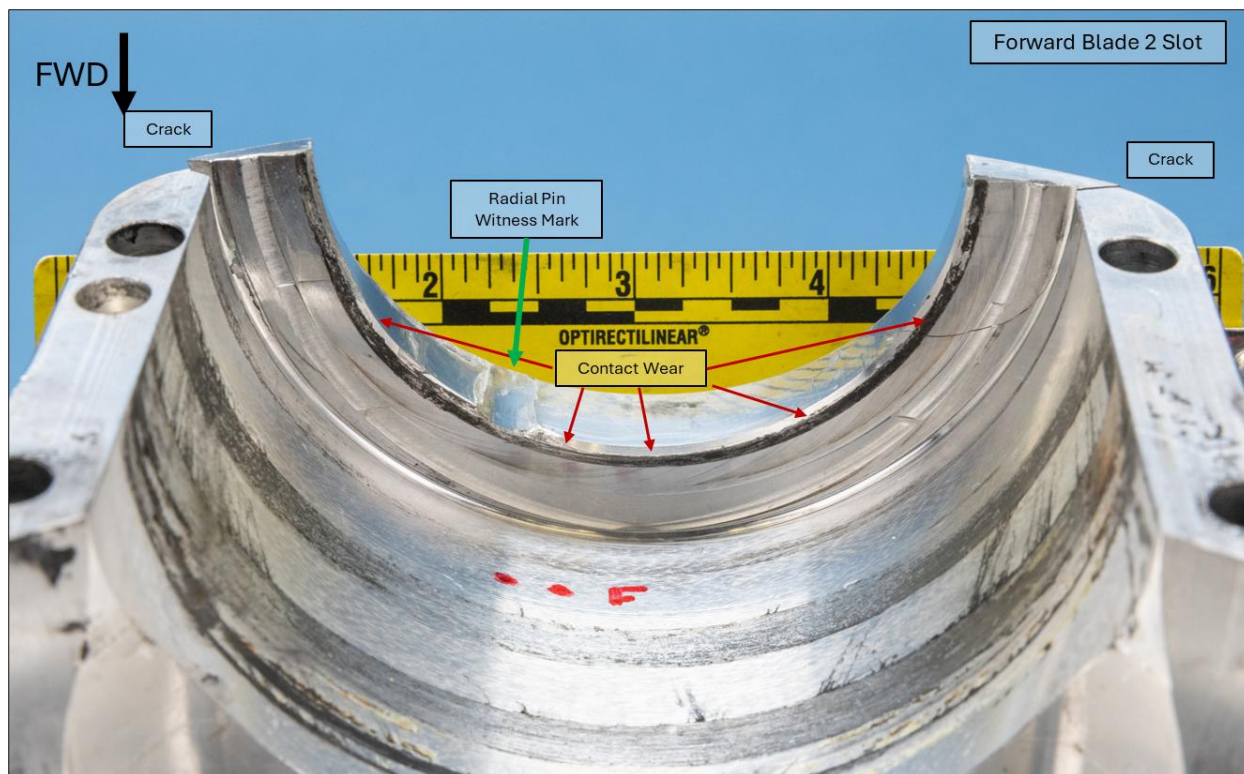
**Figure 17.** Radial view of the forward shell Blade 2 slot exhibiting the contact wear observed on the inner lip of the hub opening.

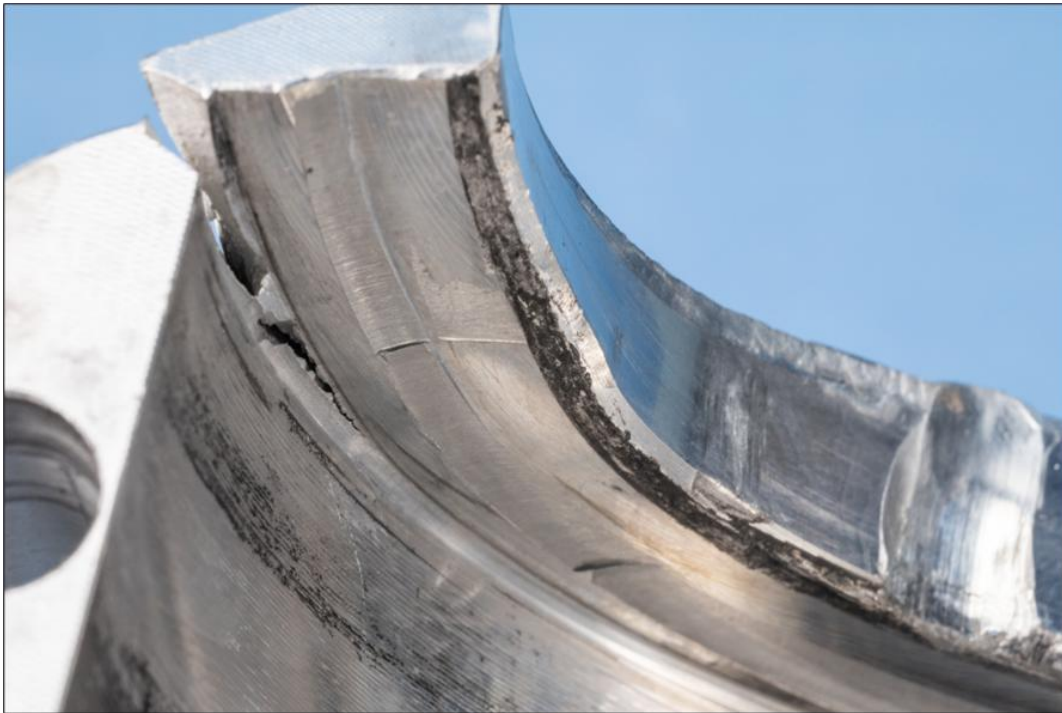
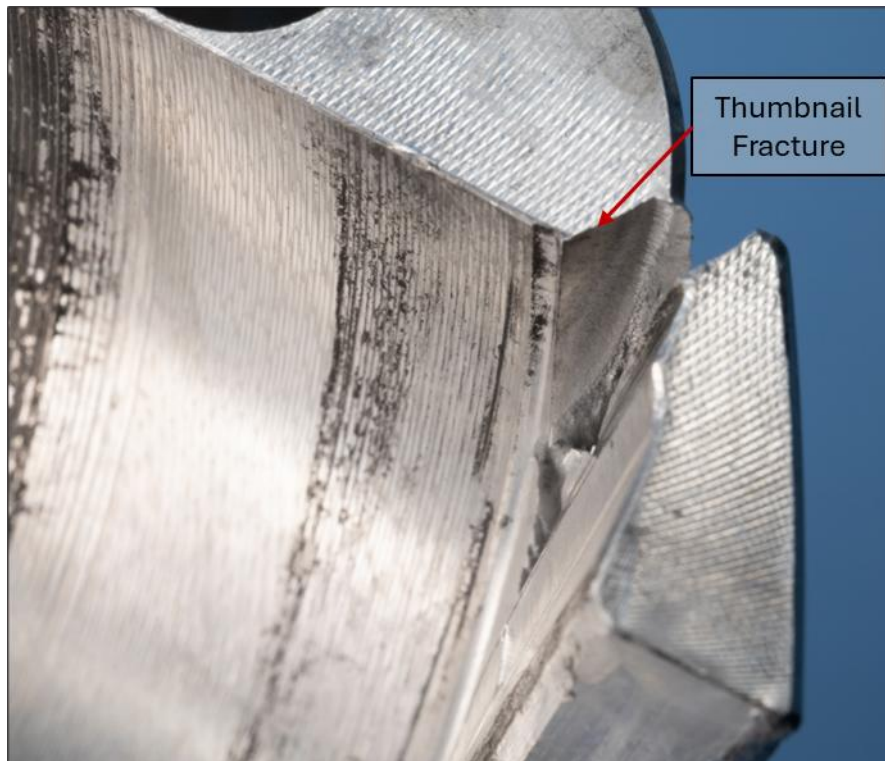
**Figure 18.** Detail images of a crack observed on the forward hub blade slot corners. While the bulk of the gross deformation likely occurred at the point of blade release, dark contact wear and the presence of a thumbnail crack emanating from the corner of the slot suggests a prolonged period of loading.

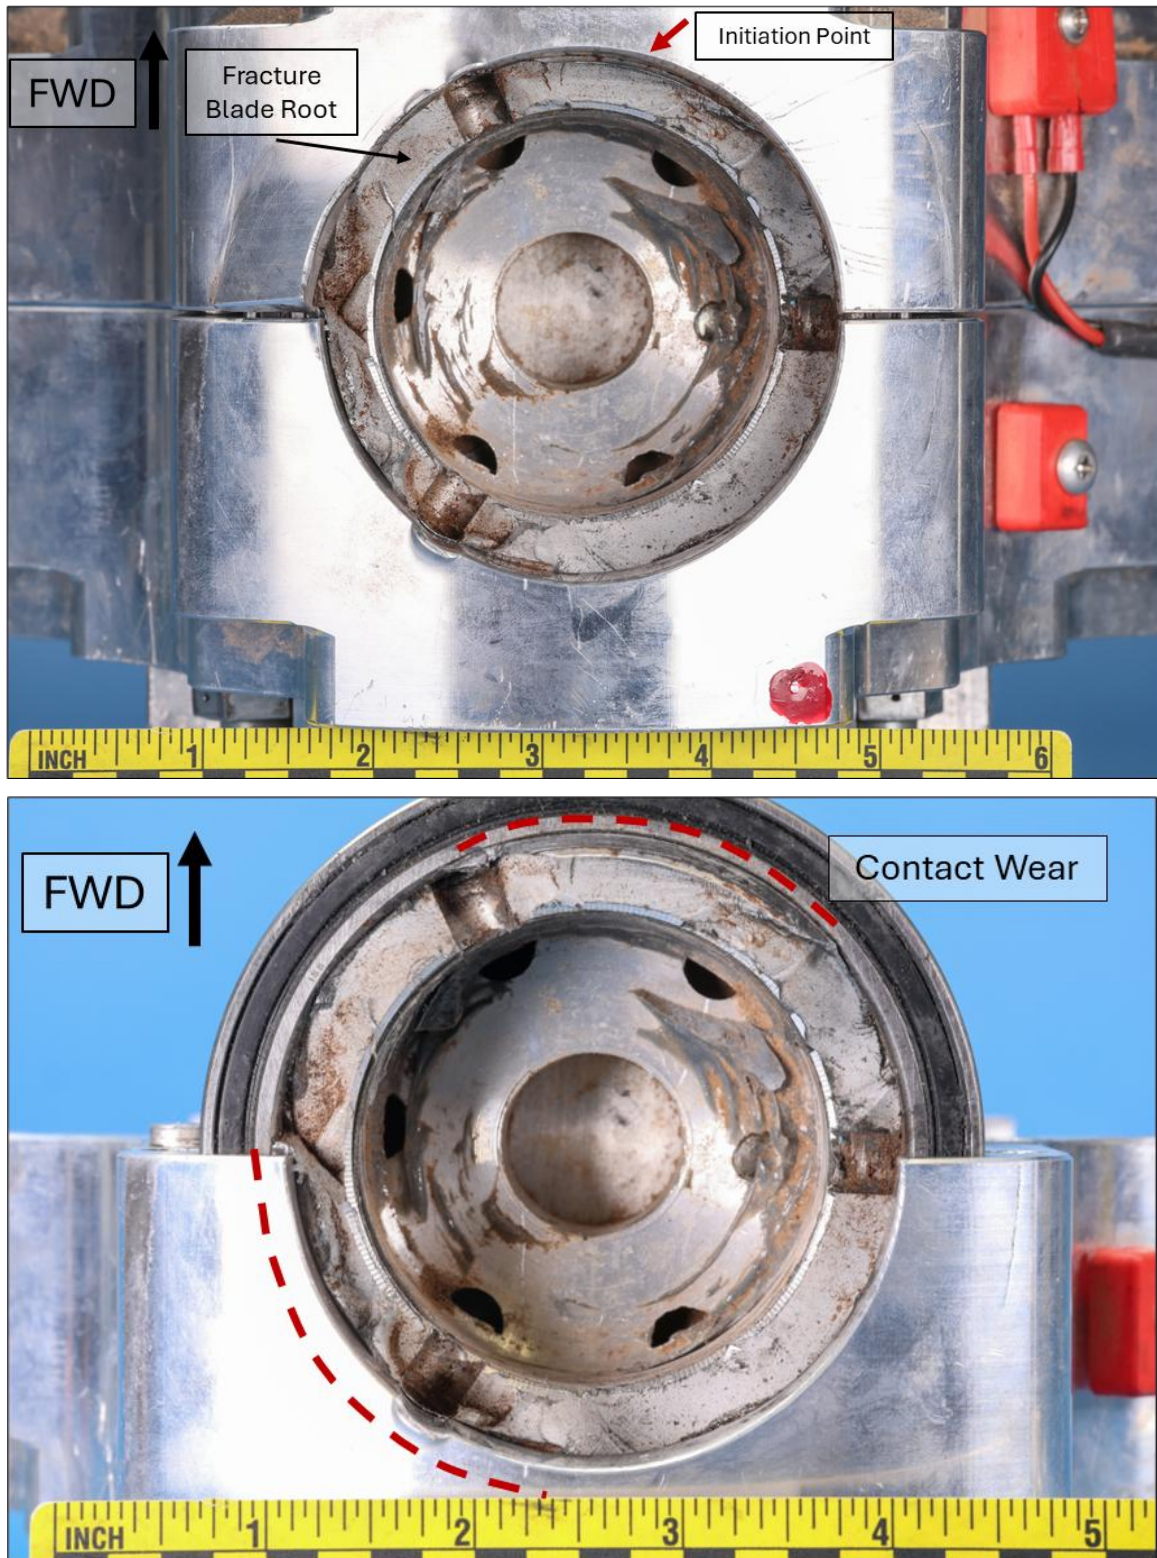
**Figure 19.** Annotated photographs of the propeller hub Blade 2 slot assembled with the bearing and fractured blade root. The fracture surface is oriented in the blade position at propeller liberation.
