# National Transportation Safety Board

Office of Research and Engineering

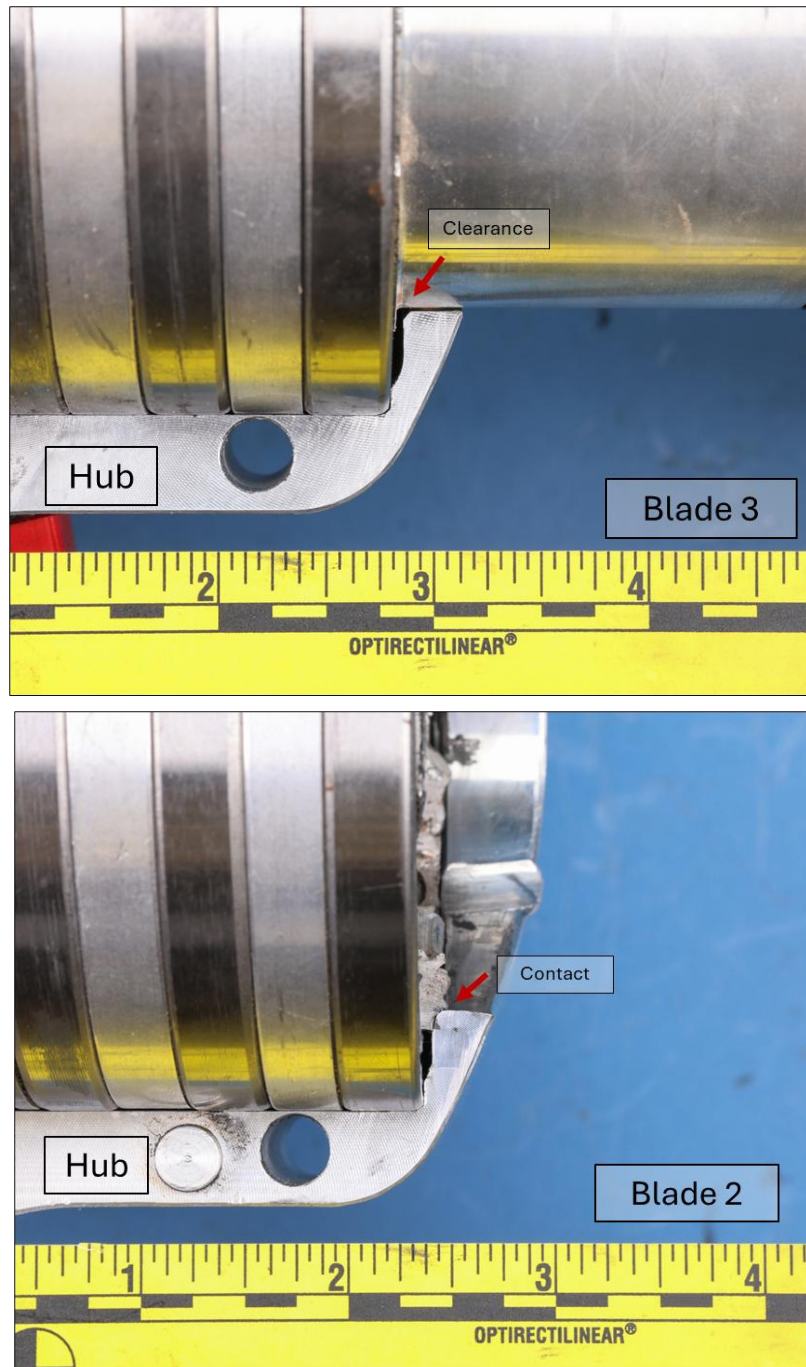
**Figure 20.** Comparison images of the Blade 3 (top) and Blade 2 (bottom) blade root bearing assemblies affixed within their respective slots. Clearance was observed between the hub opening and the blade root of Blade 3, allowing the Blade 3 pitch to rotate freely without contact. However, this clearance was not observed in the assembled Blade 2, allowing contact between the blade root and propeller hub opening. The contact surfaces corresponded with the aggressive wear observed on the remnants of the fillet surface observed on the fracture surface, as well as the wear observed on the inner lip of the hub opening.

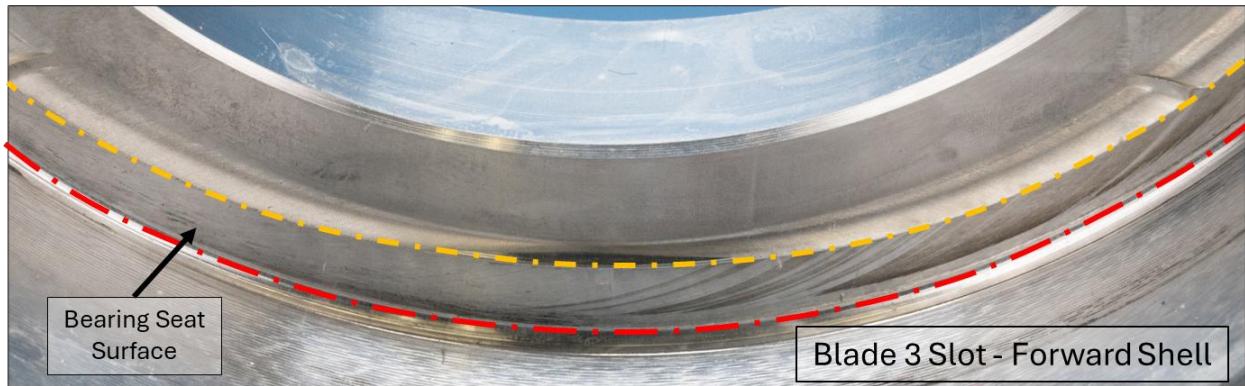
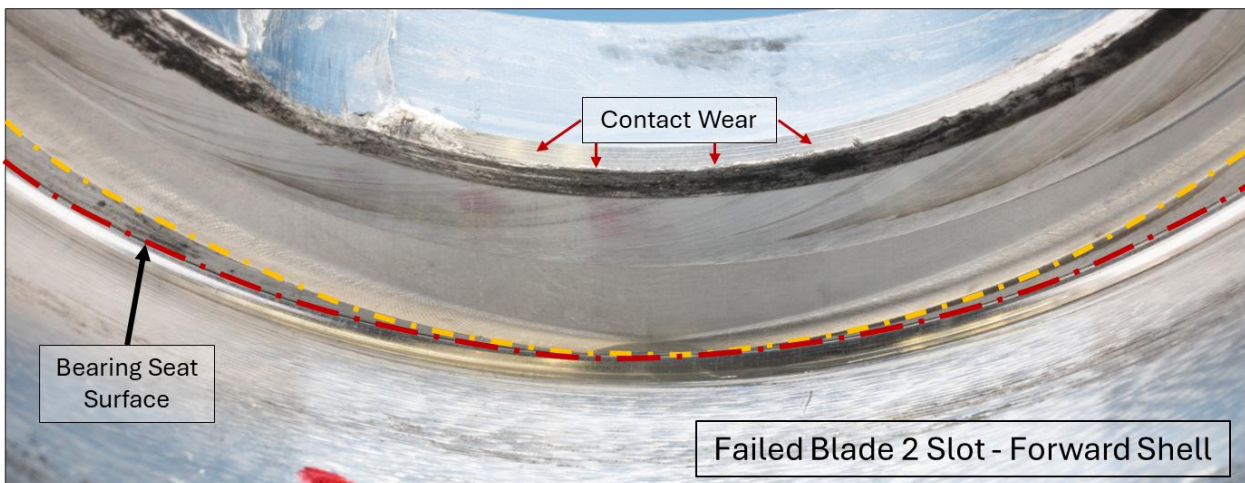
**Figure 21.** Annotated images of the inner lip surfaces of the forward shell Blade 2 and 3 slots. The bearing seat surface (contacting the top cartridge bearing) radial boundaries are identified via dashed lines, with the inner boundary denoted with orange and the outer with red. While both the Blade 3 and 1 forward slots exhibited a continuous flat seat surface, the Blade 2 seating surface disappears along the middle portion of the lip.

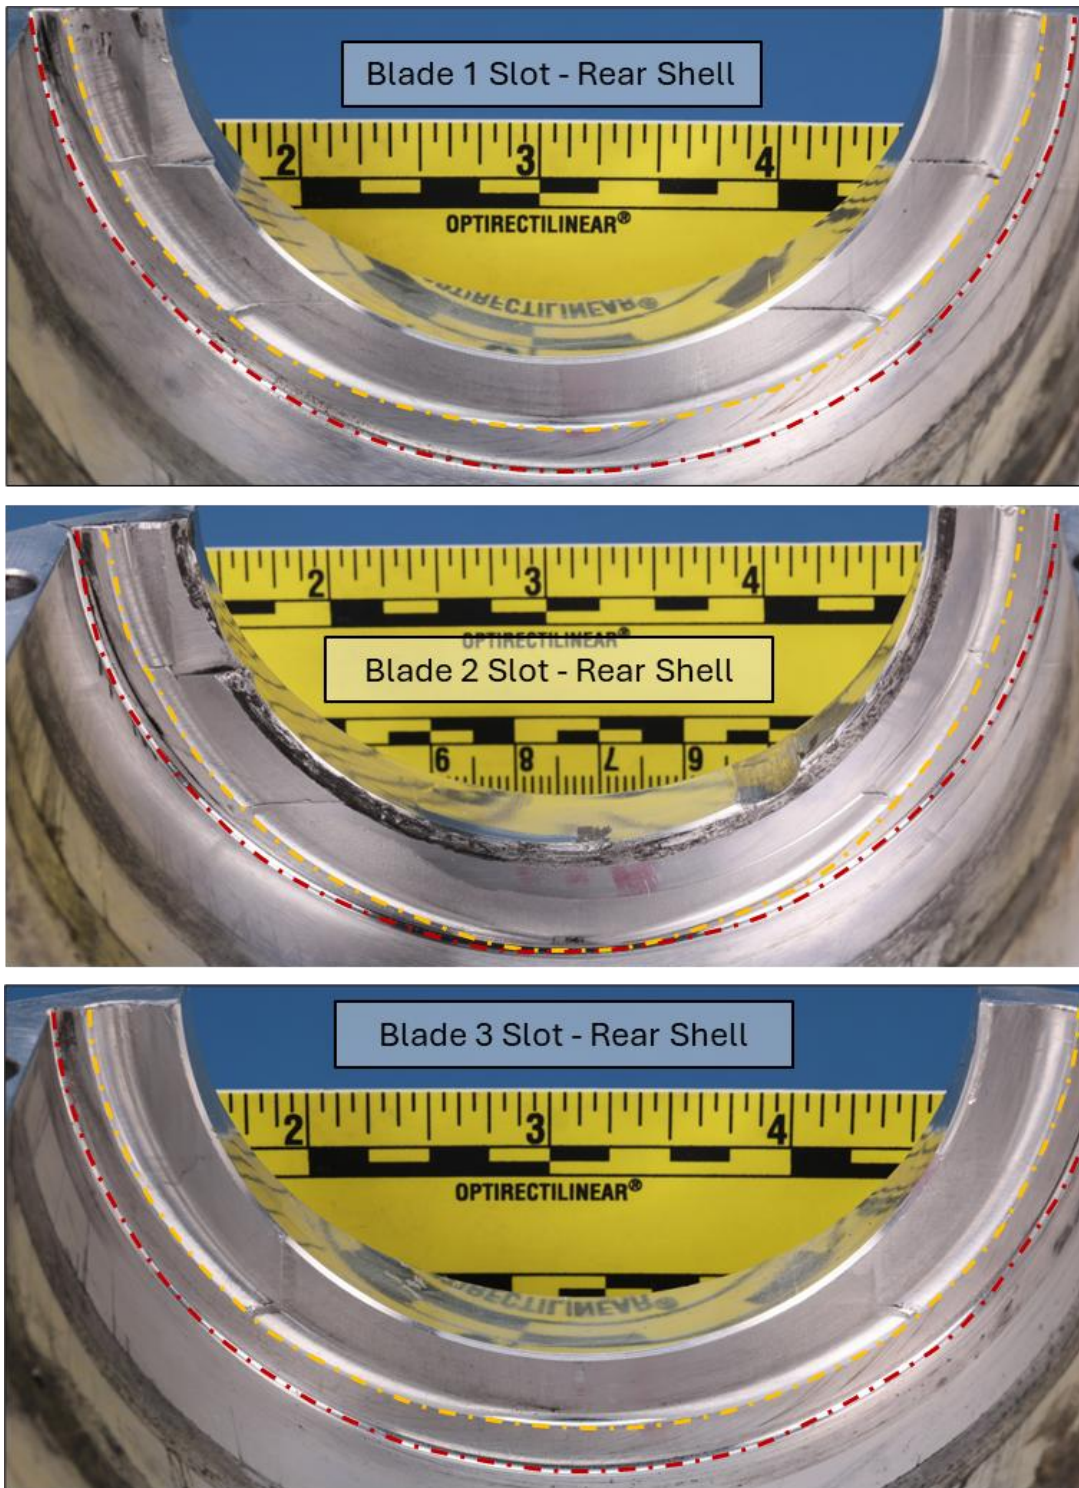
**Figure 22.** Annotated images of the inner lip surfaces of the rear shell for all three blades. Similar incongruities were observed between Blade 2, and Blades 1 & 3. Additionally, horizontally machined features were present on Blades 1 and 2 slots. Due to the rough and inconsistent appearance of these marks, it is unclear if these were intended features in the design.

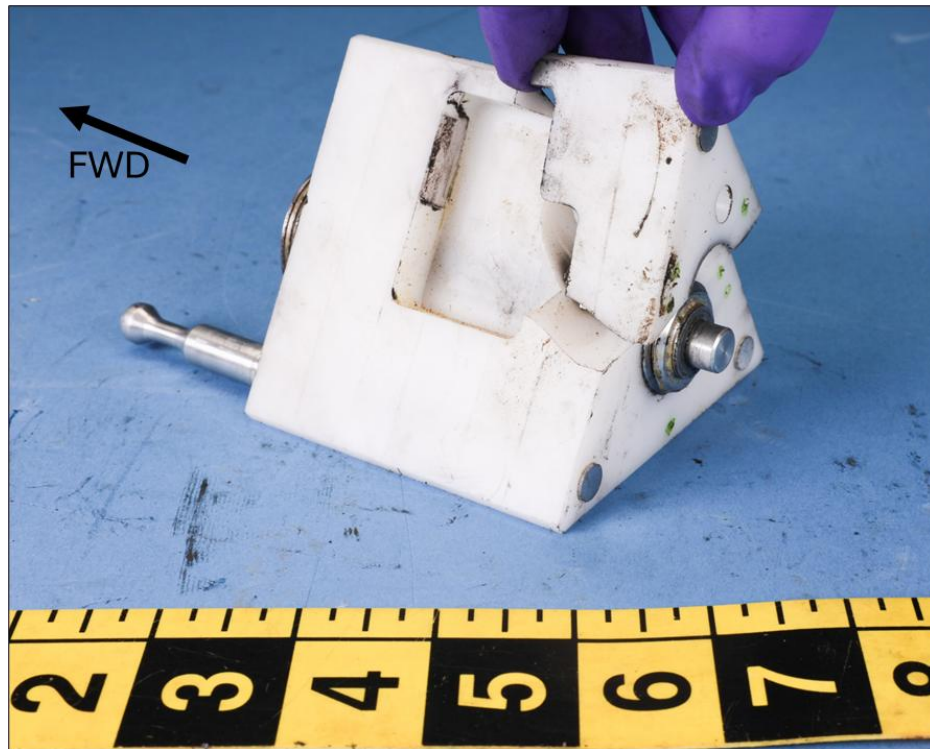
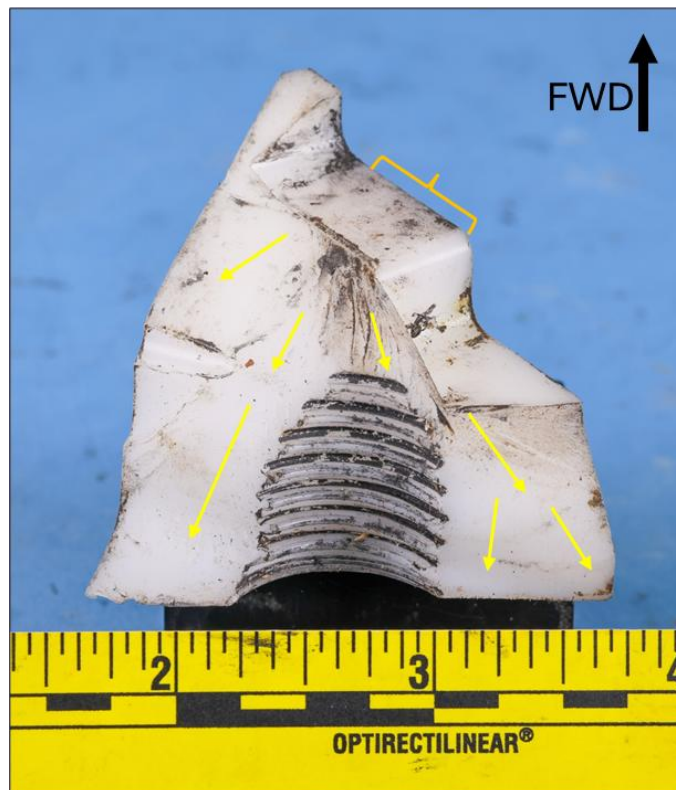
**Figure 23.** Photographic images of the fractured pitch change control block, with both pieces oriented (top) and the fracture surface annotated (bottom).
