CEN25LA150

## INVESTIGATION PHOTOGRAPHS

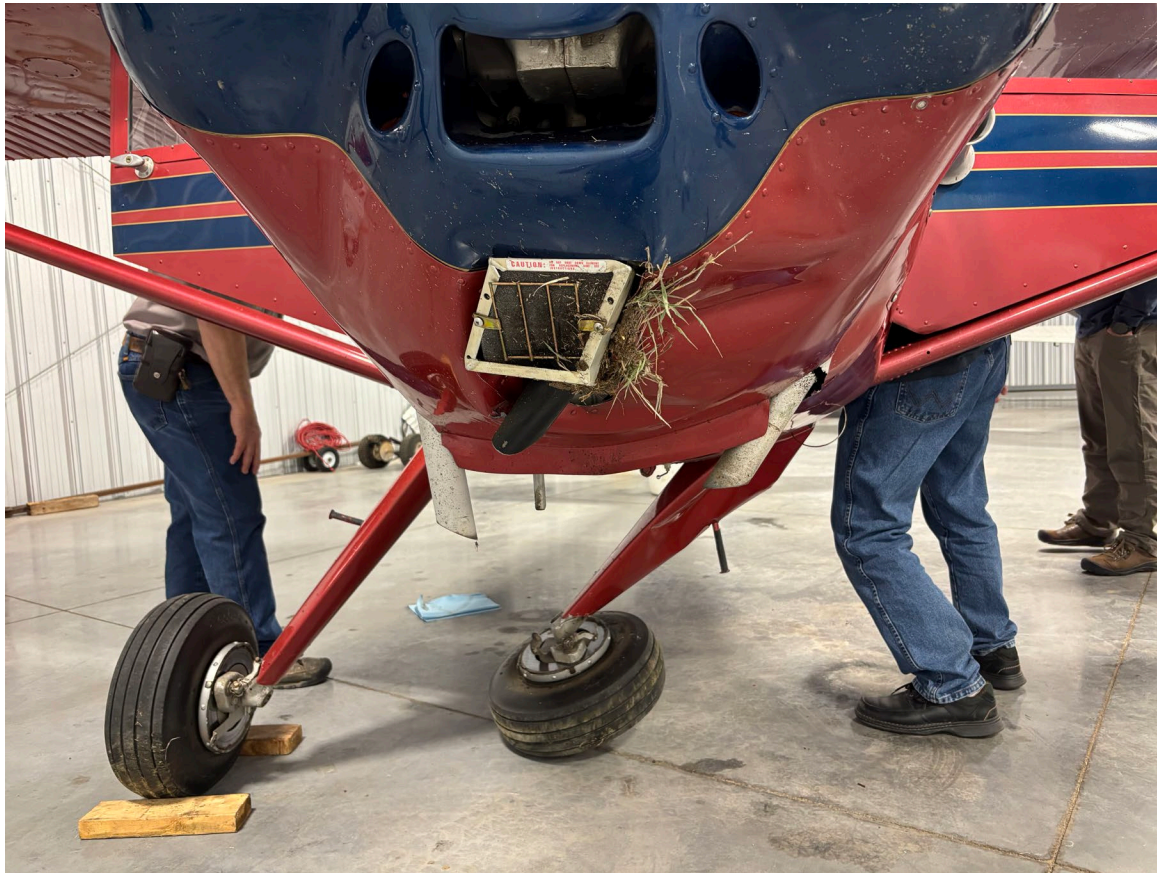
**Photograph 1 - Wrinkling of lower fuselage (Courtesy of FAA)**

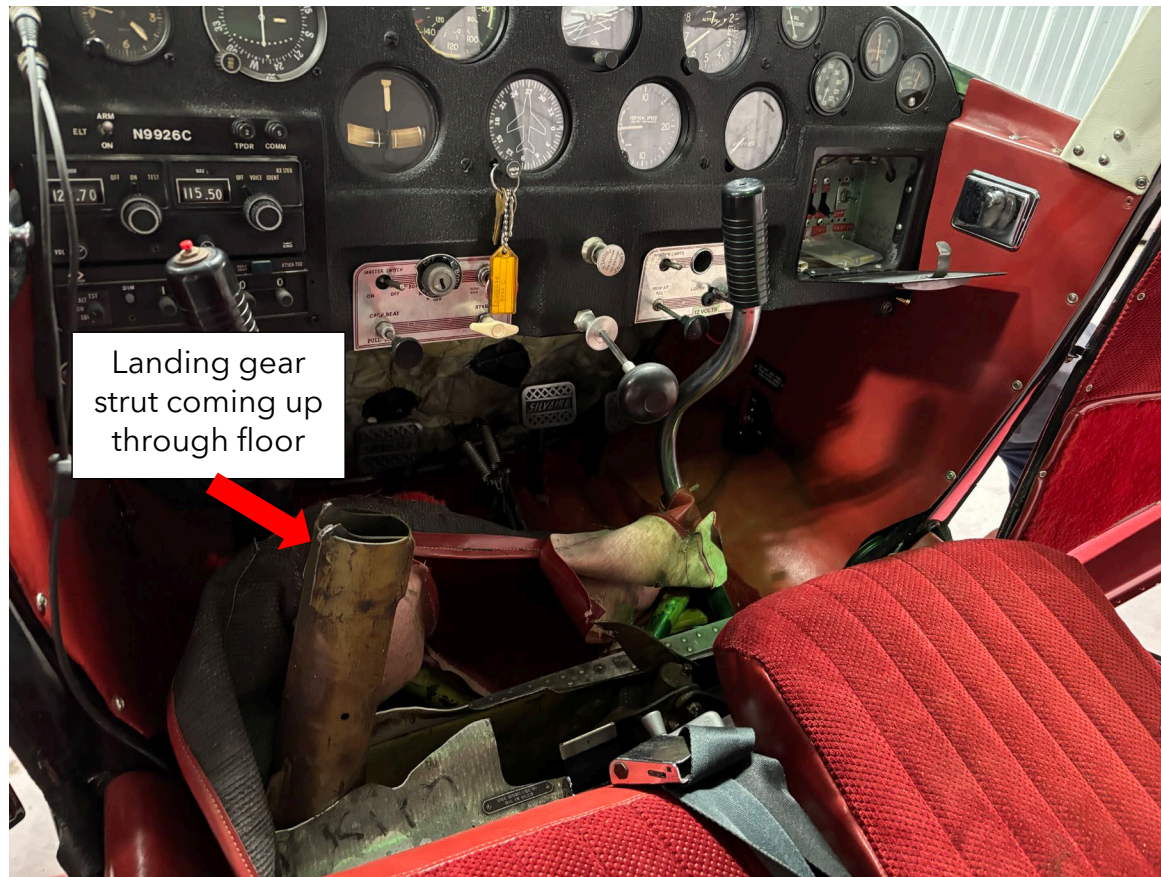
**Photograph 2 - Landing gear penetration of floor (Courtesy of FAA)**
