CEN25LA153

## INVESTIGATION PHOTOGRAPHS

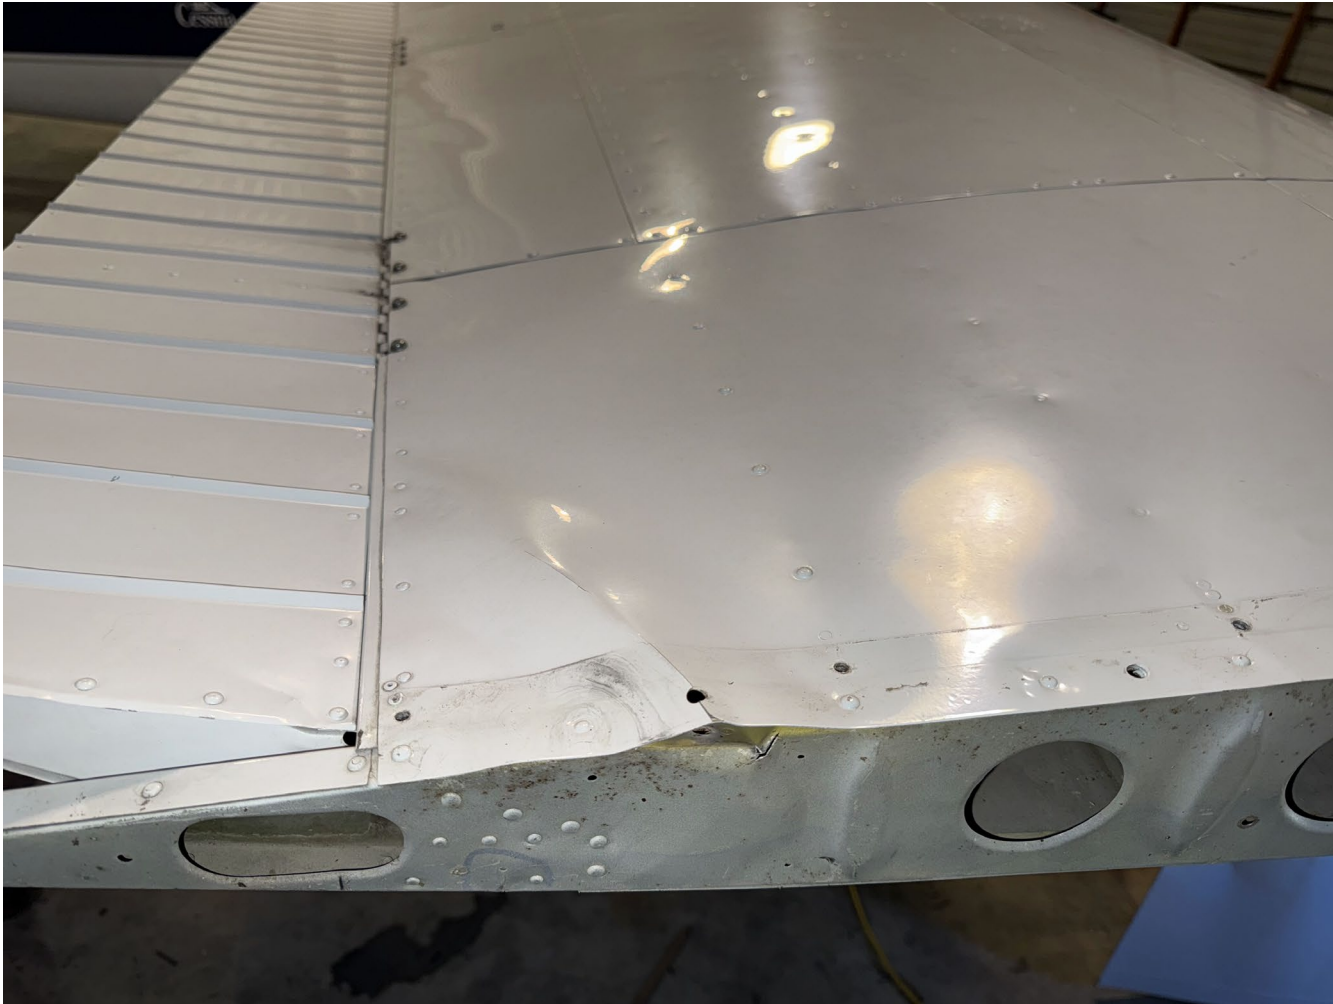
**Photograph 1 - Right Wing Damage (Courtesy of Classic Aero Maintenance)**

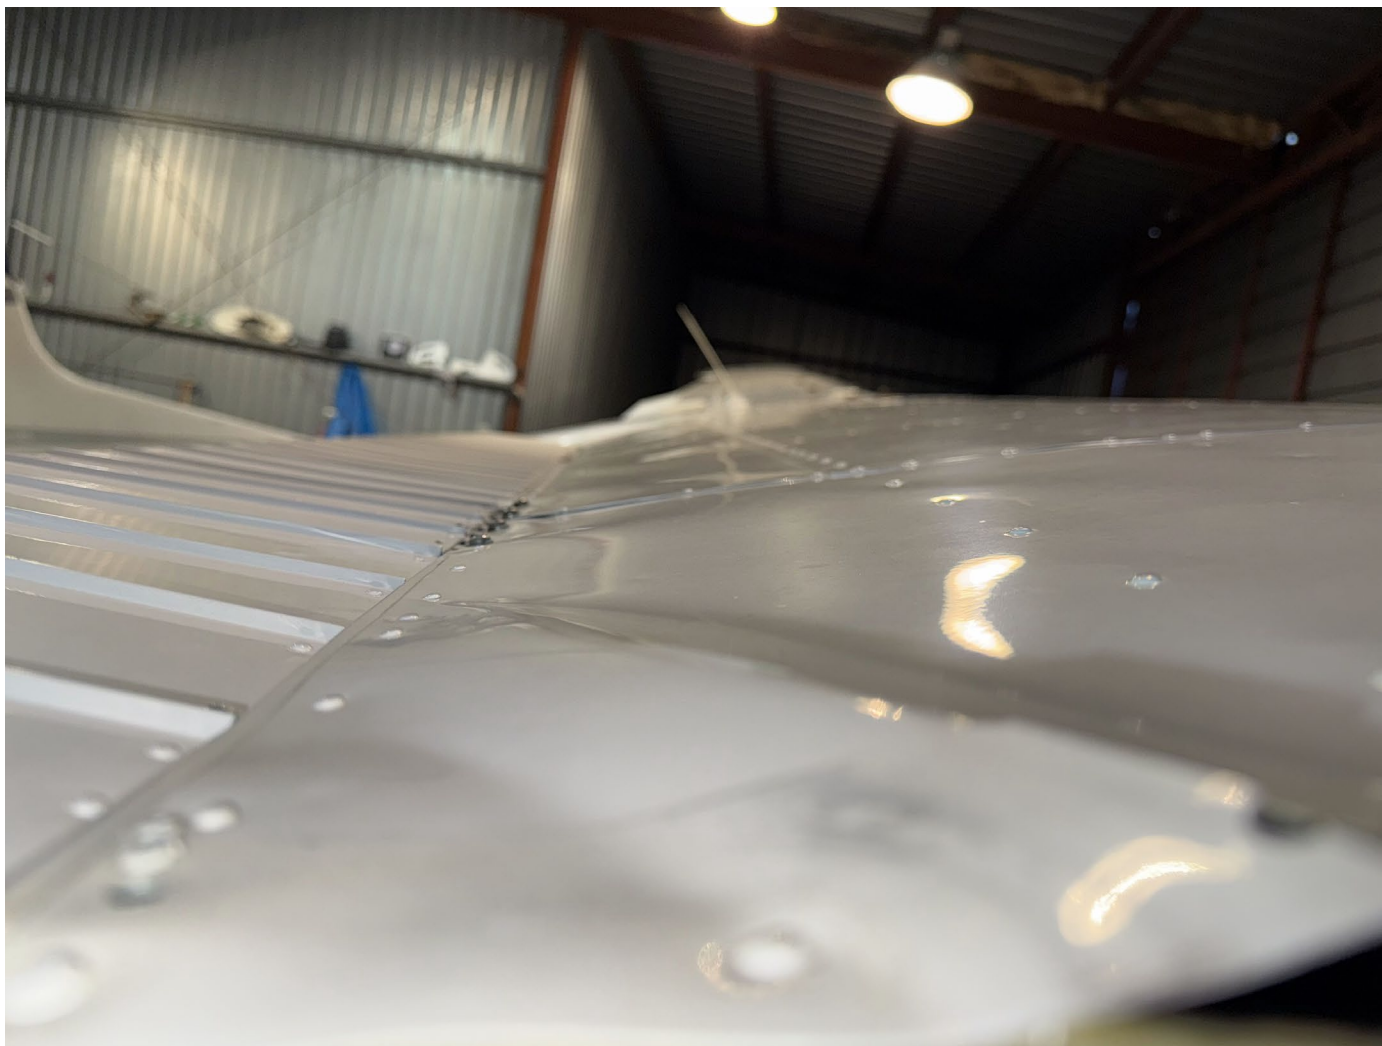
**Photograph 2 - Right Wing Side View (Courtesy of Classic Aero Maintenance)**
