CEN25LA179

## INVESTIGATION PHOTOGRAPHS

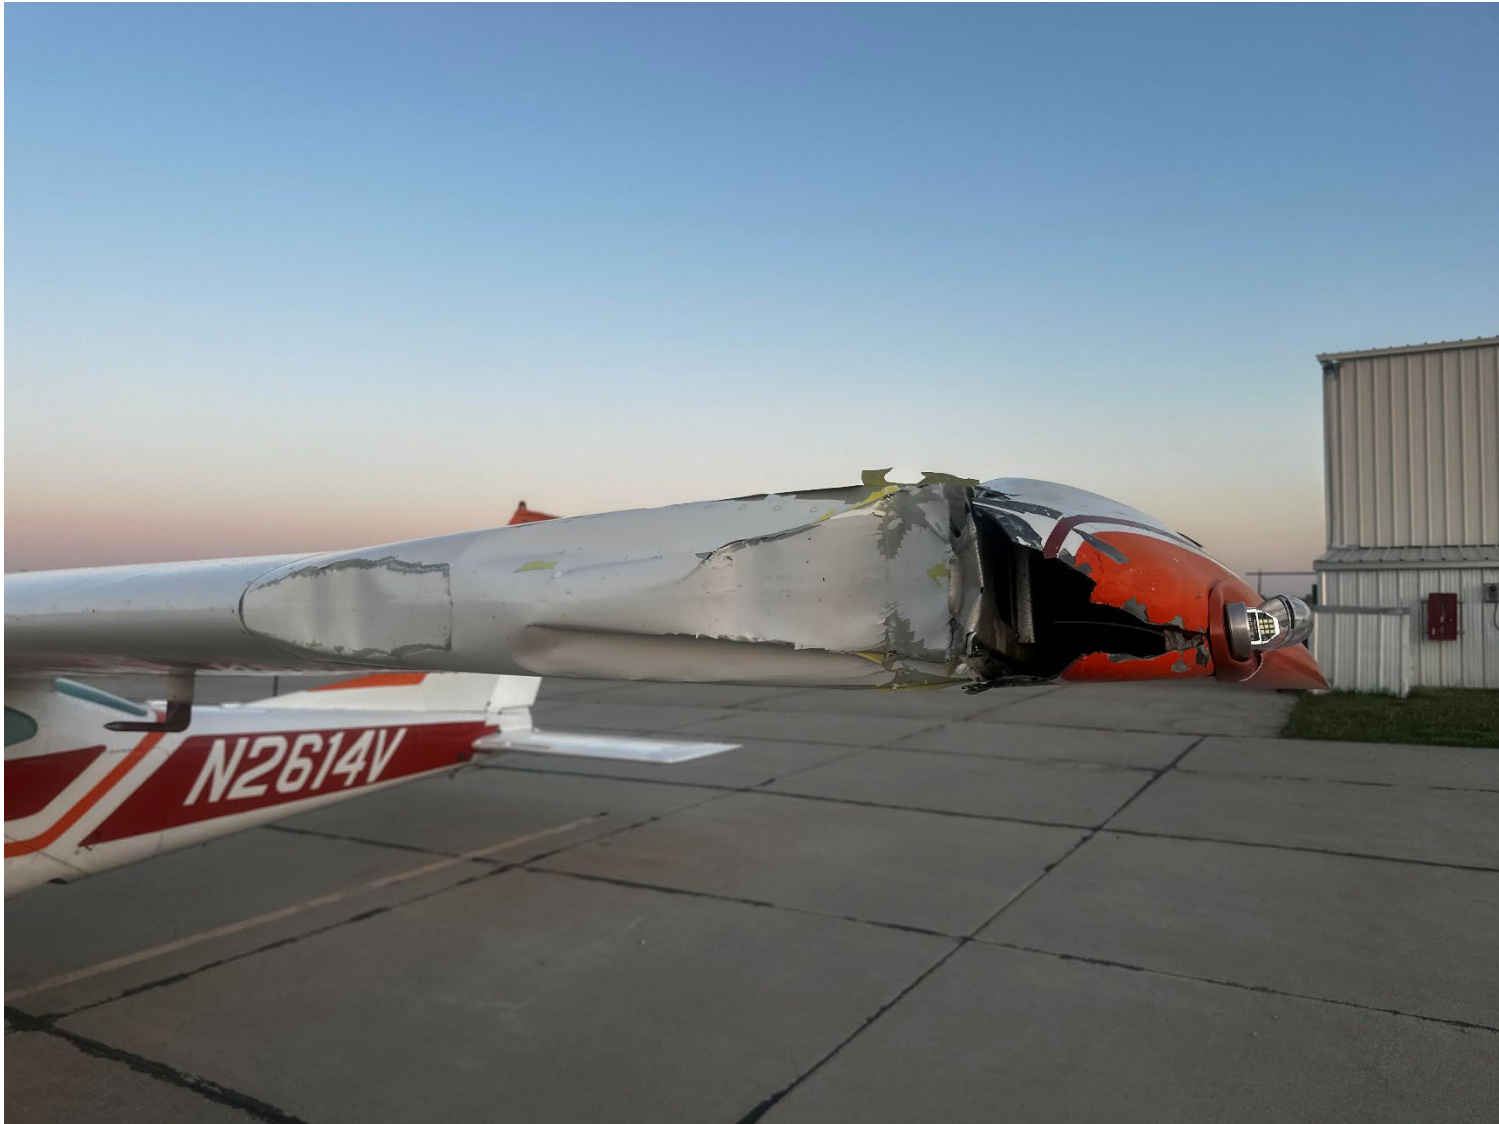
**Photograph 1 - Damaged left wing (Courtesy of pilot)**

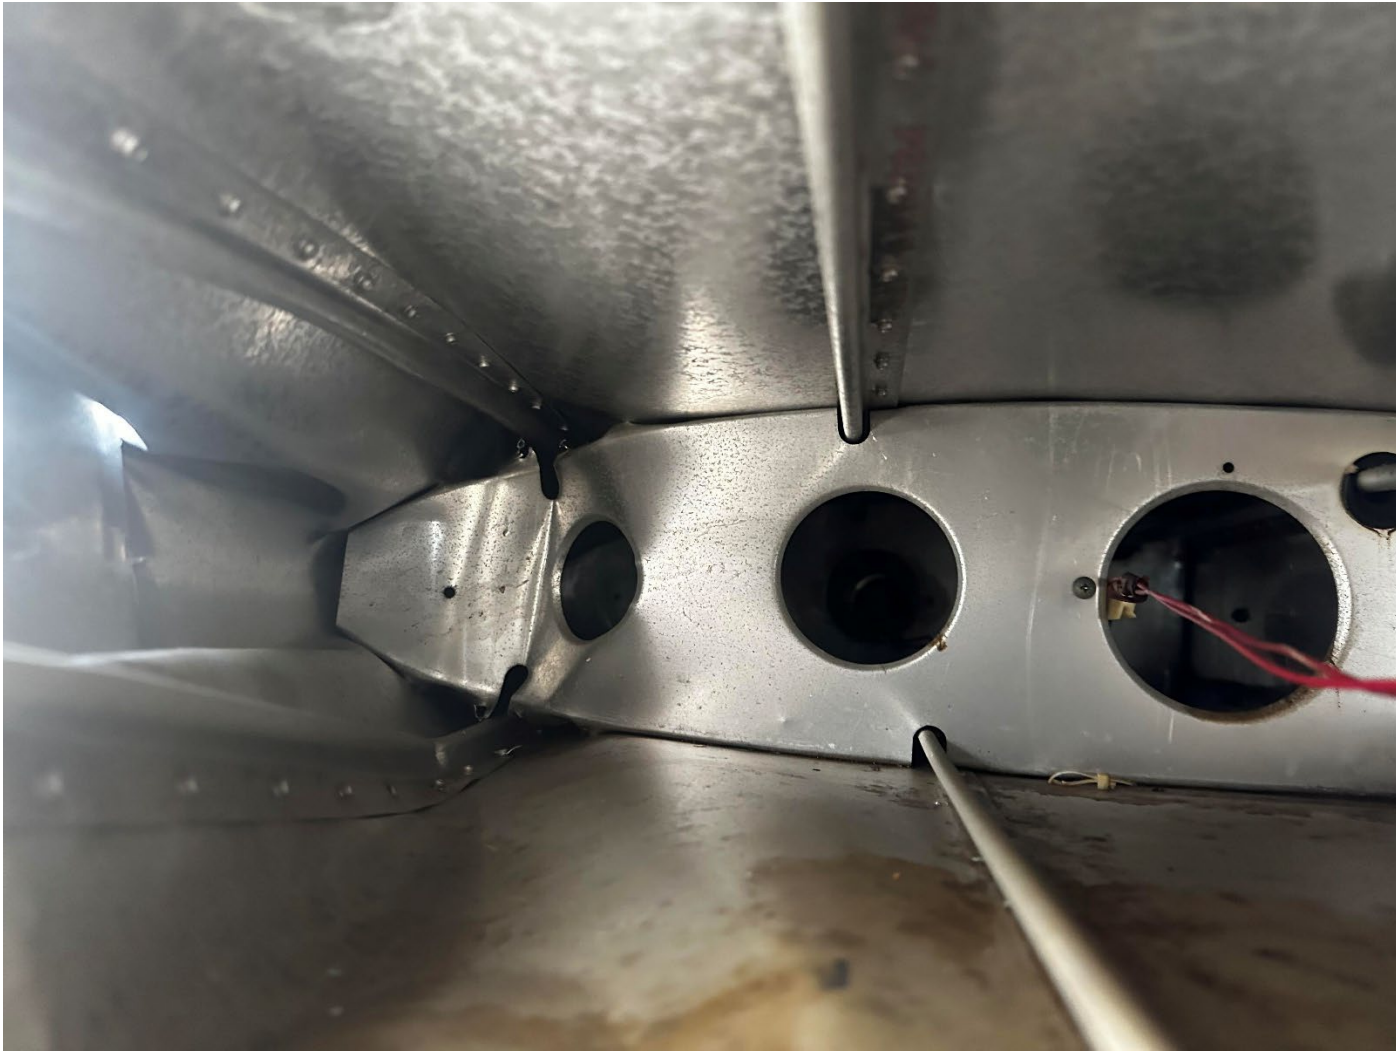
**Photograph 2 - Interior of outboard end of left wing (Courtesy of pilot)**
