## **NATIONAL TRANSPORTATION SAFETY BOARD**

### **Weather Study**

# **METEOROLOGY**

CEN25LA188

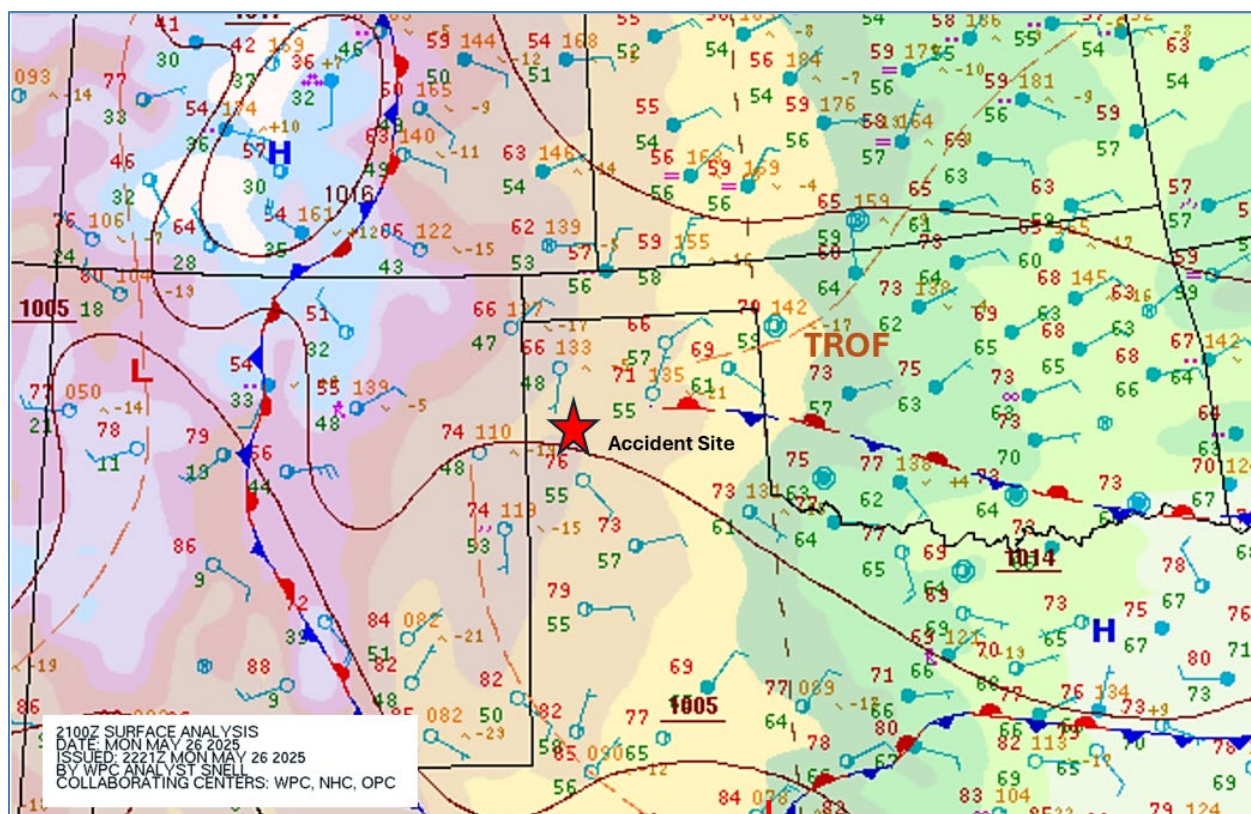
The National Weather Service (NWS) Surface Analysis Chart for 1500 CDT (2100Z) centered over the Texas panhandle is included as figure 1 with the approximate accident site marked by the red star. The chart depicted a developing stationary front extending from the Texas Panhandle into southern Oklahoma, with broken to overcast cloud cover along and north of the front. A trough<sup>2</sup> was depicted extending to the east-northeast of the accident site across extreme northern Texas into Oklahoma, and Kansas, with another trough to the west-southwest over New Mexico which extended south-southeast. A general deformation zone extended over the accident site, or a neutral point in pressure. The station models of the Texas Panhandle indicated variable winds in the area of 10 knots or less, clear skies, temperatures in the mid 70’s Fahrenheit (°F), with dew point temperatures in the mid 50’s °F.

Figure 1 - NWS Surface Analysis Chart for 1500 CDT with the approximate accident site marked by the red star.

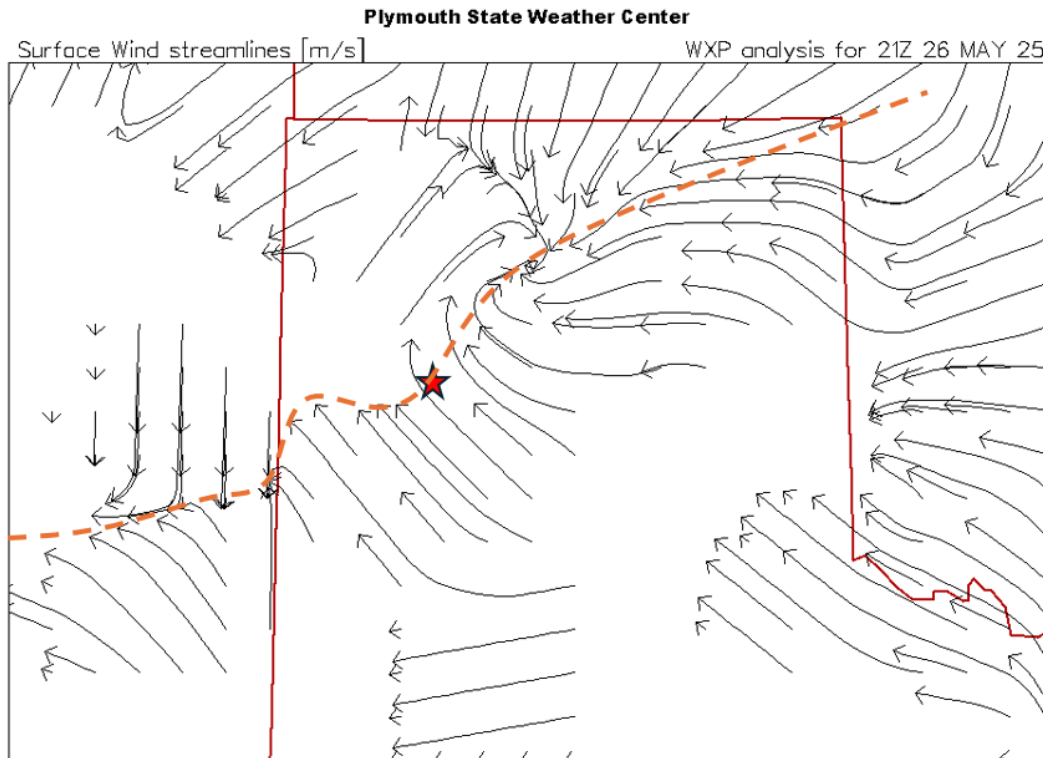
A streamline analysis<sup>3</sup> for 1500 CDT is included as figure 2 with the approximate accident site marked by the red star. The chart is based on the instantaneous wind flow from the plotted METAR observations over the area. The image depicted a general band of convergence over the Texas Panhandle with a vortex (annotated by the dashed brown line) which extended southwestward over the general vicinity of the accident site. The convergent band in the immediate vicinity of the accident site implied the potential for variable winds and support for localized lifting and potential shear in the wind field.

**Figure 2 - Streamlines analysis for 1500 CDT with approximate accident site indicated.**

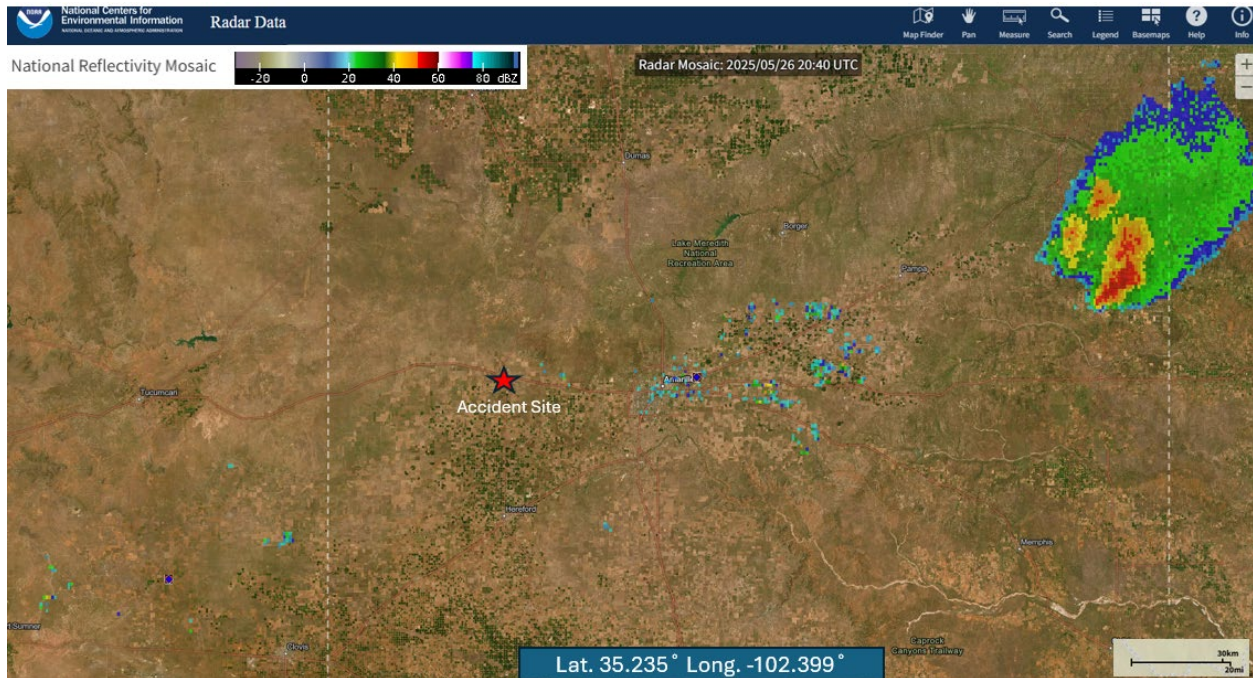
The NWS regional view of the National Composite Radar Mosaic for 1540 CDT is included as figure 3 with the approximate accident site marked by the red star. The image depicted an intense area of echoes east of Amarillo, with no significant meteorological echoes within 50 miles of the accident site. The absence of any convective echoes over the area implies no convective microbursts associated with descending precipitation cores, or organized outflow boundaries were likely occurring during the period of the accident.

Figure 3 – NWS Regional Composite radar Mosaic for 1540 CDT with the accident site marked by red star.

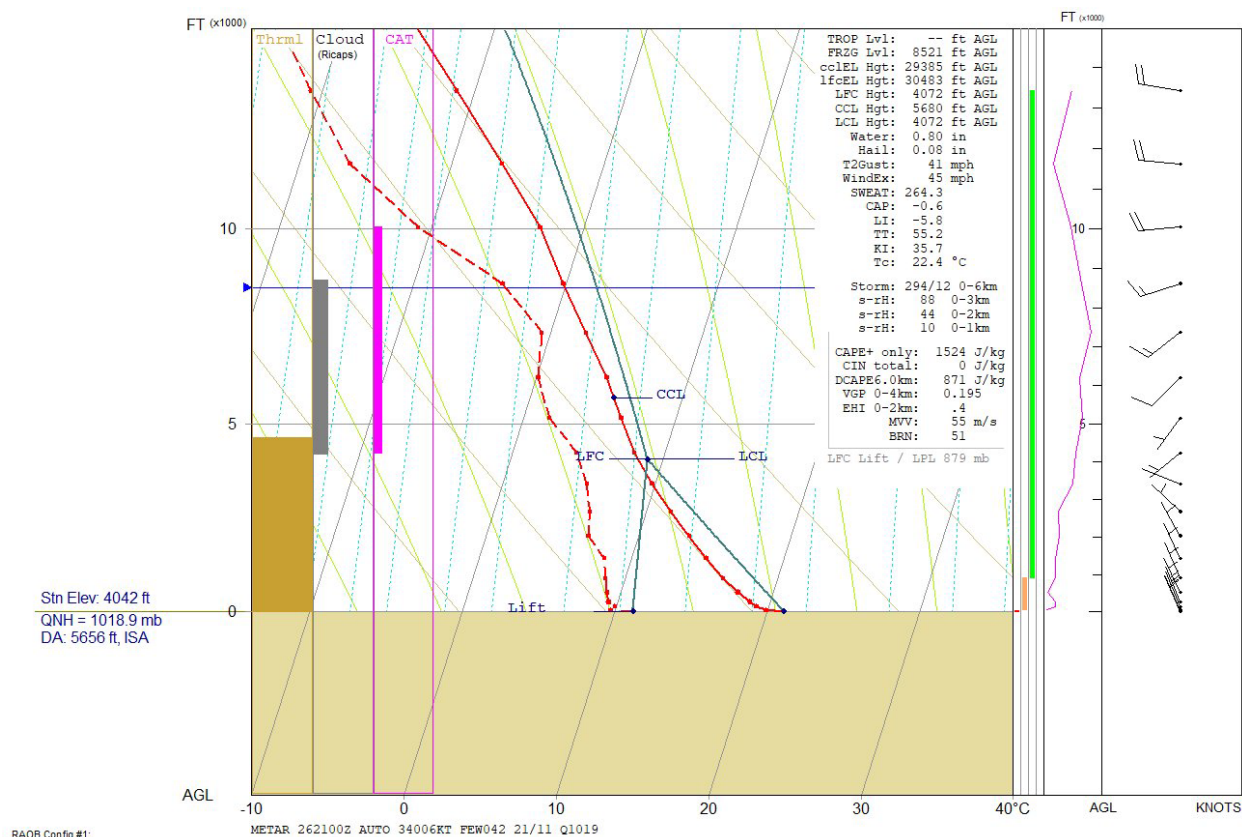
**Figure 4 - High-Resolution Rapid Refresh (HRRR) numerical model sounding over the approximate accident site for 1600 CDT from the surface to about 18,000 ft.**

The 1600 CDT HRRR sounding depicted an elevation of 4,042 ft over the grid point with a near surface temperature of 21.1°C (70°F), a dew point temperature of 11.2°C (52.2°F), a relative humidity of 53%, a sea-level pressure of 879-hPa. The resultant density altitude was calculated at 5,656 ft. The lifted condensation level (LCL) and level of free convection (LFC) were determined to be at 4,072 ft agl, and the convective condensation level (CCL) at 5,680 ft agl. The precipitable water content was 0.80 inches. The RAOB Analysis program supported a few cumulus clouds at 4,200 ft agl with tops near 8,700 ft. The sounding was characterized as conditionally unstable with a Lifted Index (LI) of -5.8 and a Convective Available Potential Energy (CAPE) of 1,524 Joules/kilogram, and the maximum vertical velocity of any potential updrafts of 55 meters/second or 110 knots. The Downdraft CAPE (DCAPE) was 871 J/kg and the T2Gust and WindEx estimate were about 40 knots. The RAOB Analysis program also indicated strong support for thermals to about 5,000 ft agl.

The sounding wind profile indicated a surface wind from about 340° at 6 knots, with winds backing to the west above 5,000 ft agl with gradually increasing wind speeds. The mean 0 to 6 kilometer (or 18,000 ft) wind was from 165° at 16 knots. The RAOB Analysis program did not highlight any strong vertical or horizontal shears in the wind field below 7,700 ft. The effects of the thermal or convective turbulence is not considered or the effect of any low-level convergence bands.

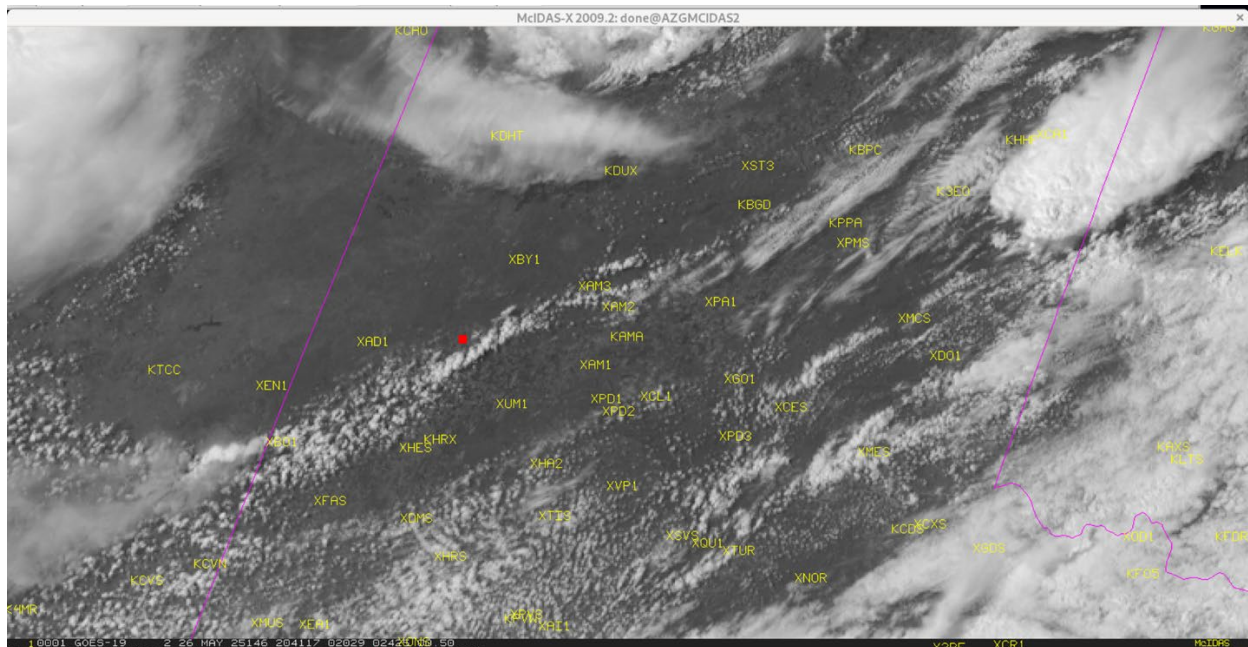
Figure 5 is the GOES-19 visible band image for 1541 CDT at 2X magnification with the accident site marked by the red square. The image depicted a line of low cumulus clouds extending northeast to southwest across the area and was located immediately south of the accident site. This line was associated with the convergence line indicated by the streamlines moving southeastward through the area. The infrared image indicated the radiative cloud top temperatures near 282 Kelvin associated with the cumulus clouds south of the accident site, which corresponded to 8.8°C and tops near 7,500 ft based on the HRRR sounding. A defined cumulonimbus cloud with an overshooting cloud top and extensive anvil outflow was observed in the vicinity of Hemphill County Airport (KHHF), Canadian, Texas in the northeast panhandle and approximately over 100

miles from the accident site. No other organized convective clouds were identified in the vicinity of the accident site.

Figure 5 - GOES-19 visible image for 1541 CDT at 2X magnification with the accident site noted in red.
