CEN25LA196

## INVESTIGATION PHOTOGRAPHS

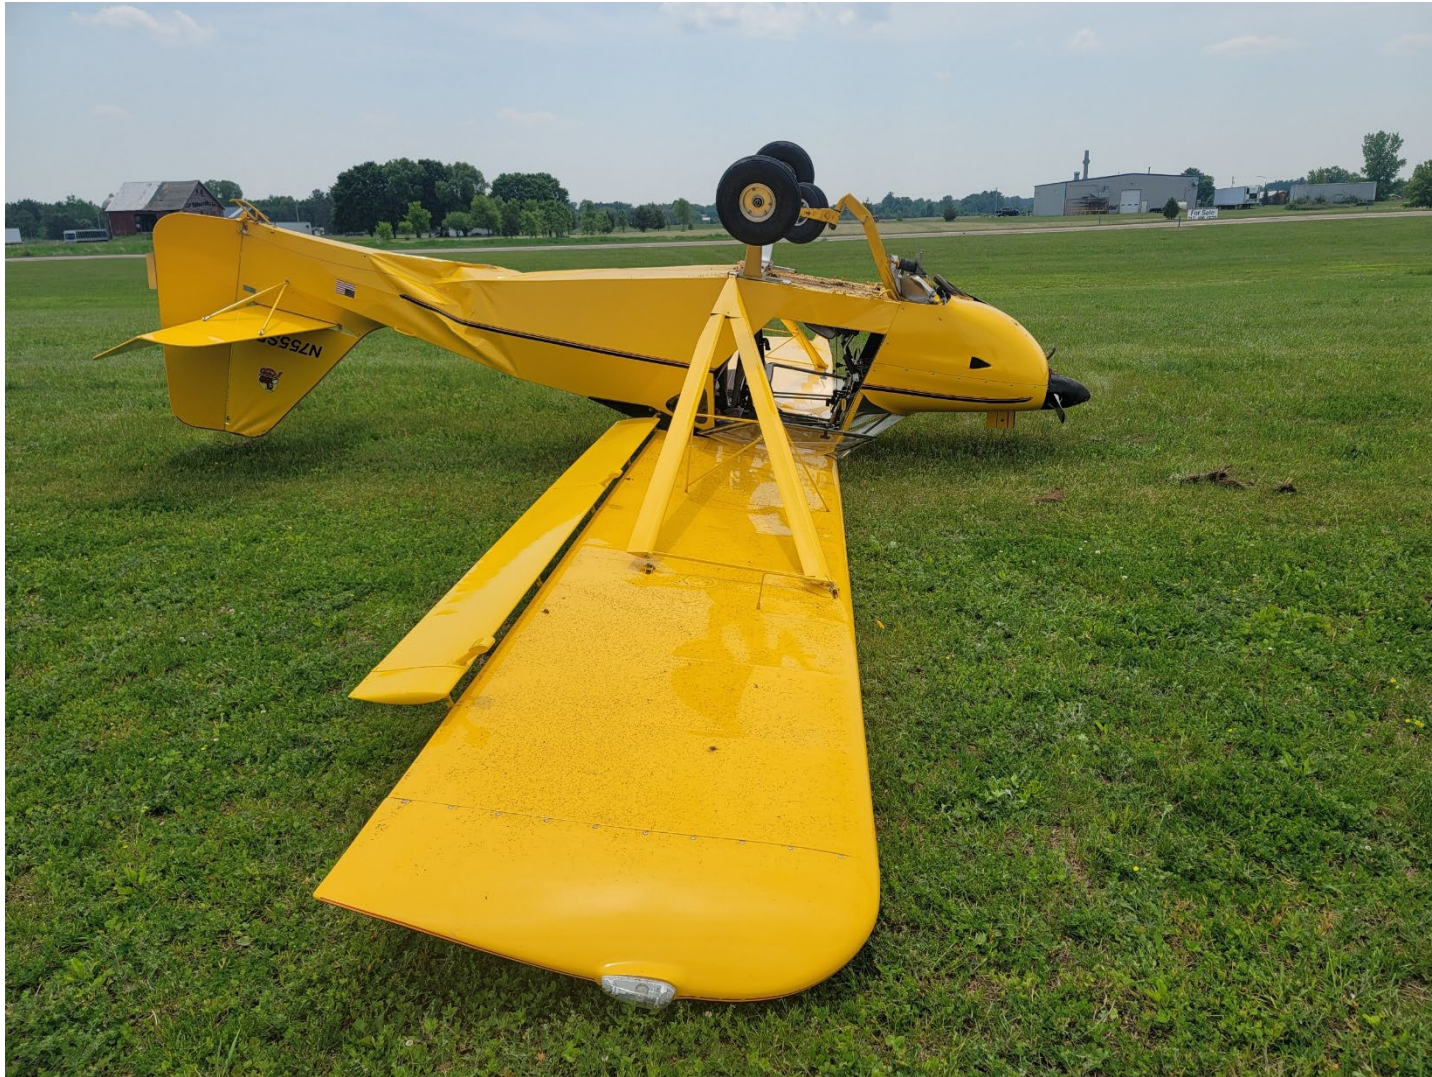
**Photograph 1 - N755SD left side (Courtesy of airport manager)**

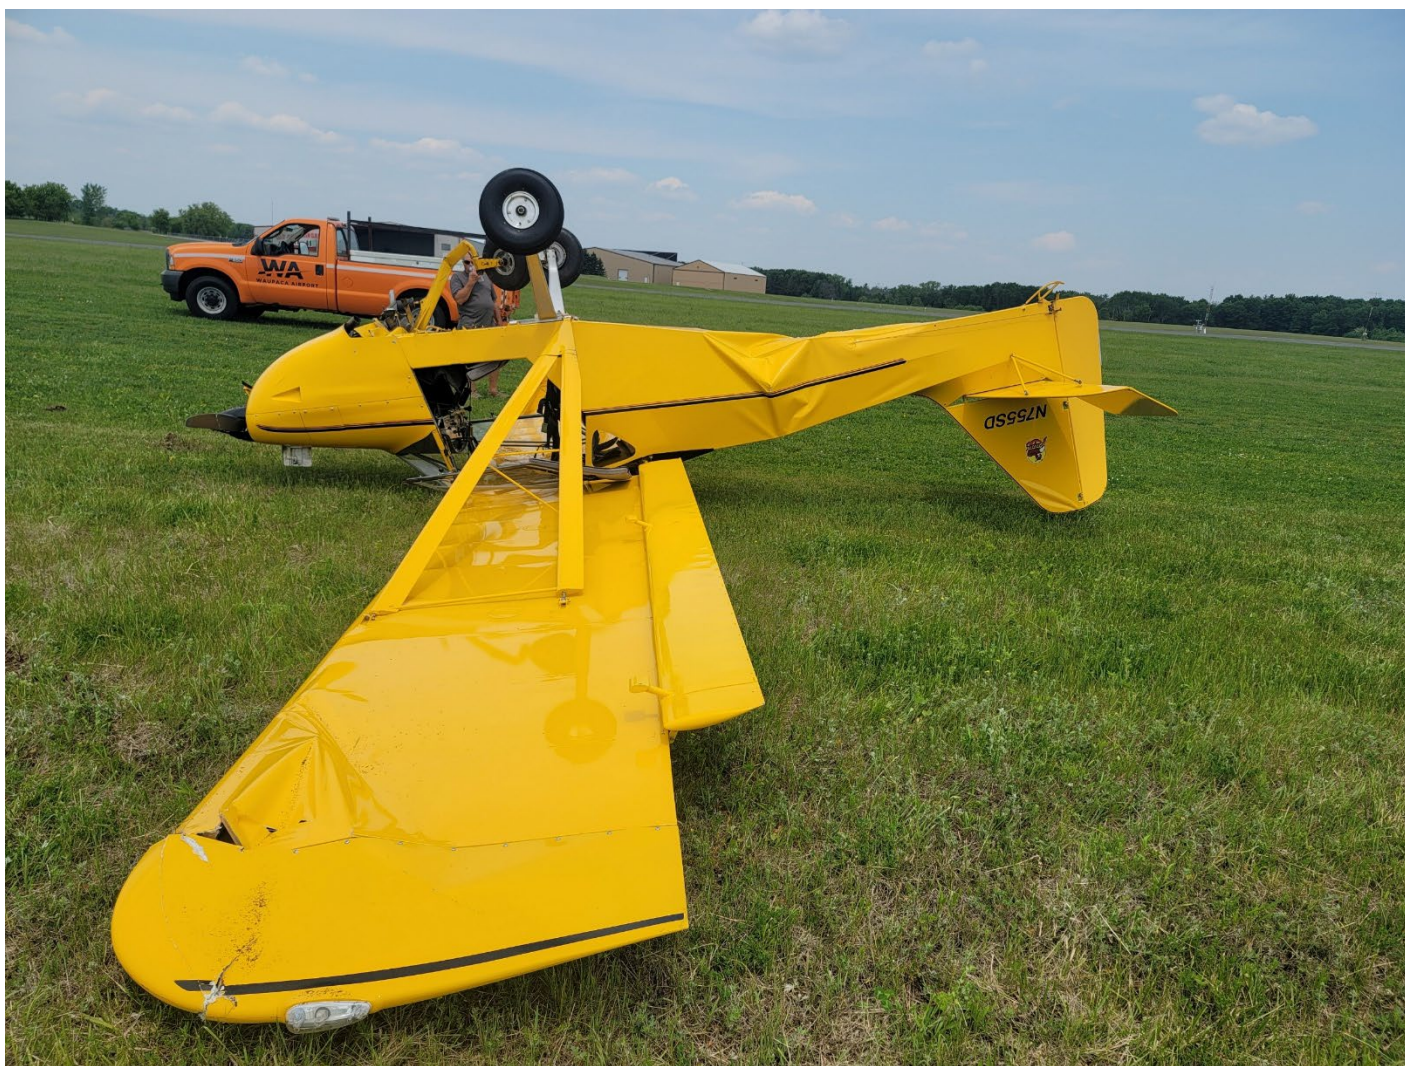
**Photograph 2 - N755SD right side (Courtesy of airport manager)**

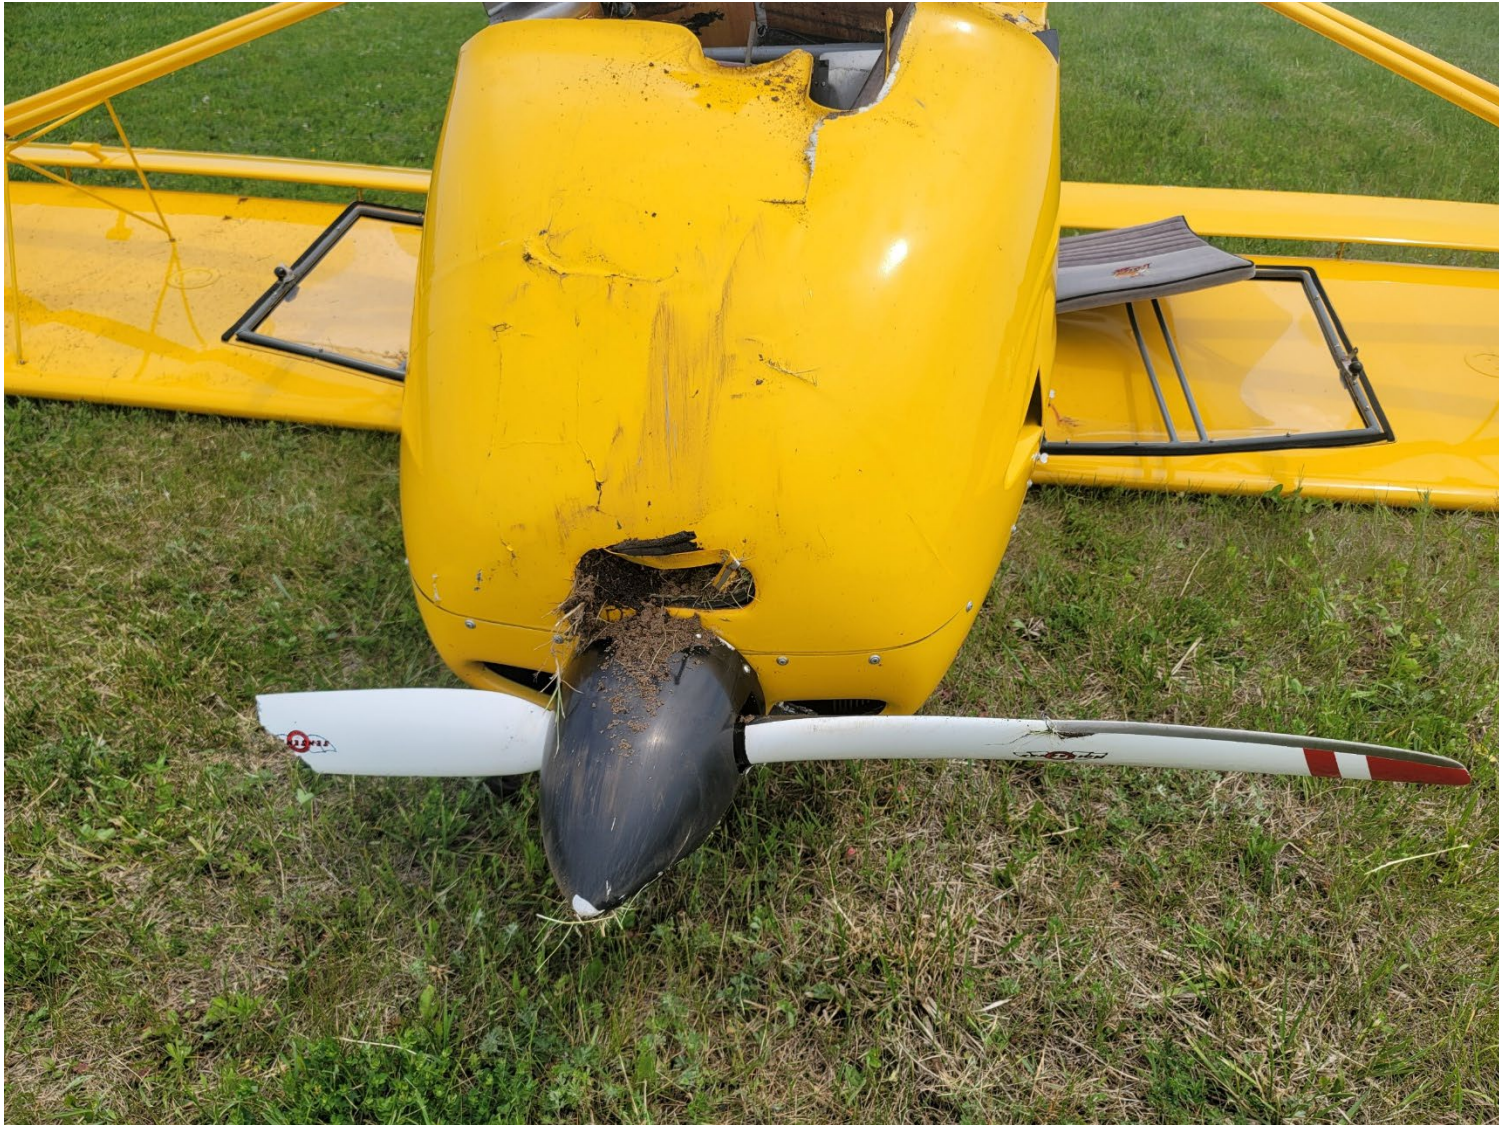
**Photograph 3 - N755SD propeller & lower engine cowling  
(Courtesy of airport manager)**

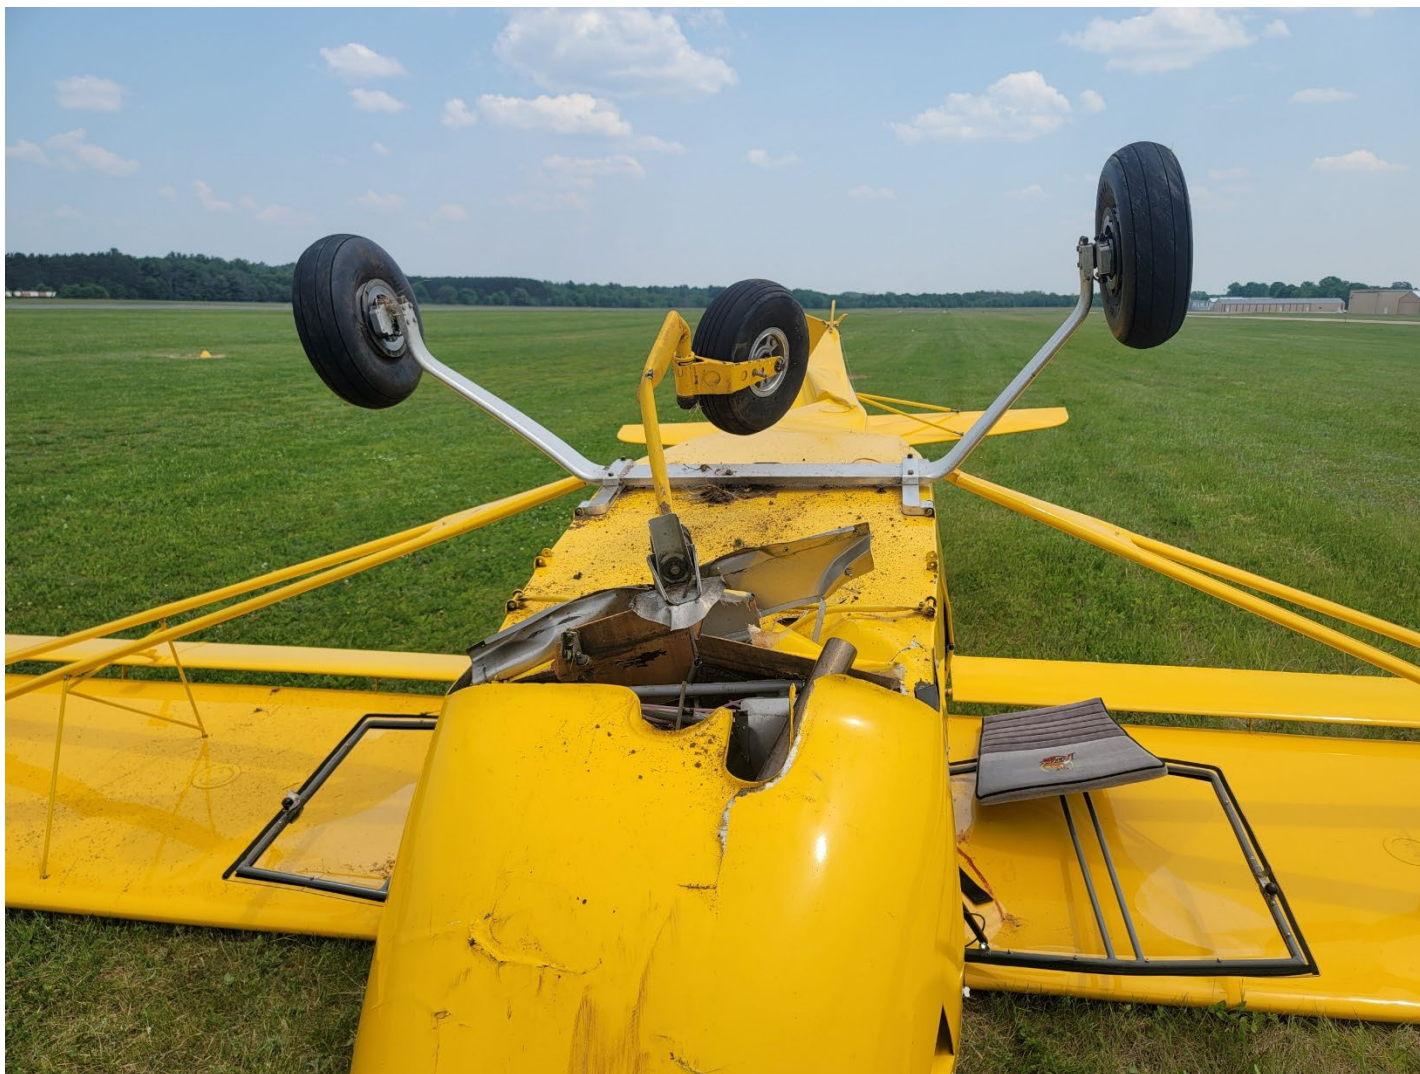
**Photograph 4 - N755SD nose landing gear / belly damage  
(Courtesy of airport manager)**
