CEN25LA202

## INVESTIGATION PHOTOGRAPHS

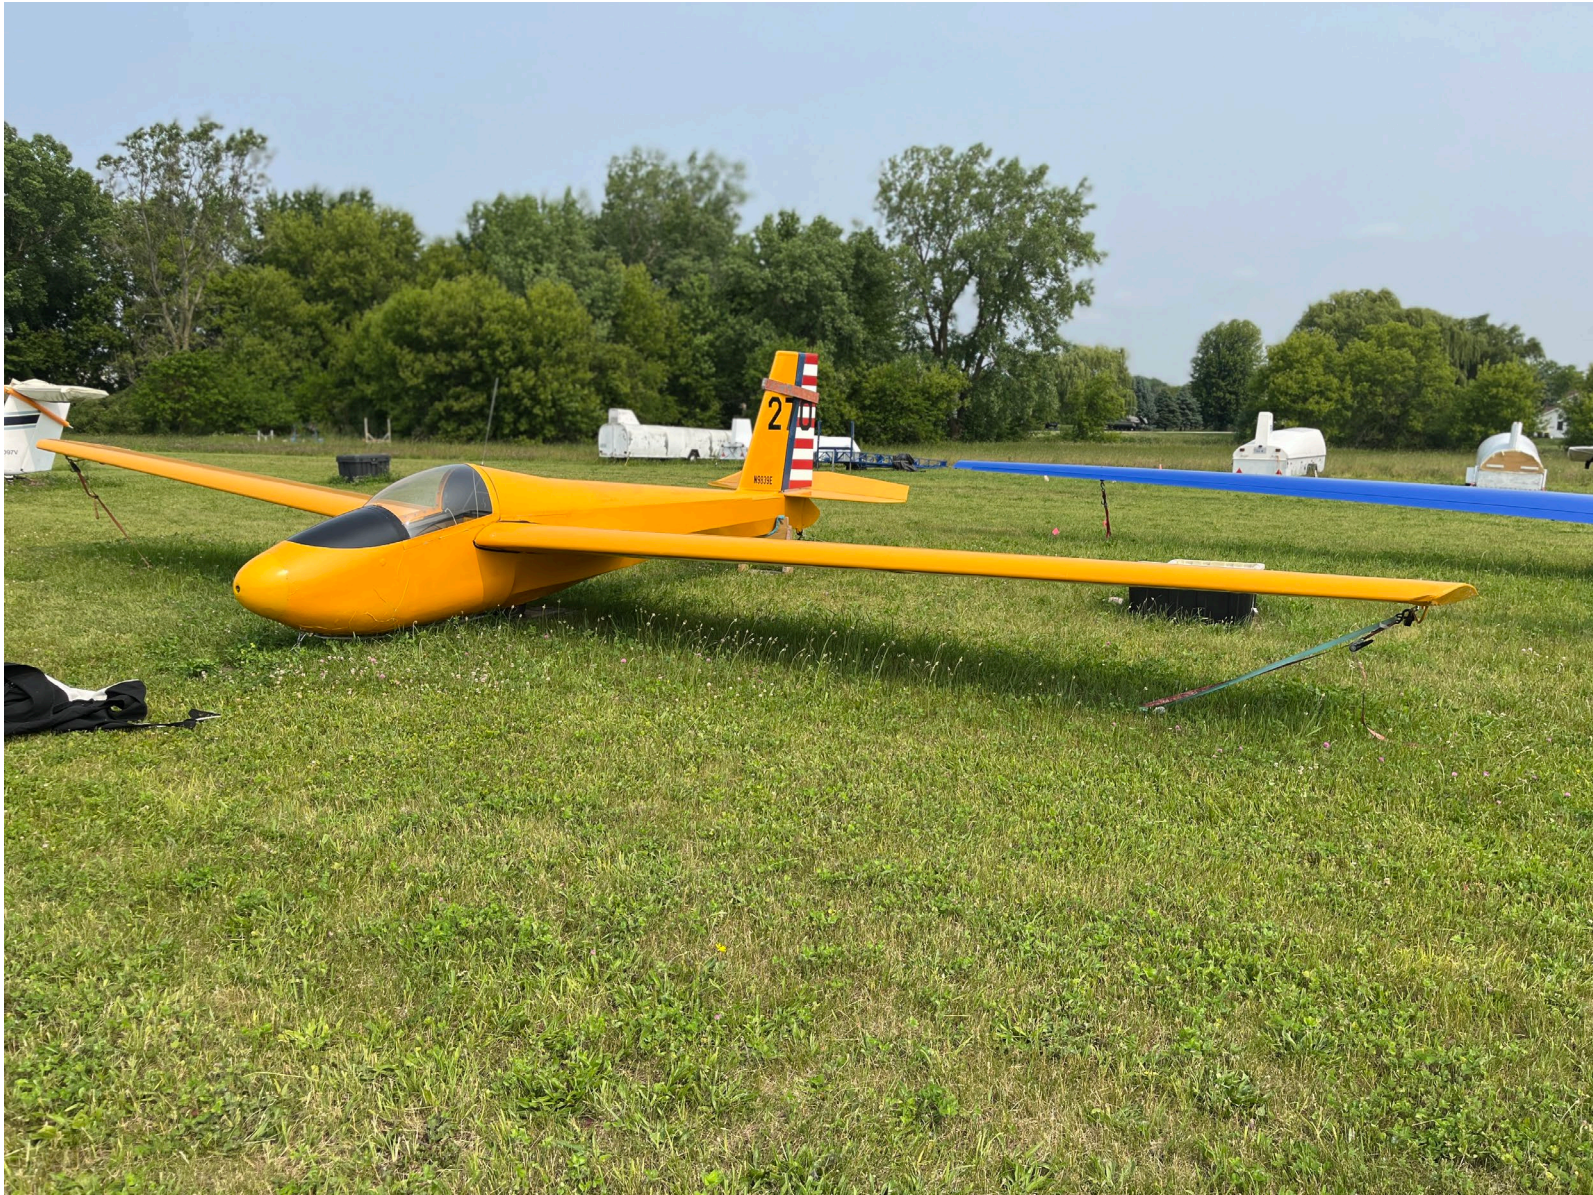
**Photograph 1 - Glider front left (Courtesy of FAA)**

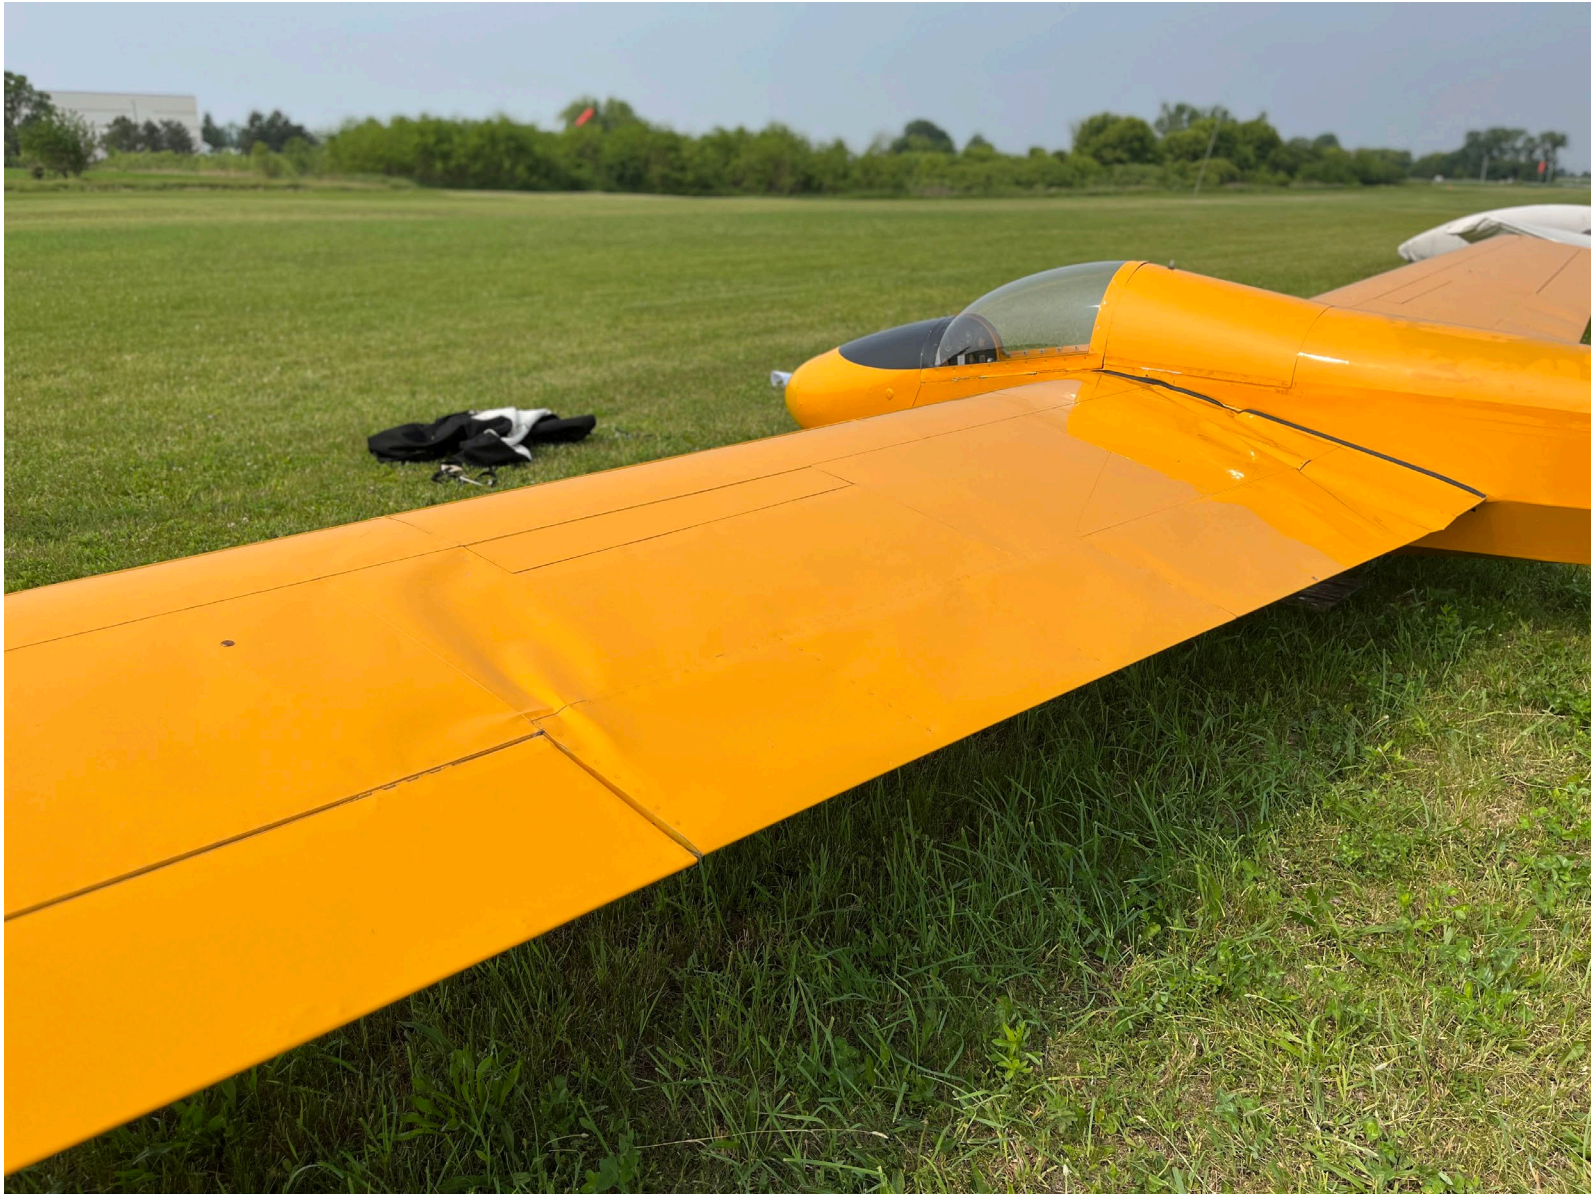
**Photograph 2 - Left wing damage (Courtesy of FAA)**

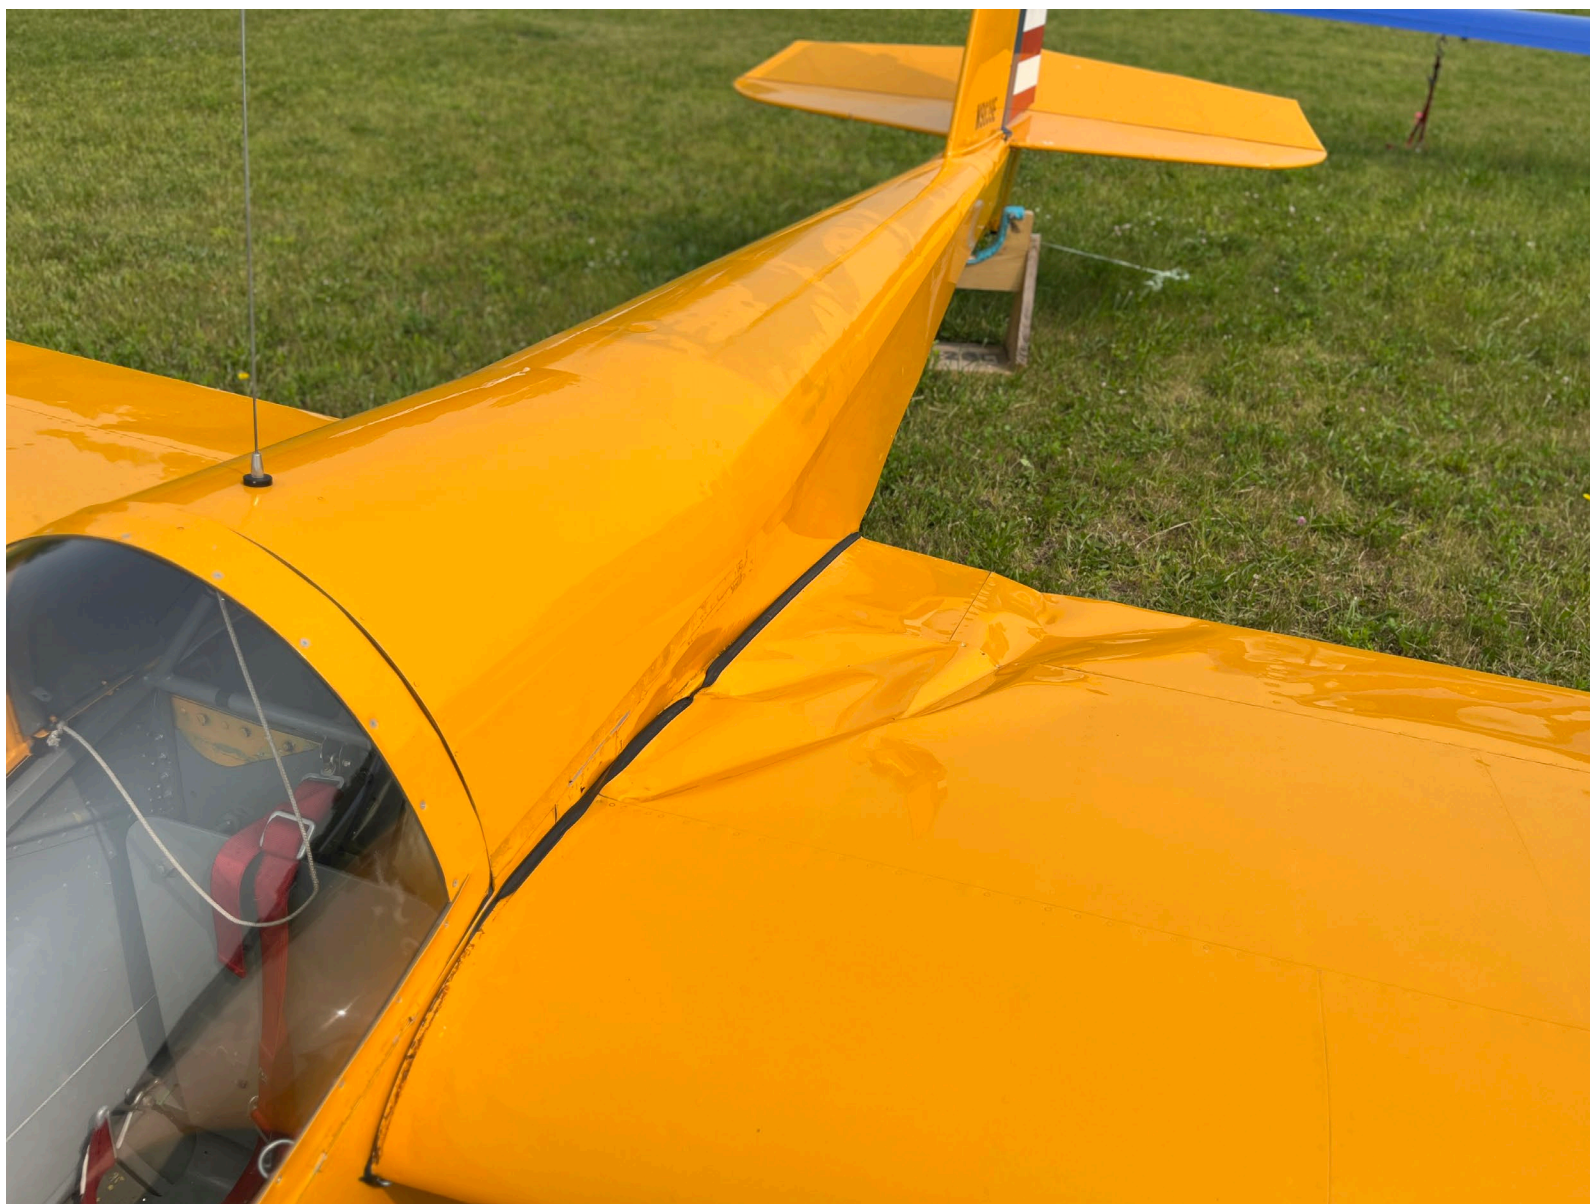
**Photograph 3 - Inboard left wing damage (Courtesy of FAA)**
