CEN25LA225

## INVESTIGATION PHOTOGRAPHS

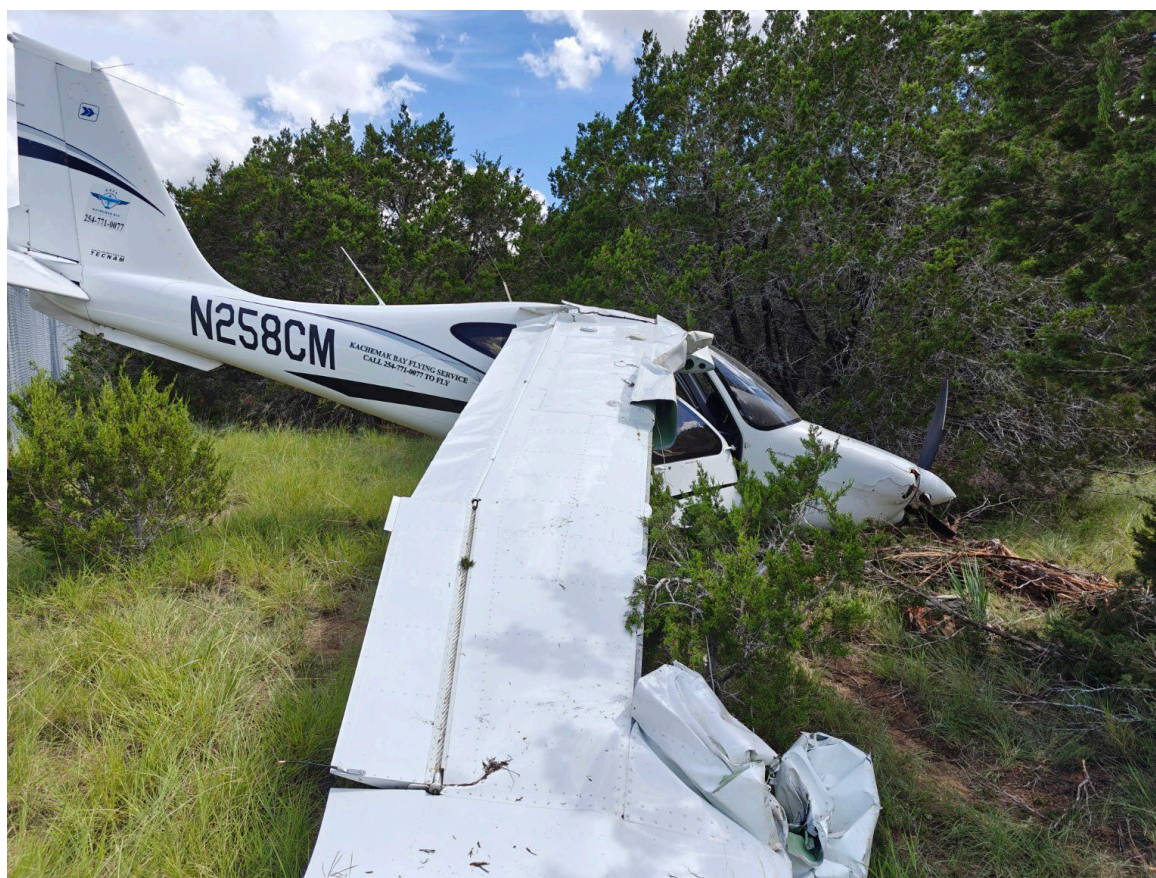
**Photograph 1 - Side view of airplane (Courtesy of FAA)**

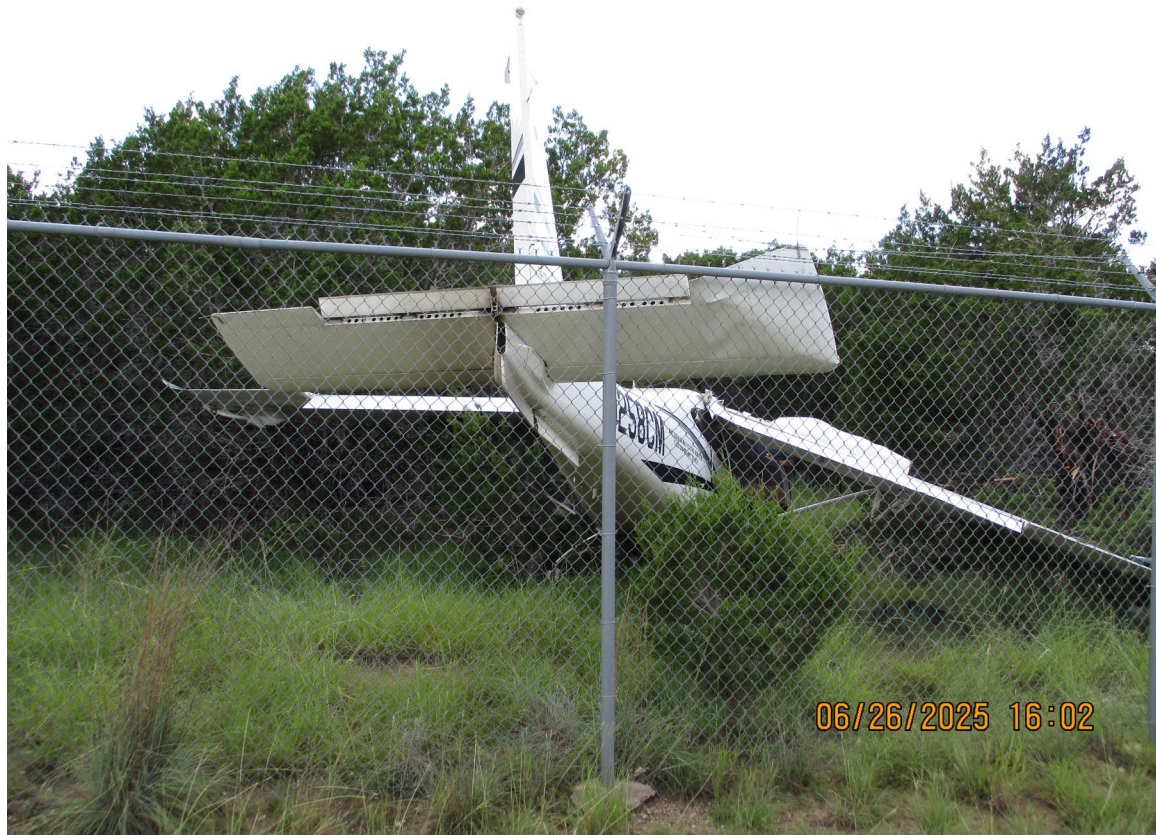
**Photograph 2 - Rear view of airplane (Courtesy of FAA)**

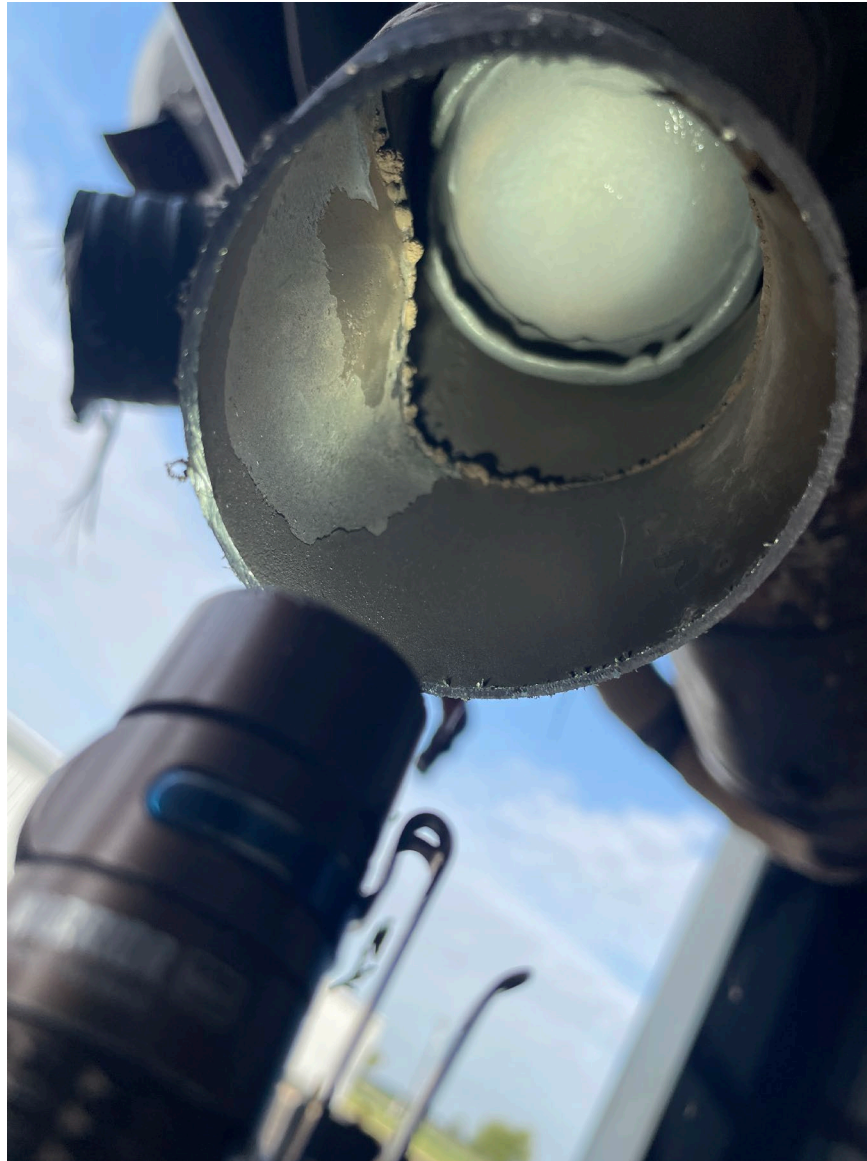
**Photograph 3 - Engine exhaust blockage as found (NTSB Photo)**

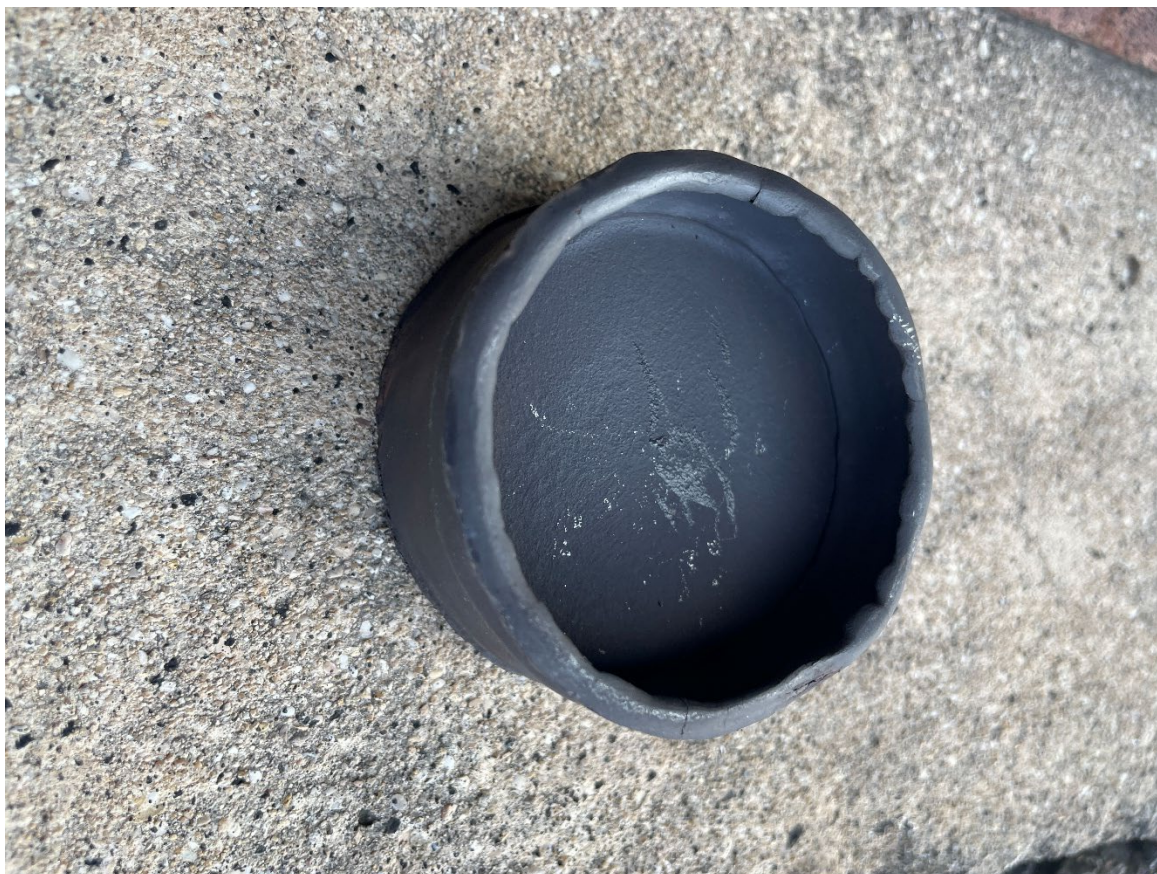
**Photograph 4 - Steel baffle plate removed from tailpipe (NTSB Photo)**

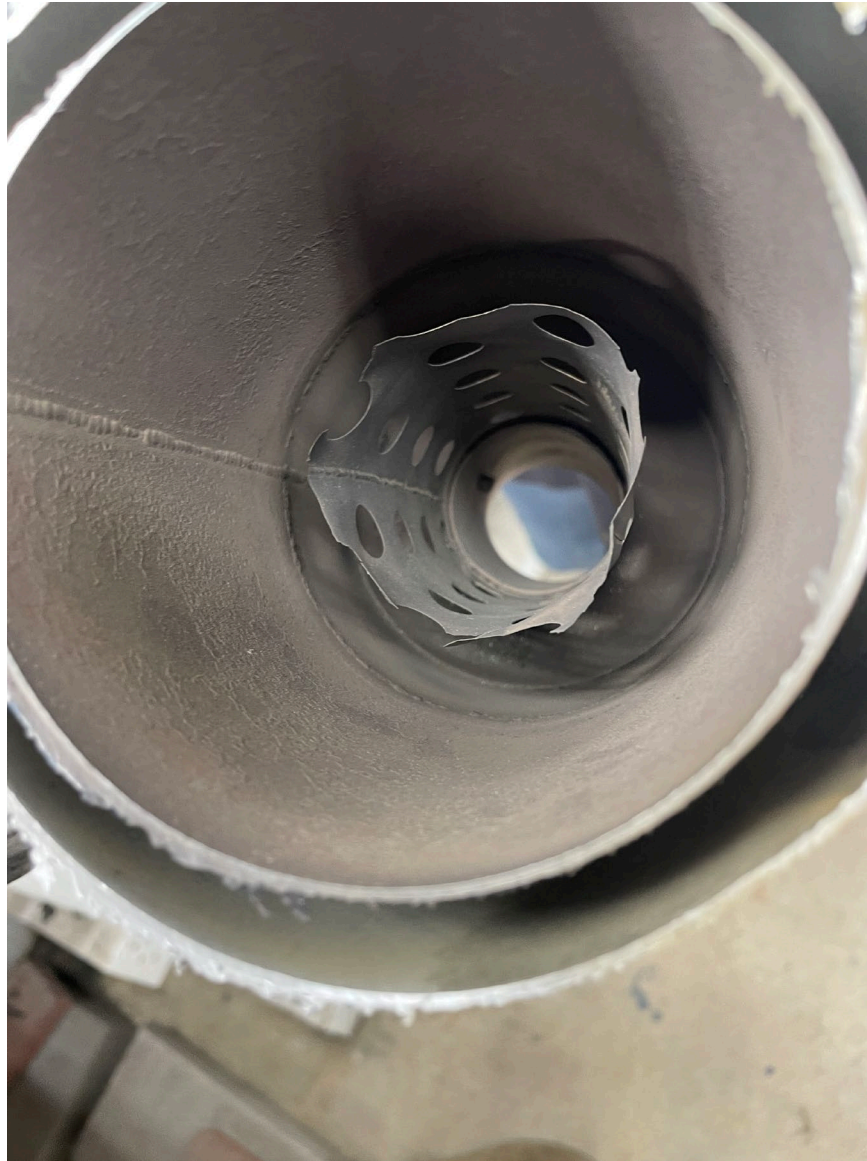
**Photograph 5 - Accident airplane muffler (NTSB Photo)**
