**N° SB 937 – CS – Ed. 1 Rev. 0****Date: 16/09/2025**

**Approval No: DO-937-250916***Page 1/5***MANDATORY** by the AD No. yyyy-xxxx ☐ **May become MANDATORY** after EASA evaluation ☒**RECOMMENDED** ..... ☐ **INFORMATION** ..... ☐**SUBJECT:** P2010 Lycoming – Exhaust Muffler Flame Tube Inspection

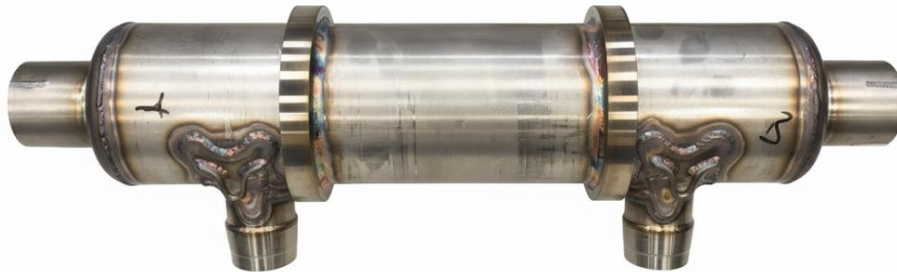
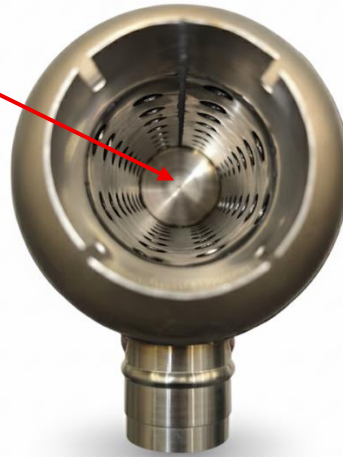
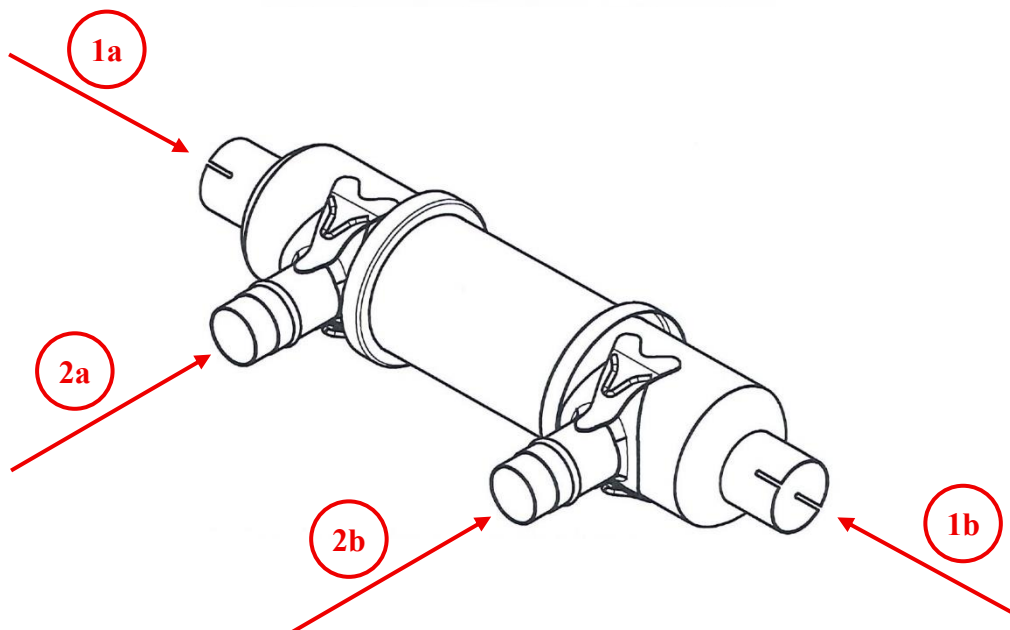
**Figure 1 - Lycoming IO-360 Exhaust Muffler Flame Tube Inspection**

| <i>N</i> | <i>Accomplishment Instructions</i> |
|---|---|
| <b>3a</b> | <p><b><i>Exhaust assembly P/N 210-6-2051-401 (applicable to Lycoming IO-360 only)</i></b></p> <p><b><i>Refer to Figure 1</i></b></p> <p><i>Perform a detailed borescope inspection of the internal surfaces of the perforated flame tube within the exhaust muffler, accessing the interior through both the left and right entry points (points 1a and 1b). Focus the inspection on the region adjacent to the steel baffle plate located at the mid-length of the flame tube itself. <u><b>It is mandatory to perform the inspection from both sides to ensure full coverage.</b></u> Check for any of the following conditions: cracks, fractures or any signs of potential initiation of such defects. Subsequently, conduct a borescope inspection of the external surfaces of the perforated flame tube by inserting the borescope through both the outlet ports normally leading to the exhaust terminals (points 2a and 2b), <u>checking for the same conditions as above.</u> The external surface of the flame tube shall be inspected along its entire length, with particular attention to the area around the two edges of the steel baffle plate that are welded to the flame tube.</i></p> |

**Steel baffle plate located at mid-length of the flame tube (view from the inside of the tube)**

| <i>N</i> | <i>Accomplishment Instructions</i> |
|---|---|
| <b>4</b> | <p><b><i>If any abnormal condition is found, contact Tecnam for further instructions (an Occurrence Report will be required)</i></b></p> <p><i>If no damage is found during the inspections as per steps 3a or 3b, proceed with reinstalling the exhaust muffler. Refer to the applicable procedure in AMM, ATA 78-10 (Lycoming IO-360) or AMM Supplement S6, ATA 78-10 (Lycoming IO-390)</i></p> |

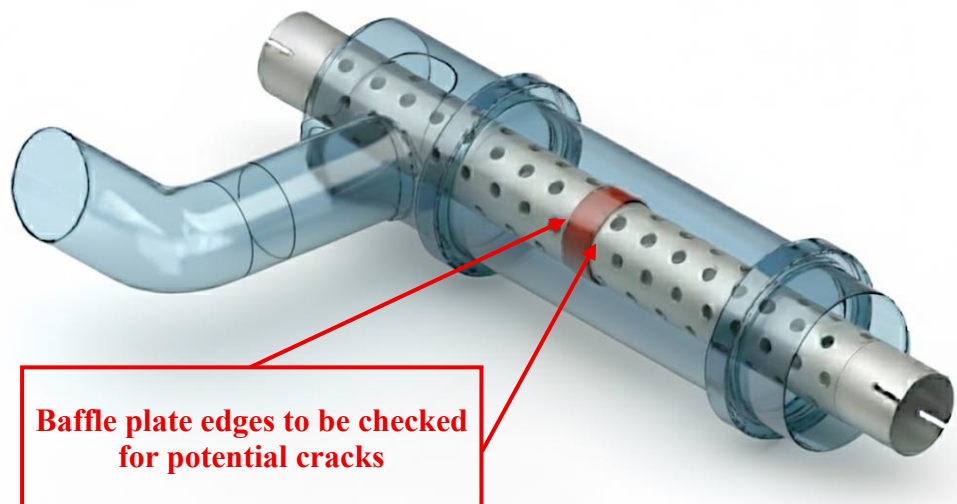
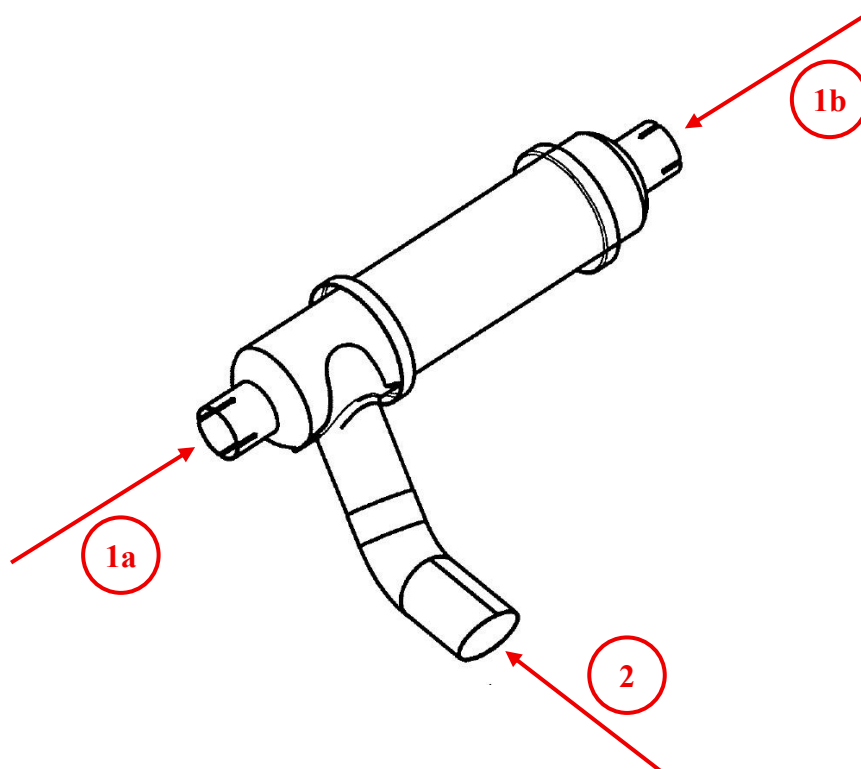
***Figure 2 - Lycoming IO-390 Exhaust Muffler Flame Tube Inspection (3D model for reference only)***

| <i>N</i> | <i>Accomplishment Instructions</i> |
|---|---|
| <b>3b</b> | <p><b><i>Exhaust assembly P/N 210-6-3200-401 (applicable to Lycoming IO-390 only)</i></b></p> <p><b><i>Refer to Figure 2</i></b></p> <p><i>Perform a detailed borescope inspection of the internal surfaces of the perforated flame tube within the exhaust muffler, accessing the interior through both the left and right entry points (points 1a and 1b). Focus the inspection on the region adjacent to the steel baffle plate located at the mid-length of the flame tube itself (the plate is highlighted in red in the 3D model shown as reference). <u><b>It is mandatory to perform the inspection from both sides to ensure full coverage.</b></u> Check for any of the following conditions: cracks, fractures or any signs of potential initiation of such defects. Subsequently, conduct a borescope inspection of the external surfaces of the perforated flame tube by inserting the borescope through the single outlet port normally leading to the exhaust terminal (point 2), <u>checking for the same conditions as above.</u> The external surface of the flame tube shall be inspected along its entire length, with particular attention to the area around the two edges of the steel baffle plate that are welded to the flame tube.</i></p> |
